# Mitchell Park Horticultural Conservatory Domes

Peer Review — Precast and Cladding

**WJE** | ENGINEERS  
ARCHITECTS  
MATERIALS SCIENTISTS  
Wiss, Janney, Elstner Associates, Inc.

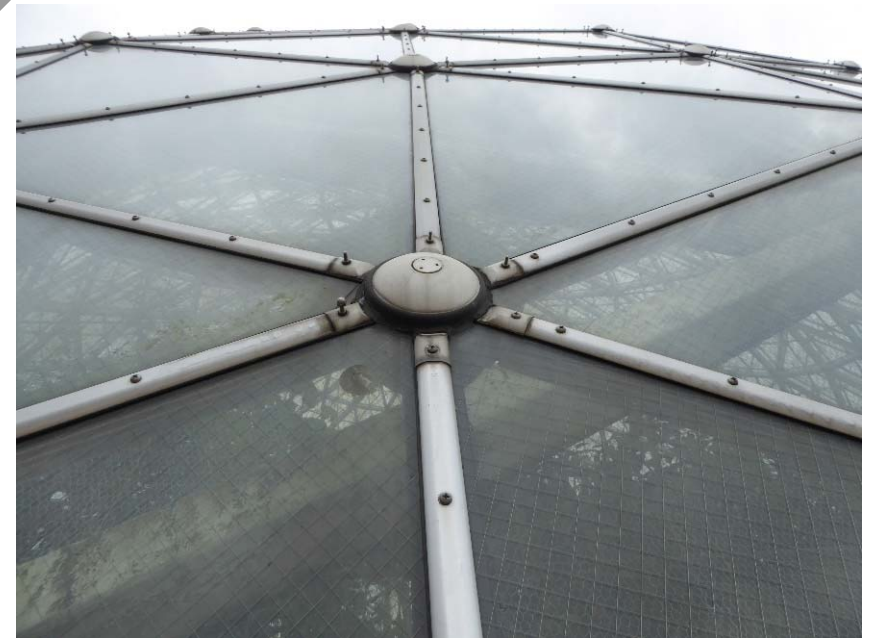
Circular hub

Opening in downspout rafter is slightly higher than base of hub

Water is intended to flow down the rafter at each hub and out at the base of the dome

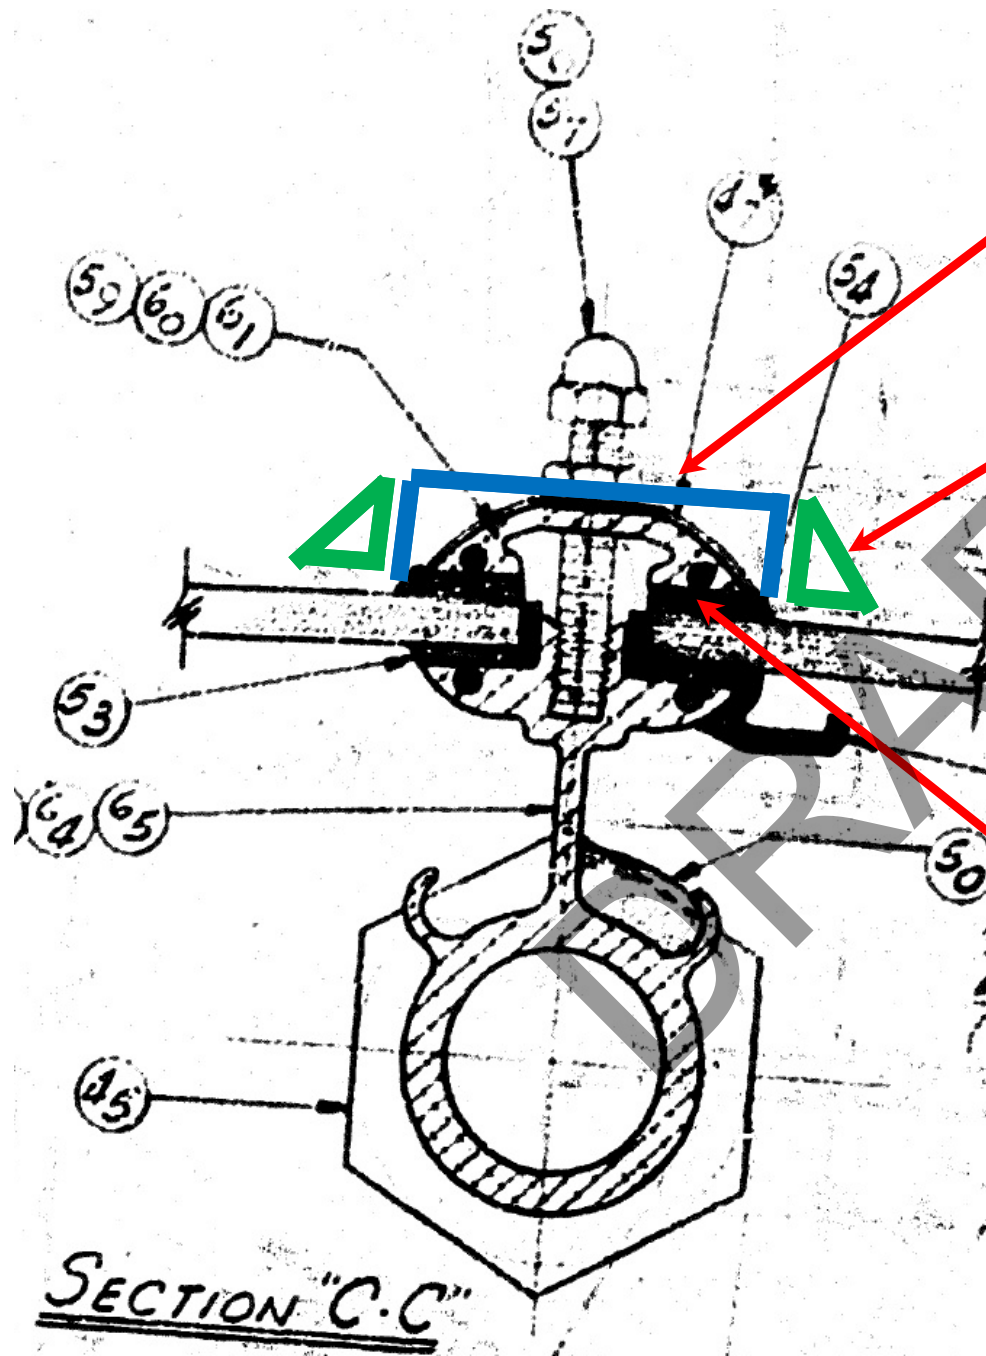
GRAEF observed water sitting in the hub below this elevation, which is likely causing water leakage at fittings. A self-leveling sealant can be installed to fill in the “depressed” area (GRAEF repair).

New pressure cap to enhance water tightness

New Sealant joint (wet seal)

New gasket

Water can then flow down the rafter at each hub and out at the base of the dome

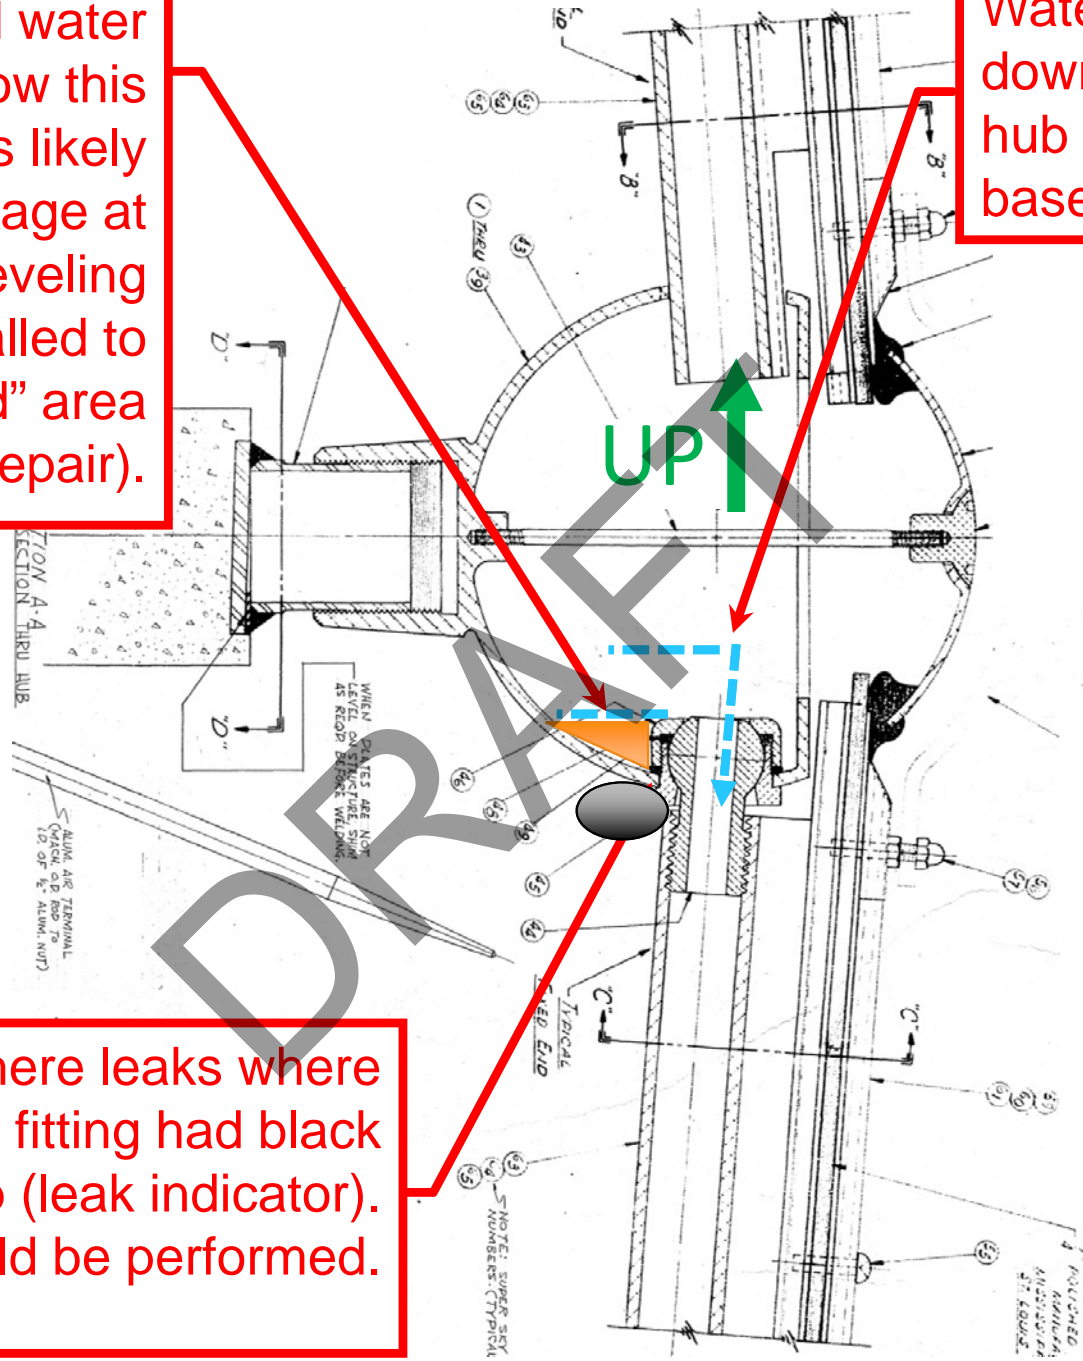
At locations where leaks were observed, the rafter fitting had black material build-up (leak indicator). Target repairs could be performed.
