**MILWAUKEE COUNTY**  
**Interoffice Memorandum**

**SUBJECT:** Caterpillar Site

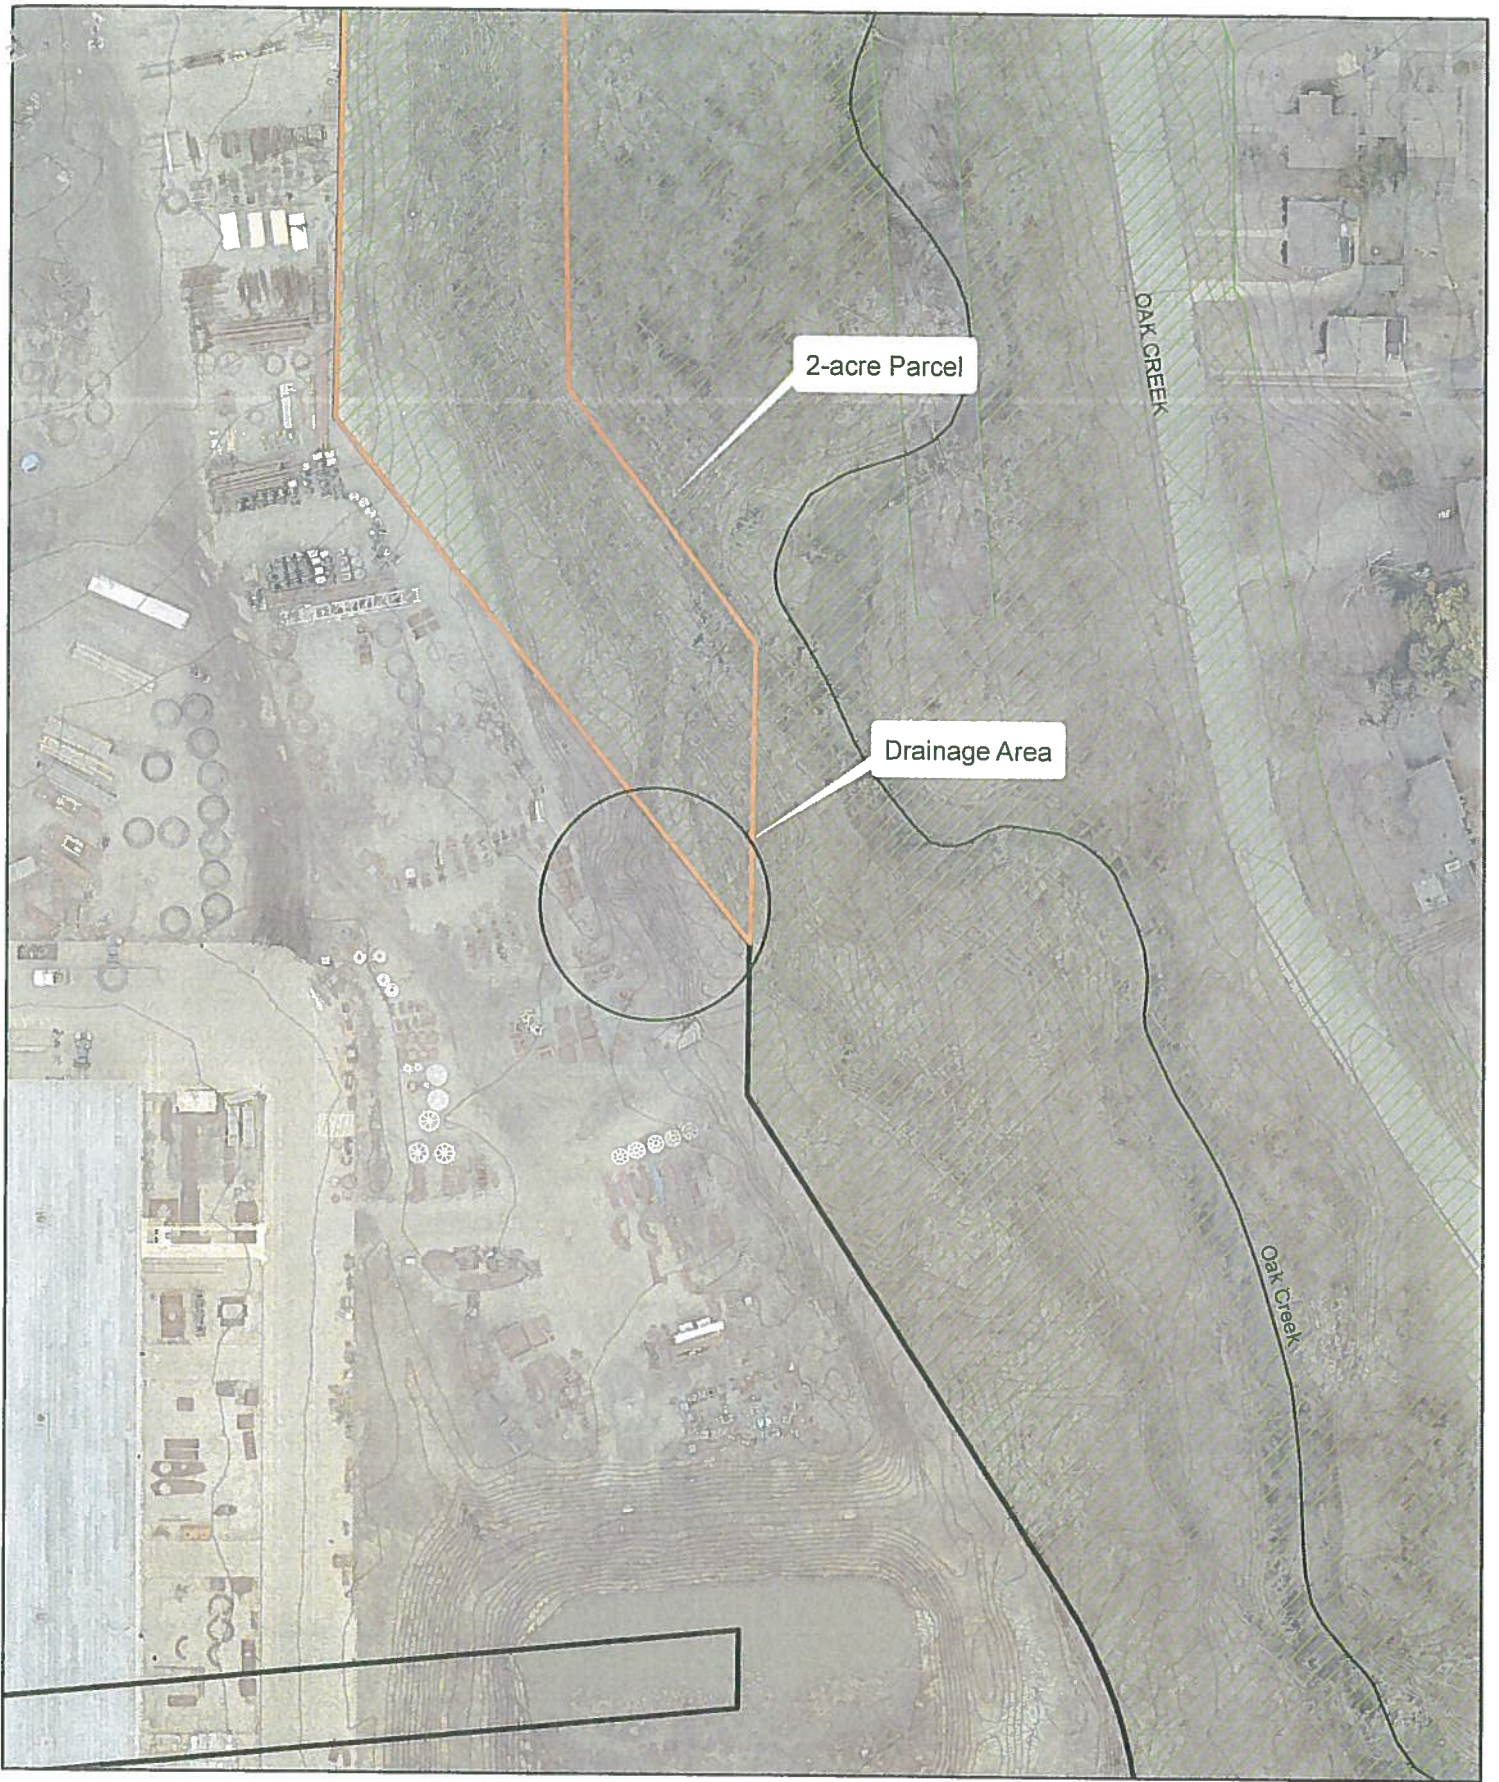
Area of Surface Water Drainage  
Figure 2

- As noted by John Osborne during the tour, an area of the landfill plateau, just west of the southwestern corner of the 2-acre parcel (Figure 2), drains storm water runoff down the east slope. The amount of flow appears to be sufficient to erode the slope, as evidenced from rivulets in the surface soil on the slope there. John Osborne indicated that, as part of the agreement, Caterpillar intends to re-direct this surface flow away from the east slope and to the storm water pond to the south.

Conditions of an agreement to transfer the parcel should require Caterpillar to make improvements to the side slope (provide buffer zone and maximum slope and vegetate), investigate the corrugated pipe outfall and redirect flow, redirect runoff from the plateau area to storm pond, and agree to perform regular inspections of the slope for erosion and seepage and effect prompt repairs to these if found.
