Subject: Capital Project WM05101 – MPM North Stairwell Structural Wall Repair

SUBJECT: MPM – North Stairwell Vestibule, phase one
Structural Investigation Report

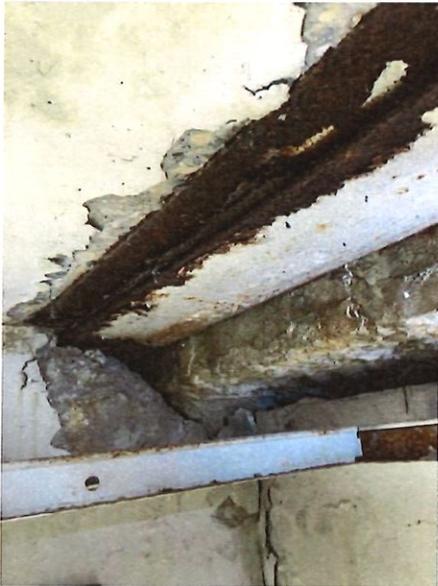
Vestibule - The ceiling of the upper level vestibule is a concrete slab that bears on an angle (L6x6x3/8) that is anchored to the north wall of the museum. Due to deteriorated waterproofing materials on the top of the structure, this angle has been exposed to water and is corroded (See Photograph 1, Appendix A). The bolts are not visible because the vertical leg of the angle is up turned and hidden from view by the slab. We assume the anchors are corroded as well, since we have seen this condition in other adjacent areas of the museum. The concrete framing around the door that separates the vestibule from the stairway has a very large crack at the top south corner of the door adjacent to the north wall of the museum (See Photographs 2 and 3, Appendix A). The reinforcement in this concrete is exposed at the crack. The rebar does not adequately reinforce this corner thus contributing to the cracked condition (See Photograph 4, Appendix A).

Photograph 1: Corrosion above horizontal angle leg in vestibule

Hence, we recommend temporary shoring of the vestibule, stairway and mezzanine floor slab above the men's toilet room. Solutions for this deterioration shall be designed in Budget Year 2020. Construction should be performed in Budget Year 2021. and constructed.

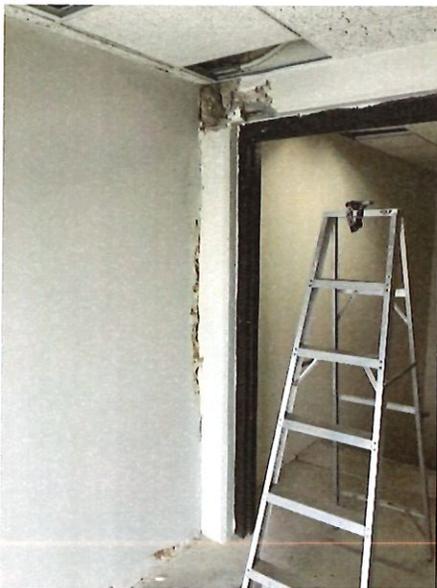
Photograph 2: Crack at doorway looking west in vestibule

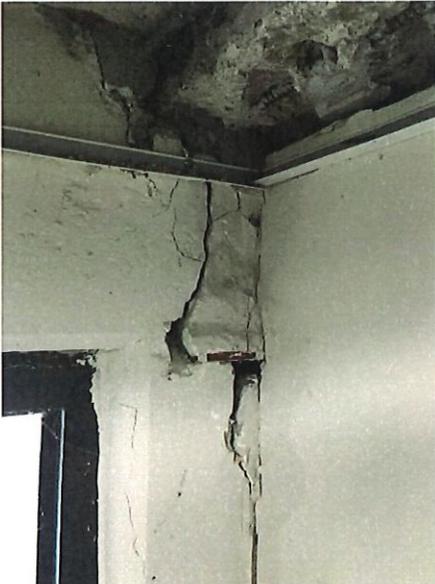
Photograph 3: Crack at doorway looking east from stairway

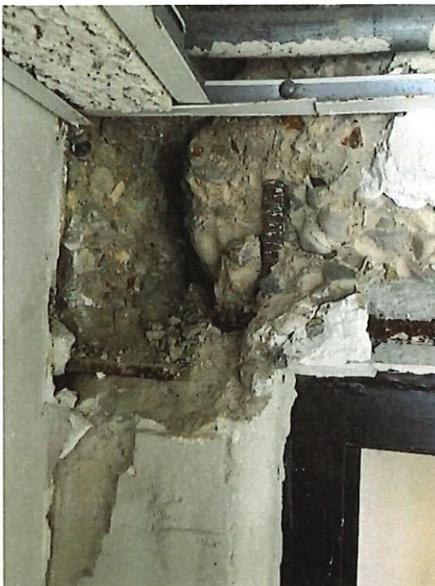
Photograph 4: Lack of proper reinforcement at doorway crack

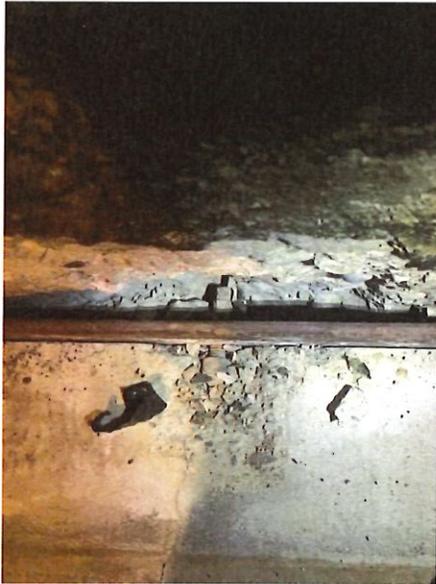
Photograph 5: Anchor pulled out of wall at mezzanine slab
