Ref.: Inspection Findings-Lyons Park Pedestrian Bridges over Lyons Creek

Structure Inspection Report

Structure Number: #1 (Southerly Bridge)

Location: Lyons Park Pedestrian Bridge over the Lyons Park Creek
(Tributary to the KK River)

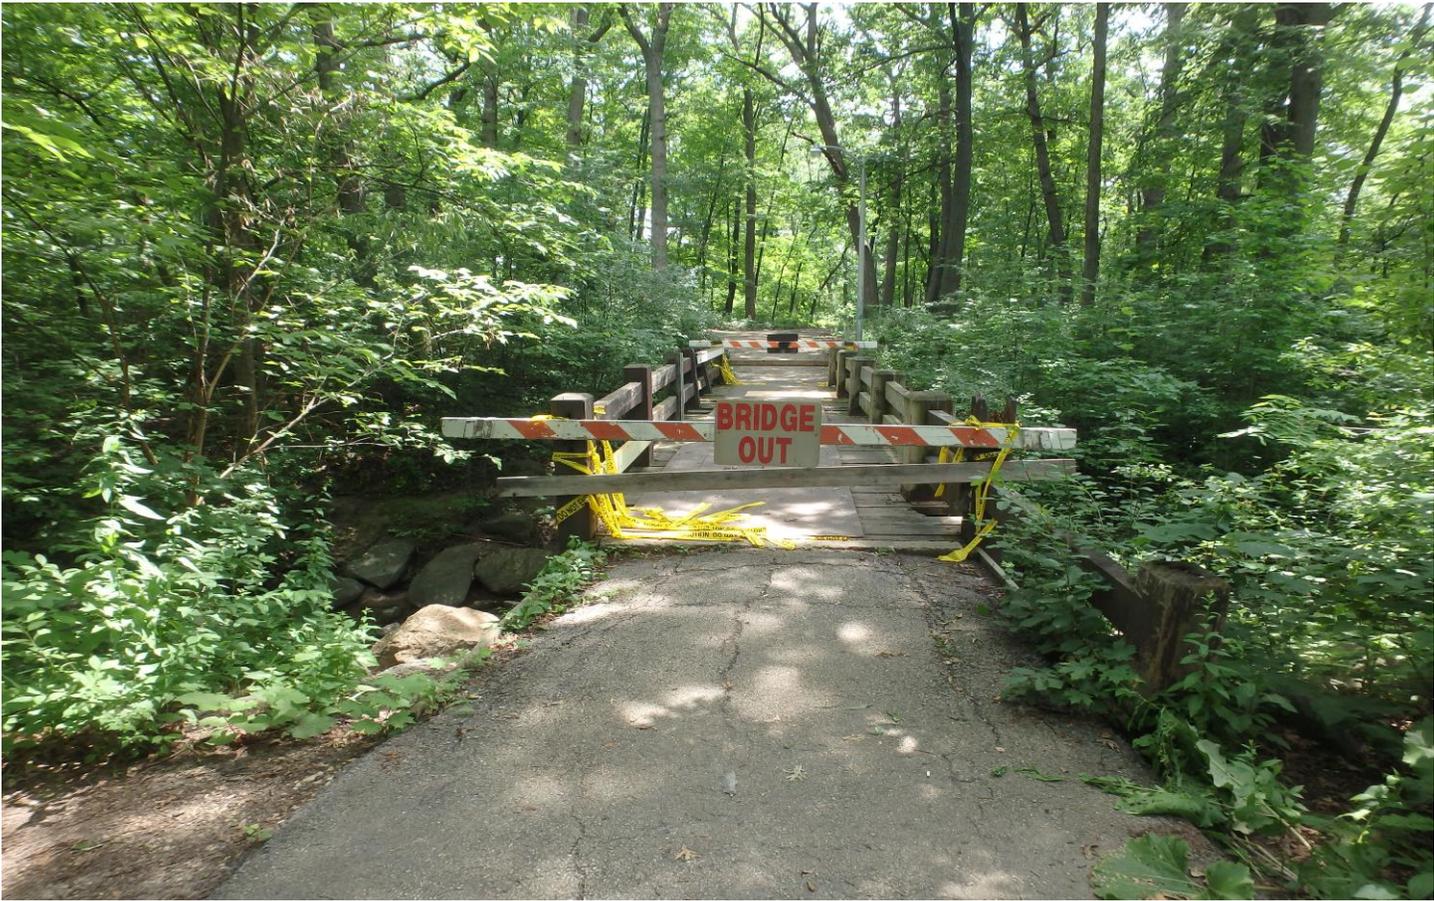
Plan View & Missing Approach Railing Looking South

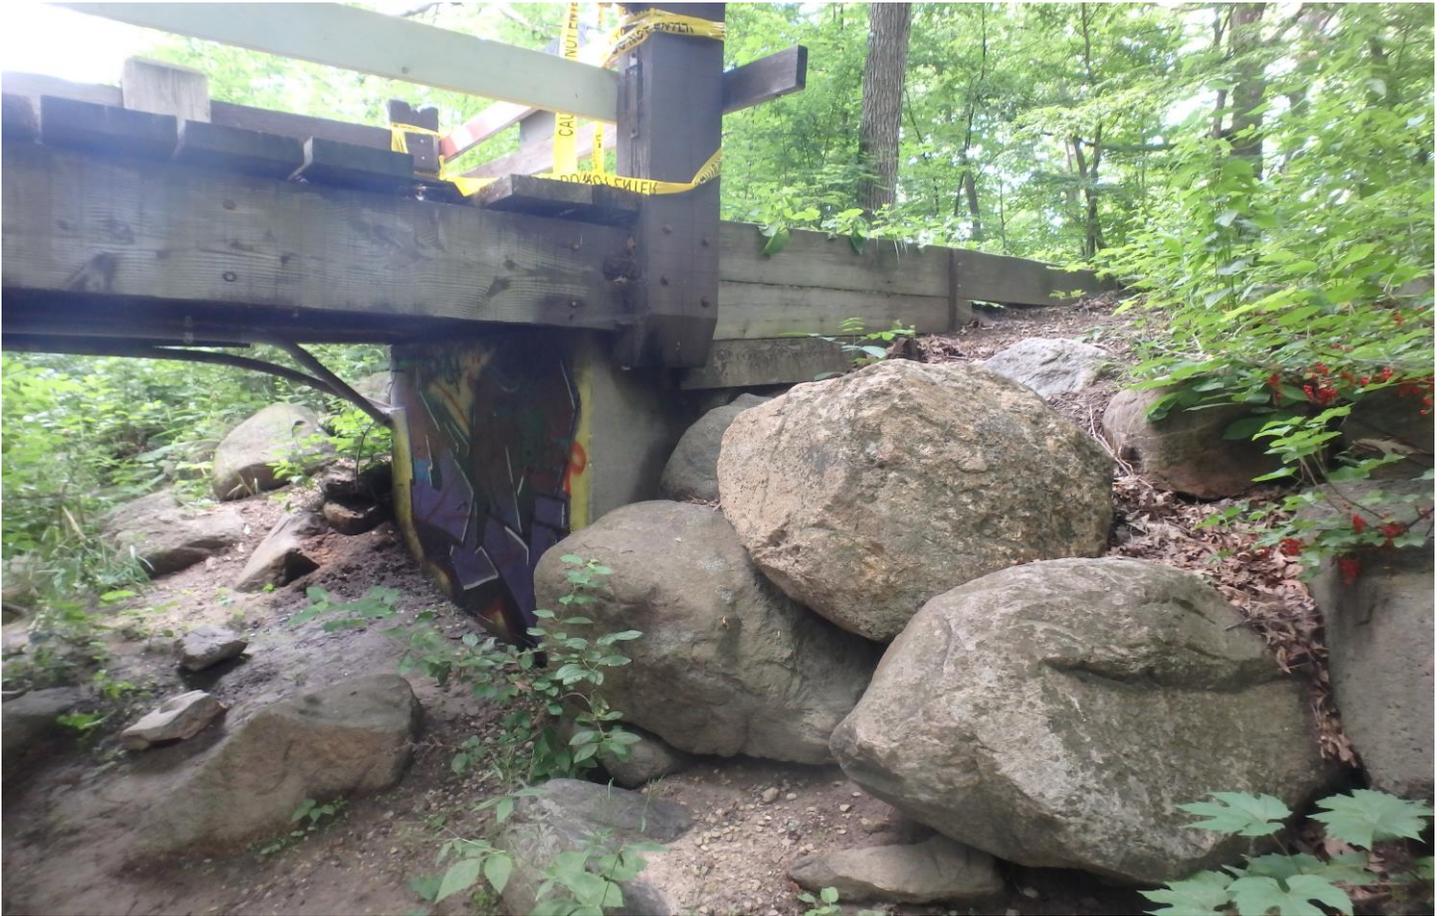
Existing Abutment & Slope Protection & Missing Approach Railing

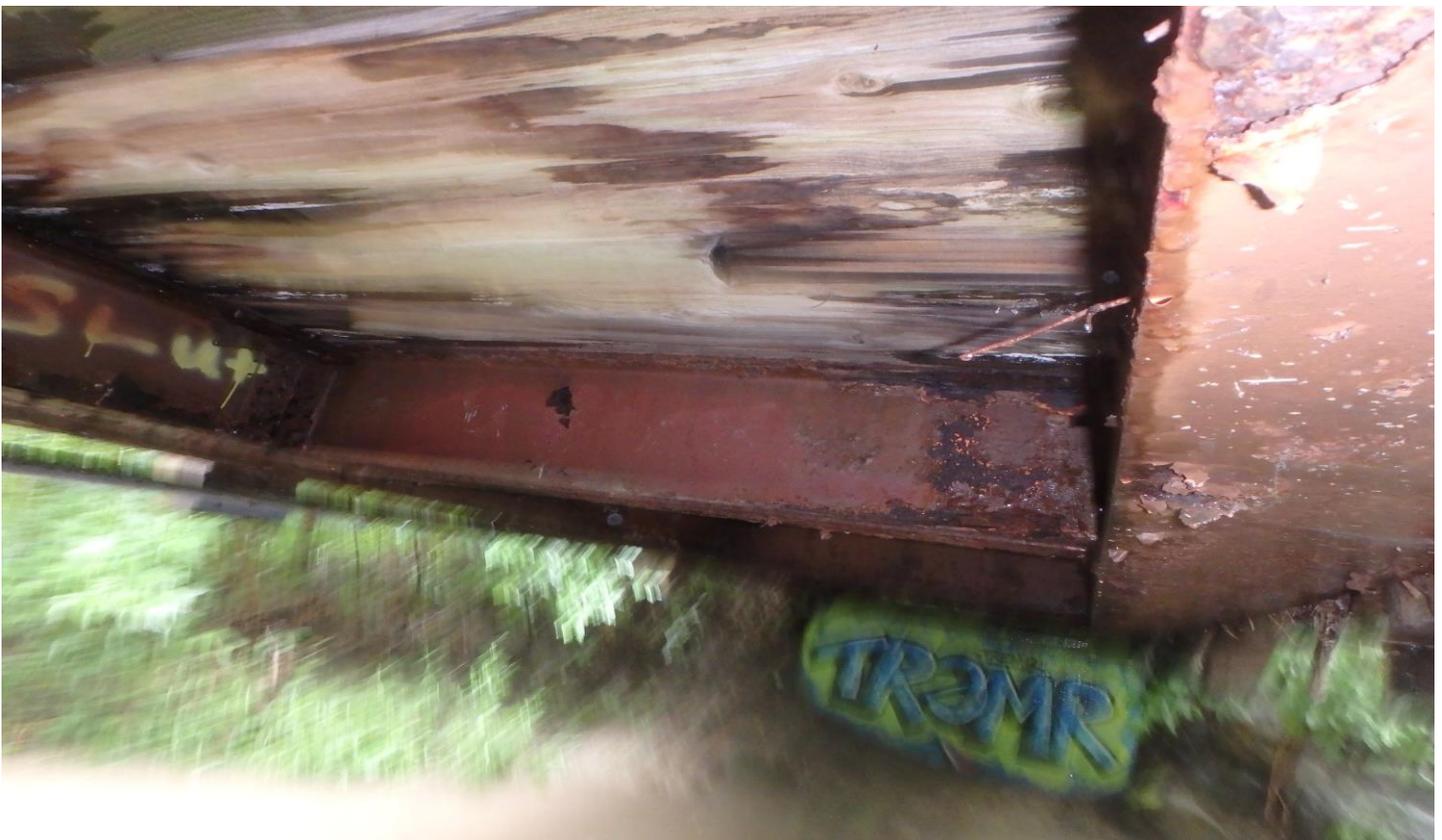
Structure Elements	Condition	Description
Superstructure	2	Poor condition with moderate to heavy steel corrosion and localized rotting, missing sections, and cracking of wood decking.
Girder/Stringer	2	Painted steel I-beam are corroded with localized minor to moderate loss of section. Paint system has failed. No sign of distress.
Floor Beams	N/A	
Diaphragm & Bracing	2	10" I-Beams
Slab / Deck	2	Wood planks
Substructure	4	Generally in good to fair condition.
Column	N/A	
Bracing	N/A	
Footing	N/A	
Abutment	4	
Wing Wall	N/A	
Retaining Wall	N/A	
Railing	1 NTS	Poor and failed condition. Not to Standard.
Riding Surface	N/A	
Approaches	3	Asphaltic approach pavement in fair condition with scattered cracks and localized rutting
Geometry	3	Bridge abutment in water during heavy rain events
Waterway	Adequate	No sign of erosion, scour, and/or bank stability
Utility	4	Two 2" metal conduits hung on the underside

Underside showing the General Rotted Wood Deck and Corroded Supporting Structural Steel

Rehabilitate or replace.

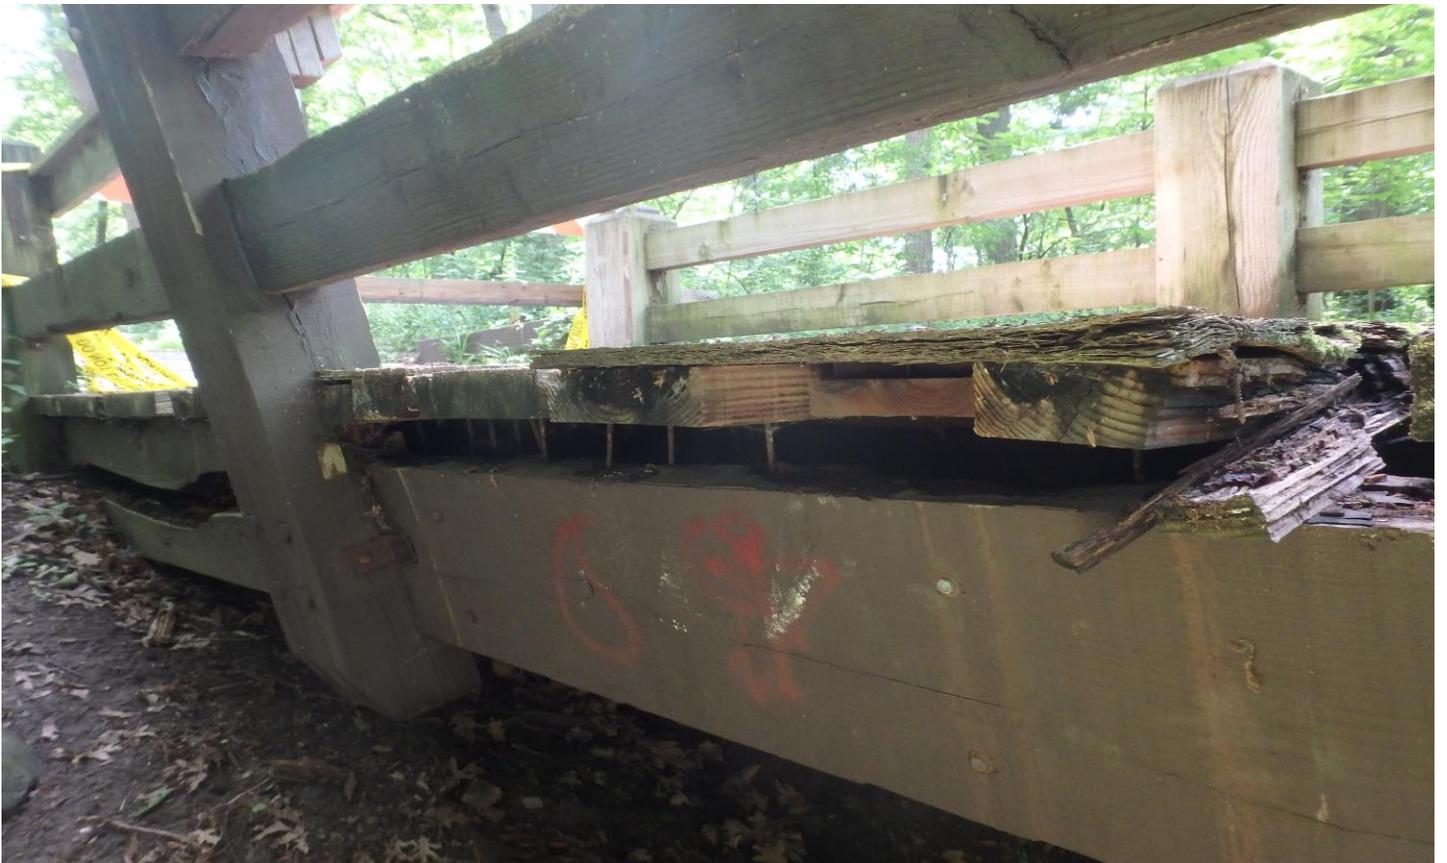
Rotted and Failed Railing, Wood Deck, and Fascia Beam

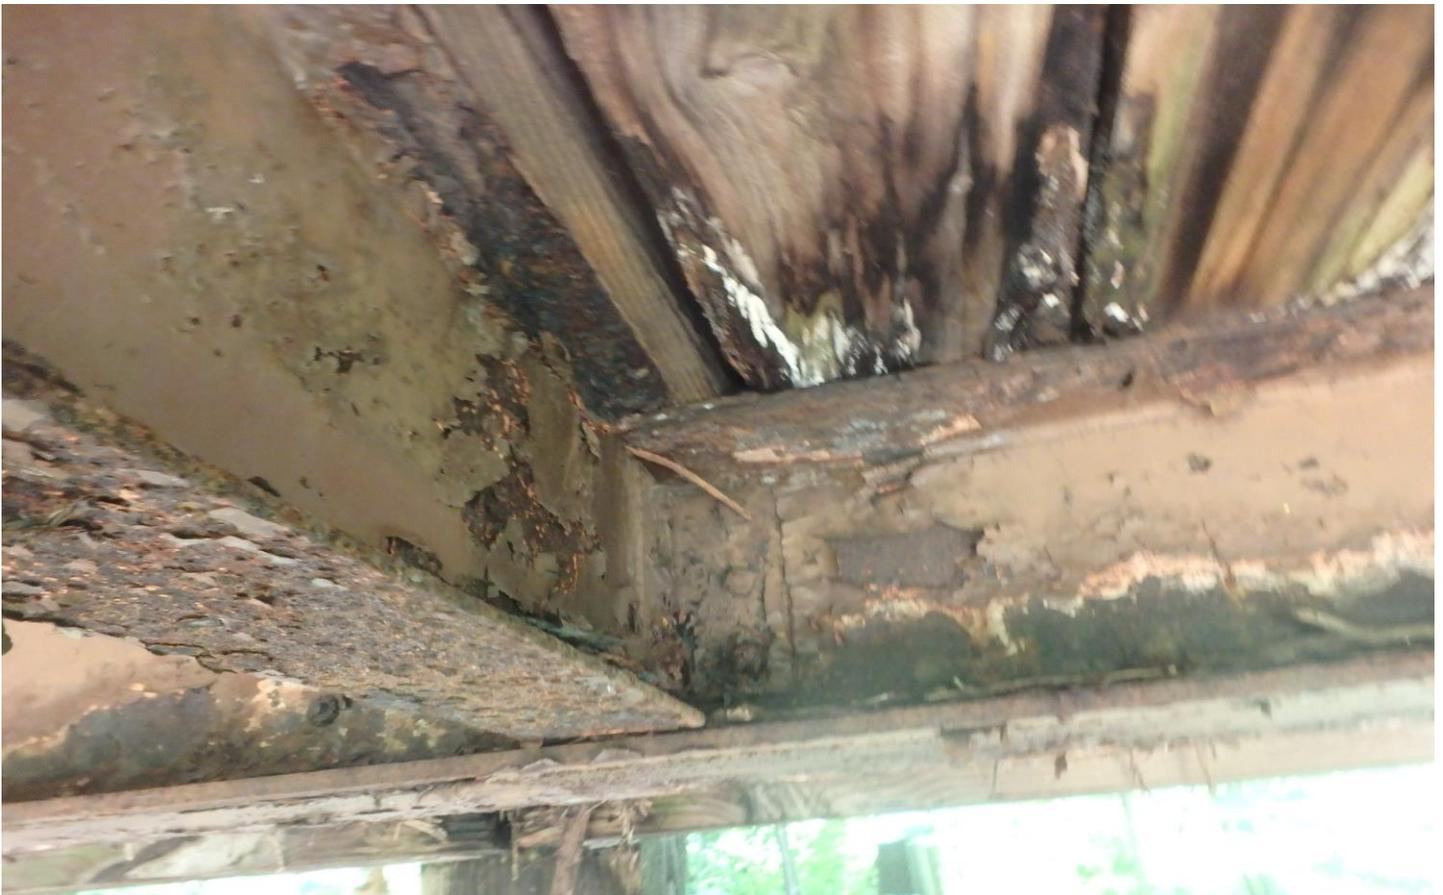
Structure Elements	Condition	Description
Superstructure	2	Poor condition with moderate to heavy steel corrosion and localized rotting, missing sections, and cracking of wood decking.
Girder/Stringer	2	Painted steel I-beam are corroded with localized minor to moderate loss of section. Paint system has failed. No sign of distress.
Floor Beams	N/A	
Diaphragm & Bracing	2	10" I-Beams
Slab / Deck	2	Wood planks
Substructure	4	Generally in good to fair condition.
Column	N/A	
Bracing	N/A	
Footing	N/A	
Abutment	4	
Wing Wall	N/A	
Retaining Wall	N/A	
Railing	2 NTS	Poor condition. Not to Standard.
Riding Surface	N/A	
Approaches	3	Asphaltic approach pavement in fair condition with scattered cracks and localized rutting
Geometry	3	Bridge abutment in water during heavy rain events
Waterway	Adequate	No sign of erosion, scour, and/or bank stability
Utility	3	Corroded 2" metal conduits hung on the underside

Underside of Deck showing corroded steel and rotted wood decking

Rehabilitate or replace. Most likely, this is the last year to remain open to the public without major repairs.

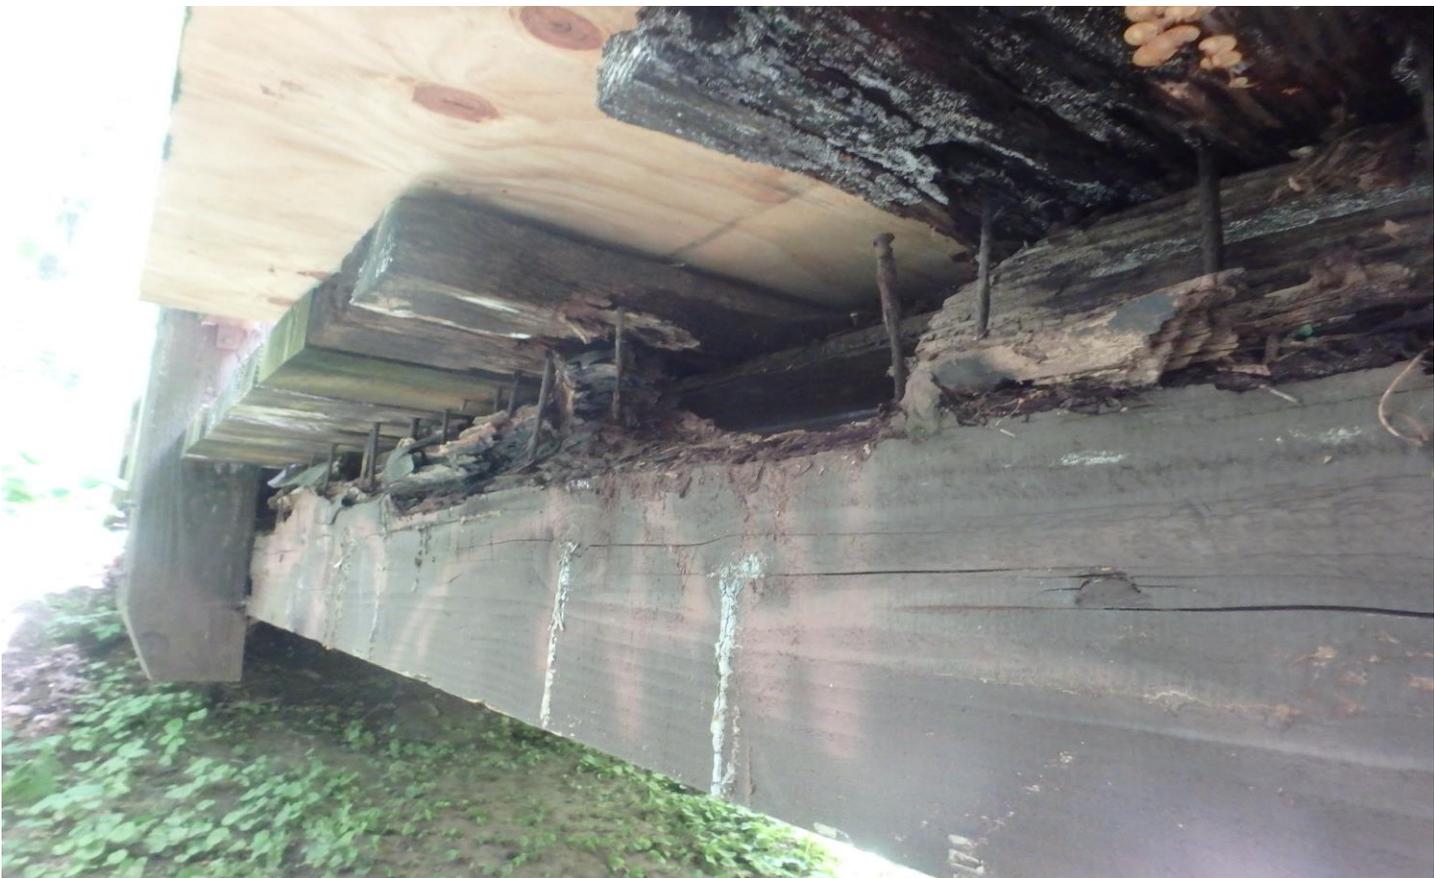
Rotted wood decking and wood fascia beam
