**MITCHELL PARK HORTICULTURAL CONSERVATORY
DOMES
Peer Review**

Milwaukee, Wisconsin

Final Report

WJE No. 2016.2700

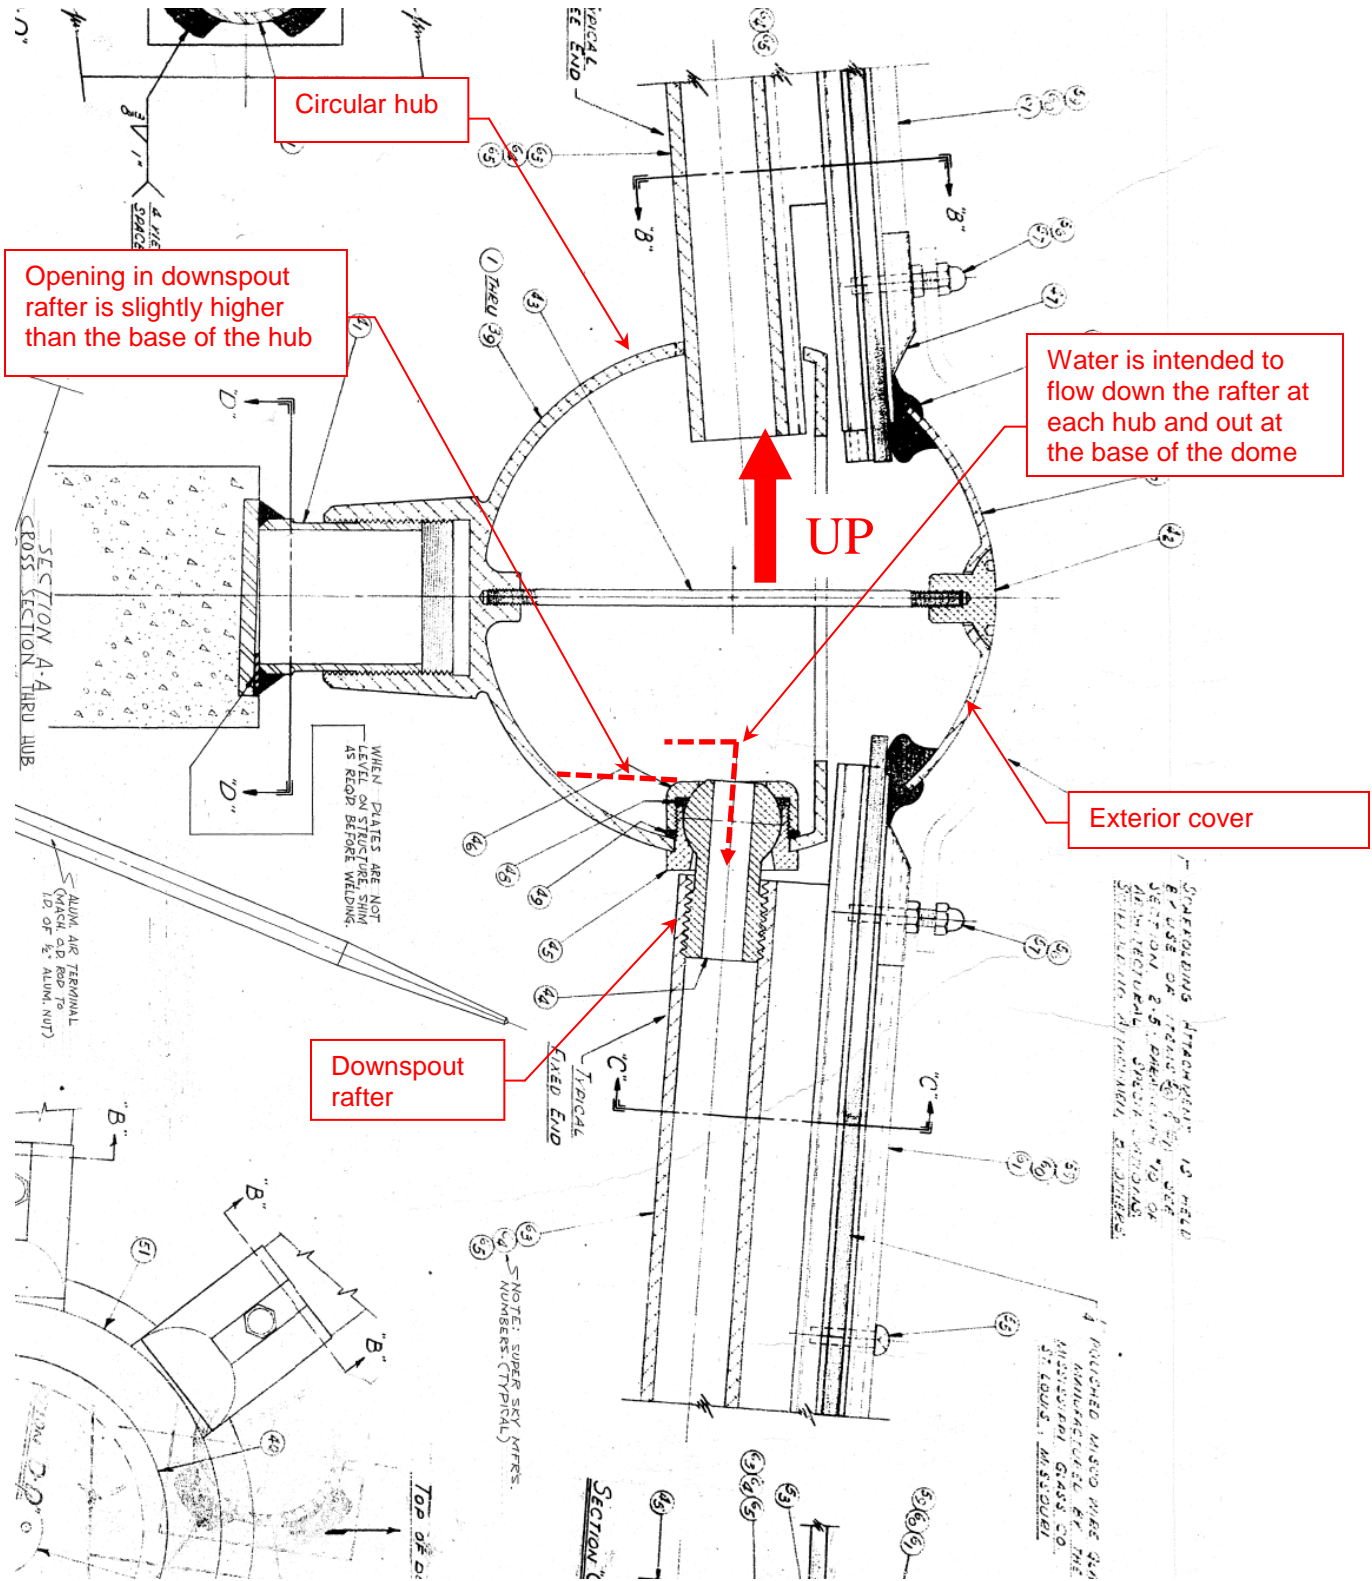
Figure 9. Section through hub from original drawings showing hub cladding drainage system

- GRAEF reported that water leakage throughout the domes has historically been a problem and still remains an ongoing issue. GRAEF reported that water was observed sitting in the hub and not allowed to drain. They attribute this problem as due to the fact that the downspout rafter extends higher than the base of the hub (see Figure 9).

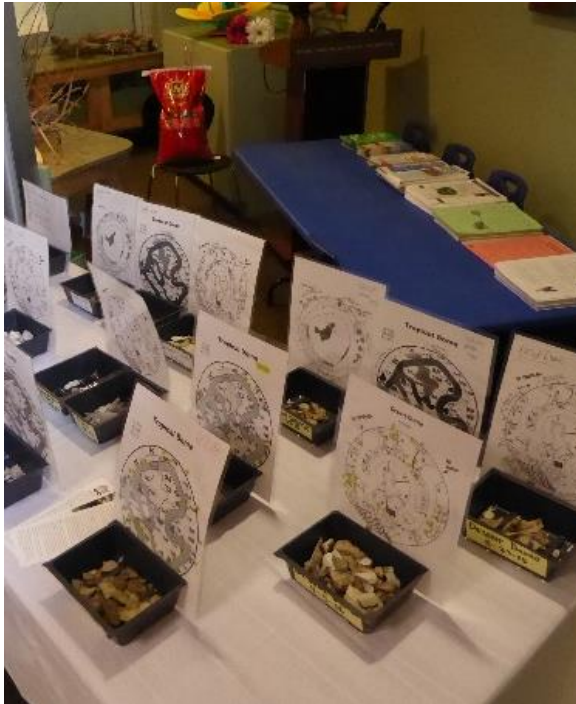
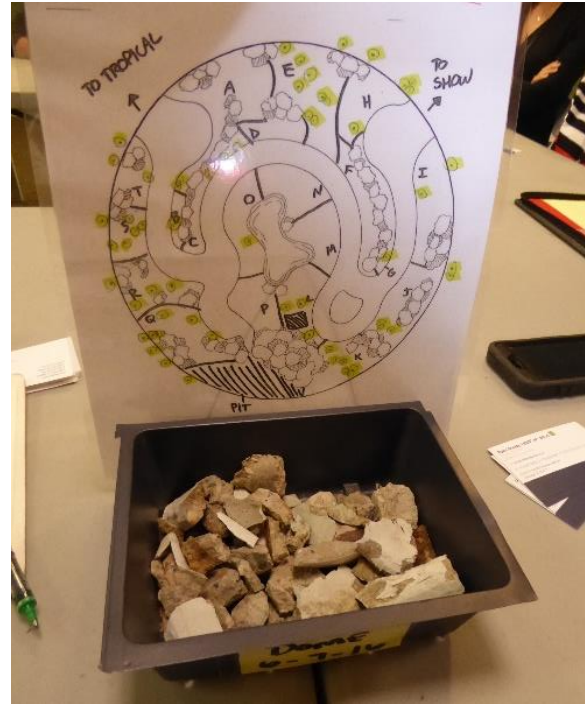
Figure 10. Fragments of concrete collected by Milwaukee County Parks staff

Figure 11. Close-up of fragments of concrete collected by Milwaukee County Parks staff

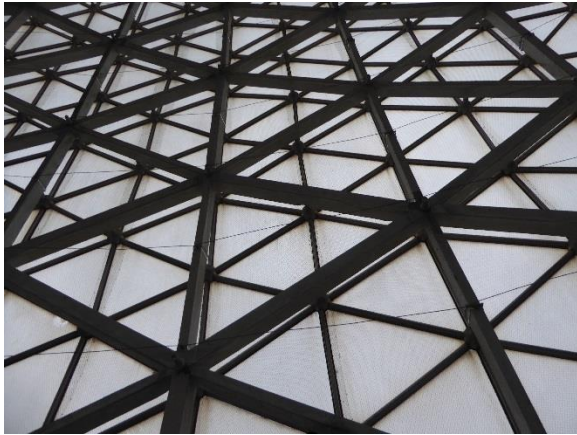
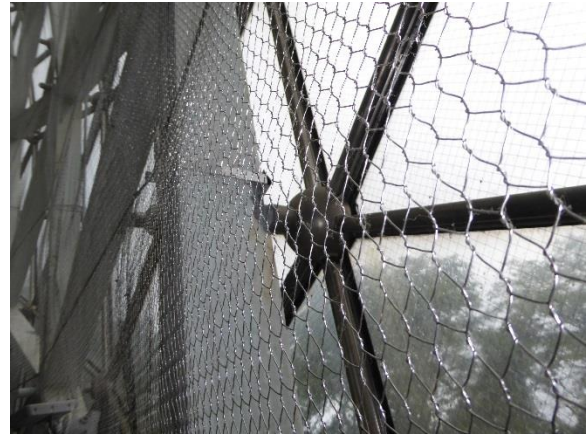
1. Mesh netting secured to the precast framing with cables was observed in the Show Dome (Figures 12 and 13). The netting was in the process of being installed in the Arid Dome.

Figure 12. Netting and cables in Show Dome

Figure 13. Close-up of netting in Show Dome

- The wire mesh could be removed after the repairs are completed to address water infiltration and spalling at embedded plates. Removing the wire mesh would require regular inspections and maintenance repairs to be completed as necessary. However, the mesh does provide a safety barrier against spalling concrete that has occurred in the domes.

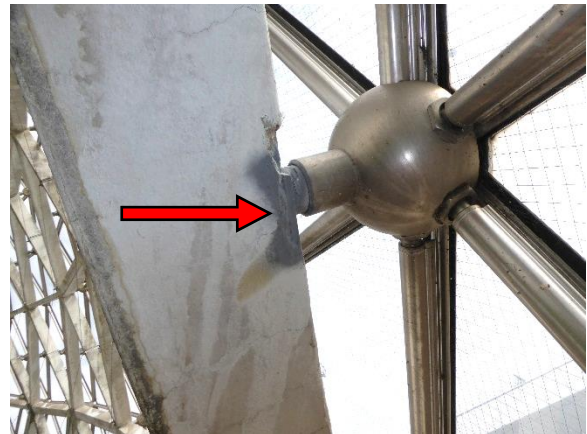
3. Concrete spalls had been removed at several embedded connections where the hub from the glass cladding is supported by the precast framing (Figures 14 and 15). The embedded plate was painted at the location of removed spalls.

Figure 14. Removed spall at connection location. Note: connection is painted with blue colored coating.

Figure 15. Removed spall at connection location. Note: connection is painted with blue colored coating.

Based on our walk-through observations and review of previous GRAEF reports, the precast concrete framing appears to be in fair condition and consistent with long-term exposure to moisture and the environments within the domes. The primary issue is spalling concrete at the embedded connections, which appears to be the result of shallow concrete cover, corrosion of embedded plates, and cyclic temperature changes. Shallow concrete cover on the sides of the embedded plates makes the concrete susceptible to spalling as originally designed. The greatest amount of spalling was observed in the Desert Dome. We would expect the humidity level to be the least in the Desert Dome, which may indicate that the humidity level is not a significant factor in causing corrosion at embedded plates and subsequent concrete spalling.

The spalling hazard can be eliminated by removing the concrete cover at embedded plates. Installation of the netting system has mitigated concerns with spalling concrete. Corrosion at embedded plates will continue if ongoing water leakage is not resolved. We would anticipate that the amount of spalling concrete will decrease as water infiltration is minimized and a higher percentage of spalls are removed at connection plates. Concrete deterioration within the main body of the concrete member has only been an issue at a few locations with minimal concrete cover over reinforcing bars. However, continued exposure to moisture with a failed coating system can lead to additional deterioration of the concrete if not addressed.

1. Remove delaminated concrete at embedded plates, and clean and paint the plates. Proactively removing potential spalls at connection plates could be performed, but may not be necessary if the netting remains in place. If removing the netting is desirable, we recommend proactively removing potential spalls at embedded connections.
2. Repair concrete spalls with exposed reinforcing steel within the body of the precast member.
3. Repair deteriorated areas of grout.
4. Clean and paint the concrete with a coating system capable of bridging over cracks. Some cracks and joints may need to be stripe coated or sealed prior to the coating installation.

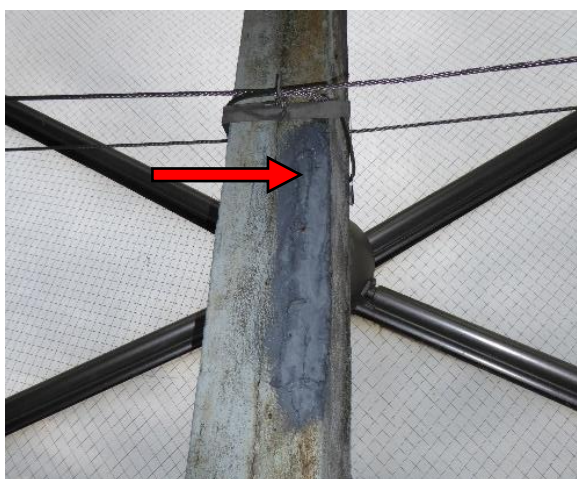
4. Concrete spalls, previously removed, were observed within the body of the precast concrete member, exposing reinforcing steel at a few locations in the Arid Dome (Figures 16 and 17). The reinforcing steel appeared to have minimal concrete cover.

Figure 16. Removed spall within the body of the precast element. Note: concrete and reinforcing steel was painted with a blue colored coating.

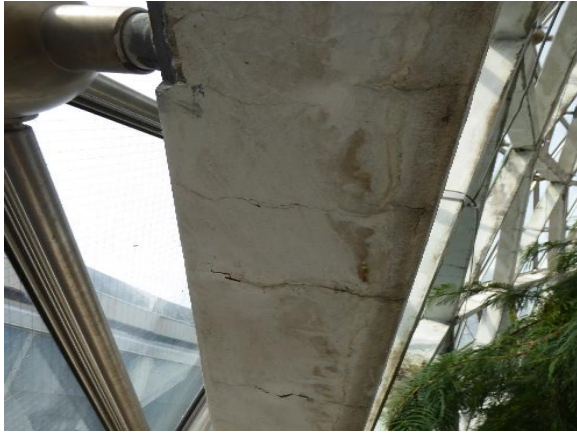
Figure 18. Transverse cracks on precast member

The cracks observed on precast members are not an indication of any structural deficiency and appear to be the result of concrete shrinkage and stresses associated with normal structural behavior. In their current state, the cracks will continue to open and close with temperature change. The drying shrinkage in this concrete has mostly taken place and is not a factor to cause further cracking. The cracks should be protected from moisture. GRAEF reported cracks between precast members, and between the concrete base and precast members. We suspect that the cracks were observed in the coating system at the joint between precast members and between the concrete base and precast members. The joint should be sealed during the installation of the new coating system.

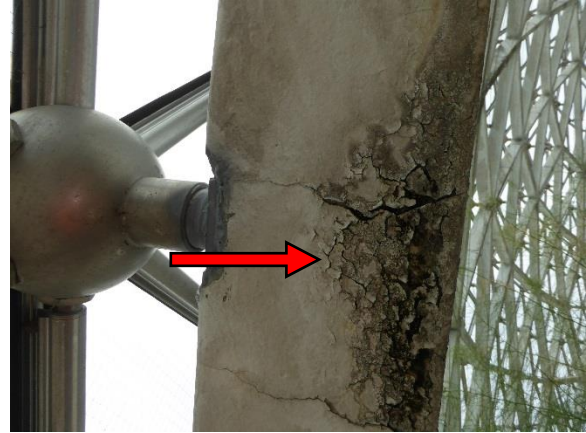
7. Cracked and peeling paint was observed on most precast members (Figure 19).

Figure 19. View of cracked and peeling coating on precast member

- We recommend that the following characteristics be considered with the selection of a coating system: concrete carbonation protection, waterproofing, and aesthetics. The recommended coating systems by GRAEF for the precast concrete include an epoxy system and a stain. The stain will not be able to bridge cracks in the concrete and we do not recommend that a stain be installed. We recommend that further research be performed by GRAEF to understand the crack bridging capabilities of the proposed epoxy system. An epoxy system may fade and degrade slowly due to ultraviolet exposure, but could be beneficial to seal the concrete from oxygen depending on future corrosion potential due to the existing concrete carbonation depth and operating environment. A breathable acrylic or acrylic elastomeric coating could also be considered for the precast concrete members. An elastomeric coating will provide good crack bridging capabilities, but may not bond well in a humid or damp environment. A different coating system could be considered for each dome depending on the interior environment. Surface preparation and removal of the existing coating system may prove very difficult due to access and protection. Therefore, we recommend trial installations, bond testing, and evaluation of different coating systems and surface preparation techniques.

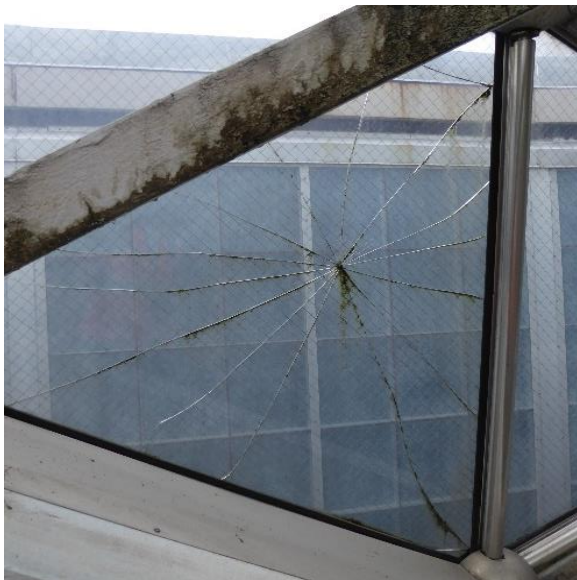
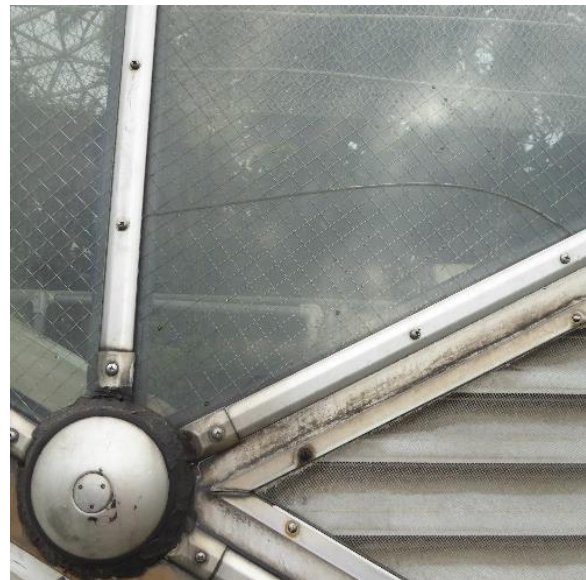
1. Cracked glass units were observed at several locations (Figures 20 and 21). Some of the cracked glass appears to be the result of impact.
2. The glazing material that separates the glass from the pressure caps has deteriorated over time. This is a likely source of water infiltration into the domes (Figure 22).
3. Sealant was installed around the hubs at several locations at the base of the domes (Figure 23).
4. Leakage was observed at approximately six locations in the Arid Dome at the connection of the hub to the downspout rafter. At locations where leaks were observed, the downspout rafter fitting had visible black material build-up, which seems to be an indicator of a leak location (Figure 24).

Figure 20. Cracked glass, likely from impact

Figure 21. Cracked glass

The primary issues with the cladding appears to be glass breakage and water infiltration. Some glass breakage appears to be related to impact while other locations may be related to thermal movements. The glass is wire reinforced. If broken, wire reinforced glass is not normally considered a falling hazard, since the wires engage the broken glass and inhibit broken glass pieces from falling. The glass framing has a drainage system that collects incidental water, either due to occasional rainwater leaks or internal condensation. GRAEF had indicated that water was observed sitting in the hub and not allowed to drain, which is likely the reason why water currently leaks out at the hub locations. In WJE's opinion, this condition is a result of the original design of the drainage system which set the opening in the downspout rafter slightly higher than the hub. We believe that this condition can be repaired (see our following Recommendations section).

- The wired glass can remain as is, unless it is broken; in which case it should be removed and replaced. Full replacement of the wired glass is not required for safety reasons. At locations where the wired glass is broken, WJE recommends replacement in-kind or with laminated glass. Laminated glass will have a change to the cladding's appearance.

1. Replace existing cracked and broken wired glass in kind, or with laminated glass. Modifications in the glass replacement design could be implemented based on the findings from further investigation and mock-up repairs.
2. Remove and replace all pressure caps and wet seal joints (Figure 25).
3. Clean hubs and install self-leveling sealant at leading hubs (Figure 26).

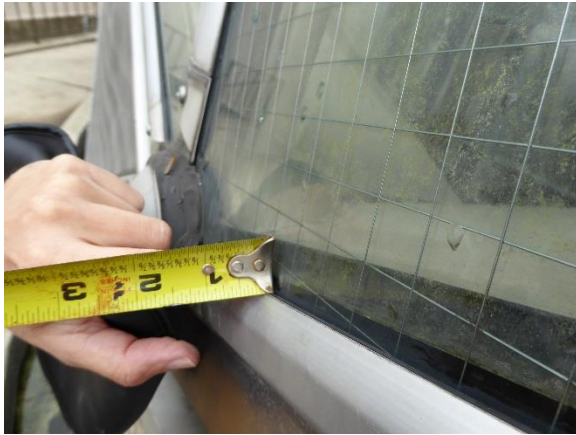
Figure 22. Glazing material at pressure cap on glass cladding

- For weather protection, WJE would normally recommend resealing the glass to aluminum joints around the dome. This is usually performed by a "wet seal" between the glass and the exterior aluminum (the pressure cap). In this case, however, the edges of the existing pressure caps are thin. Obtaining an adequate wet seal joint between the pressure cap and glass would be difficult. As an alternative, removing and replacing the pressure cap with a new redesigned pressure cap would allow for additional weather protection by: a) replacing the exterior glazing seals between the glass and the pressure cap with new glazing seals, and b) a thicker edge detail on the new pressure cap, which would allow a wet seal to supplement the new glazing seal. We believe that this redesign would largely resolve rain water leakage through the dome. We believe that this is a practical step for GRAEF to consider as an addition to their Option 1 repair.

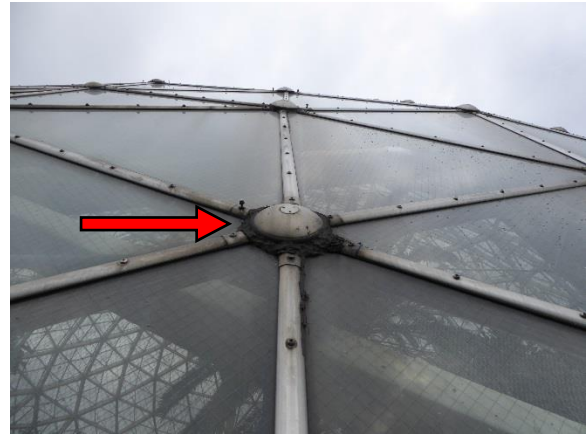
Figure 23. Sealant installed around hub of glass cladding

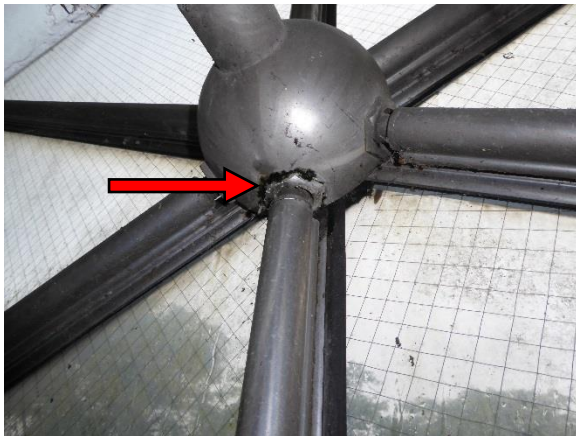
Figure 24. Black build-up on downspout rafter fitting at water leakage location
