Property: Parks  
 Site: Brown Deer Park\*

Asset Name: Boathouse\*  
 Asset Number: 980

Property: Parks  
 Site: Estabrook Park\*

Property: Parks  
 Site: Kletsch Park\*

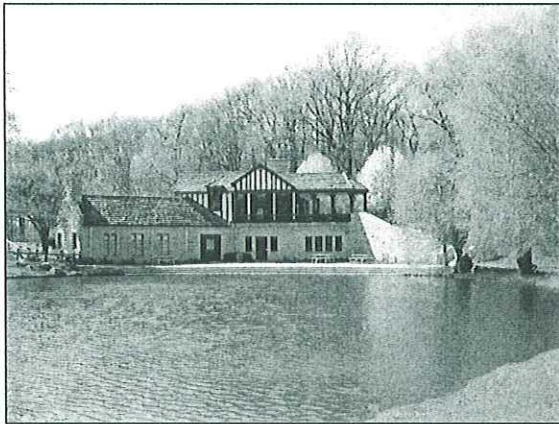
Architectural  
 Bldg 980, Boathouse.

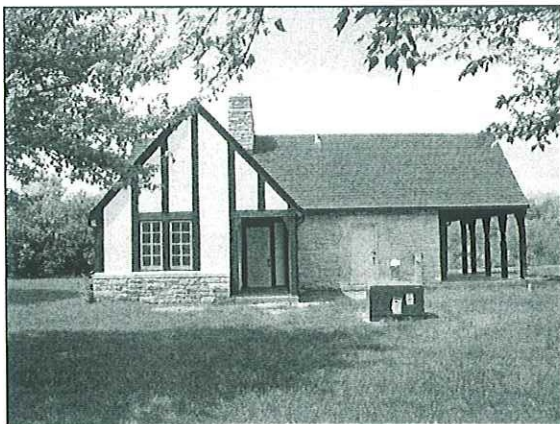
Architectural  
 Bldg. 1250, Comfort Station - Central.

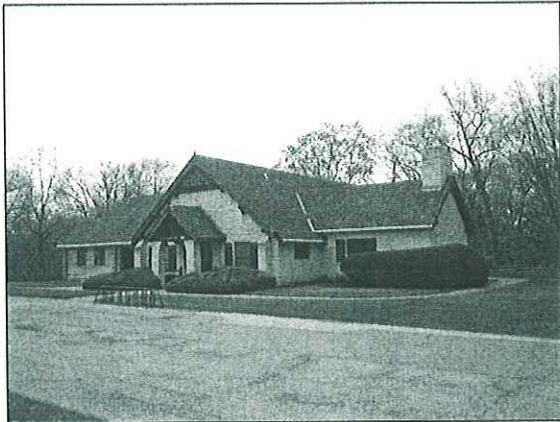
Architectural  
 Bldg. 1130, Pavilion.
