PROJECT:

Lake Park Bistro Floor

On October 21, 2021, REYN Engineering, Inc. performed observations of the kitchen floor at Lake Park Bistro. The purposed of the visit was to assess areas of the floor that were soft to foot traffic. The floor structure consists of 2x12 joists at 16" on center. The floor decking appears to have multiple layers of sheathing. The original diagonal sheathing was present in some locations but was removed in other locations. The kitchen has a protective rubber flooring over the wood. Per Amber MacCracken of Kahler Slater, the protective flooring is a product called Protect-All (protect-allflooring.com). There are two drains located in the area that was reviewed.

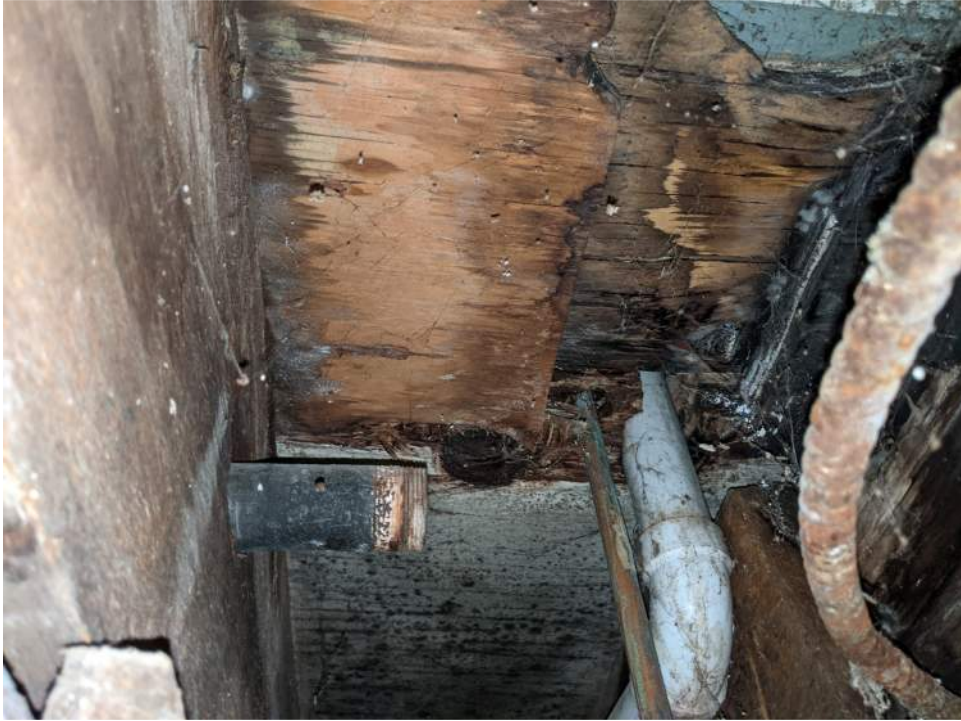
1. Significant long term water damage was noted. Deck material was deteriorated and compromised due to the water damage. Refer to Photographs 1 through 6.
2. Mold was also present on the underside of the sheathing, indicating moisture is reaching the sheathing. Refer to Photograph 7.
3. At least one joist had rot. Refer to Photograph 8.

The area of damage was approximately 32"x8', running approximately from the main support beam and 8' west of the main beam line, nearly centered on the lower level building column. When plywood type sheathing gets wet, the wood material swells, and the plies separate. This along with some small areas of missing sheathing caused the soft feeling of the floor. Our recommendations are as follows:

Photograph 1: Sheathing Deterioration

3. Our primary recommendation for repair is to completely remove the floor sheathing that is compromised. We do have concern regarding the structural capacity of the sheathing present. The main concern would be the possibility of the sheathing being unable to support occupants above which may result in a localized sheathing failure. As stated, this area is estimated to be 32"x8'. At a minimum, the floor sheathing should consist of ¾" APA rated sheathing attached to the joists with 10d nails at 12" on center. Due to the existing flooring build-up, additional sheathing layers may be necessary, but the base layer of sheathing should be ¾" sheathing. Build-up layers should still be APA Rated sheathing attached to the base sheathing with 8d nails at 12" o/c in all directions. We understand that this recommendation may present significant disruption to kitchen activities.

4. If item 3. Is not feasible, ¾" APA rated sheathing can be placed from below, however, this method will not alleviate all of the soft feel of the floor but will safely support the occupants above. The secondary option would consist of setting new sheathing tight to the existing sheathing from below and supporting the sheathing with a 2x4 ledger attached to the existing joists. Pieces of sheathing to match the existing thickness would need to be added as shims to make-up the differences in sheathing thicknesses. Refer to attached Sketch SK-1. This option should be considered temporary until the floor can be removed and replaced according to item 3.
5. All seams and termination points in the rubber flooring should be sealed with the manufacturers recommended sealant or tape. Water must be kept from reaching the wood sheathing.

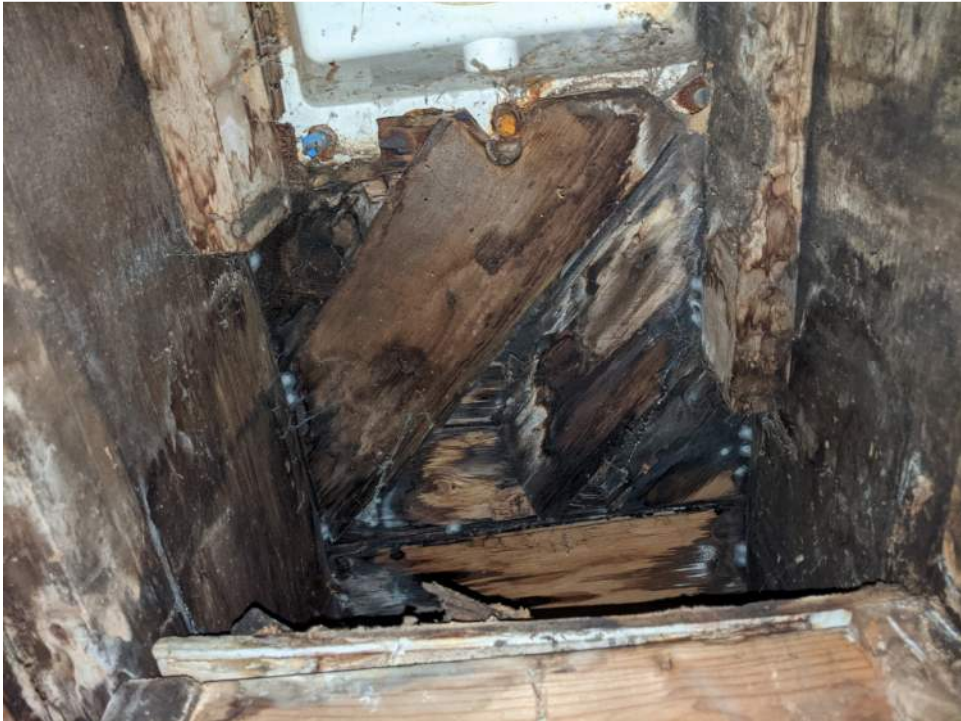
Photograph 2: Sheathing Deterioration

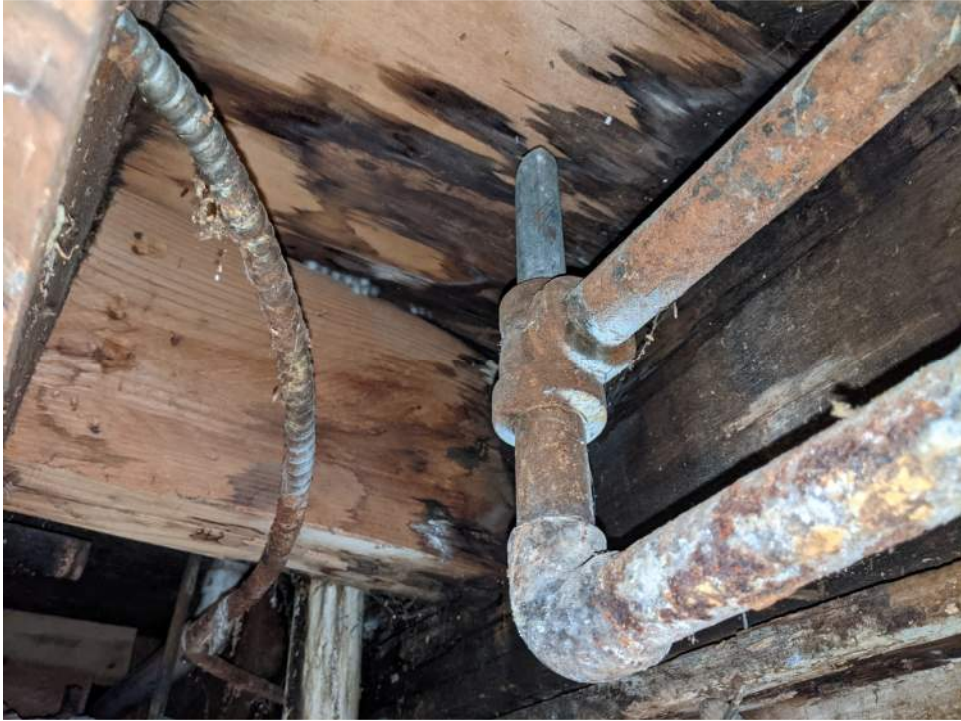
Photograph 3: Sheathing Deterioration

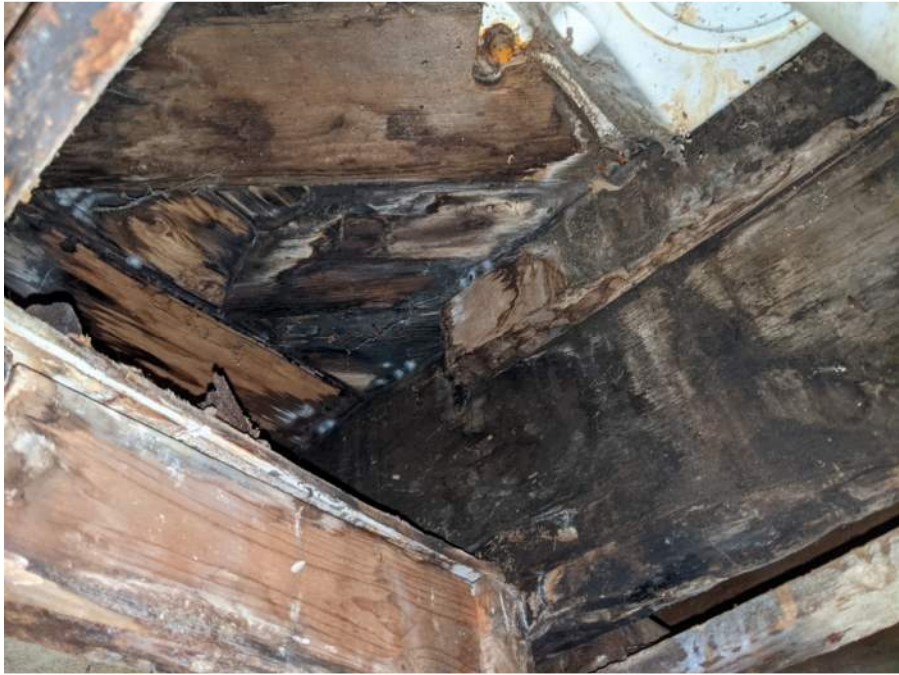
Photograph 4: Sheathing Deterioration

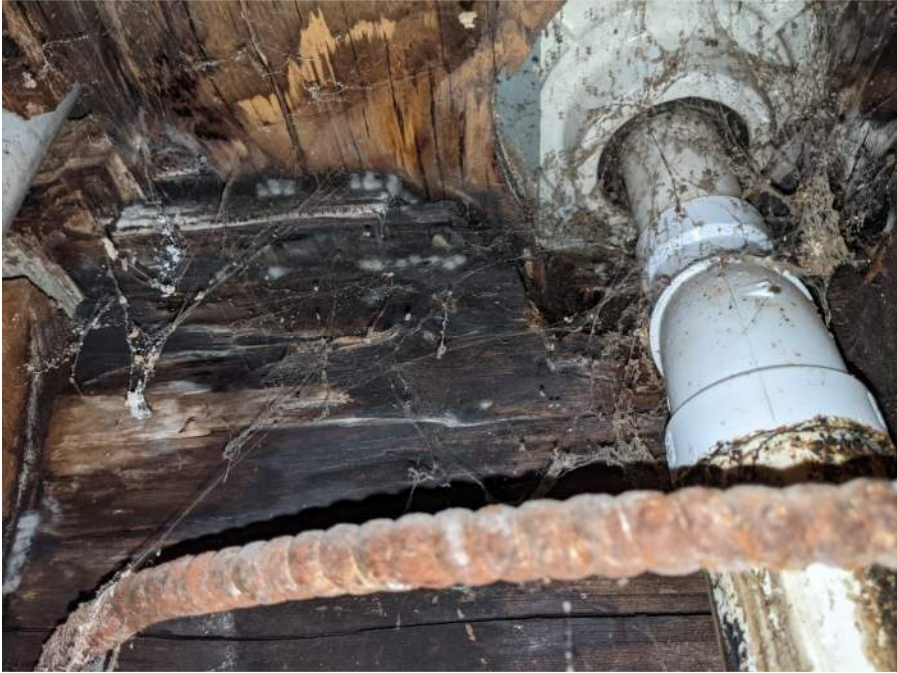
Photograph 5: Sheathing Deterioration

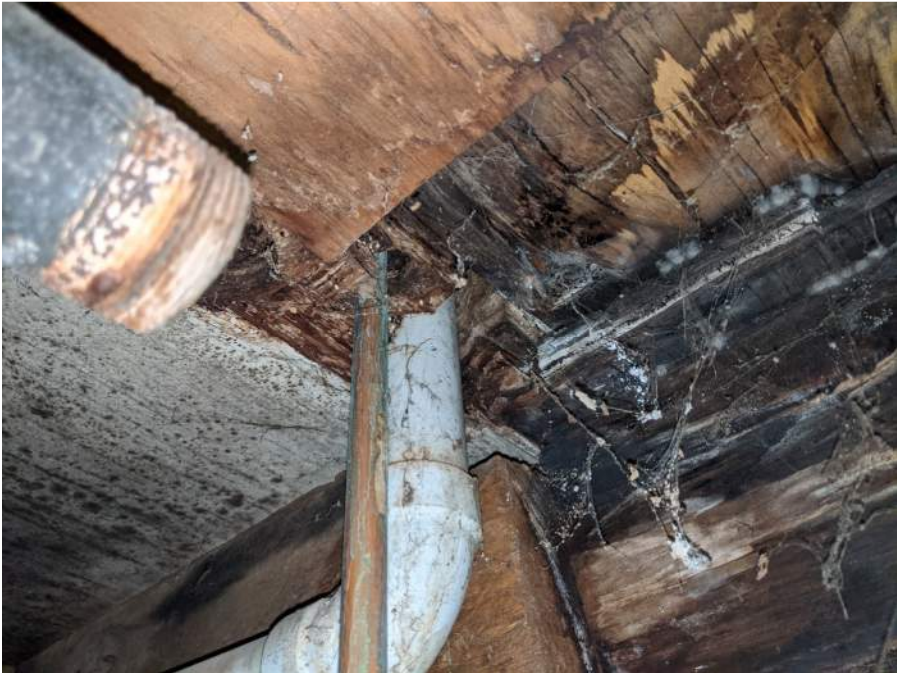
Photograph 6: Sheathing Deterioration

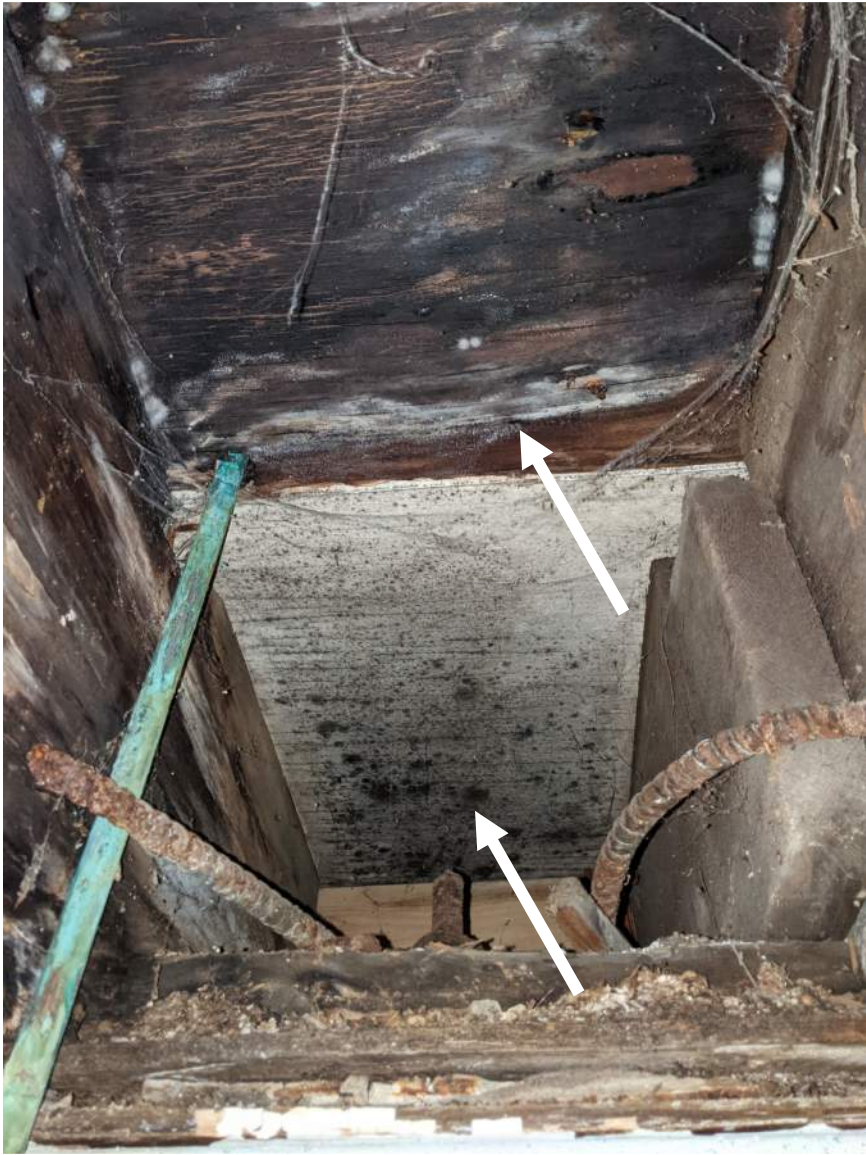
Photograph 7: Mold on Sheathing

2. All mold should be removed from the flooring. It is possible that mold exists below the rubber flooring and the top of the sheathing. If this is a significant concern to the tenant, portions of the rubber flooring should be removed, and the top of the sheathing be reviewed.

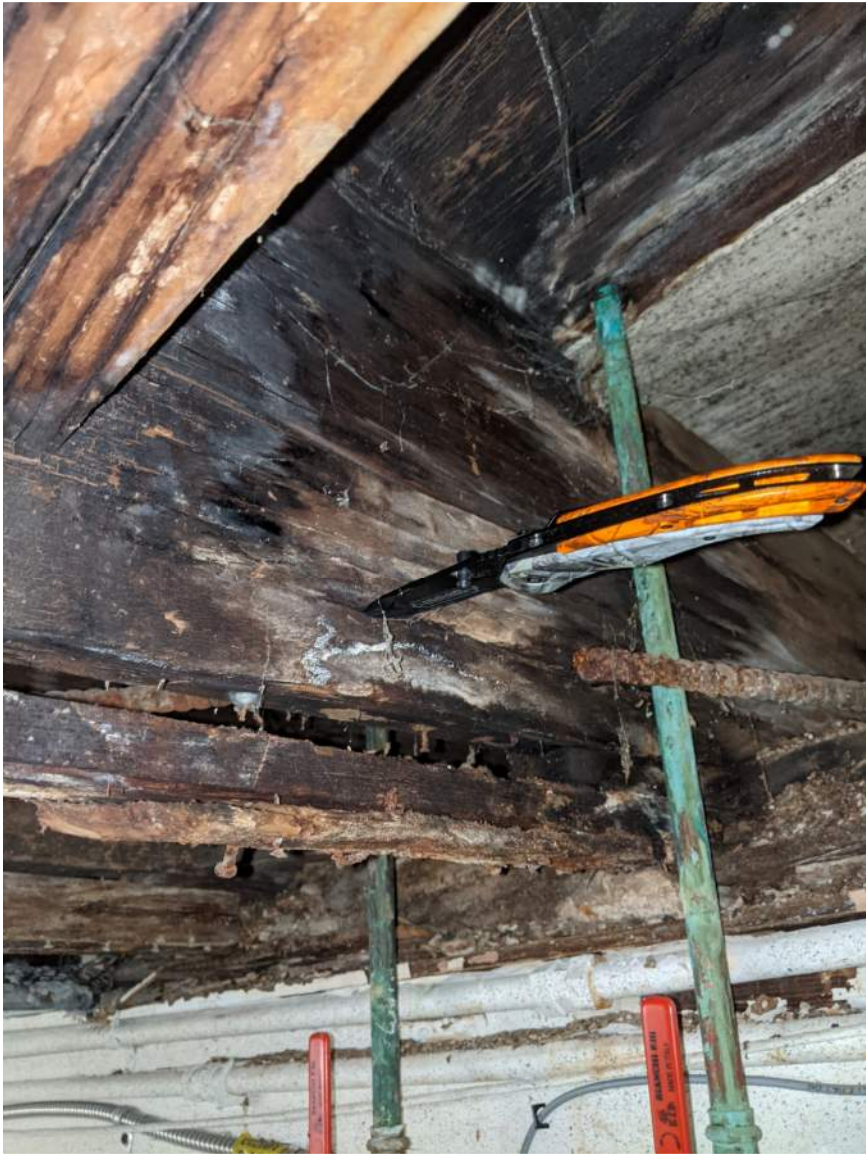
Photograph 8: Joist with Signs of Rotting

1. To repair the rotten joists, we recommend sistering a new 8'-0" long 2x12 joist to the compromised joist. The sistered member should lap 3" on the existing wood main member and extend towards the west exterior wall. The member should be attached to the existing with (2) rows of 12d nails spaced at 12" on center.
