**MITCHELL PARK HORTICULTURAL CONSERVATORY
DOMES
Peer Review**

Milwaukee, Wisconsin

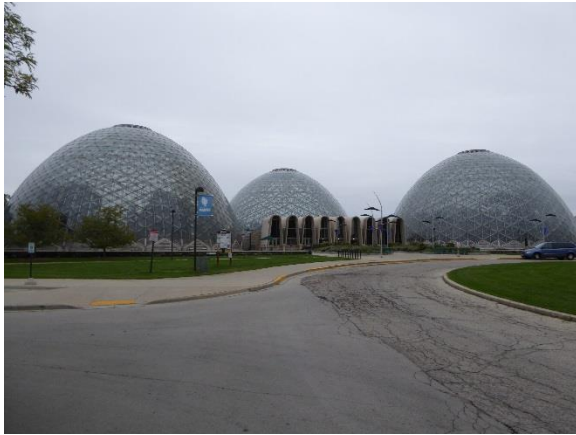
Figure 1. Overall view of the domes

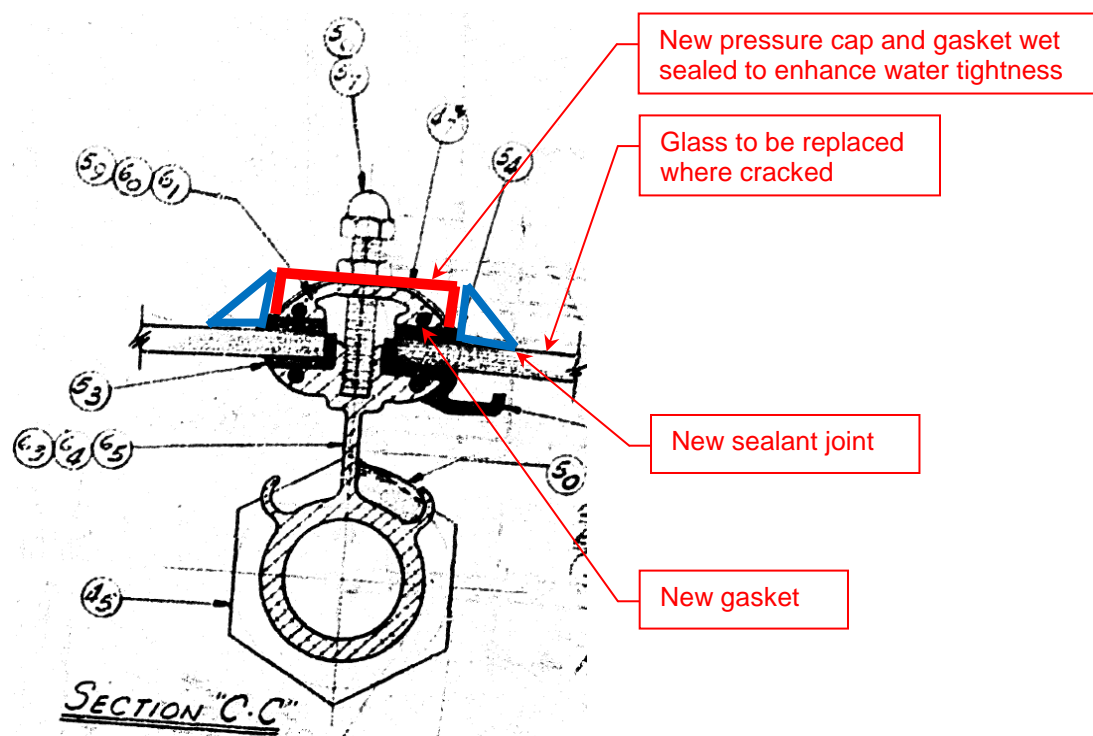
Figure 25. Section through glass and aluminum frame showing conceptual pressure cap repair for consideration

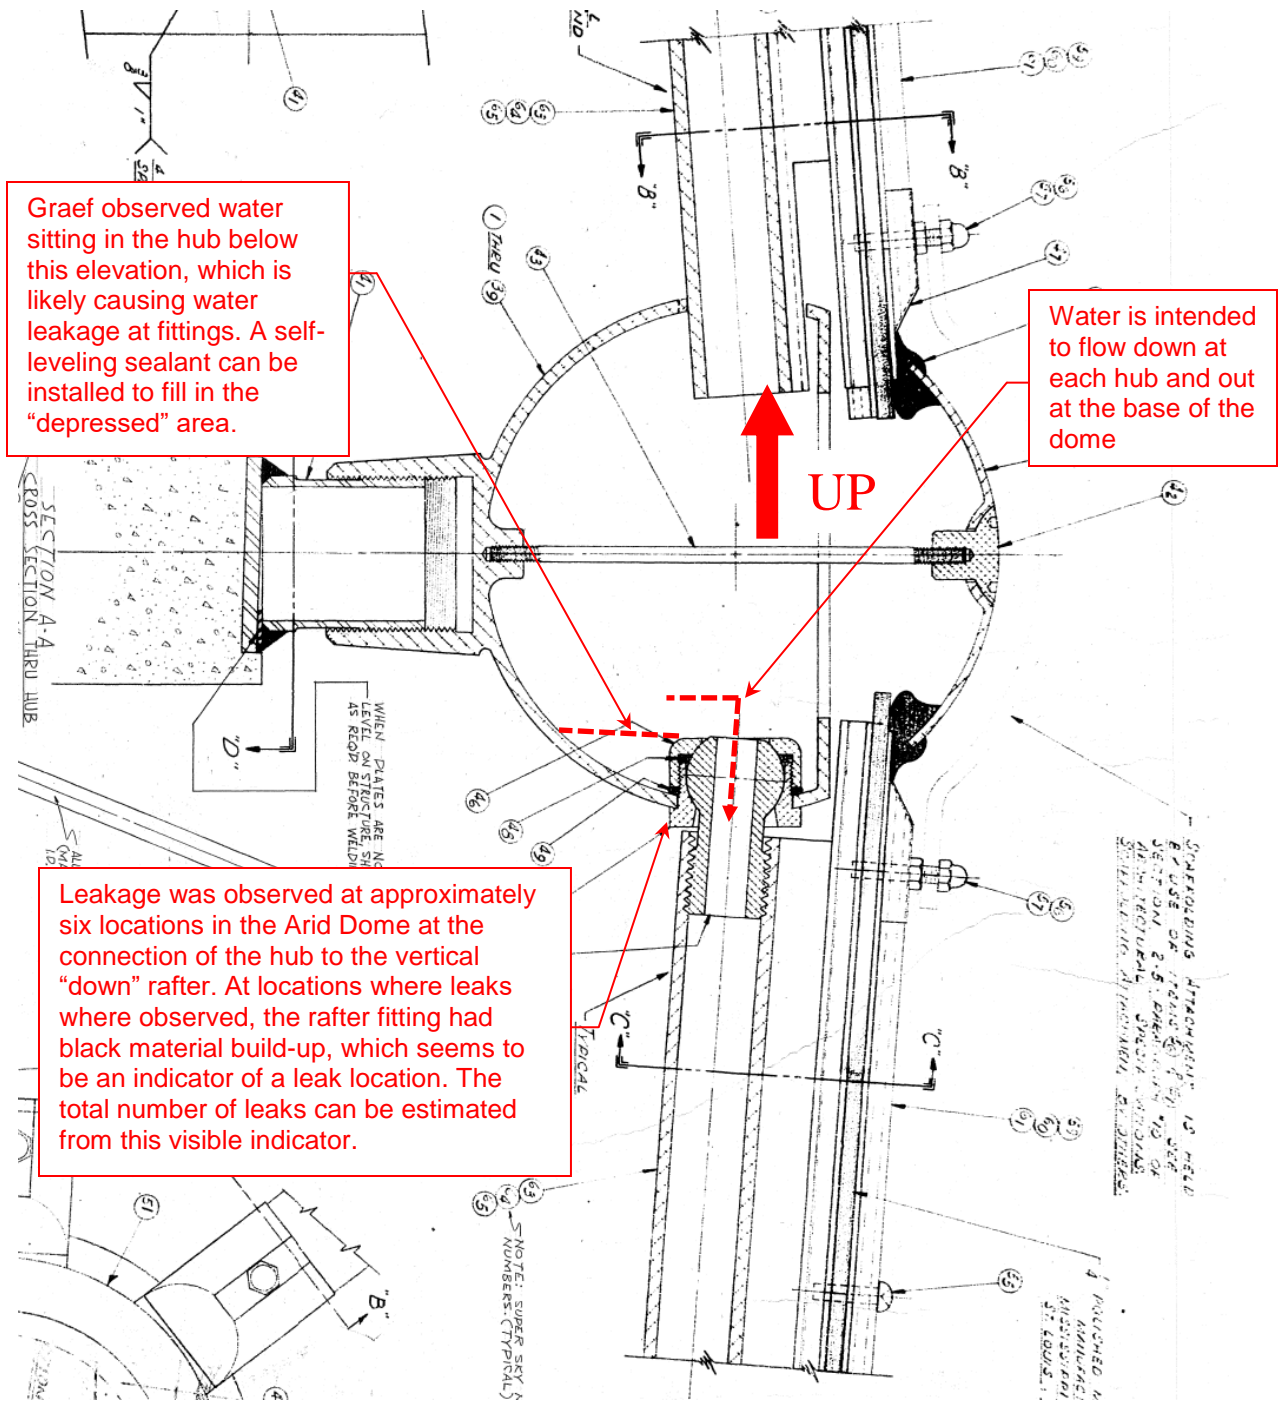
Figure 26. Conceptual hub repair
