Mitchell Park Horticultural Conservatory Domes

Peer Review — Precast and Cladding

Wiss, Janney, Elstner Associates, Inc.

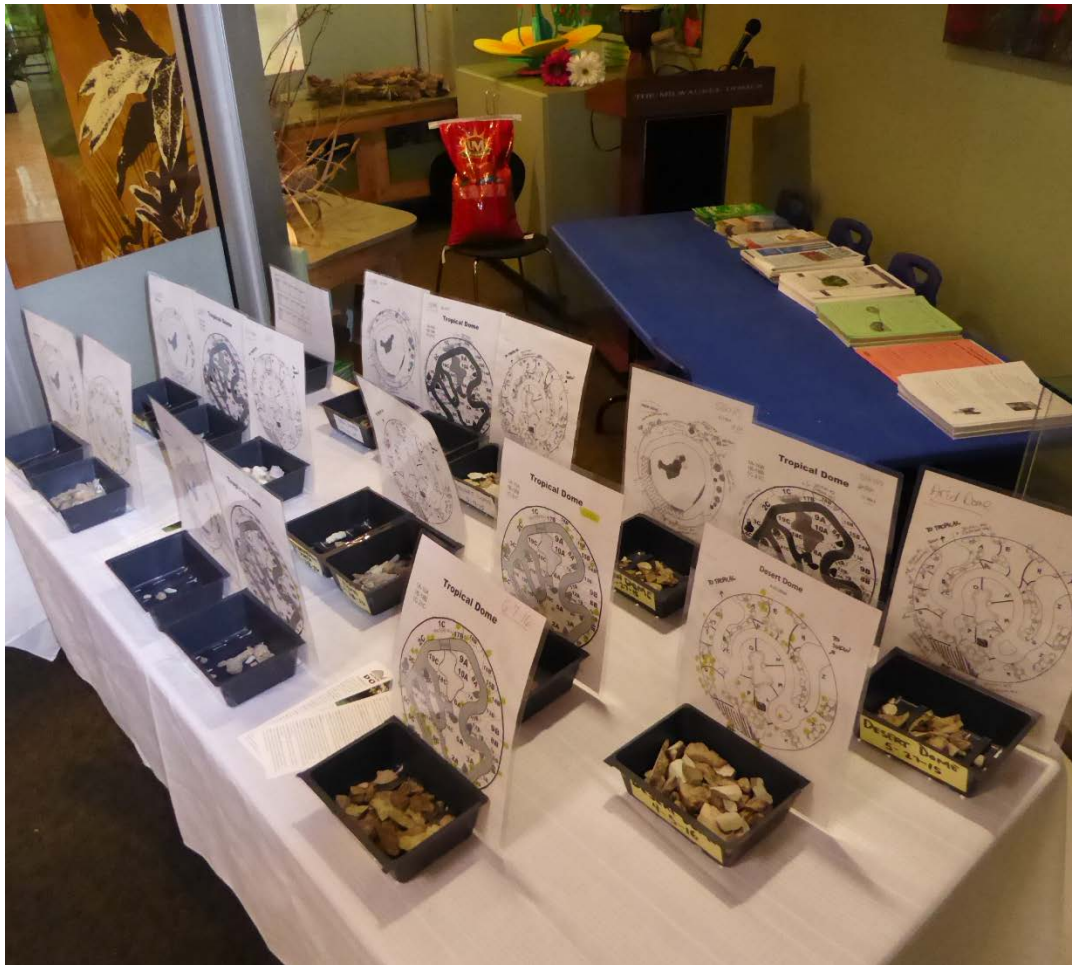
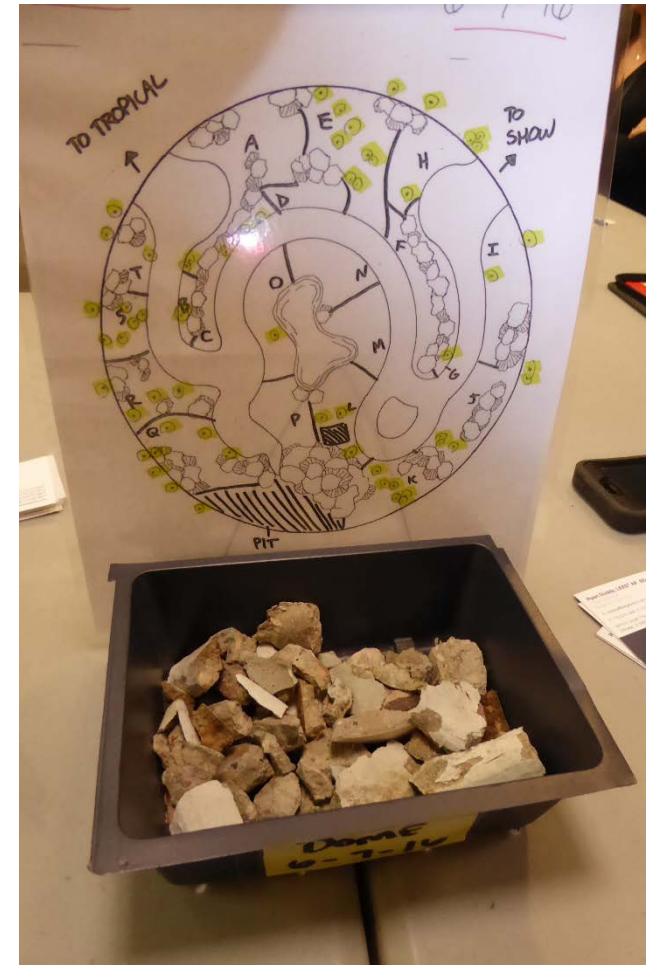
Small Concrete Fragments

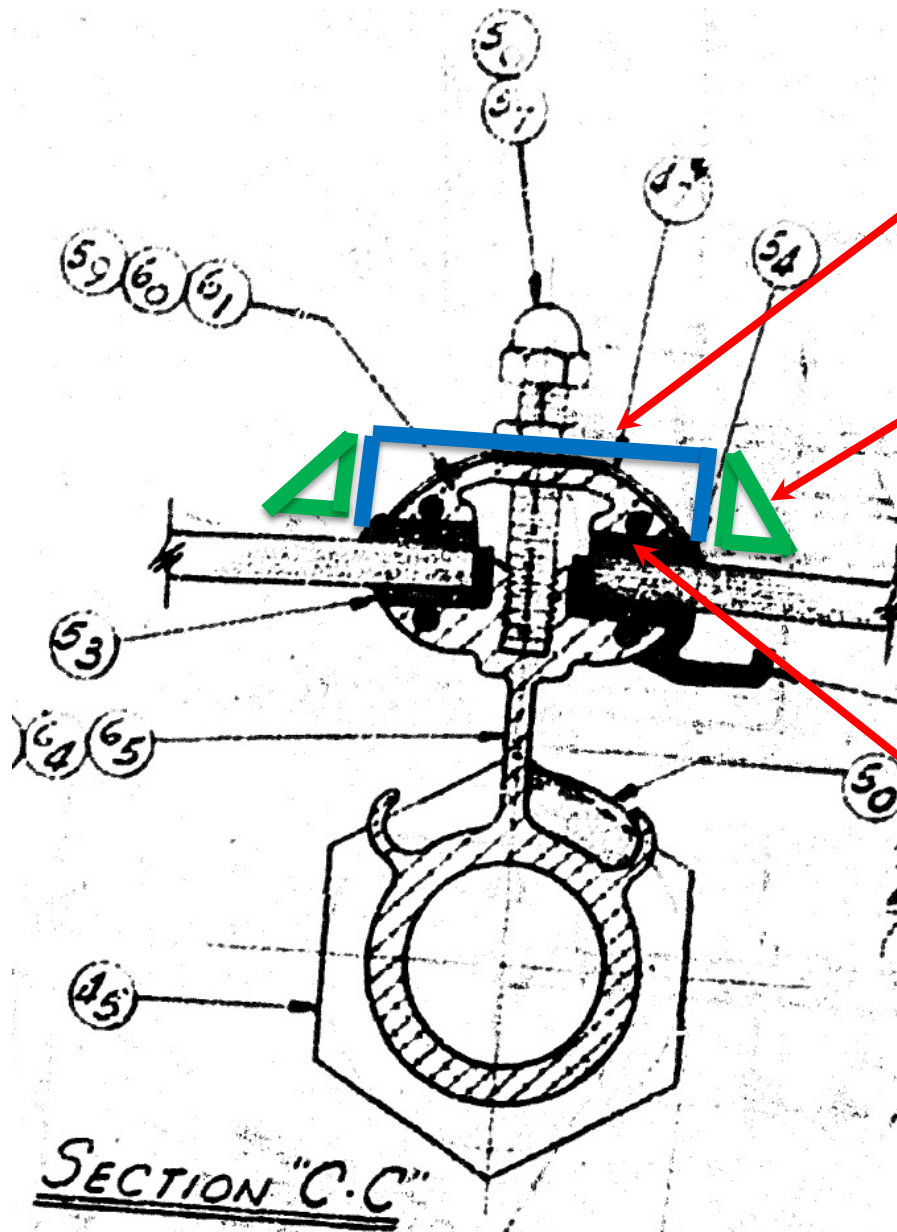
GRAEF observed water sitting in the hub below this elevation, which is likely causing water leakage at fittings. A self-leveling sealant can be installed to fill in the “depressed” area (GRAEF repair).

New pressure cap to enhance water tightness

New Sealant joint (wet seal)

New gasket

Water can then flow down the rafter at each hub and out at the base of the dome

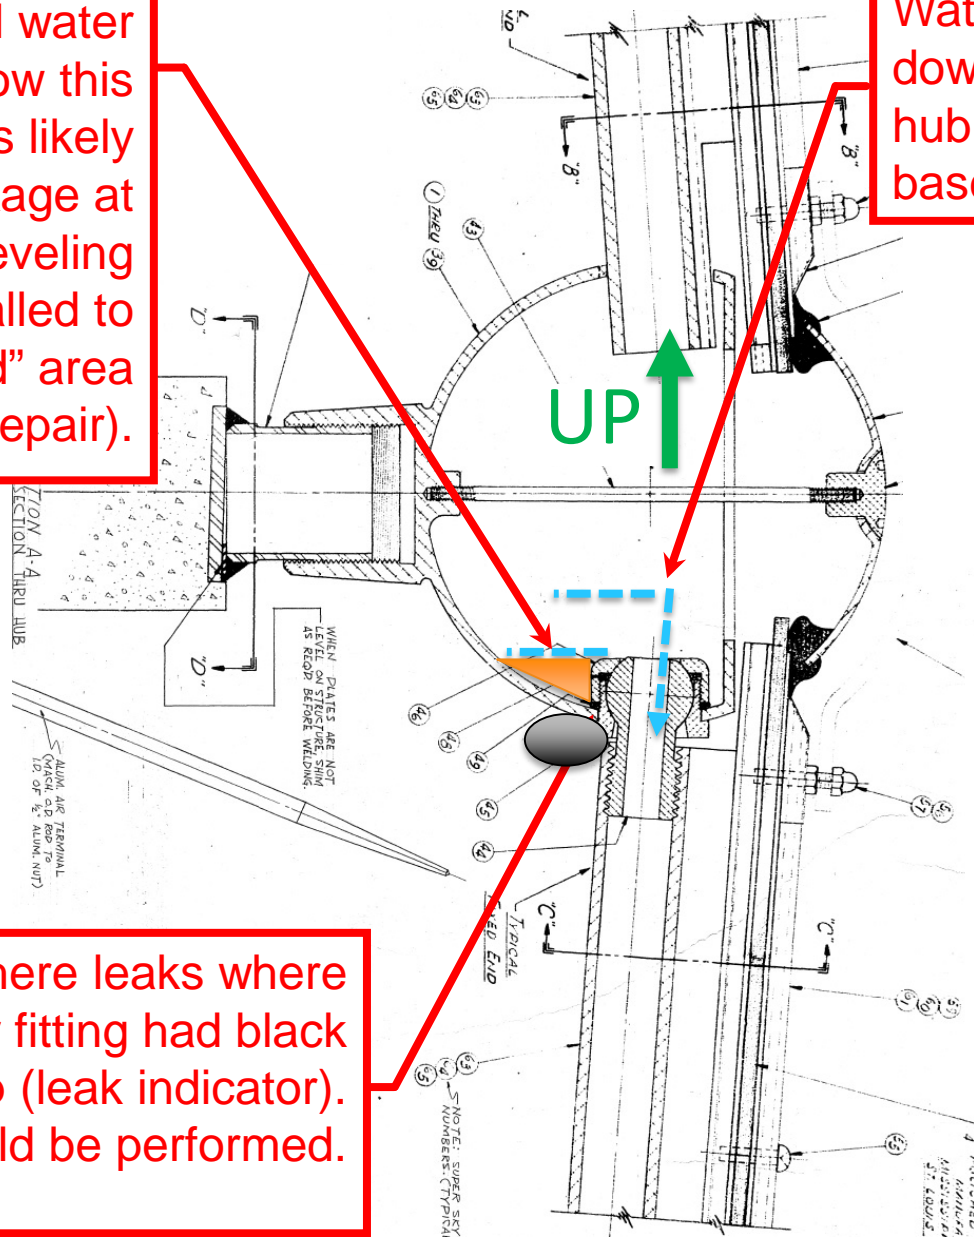
At locations where leaks were observed, the rafter fitting had black material build-up (leak indicator). Target repairs could be performed.
