Design Study Report

McKinley Park Flushing Channel

Project No. P372-20145

COLLINS
ENGINEERS INC.

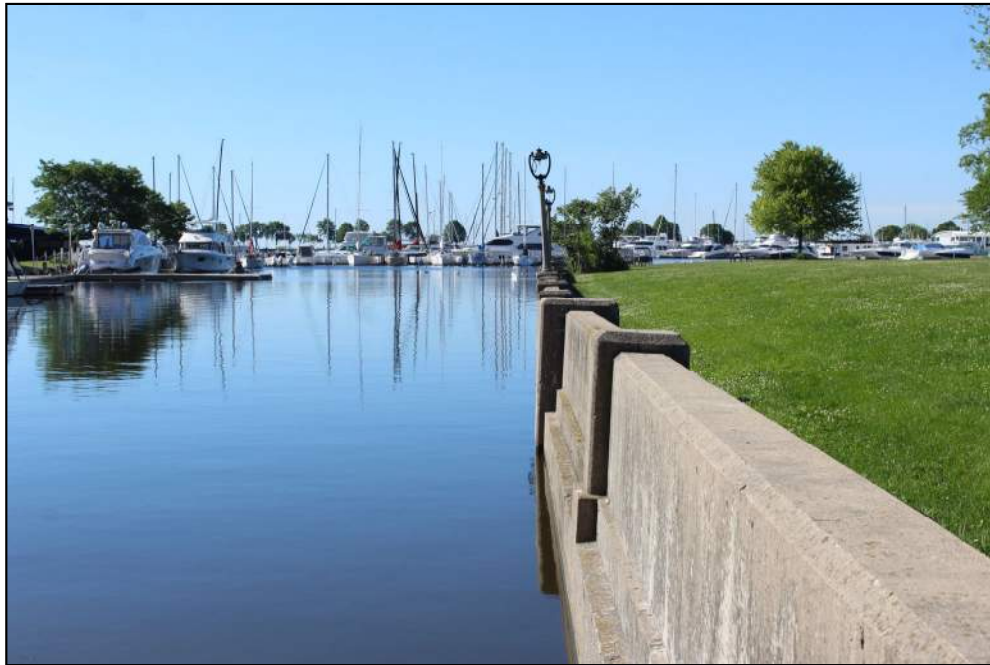
In Section 2 of the west wall, differential settlement of the concrete cap and significant deterioration of the exposed timber members comprising the wall indicate that the wall is in poor to serious condition; however, limited inspection of the timber portion was performed as the mudline extends up to approximately 1 foot below the existing concrete cap. In addition, areas of subsidence were noted along the topside of the structure indicating a loss of fill through the deteriorated timber wall.

Photo 1 – View of the west channel wall facing south. Note the differential settlement of the concrete pile cap.

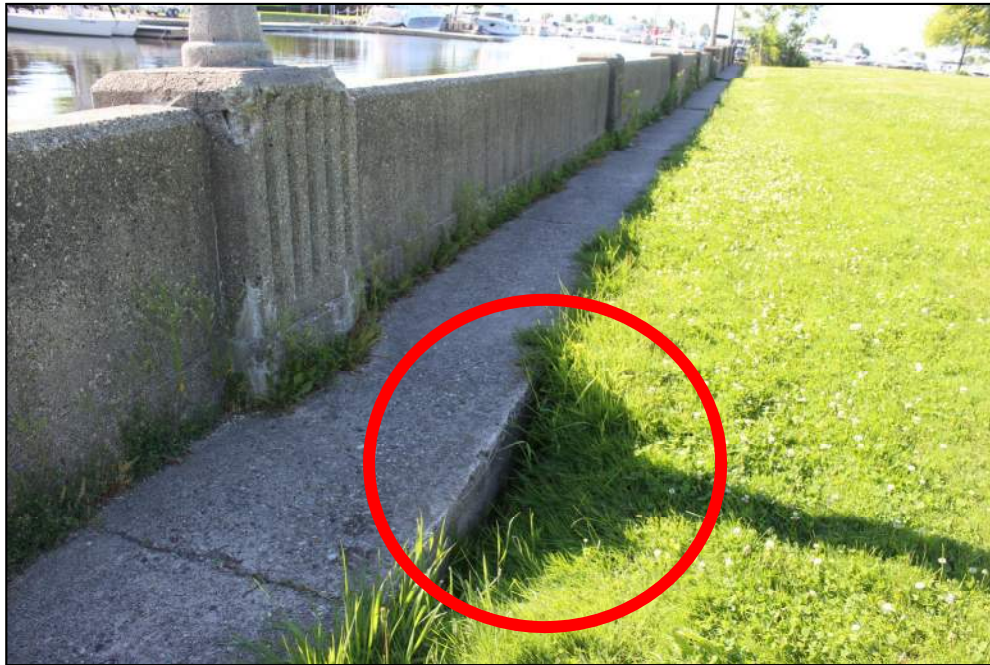
In addition to conditions observed below water, Collins noted several areas of subsidence near the edge of the concrete cap along the topside of the west and east channel walls which indicate a loss of fill through the wall system. There is a large sinkhole near the northern entrance of the west wall boat ramp (Section 2) which has unsupported concrete and exposed reinforcement. It appears that this area has been blocked off with a timber stockade fence. These areas of subsidence present a safety hazard, and the extent of sinkholes beneath the surface is unknown.

Photo 3 – Area of subsidence located along the topside of the west wall.

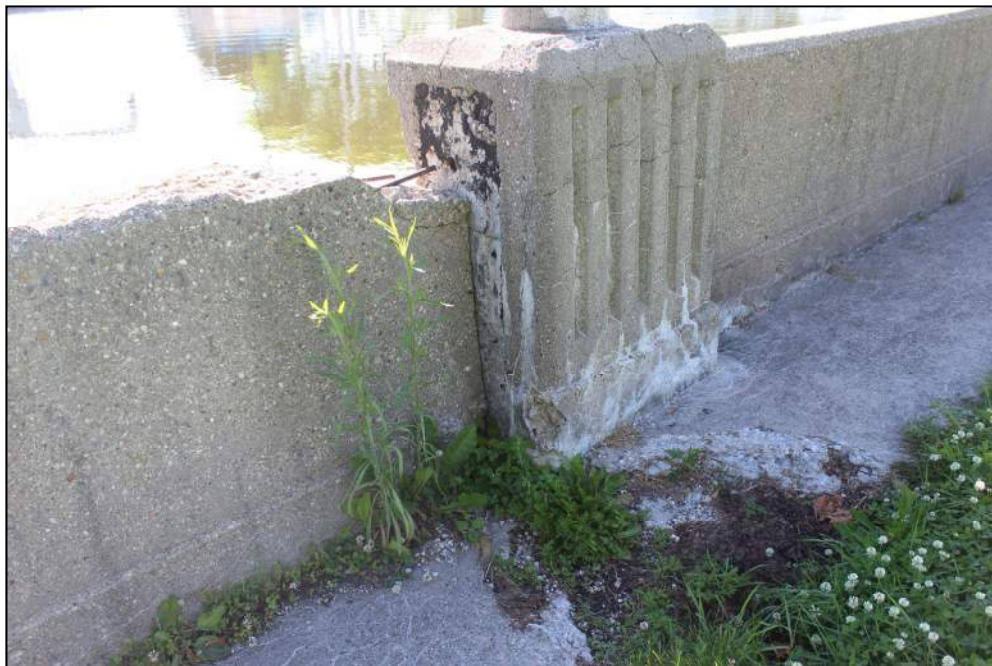
Photo 4 – Deteriorated concrete rail system along west channel wall.

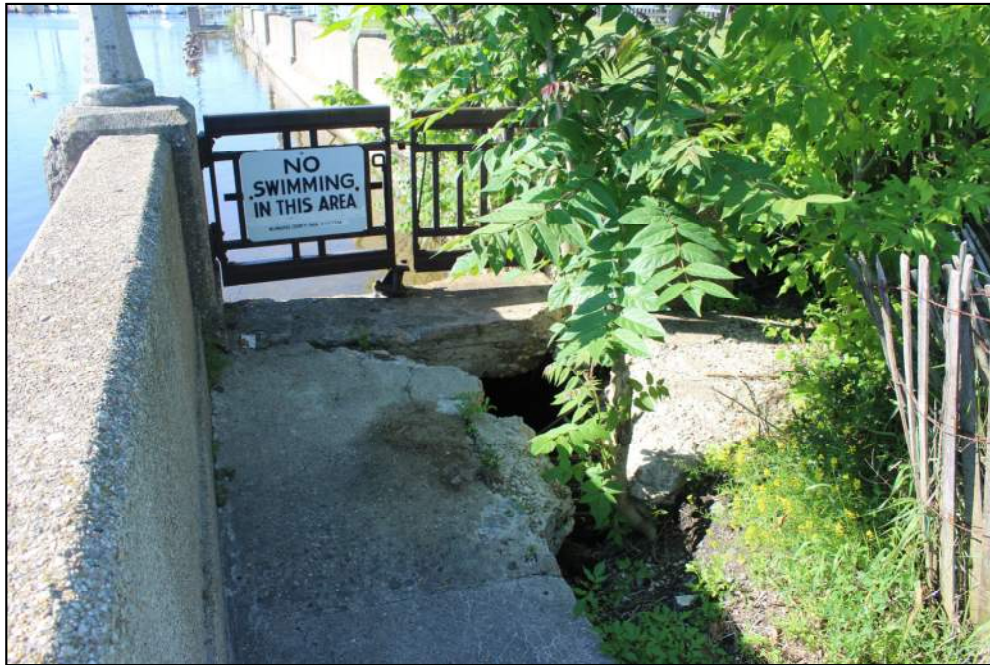
Photo 5 – Area of subsidence with unsupported concrete and exposed rebar near existing boat ramp along west channel wall.

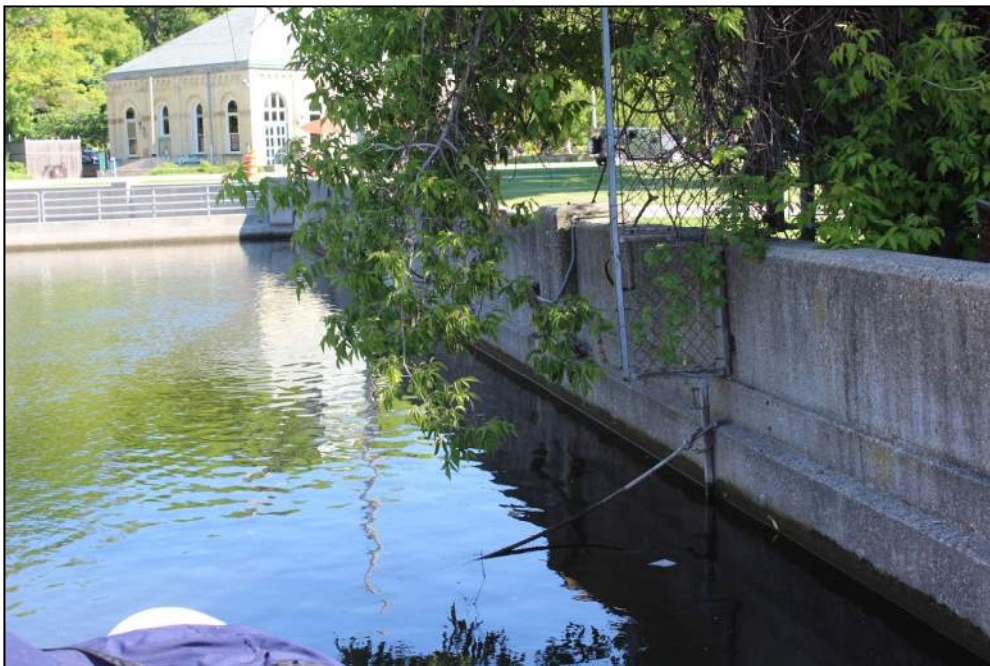
The northern section of the east wall near the headwall structure (Section 4) consists of Wakefield sheeting and timber piles which was observed to be in serious condition, with up to 100% section loss typical in timber members.

Photo 12 – View of the most northern portion of the east channel wall with concrete pile cap and rail, facing north.

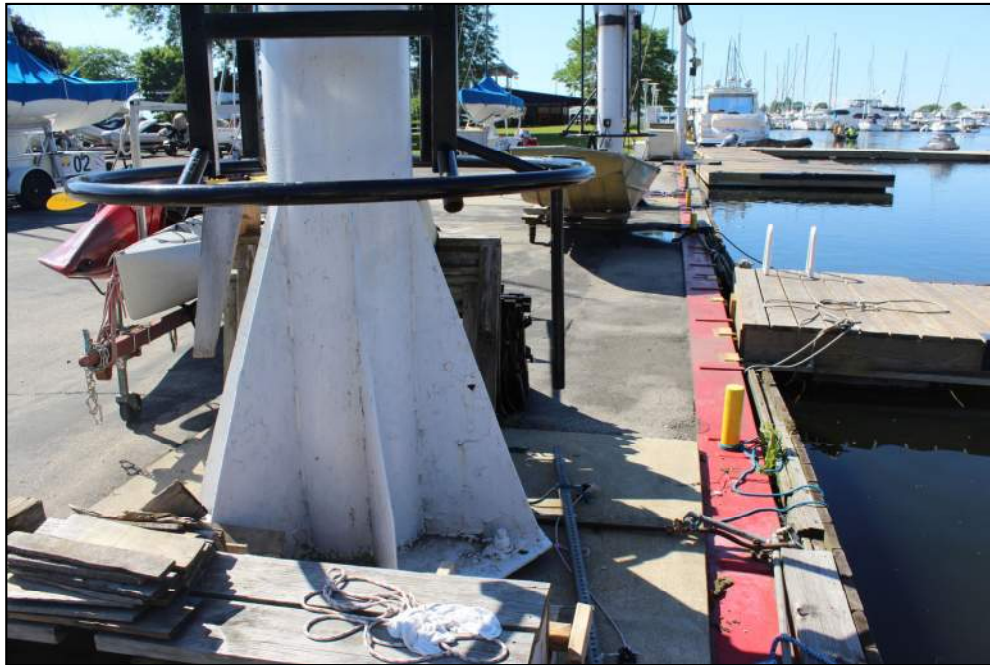
Photo 13 – View of middle section of east channel wall consisting of steel sheet pile. Note the davits located on the topside of the wall.

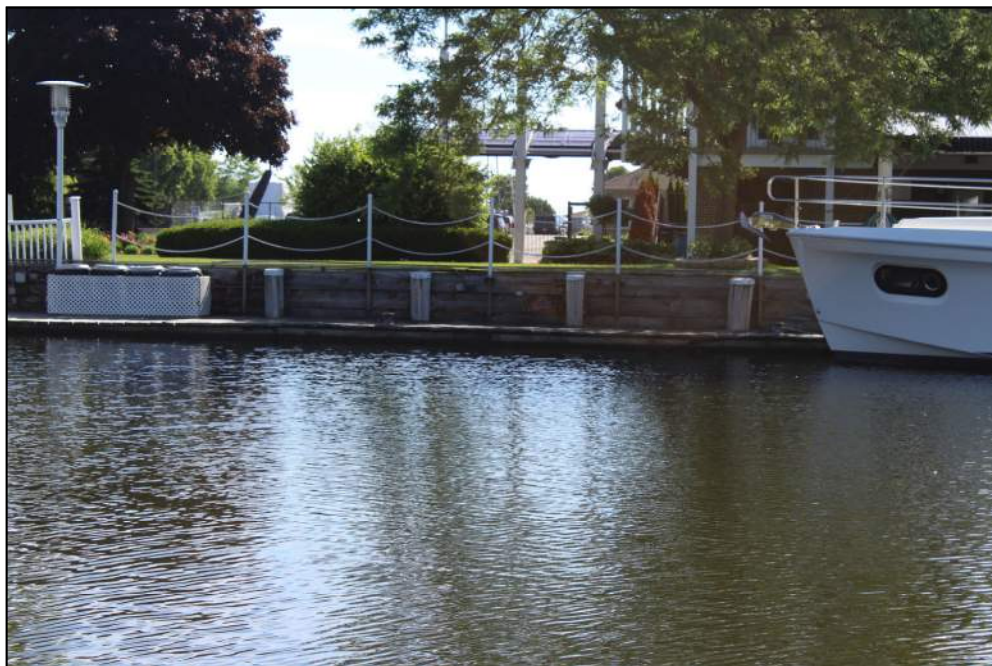
Photo 16 – View of the east channel wall facing east. Note the high water level compared to the timber pile supported pier and small retaining structure.

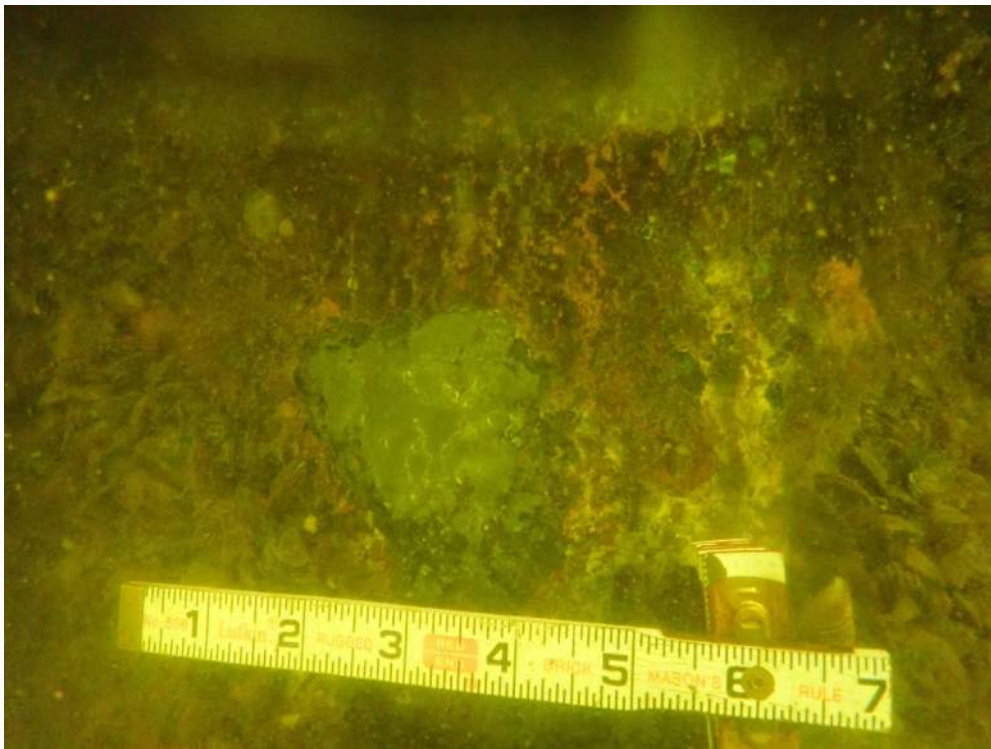
The existing steel sheet pile wall in front of the loading yard in Section 5 was observed to be corroded with heavy pitting up to 1/4-in deep. Drawings and construction records of the steel sheet pile wall were not available during the preparation of this report and the age and remaining steel thicknesses could not be confirmed. However, based on the construction type and environmental exposure typical for the area, it is likely that the original thickness of the wall was approximately 3/8 -inch thick. With corrosion section loss observed up to 1/4-inch deep, the steel thickness may be in the range of 50% to 70% section loss. Using published rates of typical corrosion for a steel sheet pile (Table 1) in "very polluted" fresh water, approximately 0.17 in (4.30 mm) of waterside section loss can be expected in 100 years, suggesting that the steel sheet pile is approximately 150-years old based on the level of corrosion observed. However; steel sheet piles were not introduced into the United States until after 1910,

Photograph 6: View of typical pitted steel sheet piling below water at Flushing Channel East-Central Wall (Wall Section 5).

For the existing steel sheet pile at the Milwaukee Yacht Club loading and unloading yard, it is recommended that the existing bulkhead be left in place and a new fiber reinforced panel and underwater grout system be installed. The panel and grout system will extend the longevity of the existing steel sheet piling.
