RE: McGovern Senior Center Engineering Report, post August 2025 Flooding

McGovern Senior Center Moisture Investigation Report

4500 W Custer Avenue
Milwaukee, WI 53218

Site Observation Date: November 14 and 18, 2025
Report Date: January 22, 2026

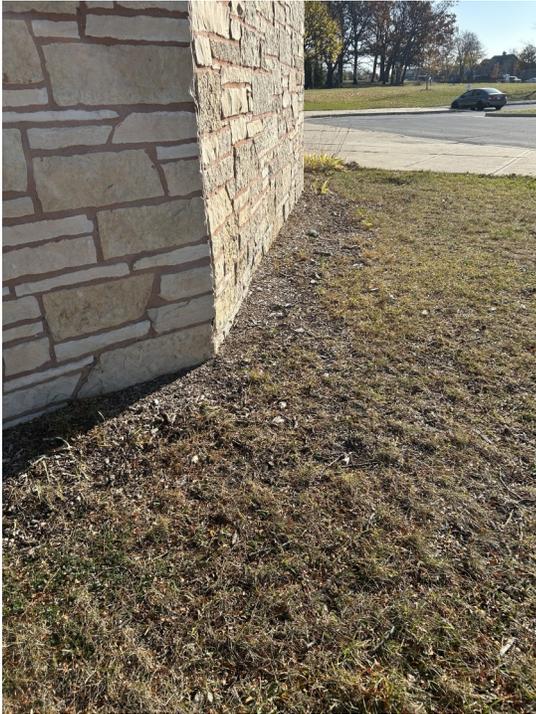
Photo 1: Unpaved area adjacent to west side of building.

- Ensure positive drainage away from building walls and provide maintenance strip adjacent to building in greenspace to reduce potential for erosion caused by roof drainage not collected in gutters.

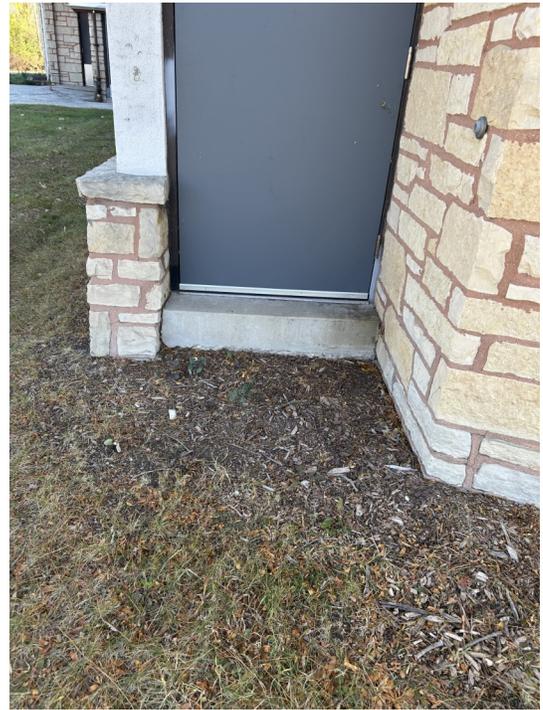
Photo 2: Unpaved area adjacent to door on west side of building.

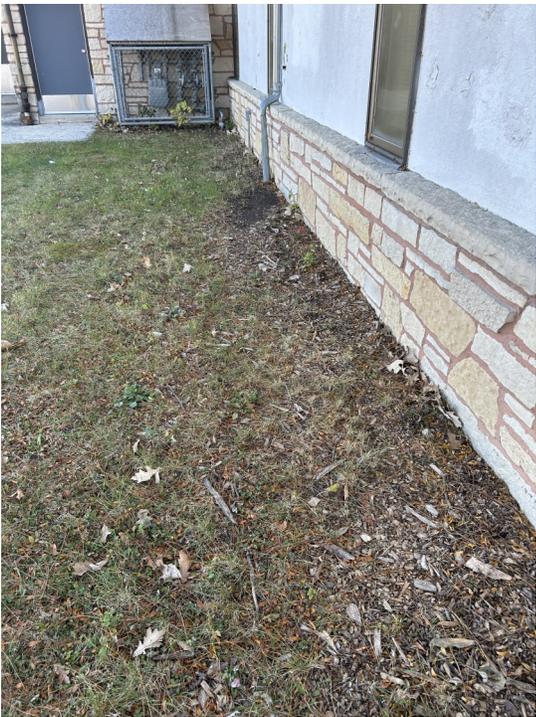
Photo 3: Unpaved area adjacent to north side of building.

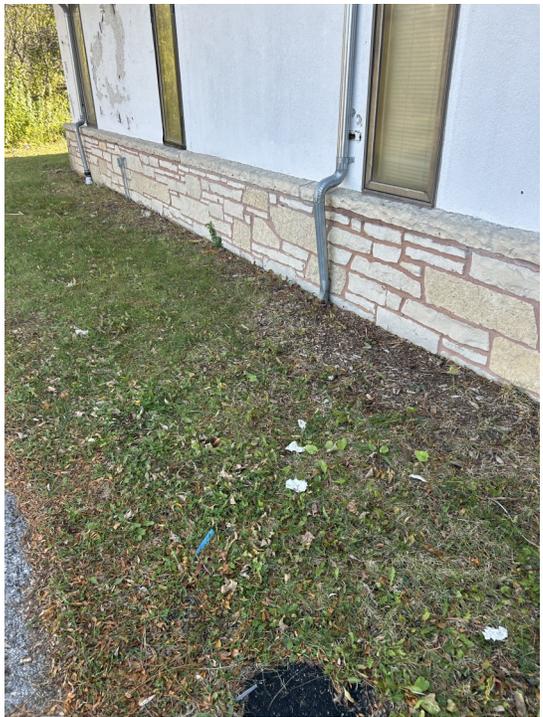
Photo 4: Unpaved area adjacent to north side of building.

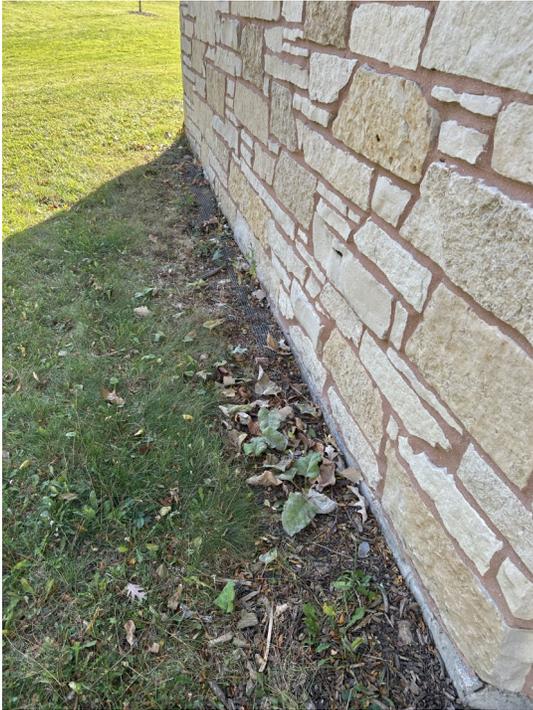
Photo 5: Unpaved area adjacent to north side of building.

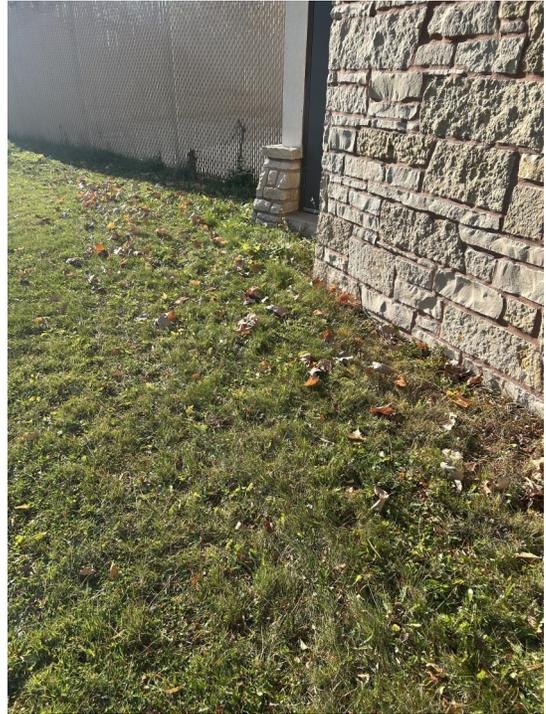
Photo 6: Unpaved area adjacent to northeast side of building.

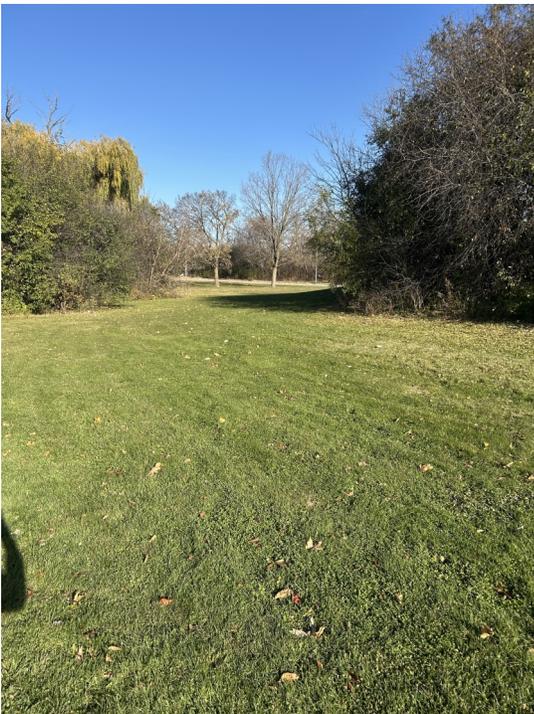
Photo 7: Existing shallow swale looking north.

- The shallow grass swale east of the building does not sufficiently capture stormwater and direct it around the building. The swale should be regraded, deepened, and extended southwesterly to capture and divert stormwater.

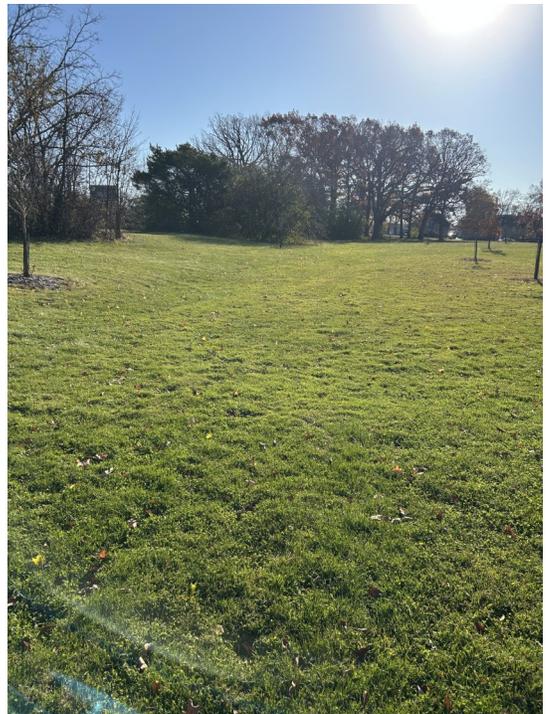
Photo 8: Existing shallow swale looking south-east.

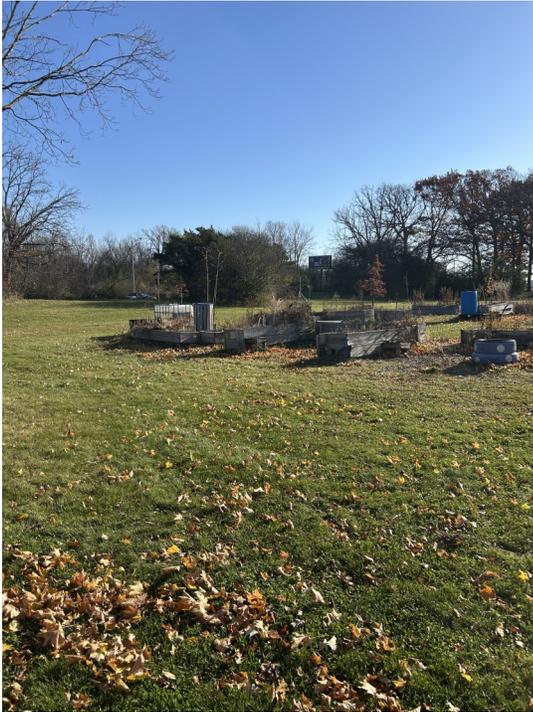
Photo 9: Area between southeast side of building and garden identified for potential shallow swale addition.

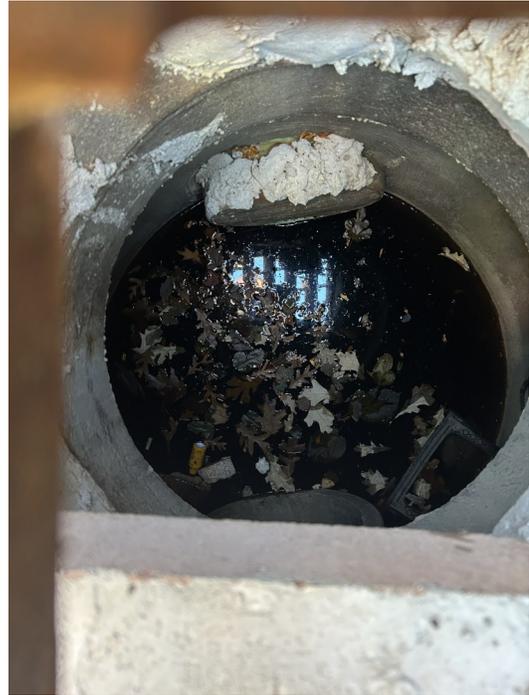
Photo 10: Inlet in parking lot with concrete filled pipe connection.

- Video inspection of internal drain tile to determine pipe routing, condition, and discharge location.
- The northernmost parking lot catch basin apparent discharge pipe appears to be filled with concrete and should be inspected to verify drainage. Install backflow prevention for all pipes leading into the storm pond.

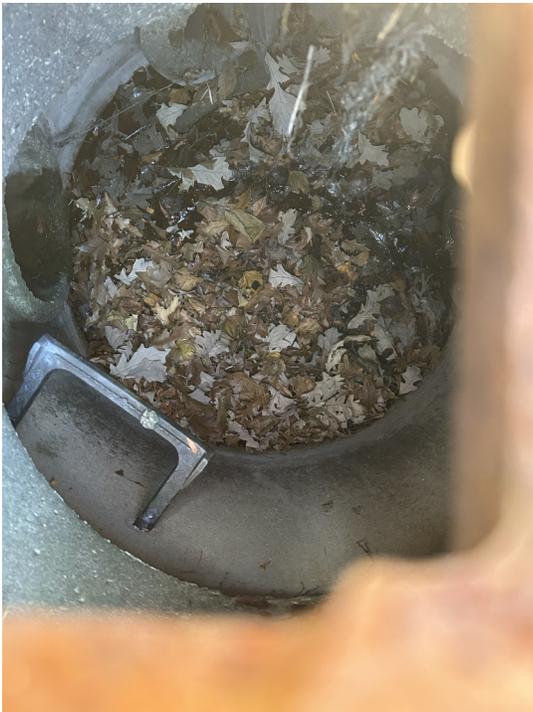
Photo 11: Inlet in parking lot south of inlet from Photo 10.

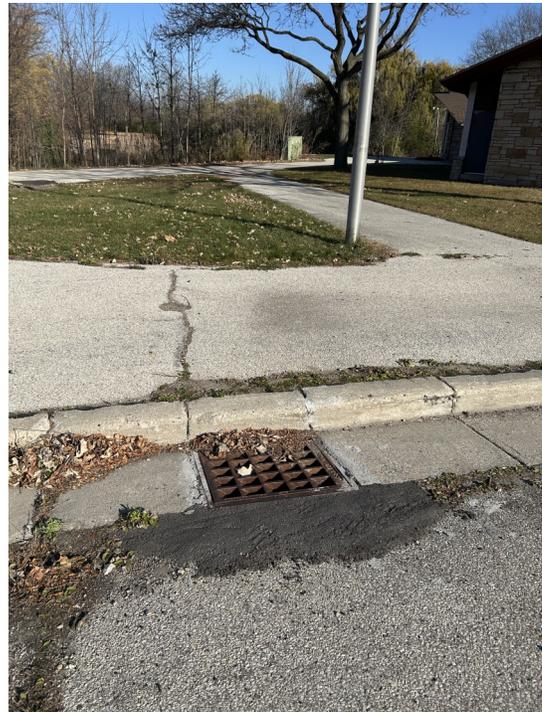
Photo 12: Exterior of inlet from Photo 10.

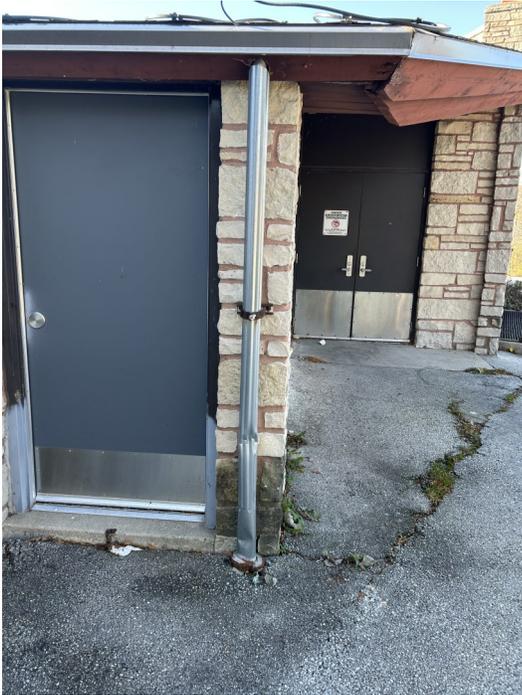
Photo 13: Deteriorating and settling asphalt on north side of building.

- Asphalt pavement adjacent to the building was observed to have settled. This settlement has resulted in water getting trapped next to the building. This can result in water entering the building through the north foundation wall. Survey and design a pavement plan to replace all asphalt walkways north of the building and provide positive drainage away from the building toward the pond.

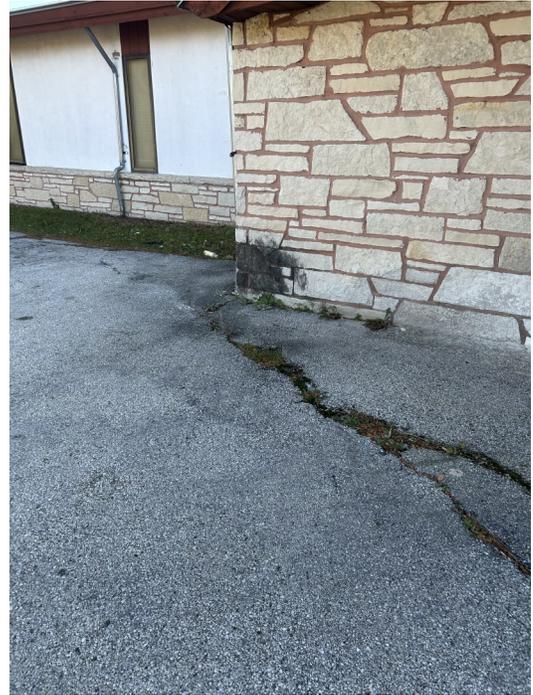
Photo 14: Cracked and settling asphalt on north side of building.

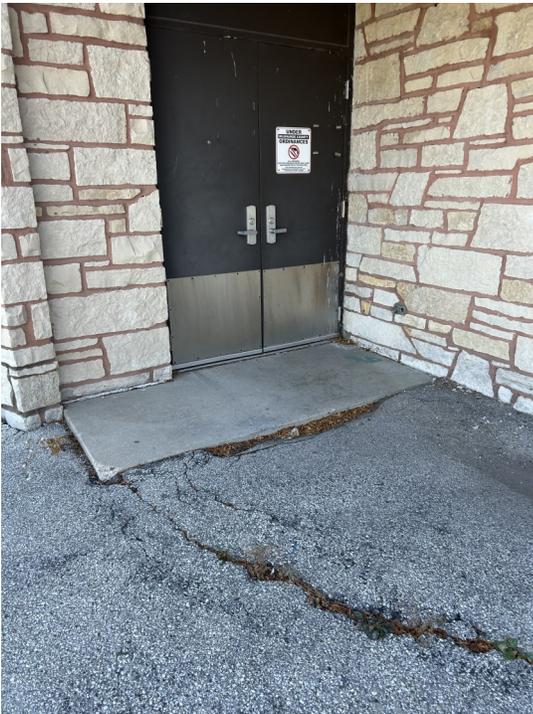
Photo 15: Settling asphalt near entrance on northwest side of building.

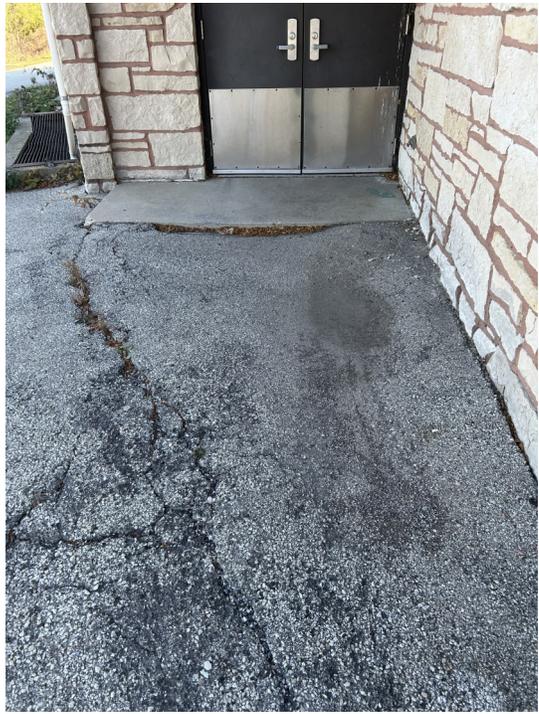
Photo 16: Deteriorating and settling asphalt on northwest side of building.

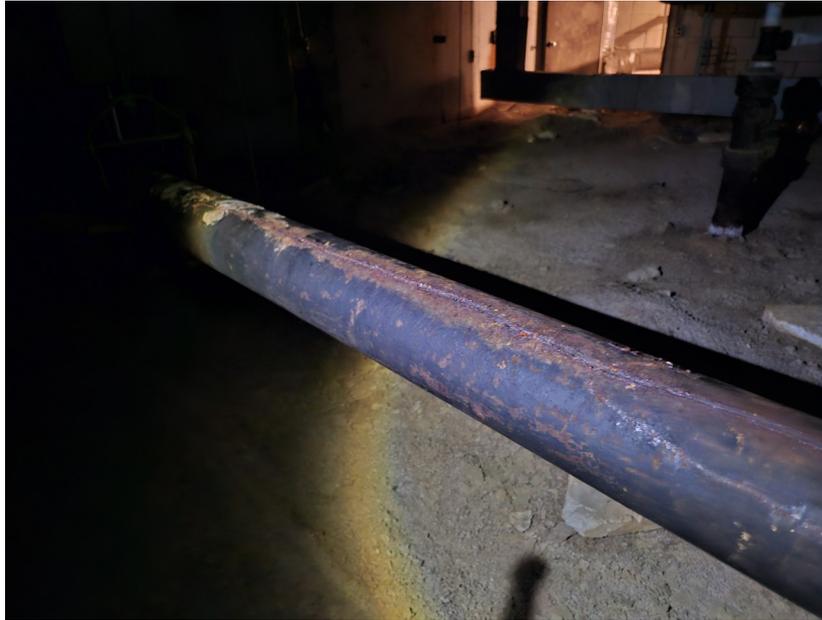
One of centralized storm pipes was sheered, discharging onto the gravel floor. Sump pump discharge pipes were observed to be disconnected and the operational status of the pumps was questionable. Pipe insulation was observed to be severely deteriorated from sustained high moisture content.

Photo 1: Damaged Storm Pipe

- Disconnect and abandon the exiting downspout connection and drainage system under the building. Seal/cap all interior storm sewer piping. Seal exterior wall penetrations. Install new exterior underground storm sewer piping collecting all roof downspouts external to building, install backflow prevention, and drain to pond in conjunction with the grading and pavement projects.

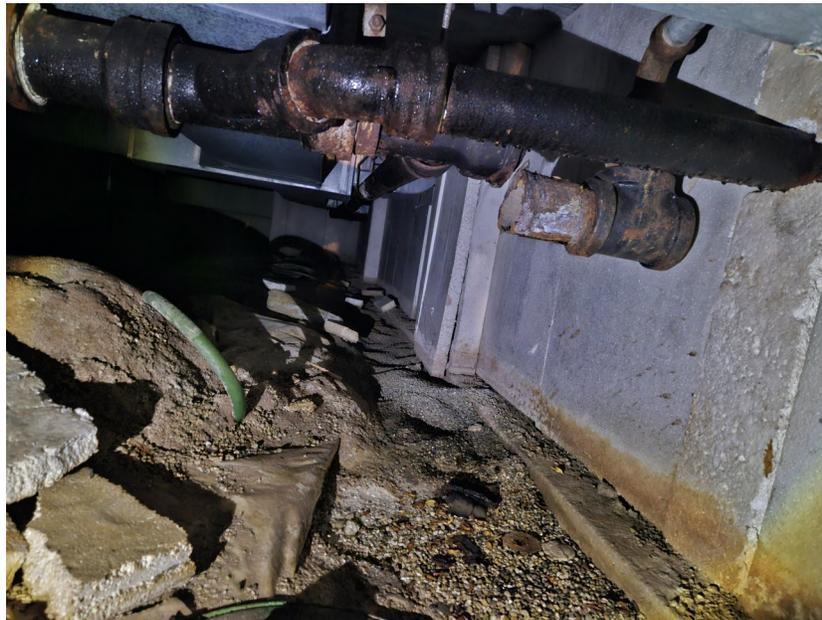
Photo 2: Broken Sprinkler Pipe

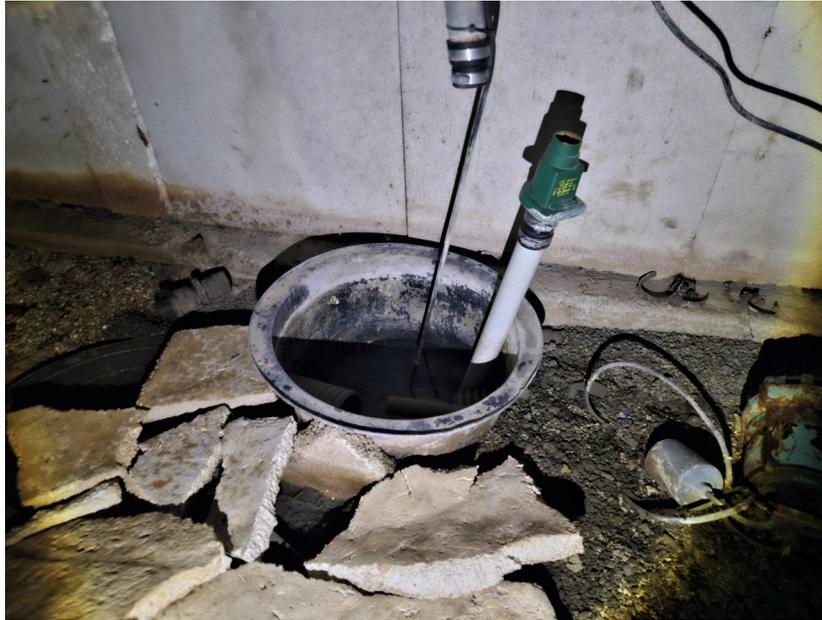
Photo 3: Disconnected Sump Pump

- Abandon the exiting drain tile system. Design a new system to effectively remove water surrounding the building foundation. Excavate and replace all interior and exterior drain tile, sump pits, and sump pumps. Install backflow prevention to discharge pipes.

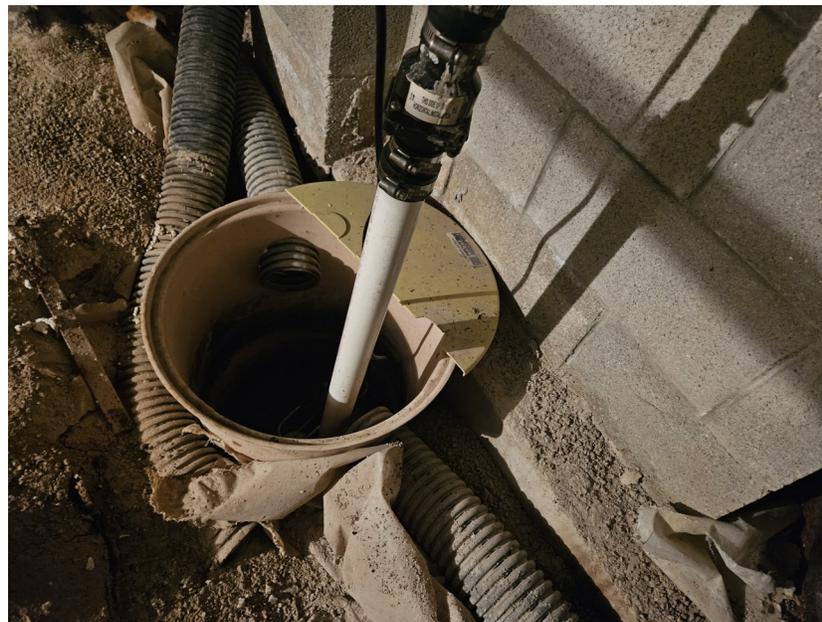
Photo 4: Sump Pit

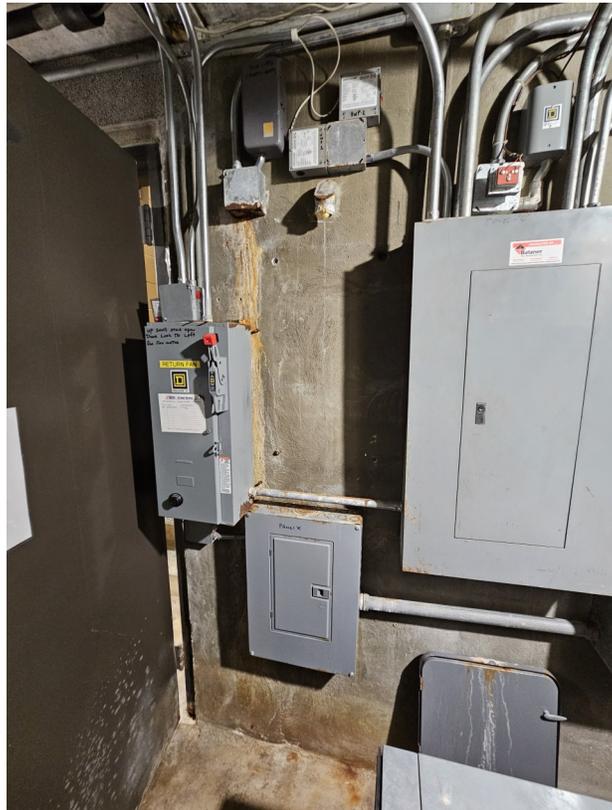
The exterior grade adjacent to the foundation wall has settled and does not slope away from the building. Electrical and exhaust wall penetrations are not sealed and show signs of water intrusion. Corrosion staining is present at and on conduit and junction boxes and exhaust ductwork for the boilers and water heater. The air handler showed heavy corrosion along the floor level.

Photo 5: Foundation Wall Penetration Leaks

- Replace all through wall electrical runs below grade and any corroded electrical components. Seal all exterior wall penetrations with backer rod and an exterior rated sealant in conjunction with adjusting the pavement surfaces to provide adequate drainage from the face of the building away for a minimum of 5 feet.

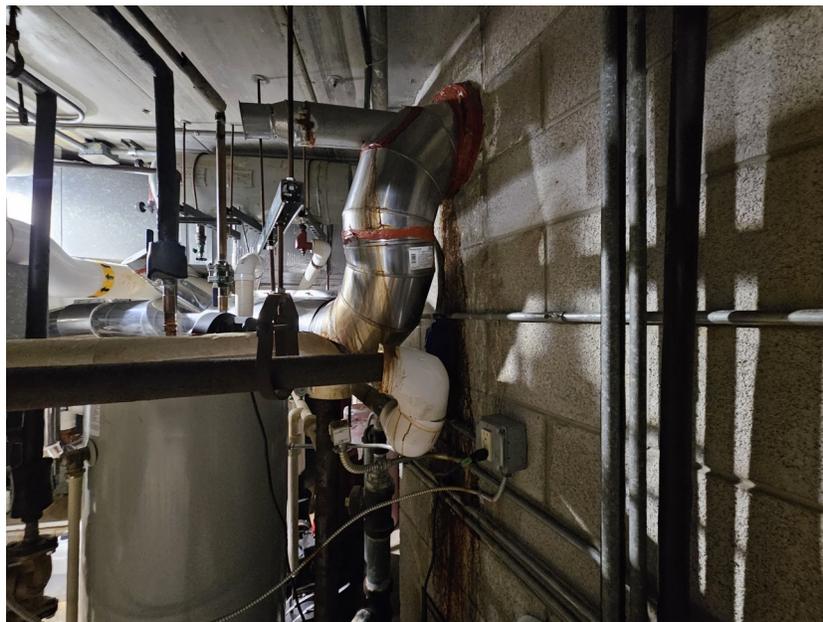
Photo 6: Boiler Exhaust Leak

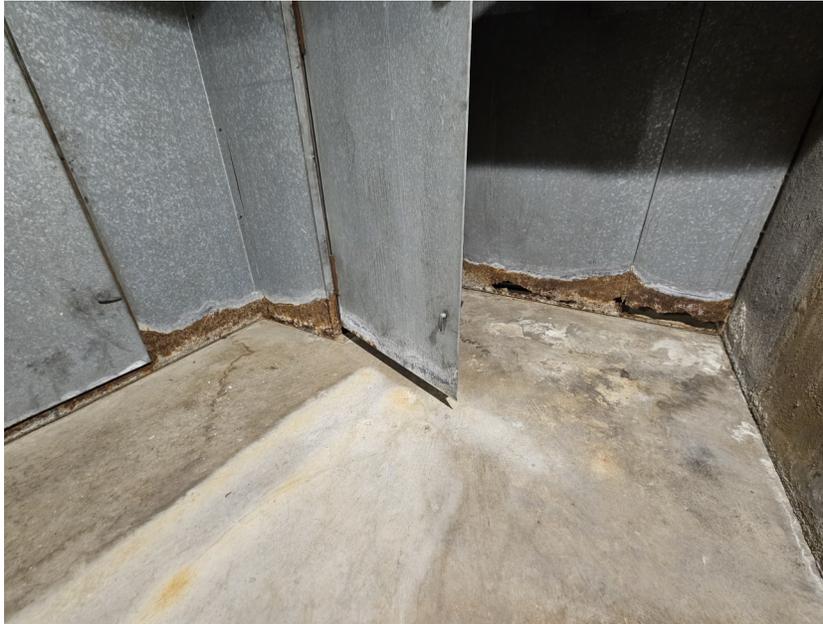
Photo 7: HVAC Corrosion

- Repair air handler ductwork sheet metal in conjunction with moisture mitigation efforts to isolate HVAC supply air and filters from the adjacent mechanical room space.

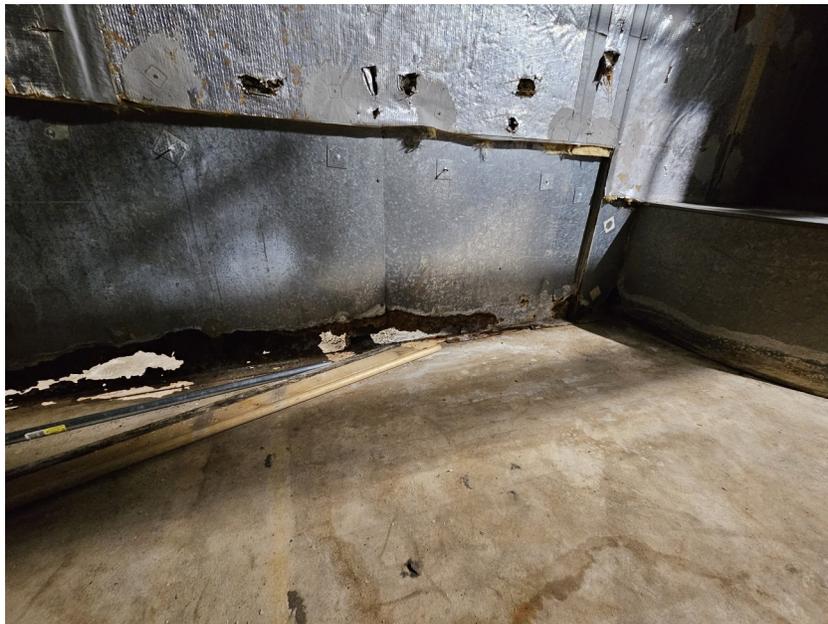
Photo 8: HVAC Corrosion

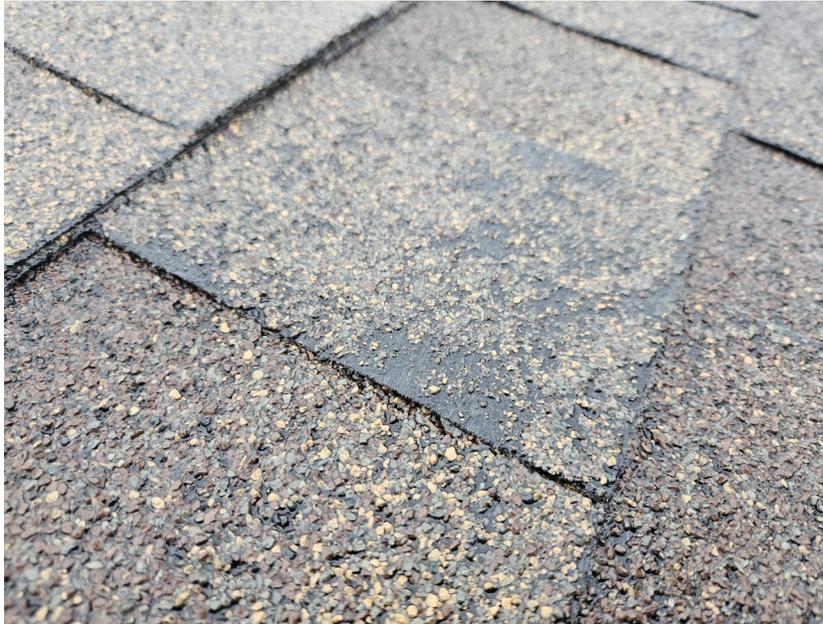
Photo 9: Roof Aging

- The majority of the roof asphalt shingles were nearing the end of their typical useful life. Perform a full roof replacement. Add a rejecting trim piece with drip edge under the outer edge of shingles at sections of the roof where no gutter is present. Regularly clean gutters to prevent debris from clogging downspout inlets. Tuckpoint all cracking mortar. Remove and replace all sealant. Add chimney caps to the flues where missing.

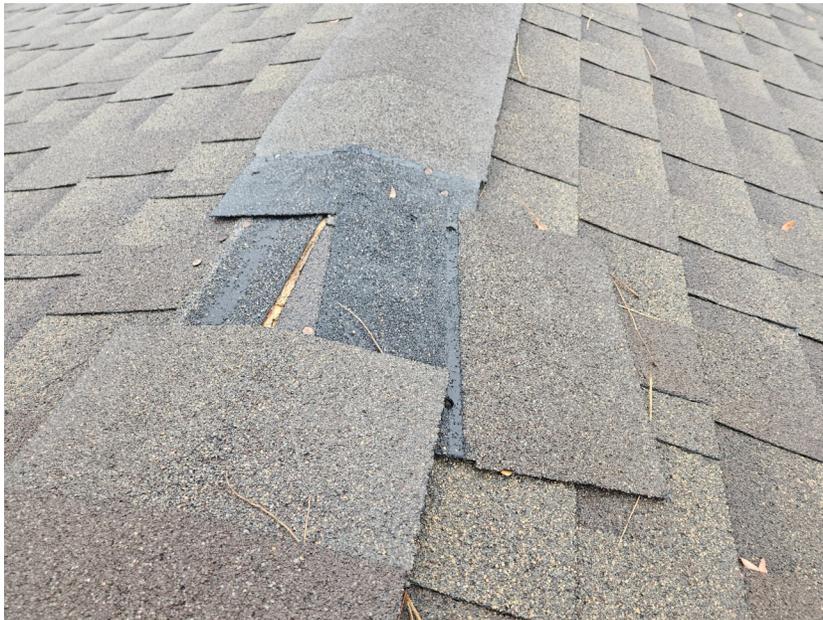
Photo 10: Roof Damage

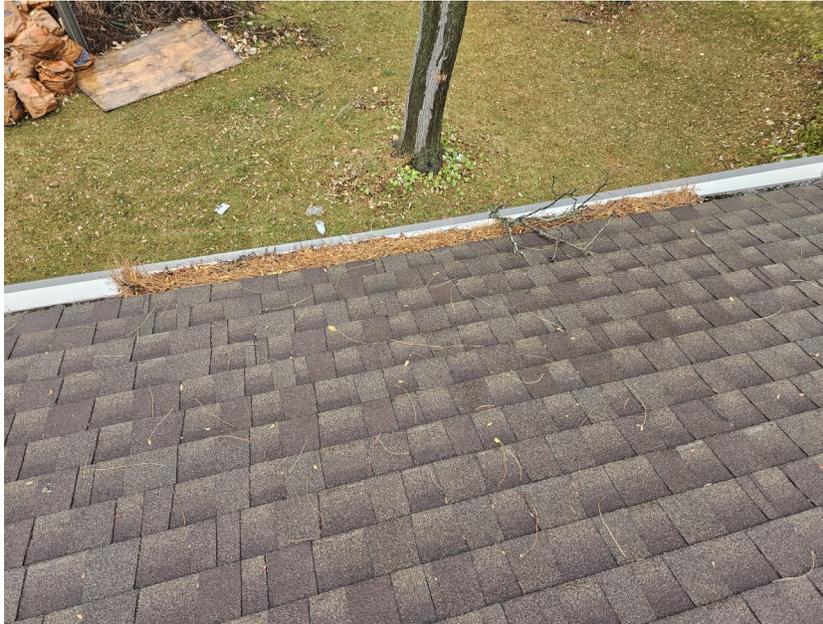
Photo 11: Blocked Gutter Inlet

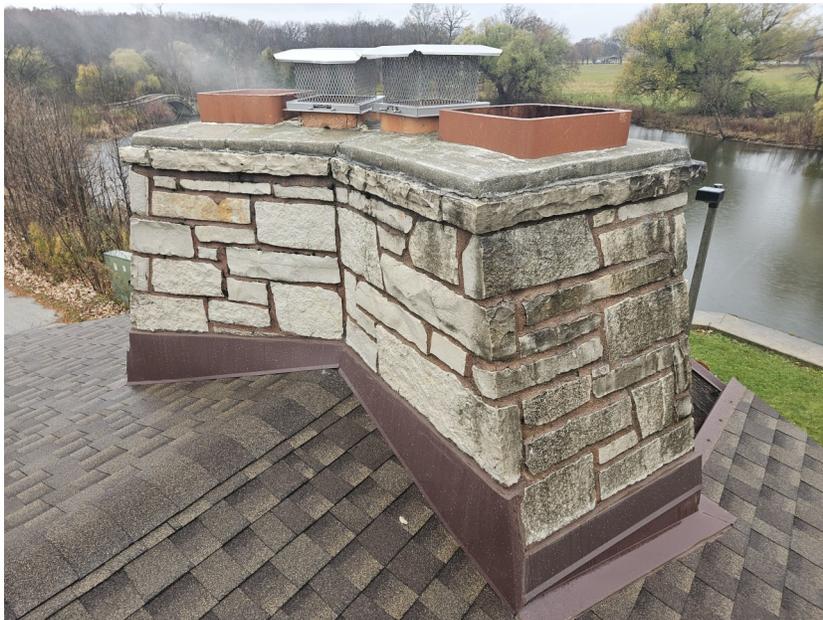
Photo 12: Missing Flue Cap

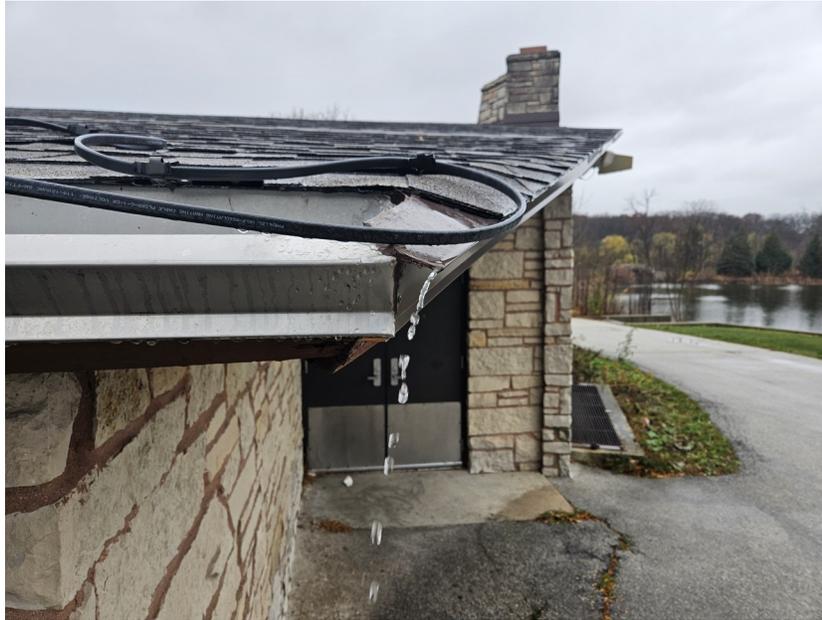
Photo 13: Needed Trim Where There is No Gutter

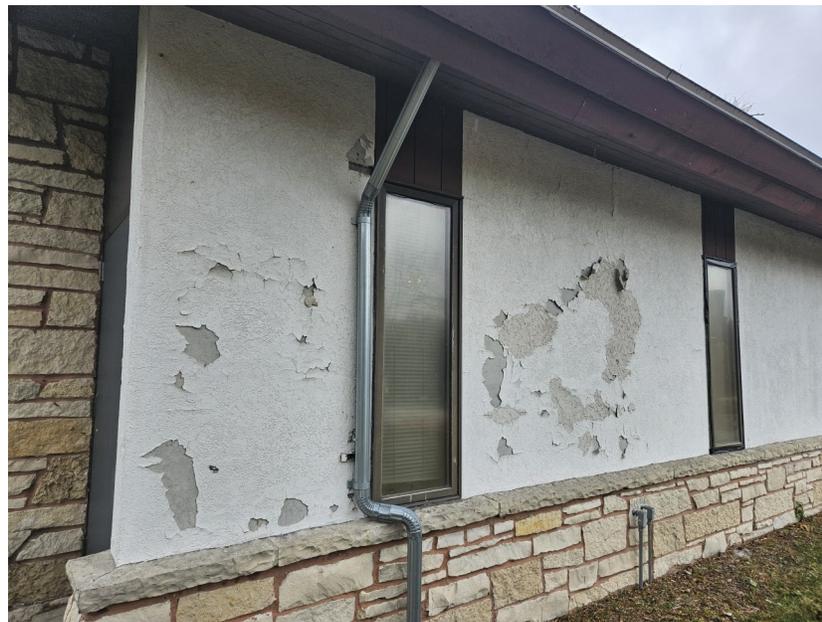
Photo 14: Façade Damage

- Remove peeling paint and repair the façade as necessary where damaged. Prime and paint to match existing.

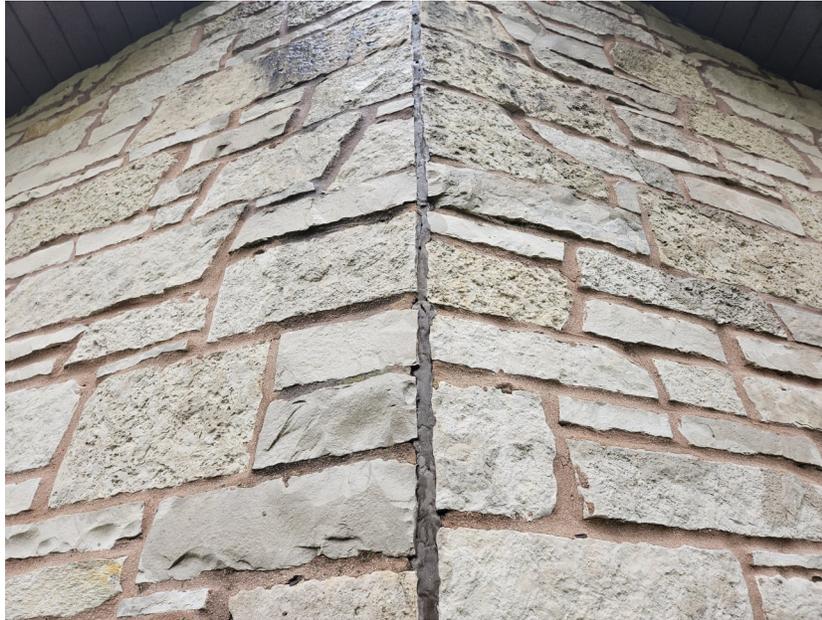
Photo 15: Failing Sealant

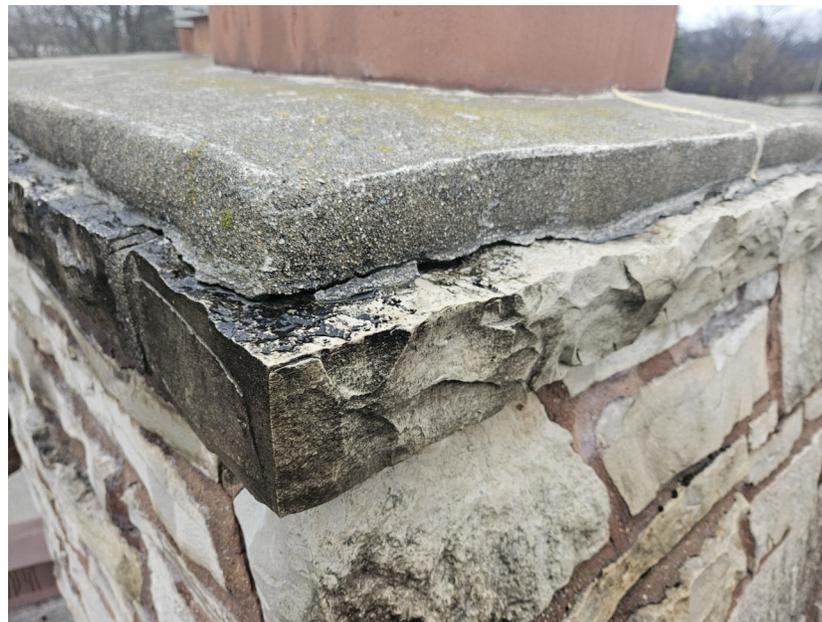
Photo 16: Cracking Mortar
