RE: McGovern Senior Center Engineering Report, post August 2025 Flooding

# McGovern Senior Center Moisture Investigation Report

4500 W Custer Avenue  
Milwaukee, WI 53218

Project Number – 24609

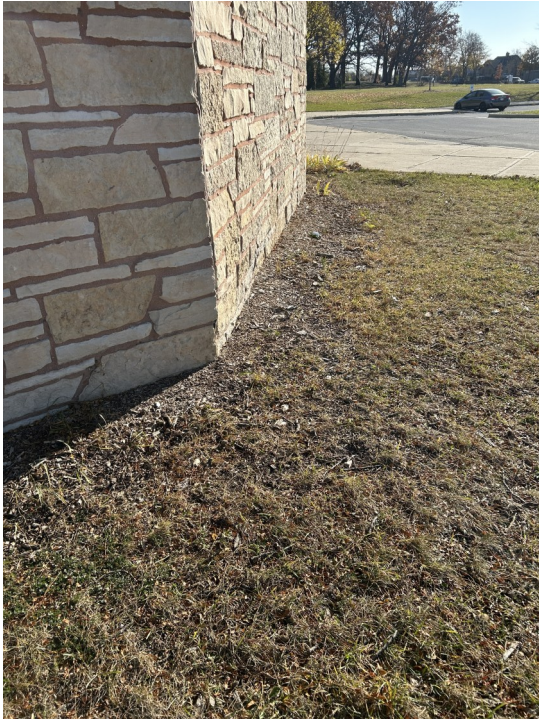
Photo 1: Unpaved area adjacent to west side of building.

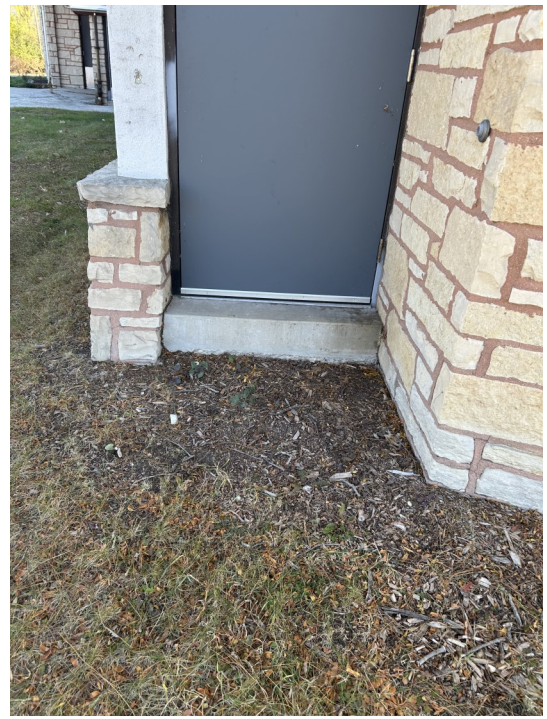
Photo 2: Unpaved area adjacent to door on west side of building.

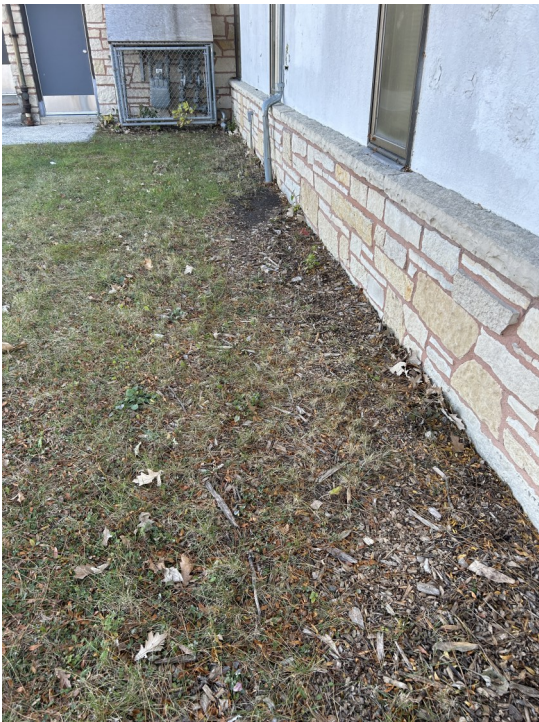
Photo 3: Unpaved area adjacent to north side of building.

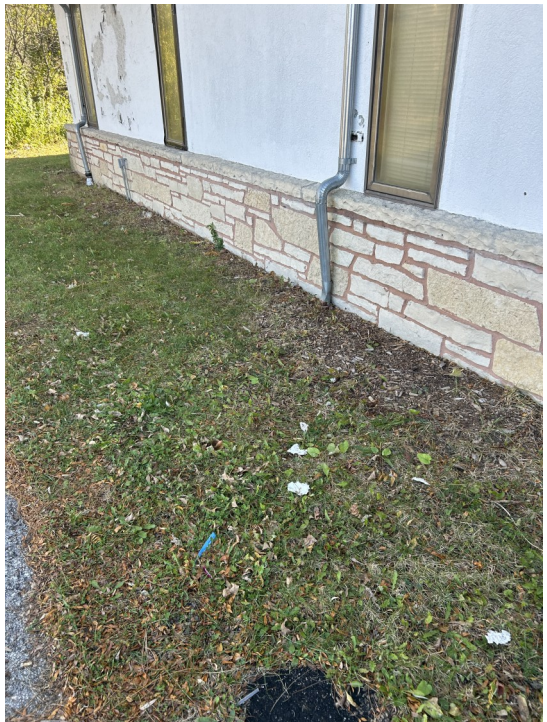
Photo 4: Unpaved area adjacent to north side of building.

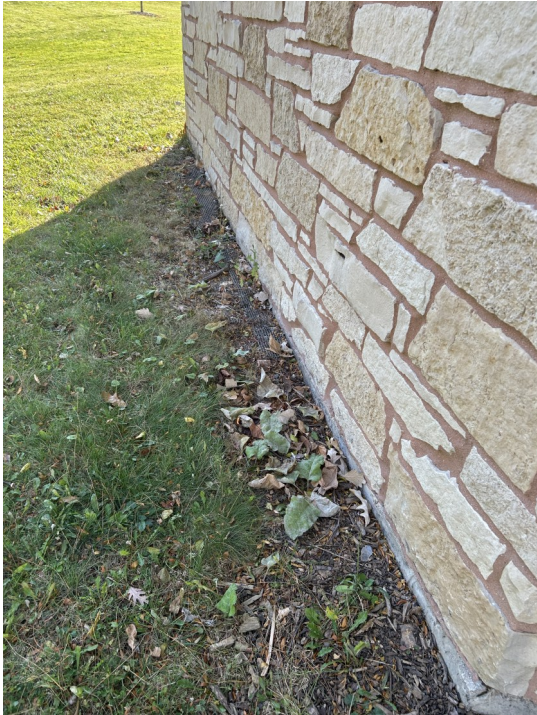
Photo 5: Unpaved area adjacent to north side of building.

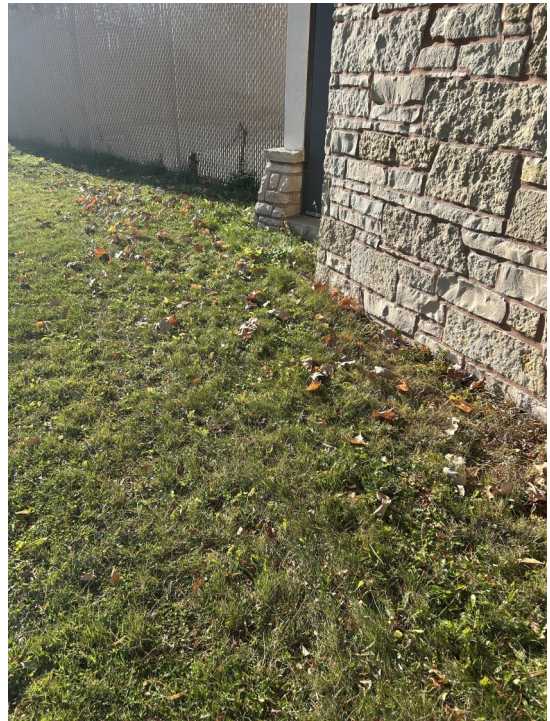
Photo 6: Unpaved area adjacent to northeast side of building.

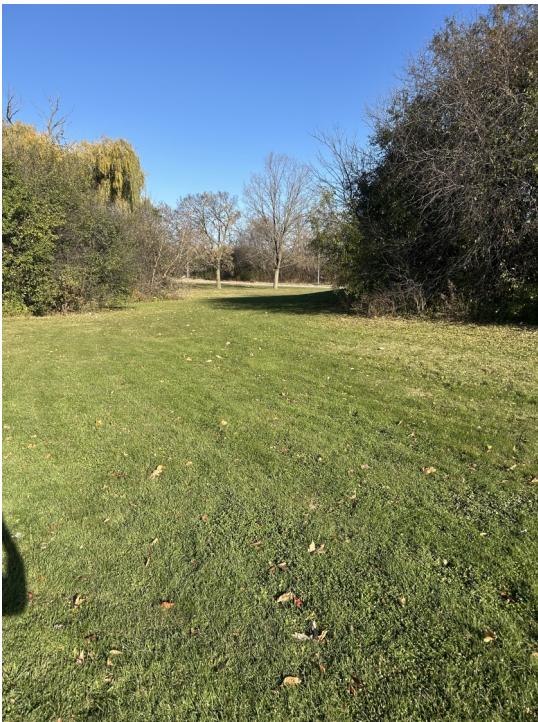
Photo 7: Existing shallow swale looking north.

- The shallow grass swale east of the building does not sufficiently capture stormwater and direct it around the building. The swale should be regraded, deepened, and extended southwesterly to capture and divert stormwater.

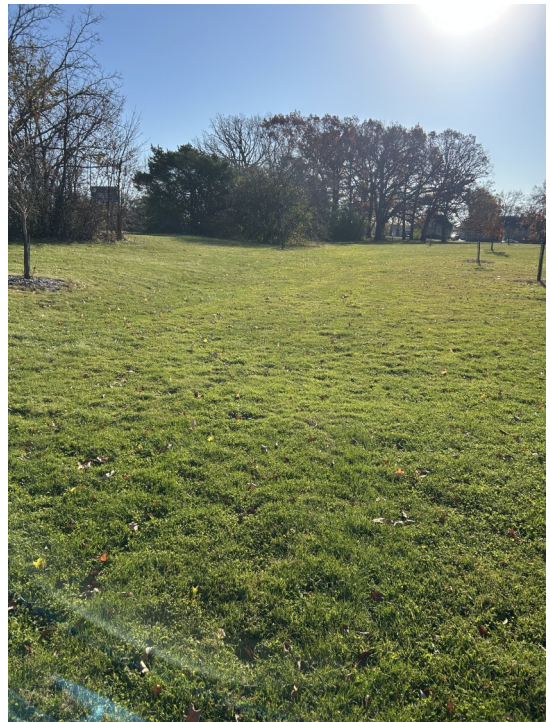
Photo 8: Existing shallow swale looking south-east.

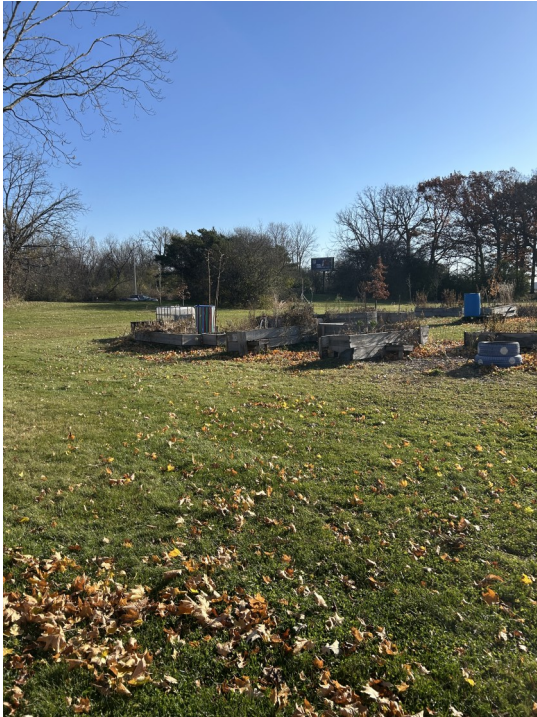
Photo 9: Area between southeast side of building and garden identified for potential shallow swale addition.

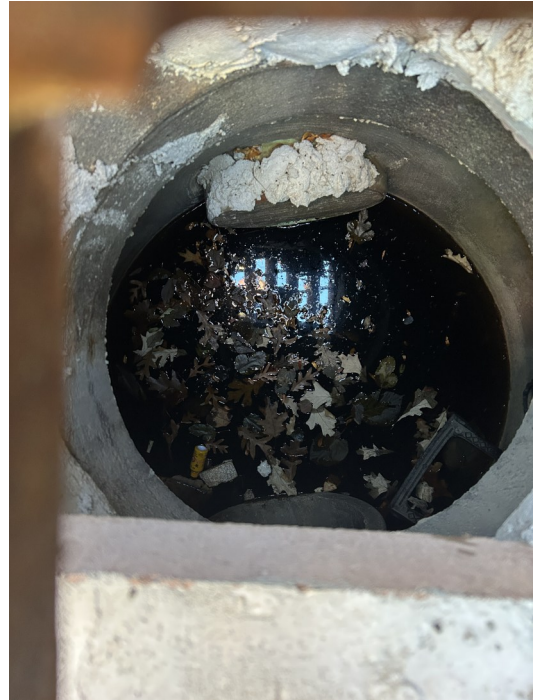
Photo 10: Inlet in parking lot with concrete filled pipe connection.

- Video inspection of internal drain tile to determine pipe routing, condition, and discharge location.
- The northernmost parking lot catch basin apparent discharge pipe appears to be filled with concrete and should be inspected to verify drainage. Install backflow prevention for all pipes leading into the storm pond.

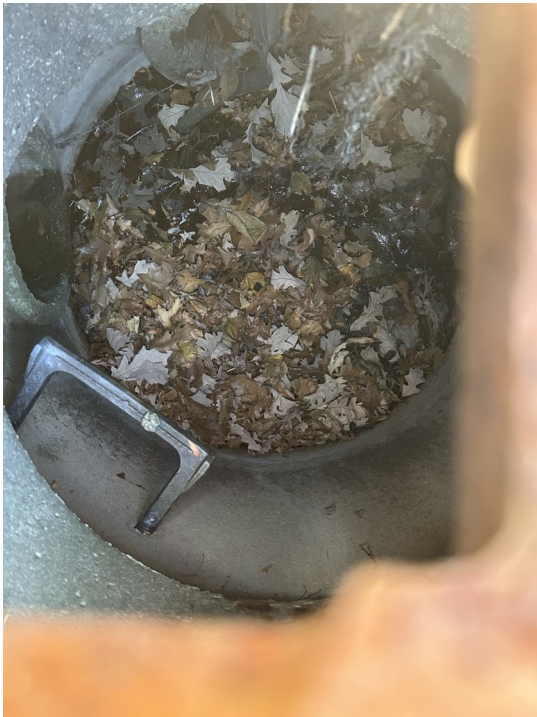
Photo 11: Inlet in parking lot south of inlet from Photo 10.

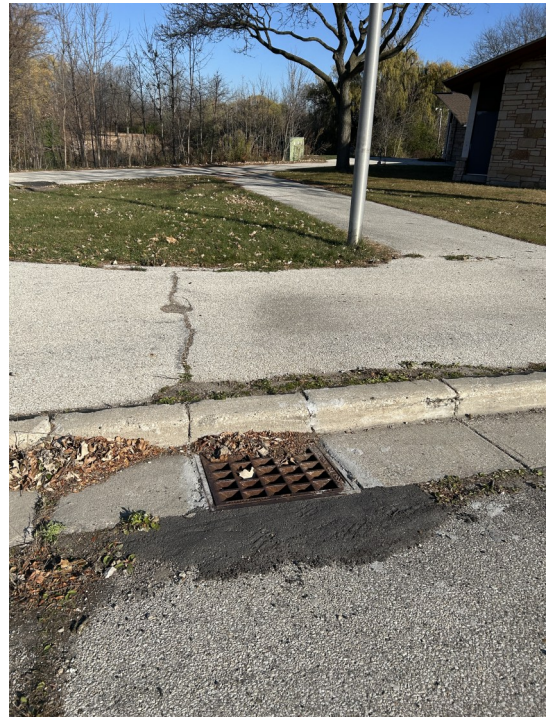
Photo 12: Exterior of inlet from Photo 10.

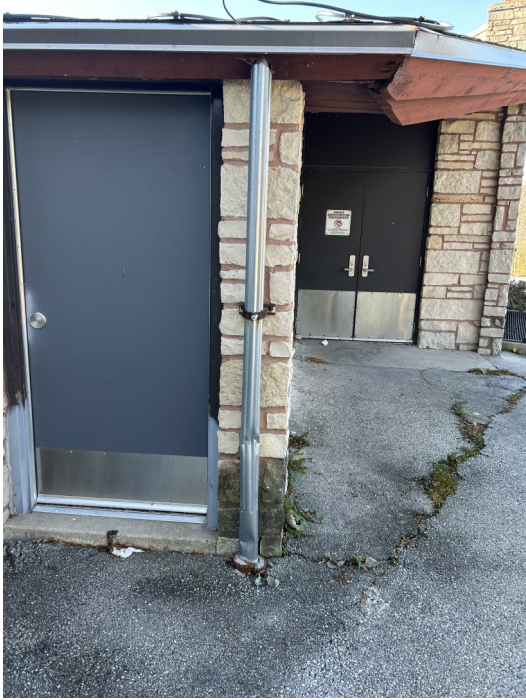
Photo 13: Deteriorating and settling asphalt on north side of building.

- Asphalt pavement adjacent to the building was observed to have settled. This settlement has resulted in water getting trapped next to the building. This can result in water entering the building through the north foundation wall. Survey and design a pavement plan to replace all asphalt walkways north of the building and provide positive drainage away from the building toward the pond.

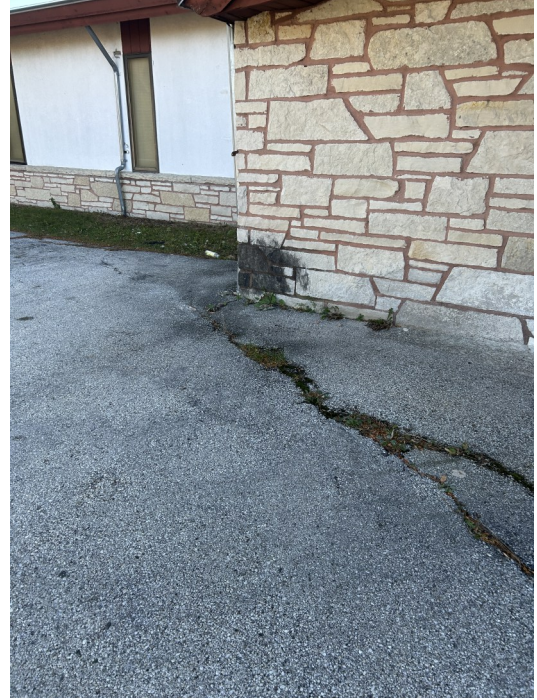
Photo 14: Cracked and settling asphalt on north side of building.

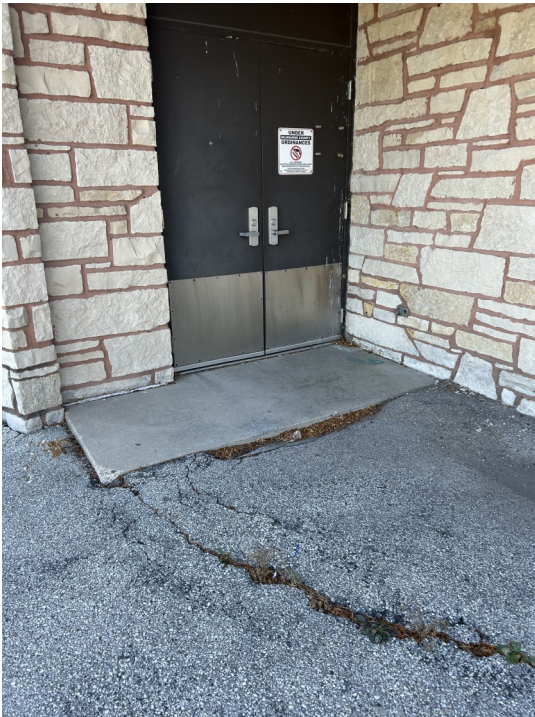
Photo 15: Settling asphalt near entrance on northwest side of building.

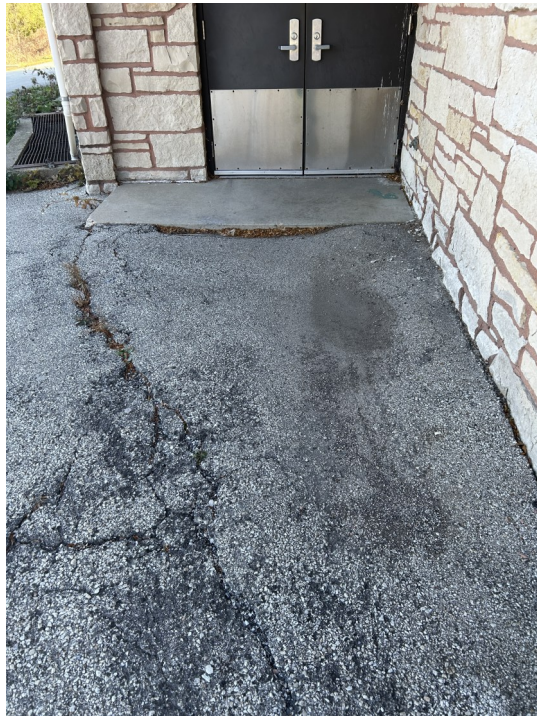
Photo 16: Deteriorating and settling asphalt on northwest side of building.

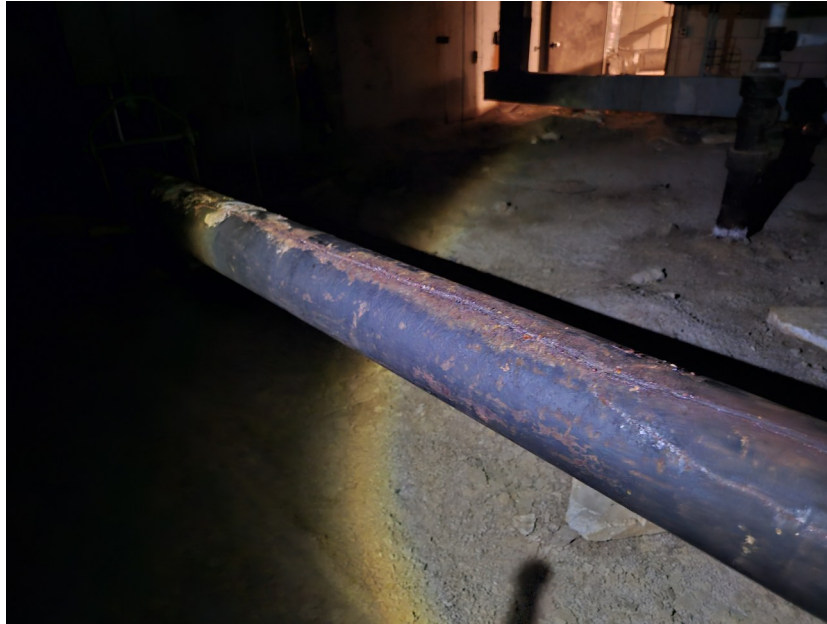
One of centralized storm pipes was sheered, discharging onto the gravel floor. Sump pump discharge pipes were observed to be disconnected and the operational status of the pumps was questionable. Pipe insulation was observed to be severely deteriorated from sustained high moisture content.

Photo 1: Damaged Storm Pipe

- Disconnect and abandon the exiting downspout connection and drainage system under the building. Seal/cap all interior storm sewer piping. Seal exterior wall penetrations. Install new exterior underground storm sewer piping collecting all roof downspouts external to building, install backflow prevention, and drain to pond in conjunction with the grading and pavement projects.

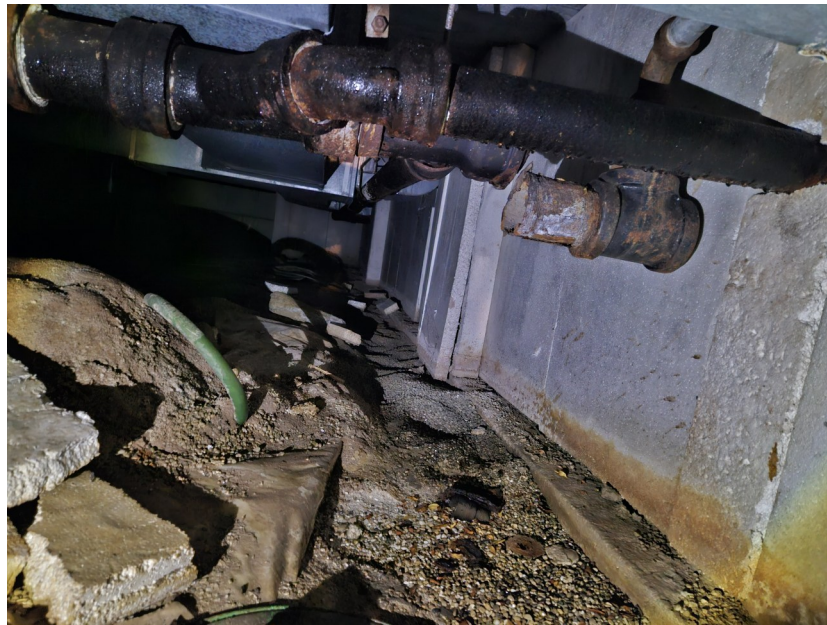
Photo 2: Broken Sprinkler Pipe

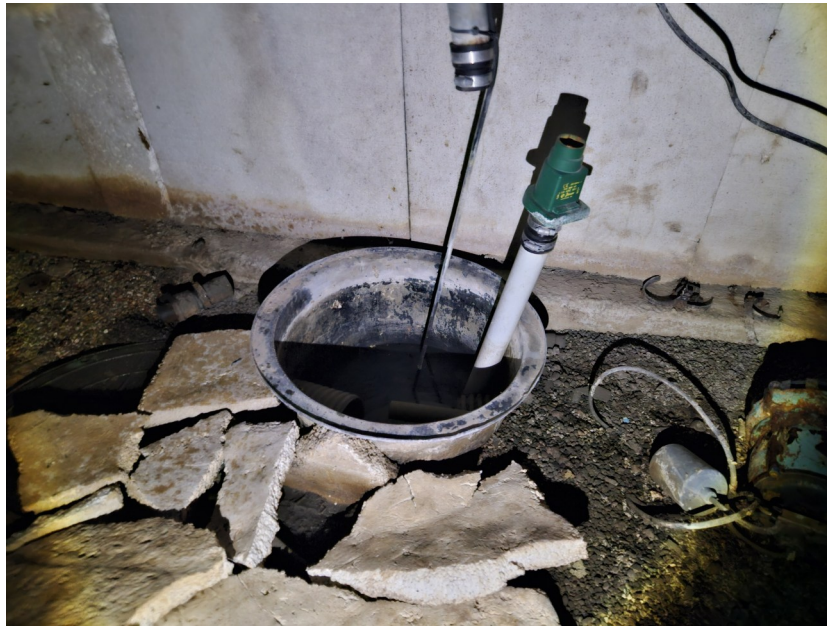
Photo 3: Disconnected Sump Pump

- Abandon the exiting drain tile system. Design a new system to effectively remove water surrounding the building foundation. Excavate and replace all interior and exterior drain tile, sump pits, and sump pumps. Install backflow prevention to discharge pipes.

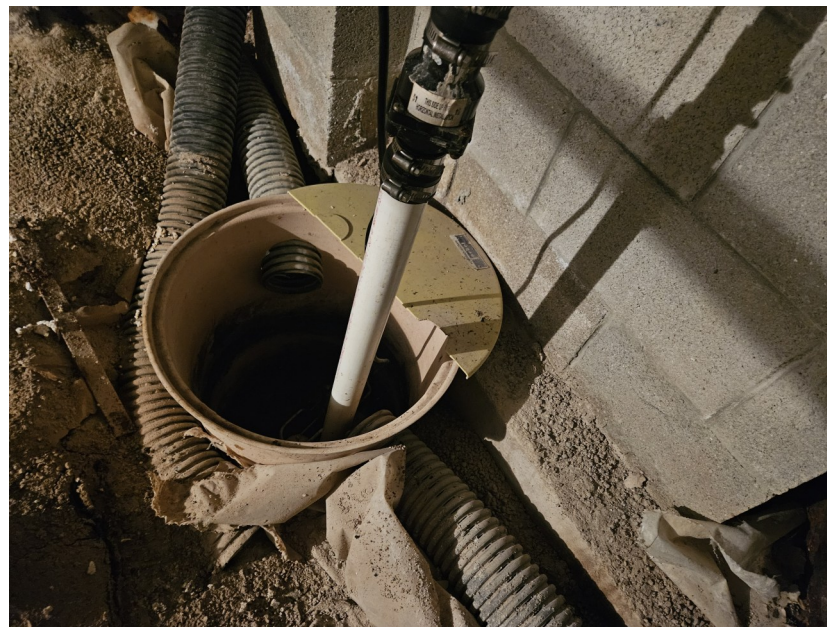
Photo 4: Sump Pit

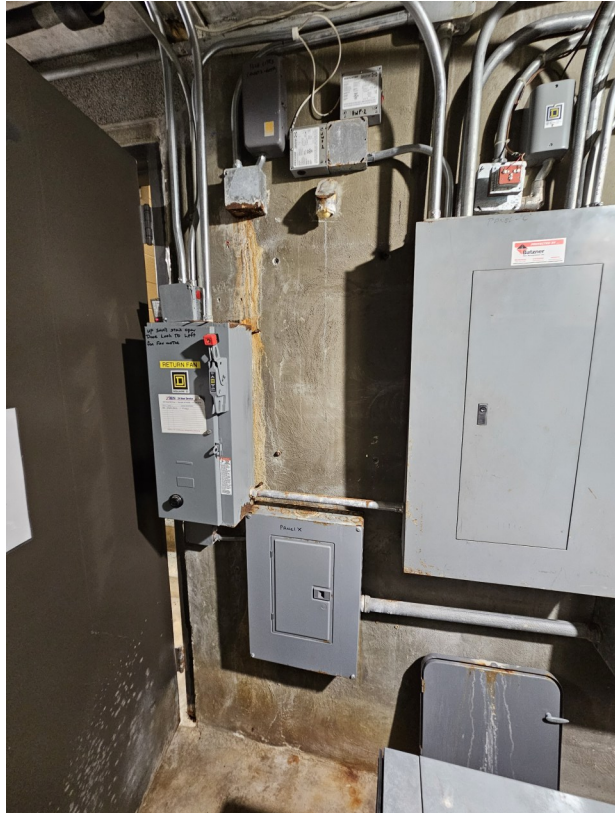
The exterior grade adjacent to the foundation wall has settled and does not slope away from the building. Electrical and exhaust wall penetrations are not sealed and show signs of water intrusion. Corrosion staining is present at and on conduit and junction boxes and exhaust ductwork for the boilers and water heater. The air handler showed heavy corrosion along the floor level.

Photo 5: Foundation Wall Penetration Leaks

- Replace all through wall electrical runs below grade and any corroded electrical components. Seal all exterior wall penetrations with backer rod and an exterior rated sealant in conjunction with adjusting the pavement surfaces to provide adequate drainage from the face of the building away for a minimum of 5 feet.

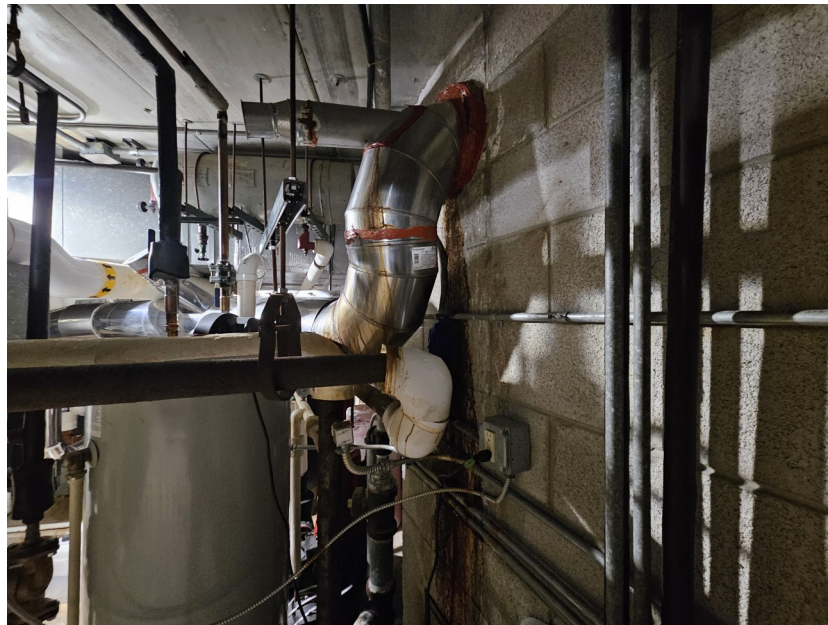
Photo 6: Boiler Exhaust Leak

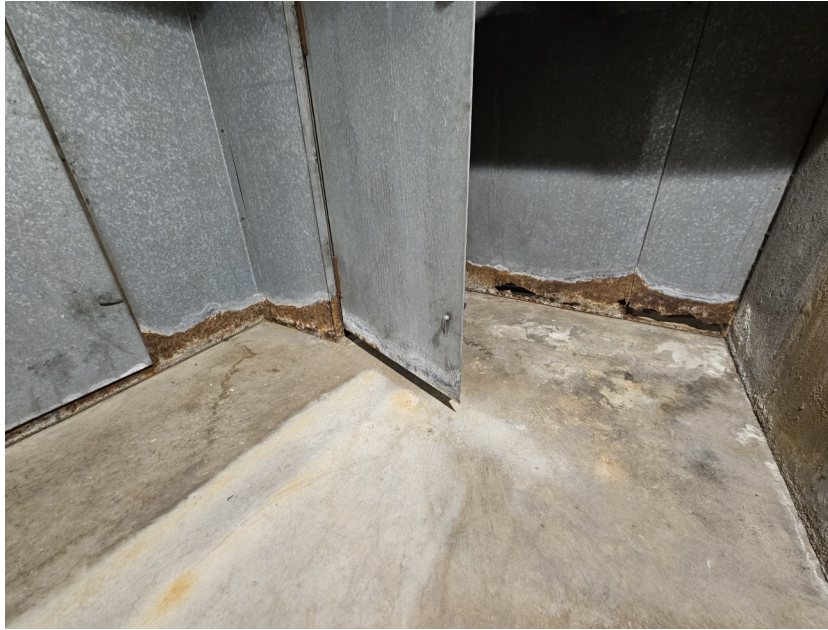
Photo 7: HVAC Corrosion

- Repair air handler ductwork sheet metal in conjunction with moisture mitigation efforts to isolate HVAC supply air and filters from the adjacent mechanical room space.

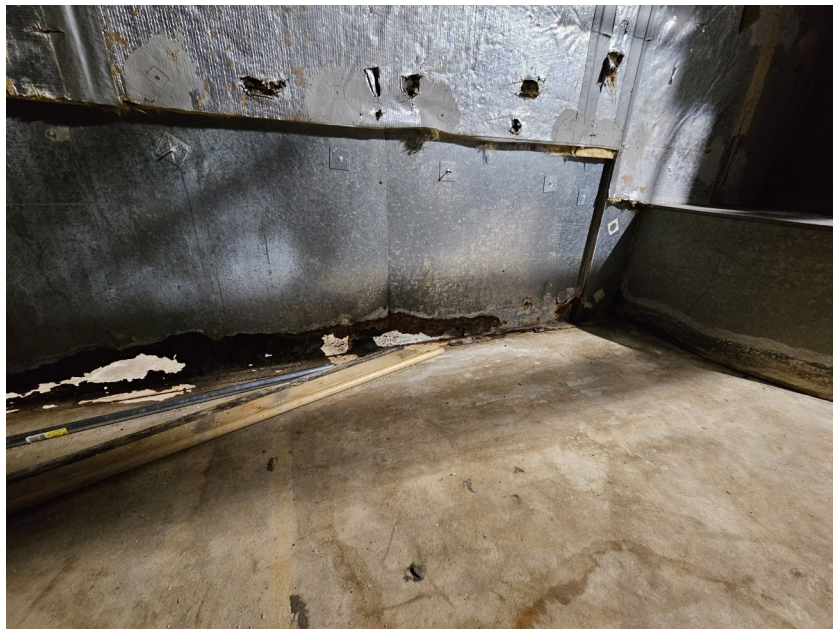
Photo 8: HVAC Corrosion

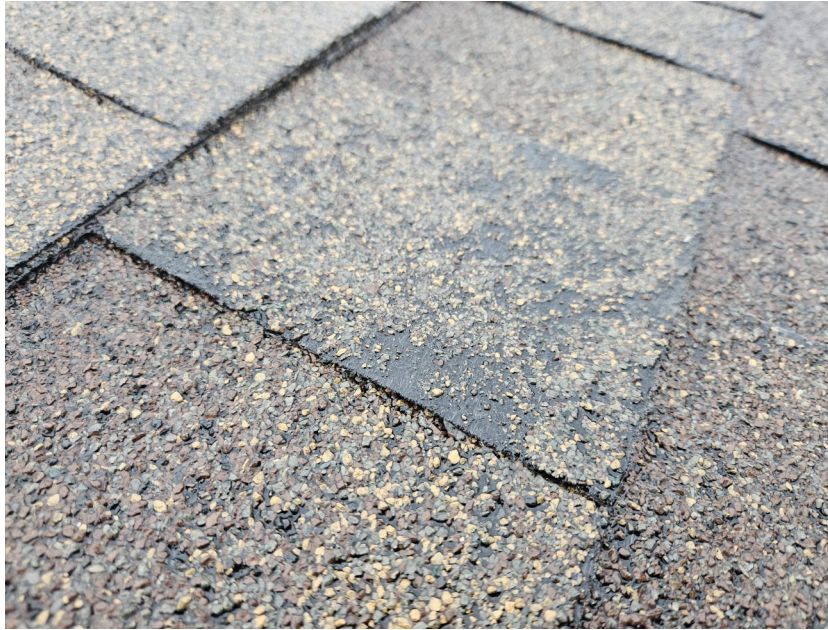
Photo 9: Roof Aging

- The majority of the roof asphalt shingles were nearing the end of their typical useful life. Perform a full roof replacement. Add a rejecting trim piece with drip edge under the outer edge of shingles at sections of the roof where no gutter is present. Regularly clean gutters to prevent debris from clogging downspout inlets. Tuckpoint all cracking mortar. Remove and replace all sealant. Add chimney caps to the flues where missing.

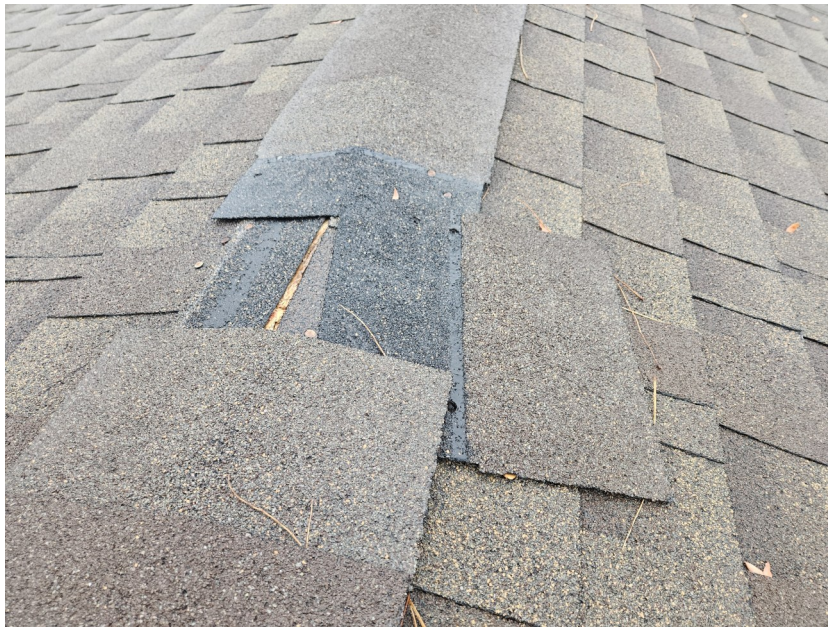
Photo 10: Roof Damage

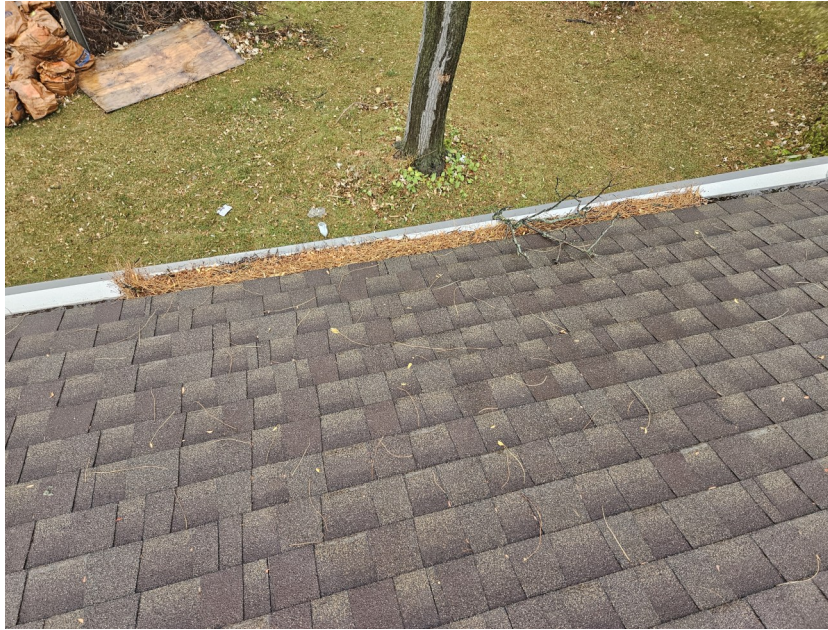
Photo 11: Blocked Gutter Inlet

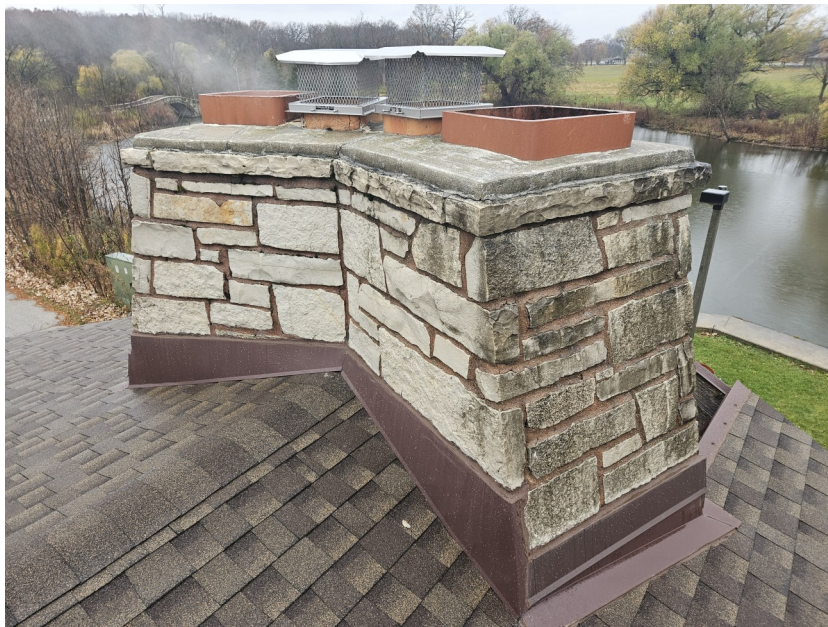
Photo 12: Missing Flue Cap

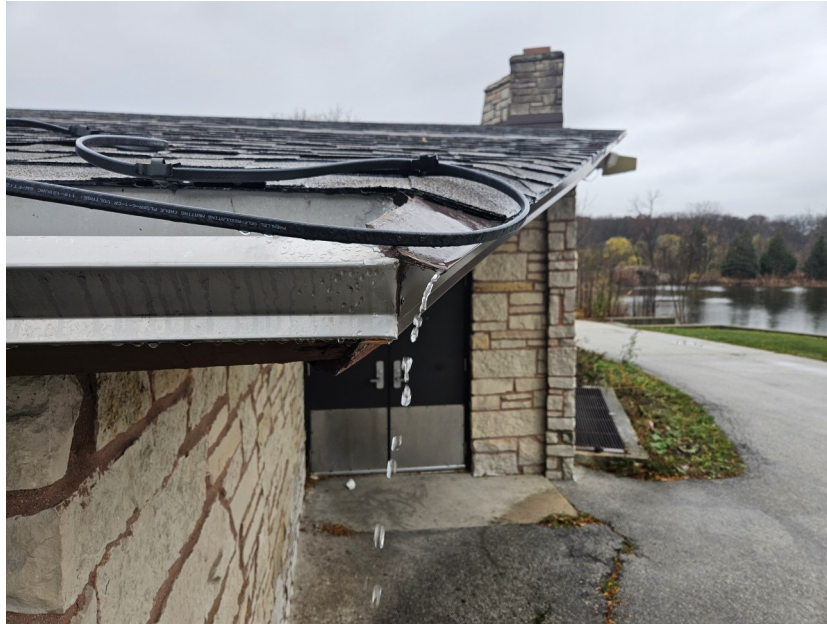
Photo 13: Needed Trim Where There is No Gutter

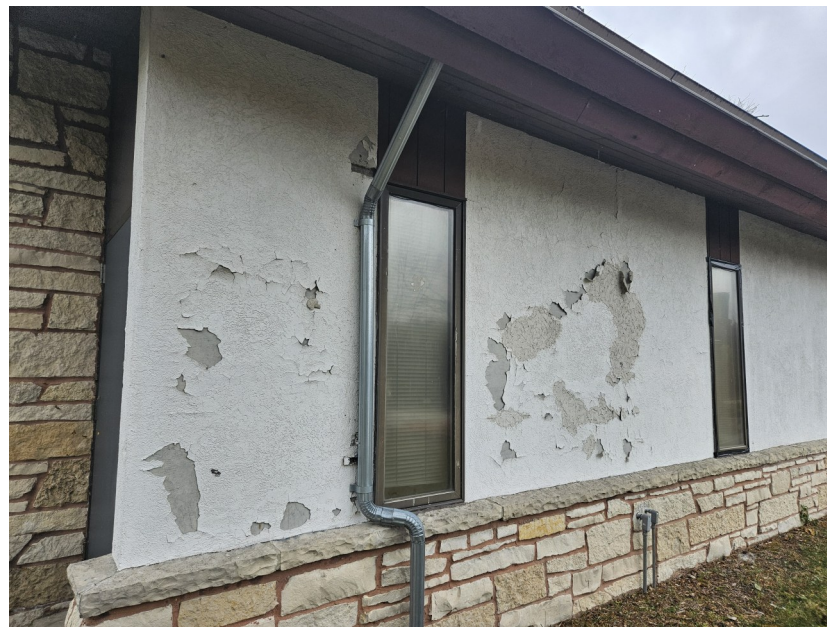
Photo 14: Façade Damage

- Remove peeling paint and repair the façade as necessary where damaged. Prime and paint to match existing.

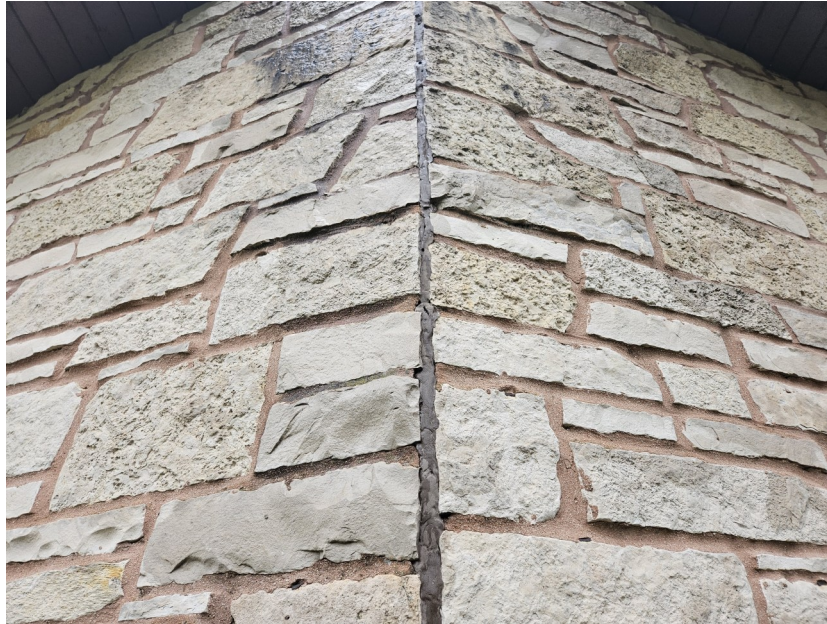
Photo 15: Failing Sealant

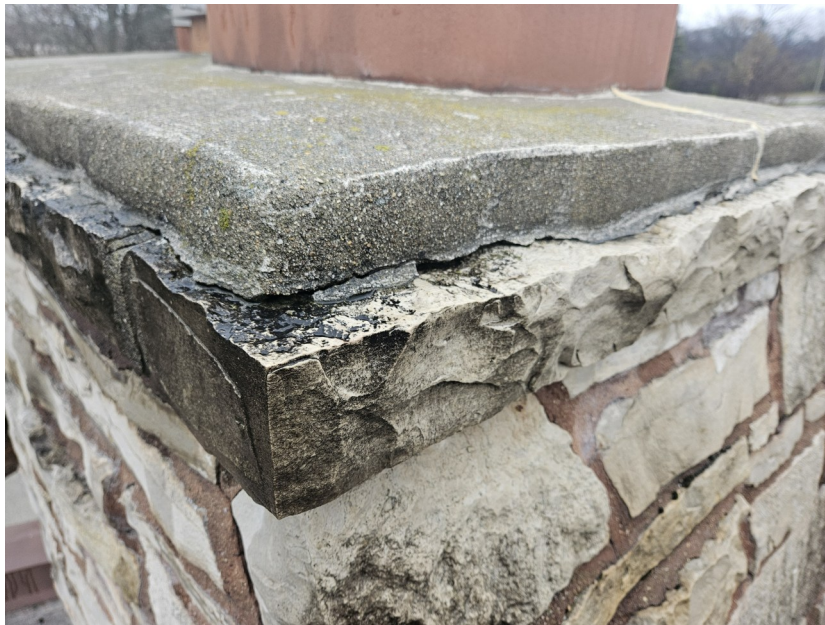
Photo 16: Cracking Mortar
