PRE-RENOVATION ASBESTOS INSPECTION AND SAMPLING REPORT

**Marcia P. Coggs Human Services Center
Asset #5600
1220 W Vliet St.
Milwaukee, WI, 53205-2117.**

March 16, 2022

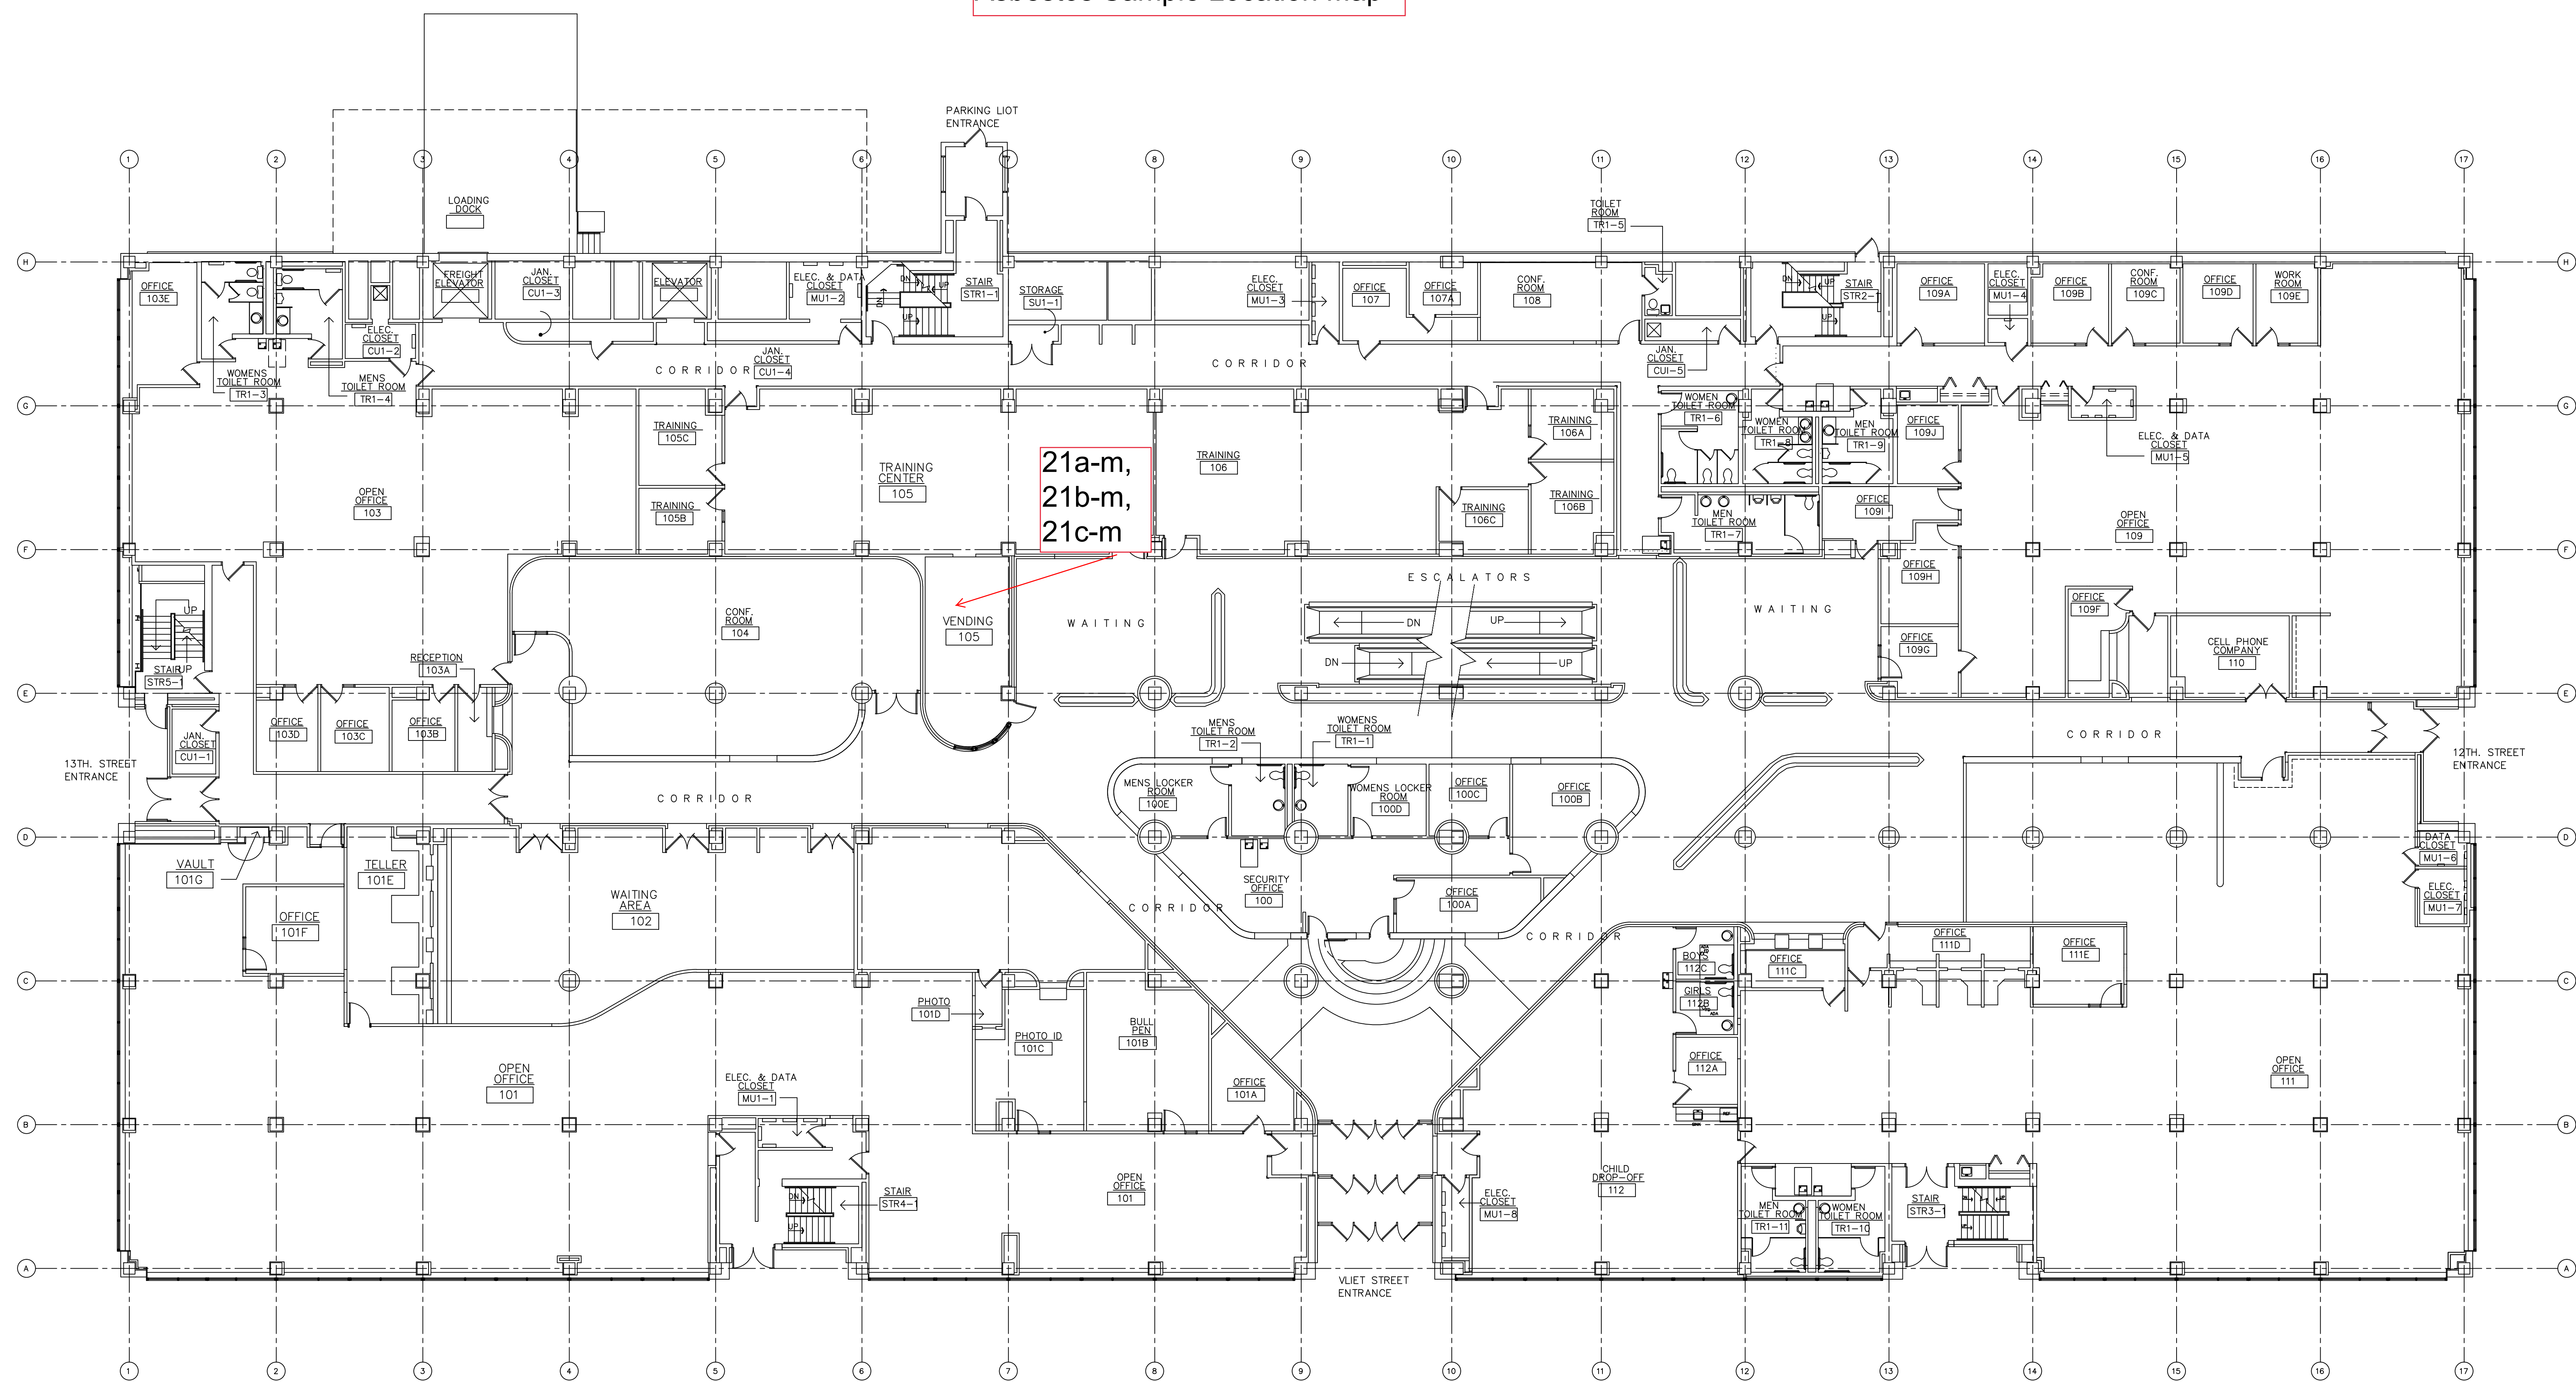
Asbestos Sample Location Map

- Quantities are estimated and additional material may be located within walls .
- ACM was found in the mastic in the break room (Samples 21a-m, 21b-m & 21c-m). The mastic is considered Category I Non-Friable asbestos; however, it must be properly abated prior to renovations if the material will be disturbed during renovation activities.

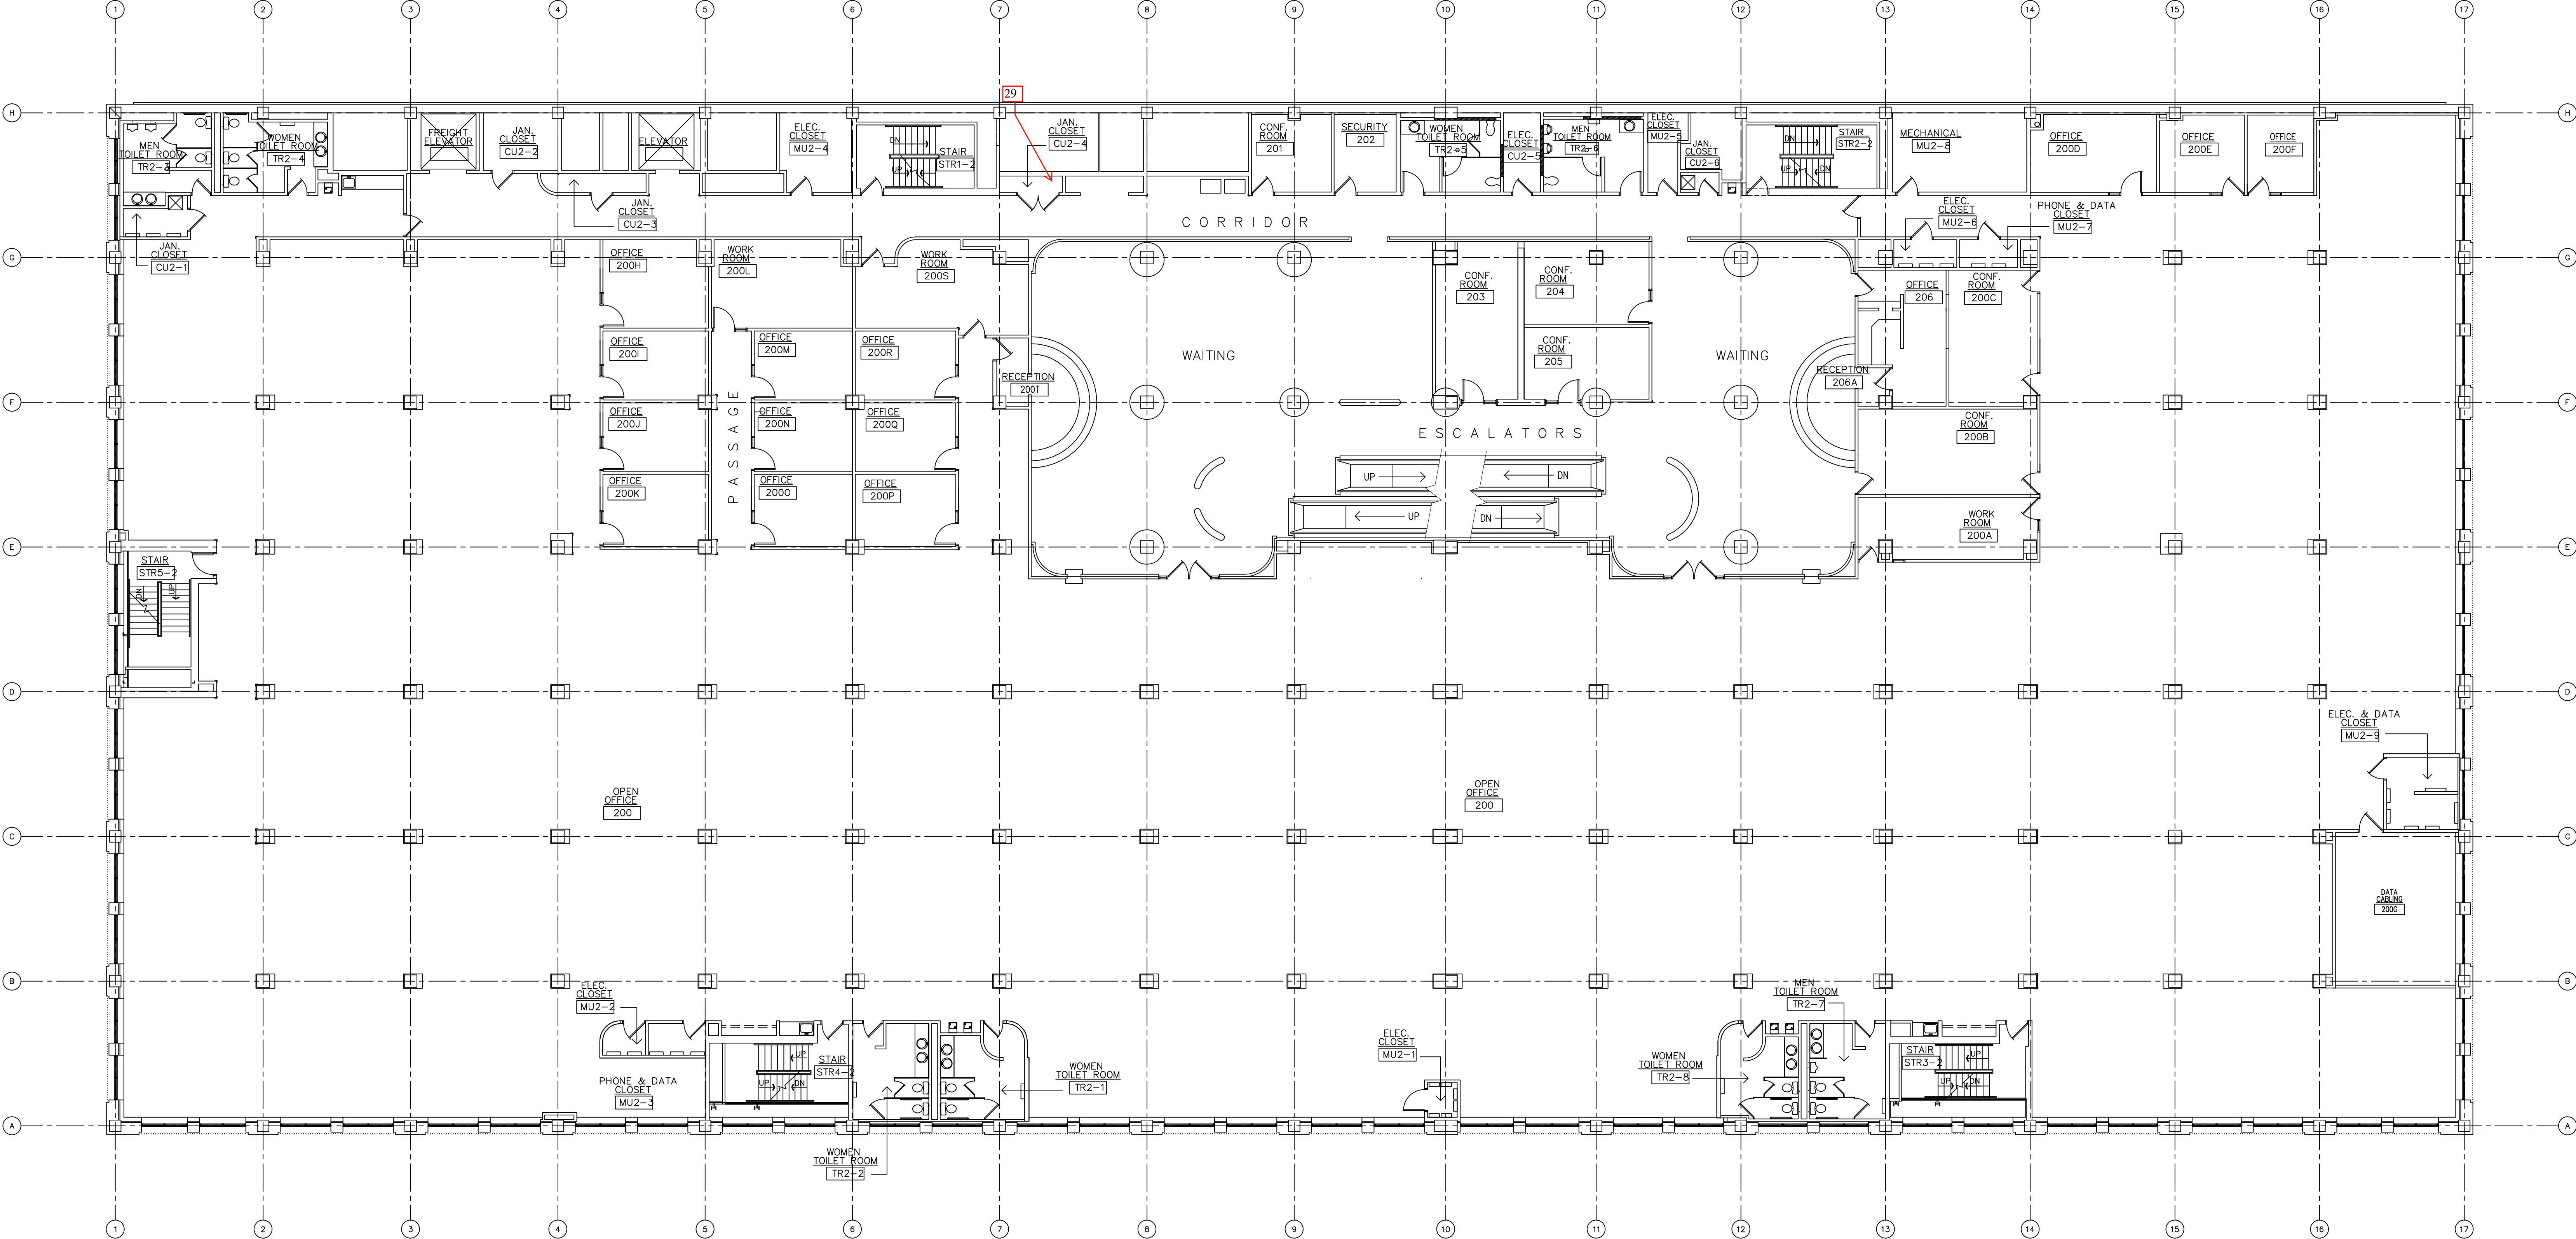
Asbestos Sample #29 location map

- ACM was found above the ceiling tile in the small pipe run (Samples 29a, 29b & 29c). The pipe insulation is Friable asbestos and must be properly abated prior to renovations if the material will be disturbed during renovation activities.
