Milwaukee County Coastal Resources Inventory

Milwaukee County, Environmental Services Unit

Milwaukee County Project 5741-19805

OCTOBER 7, 2020

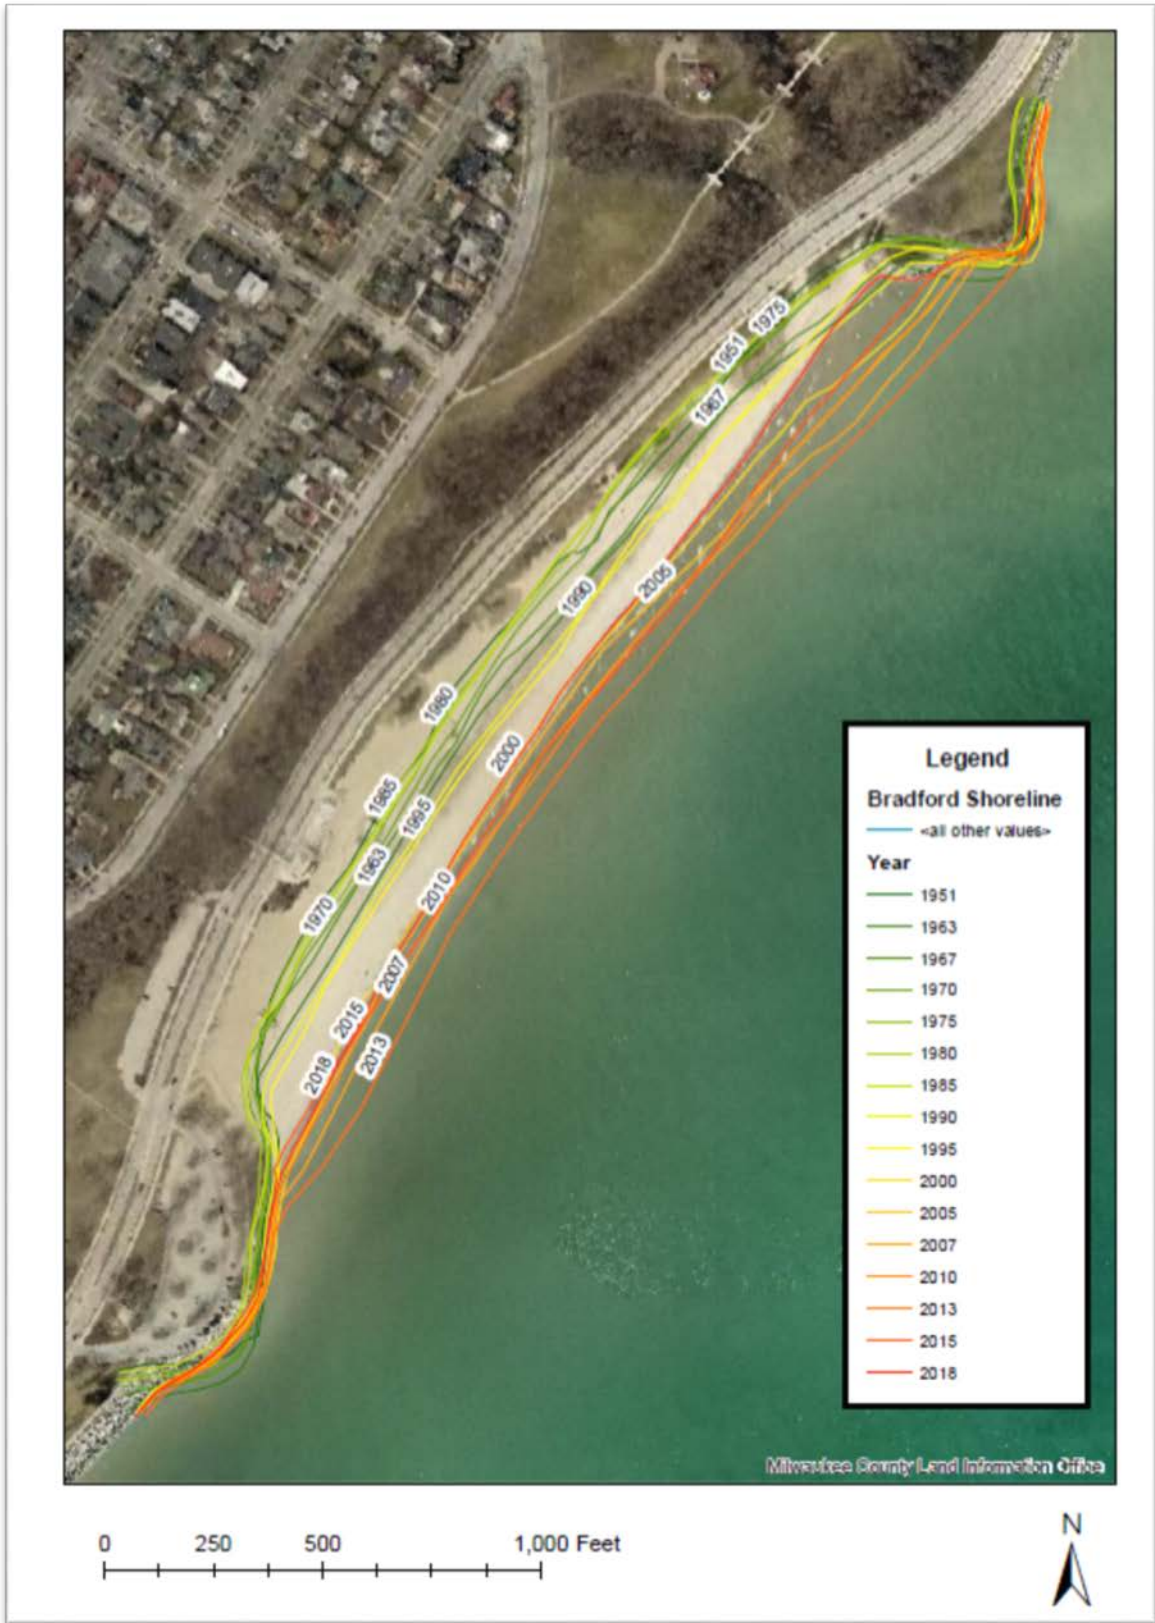
Figure 4. Bradford Beach Shoreline 1951 to 2018.

An example of beach change occurs at Bradford Beach; the northern portion has eroded. NOAA lake elevation predictions suggest the continuation of beach shrinkage, moving southward throughout the summer and fall of 2019.

Below is a Bradford Beach with 3D surface models in AutoCAD Civil 3D representing various years throughout the 2000s. In each year, modeled areas that had dry land the sand volumes had declined when lake levels were higher. This indicates that the lake is eroding sand volumes in areas that are yet to be fully submerged, not just taking up surface area due to elevation. The waves are eliminating and encroaching on land that is higher than the water elevation. An 18-inch drop off from top to bottom of this edge is cut away by wave action.

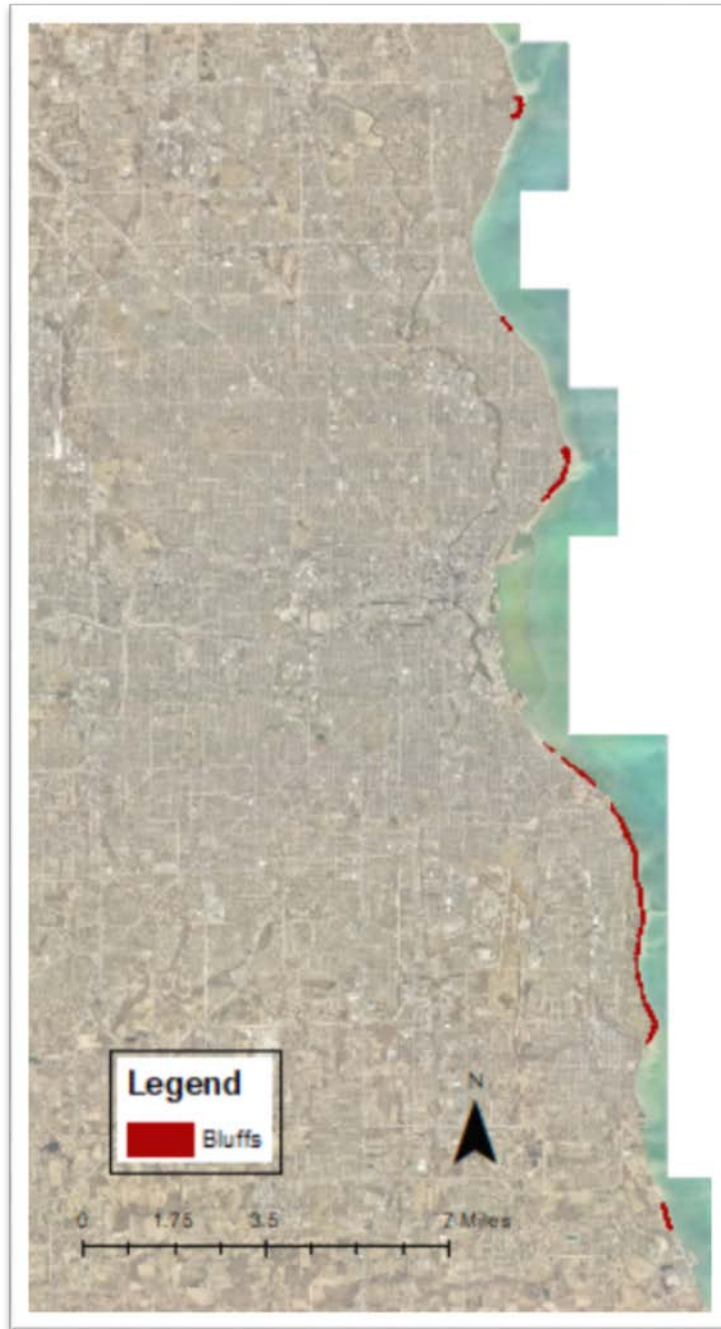
Figure 5. Milwaukee County Bluffs

Condition Assessment: Metrics consisted of Slope Compared to 22°², Vegetative Cover⁴, bluff Modification⁴, and Bluff Failure⁴. Each asset category has a different set of metrics to measure vulnerability. If the condition score is equal to or less than 1.67 the assets overall condition is “poor”, between 1.67 and 2.33 is considered “fair,” and greater than 2.33 is considered “good.”

County Park	Bluff Length (ft)	Condition Score (mean)
Bay View Park	4,238	2.15
Bender Park	2,757	2.11
Big Bay Park	1,554	2.26
Doctors Park	2,184	2.44
Grant Park	8,410	2.15
Lake Park	7,374	2.55
Sheridan Park	9,681	2.13
South Shore Park	1,634	2.45
Warnimont Park	7,674	1.87
Grand Total	45,506

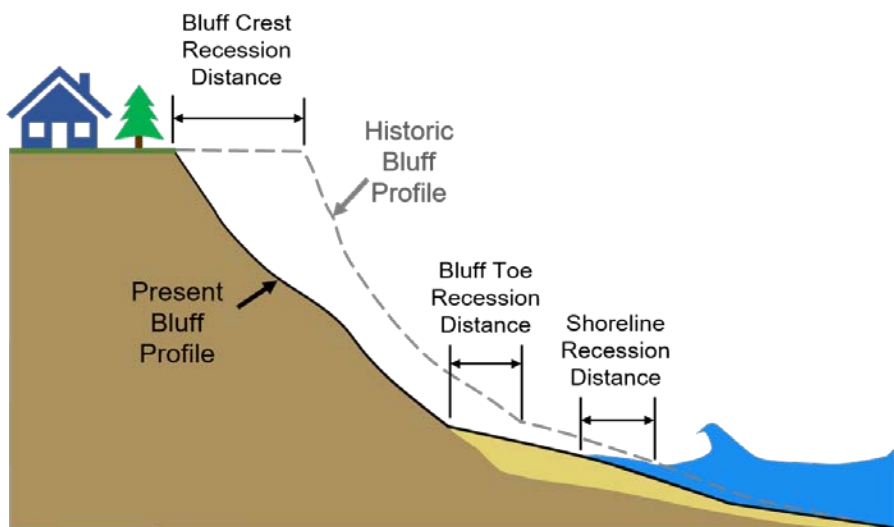
Figure 7. Bluff Changes⁴

The volume change compares the same bluff area between 2010 and 2015, using GIS's cut fill tool. This is summarized in Table 9. Bluff sites not only had sections with volume lost but also gained. These were summed in total volume lost and gain. The total volume change is the difference between gained and lost. The additional volume could only come from areas upland of the bluff crest, with the 2010 crest and underlying soil eroding down the face of the bluff by 2015 as shown in Figure 7. This suggests the upland area is similarly vulnerable to erosion as in the bluff face.
