# Milwaukee County Parks

- Coastal Asset Inventory
- Coastline Management Guidelines

December 2020

## Milwaukee County Coastal Resources Inventory

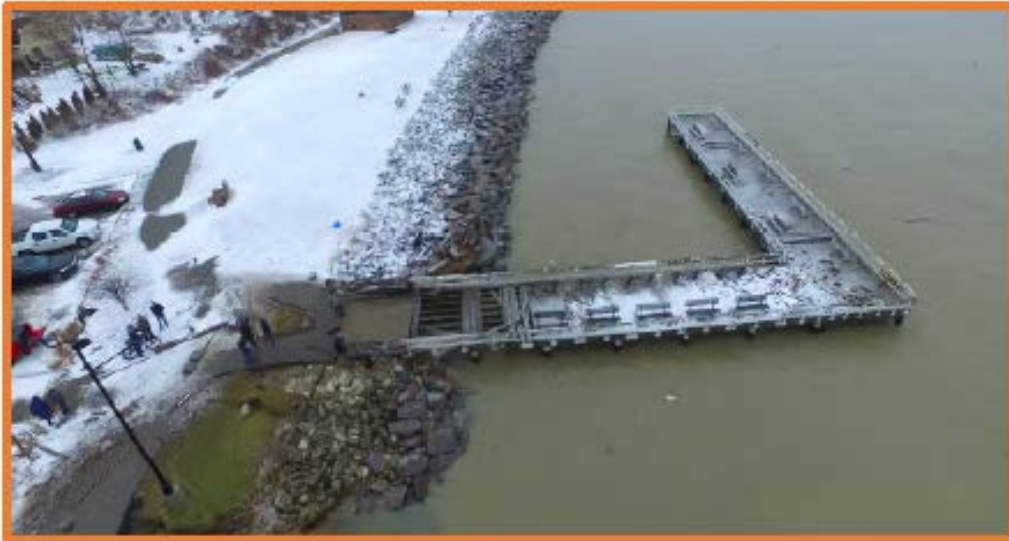
Cupertino Pier Debris – Image Captured January 2020, Source: MCOEM

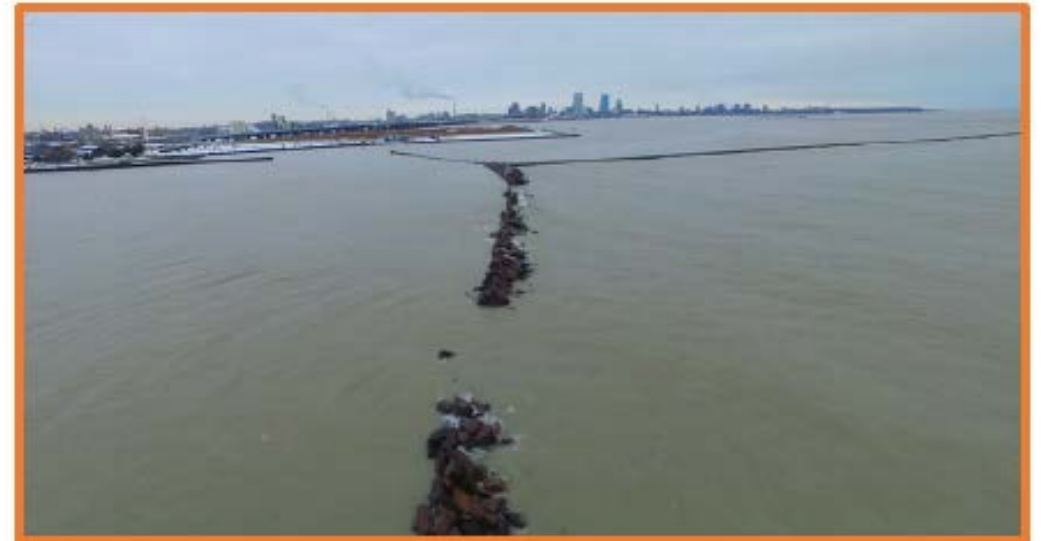
South Shore Breakwater Damage – Image Captured January 2020, Source: MCOEM
