WIL-O-WAY UNDERWOOD RECREATION

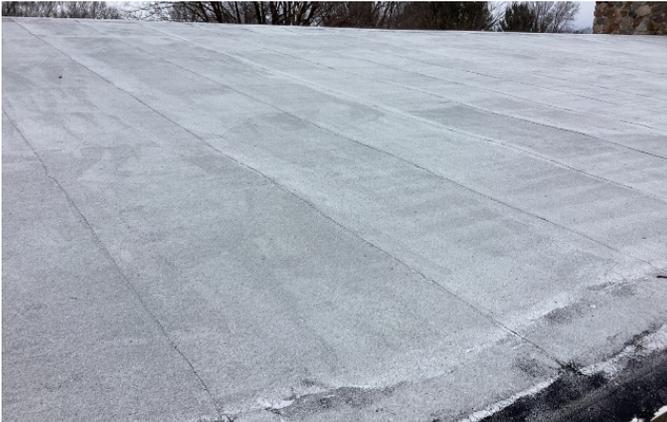
ROOFING AT END OF LIFE CONDITION

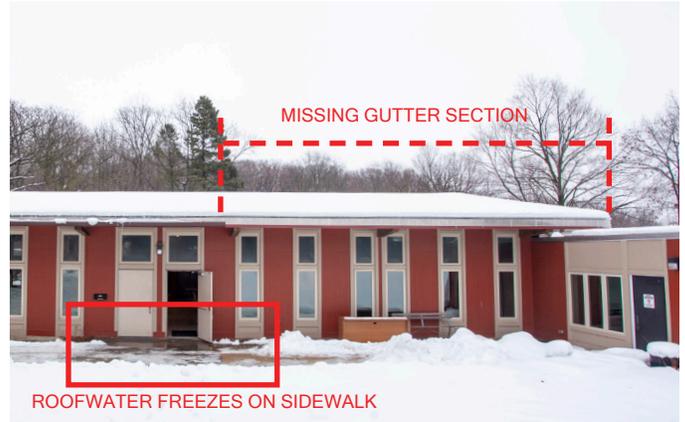
MISSING GUTTER SECTION

ROOFWATER FREEZES ON SIDEWALK

MISSING & INEFFECTIVE GUTTERS LEAD TO ICE DAMMING, ROOF DAMAGE, & SLIPPERY WALKWAYS

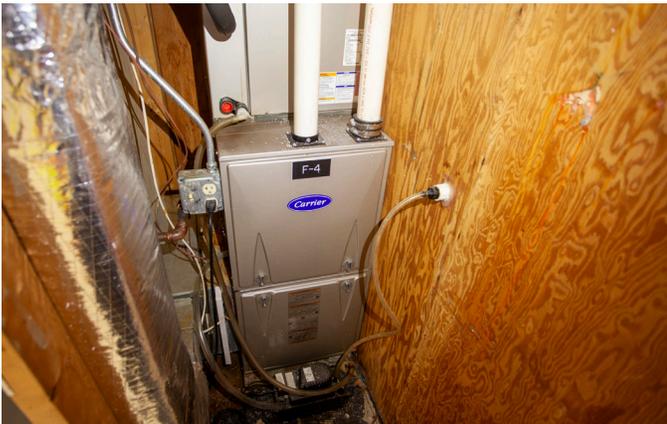
FURNACE - END OF USEFUL LIFE

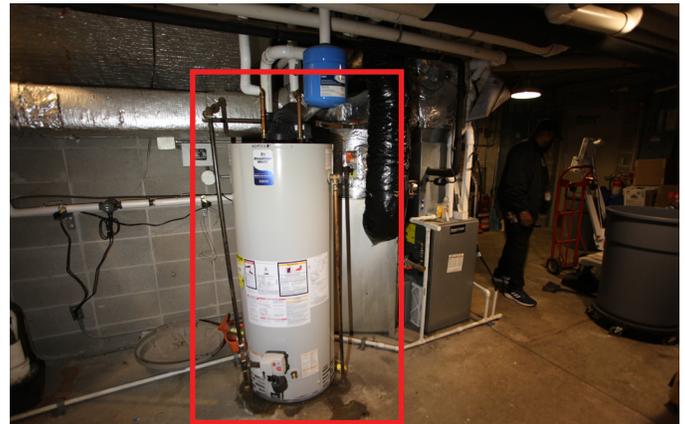
WATER HEATER - END OF USEFUL LIFE

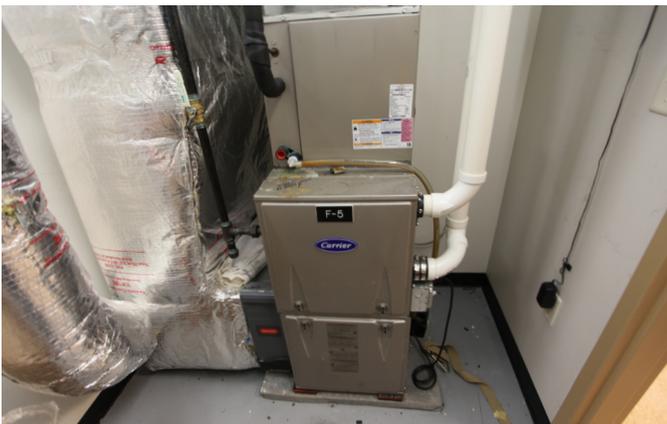
FURNACE - END OF USEFUL LIFE

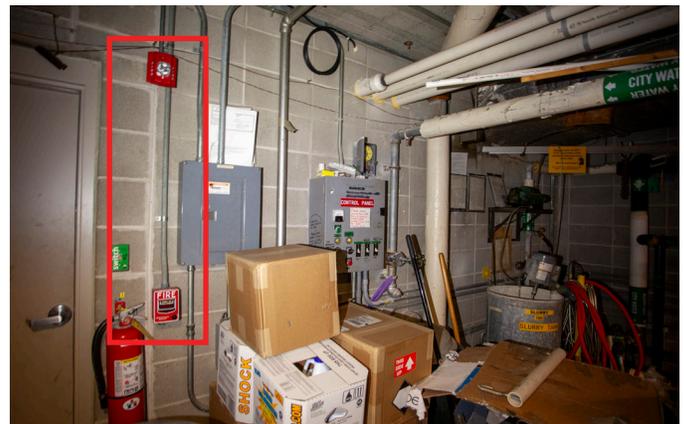
INACTIVE/OBSOLETE ALARM

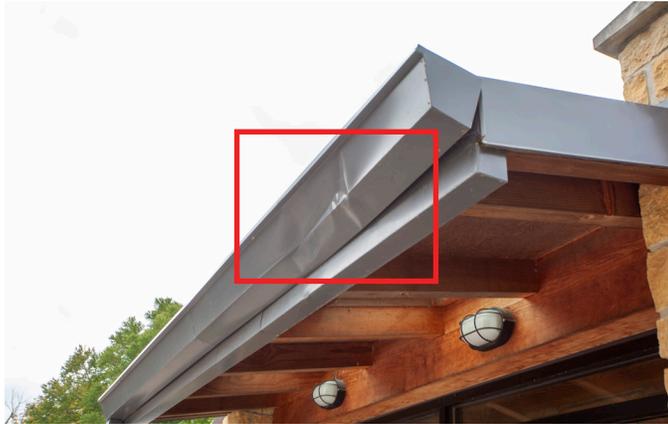
DAMAGED GUTTERS

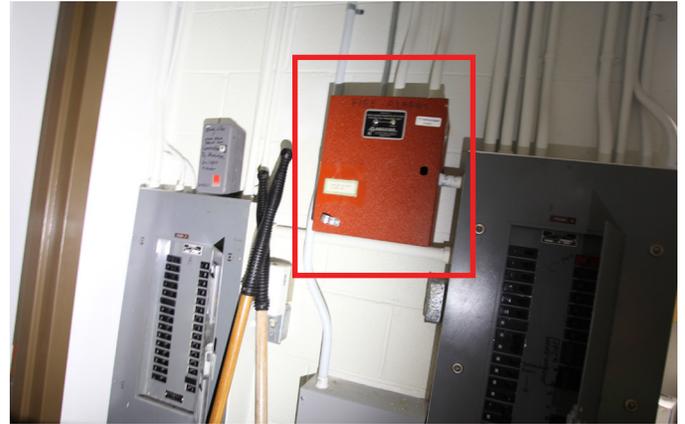
DEFECTIVE ALARM SYSTEM: TYPICAL OF MCGOVERN, WILSON, KELLY, & WASHINGTON PARK

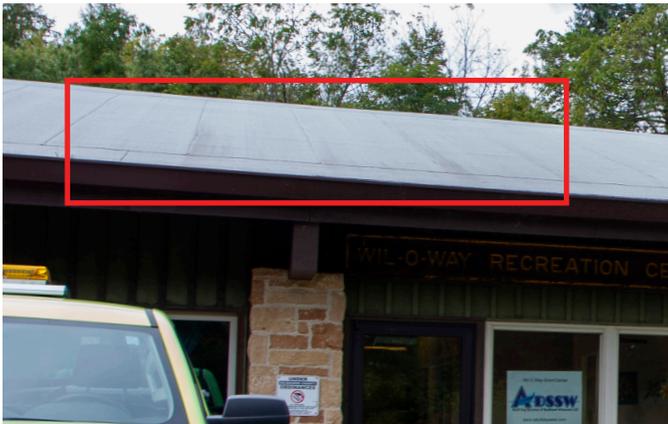
ROOFING AT END OF LIFE CONDITION

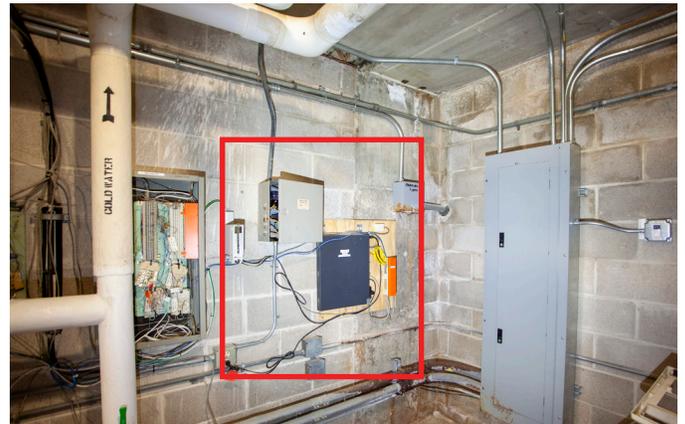
NONFUNCTIONING SECURITY SYSTEM

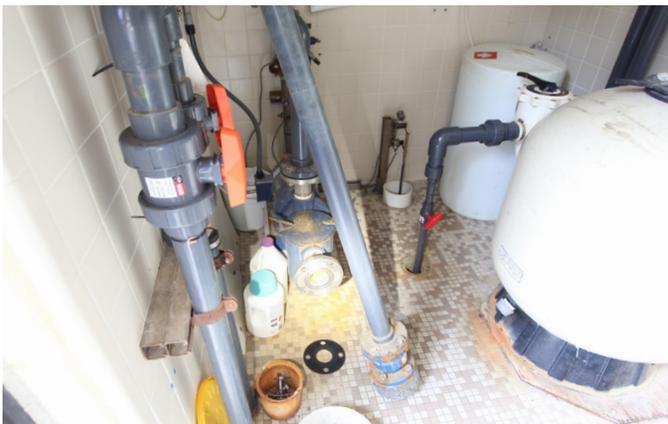
SPLASHPAD FILTRATION EQUIPMENT
DETERIORATED & NEARING END OF LIFE CYCLE

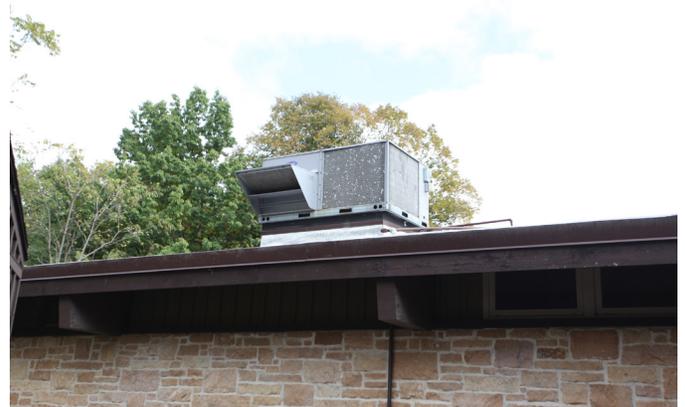
ROOFTOP HVAC AT END OF LIFE CONDITION

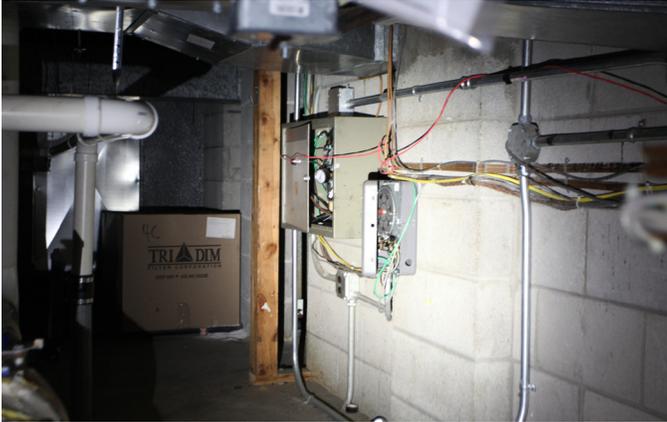
INOPERABLE HVAC CONTROLS

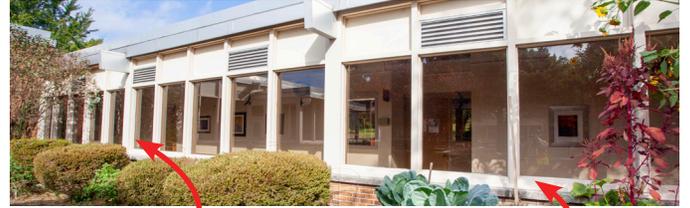
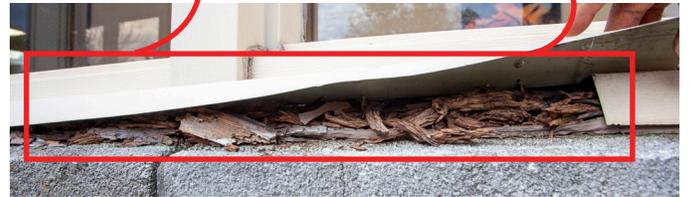
ROTTED WINDOWS-TYPICAL ON ALL WINDOWS AT WASHINGTON PARK

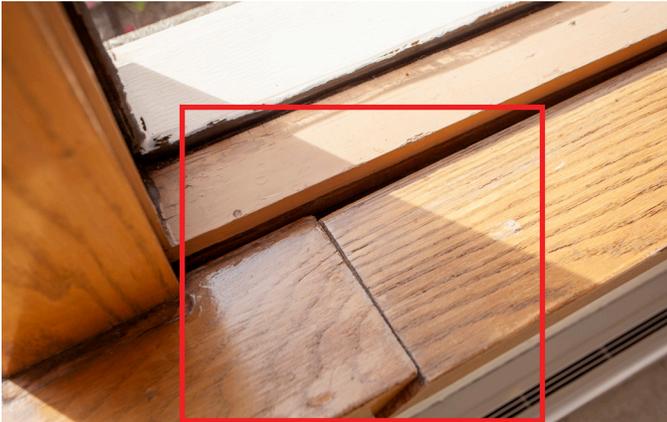
INTERIOR DAMAGE DUE TO FAILED WINDOWS

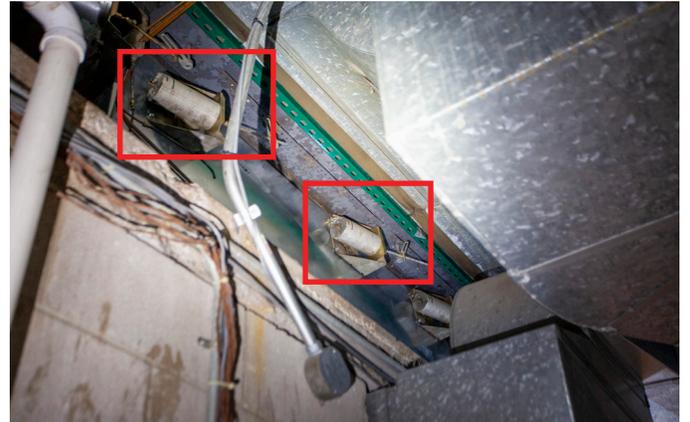
DISCONNECTED GEARS TO OPERATE/OPEN LOUVERS FOR HVAC

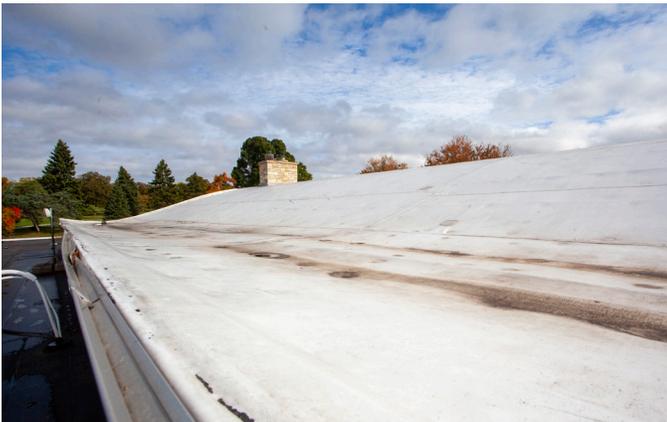
ROOFING MEMBRANE AT END OF USEFUL LIFE & FREQUENTLY LEAKS

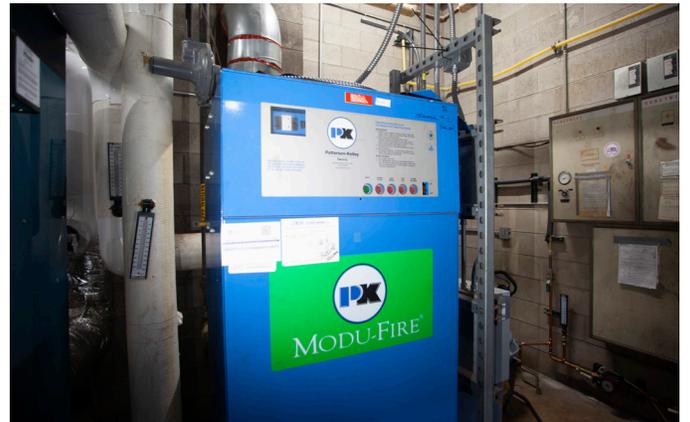
ONE OF TWO HEATING SYSTEM BOILERS, THIS ONE IS INOPERABLE

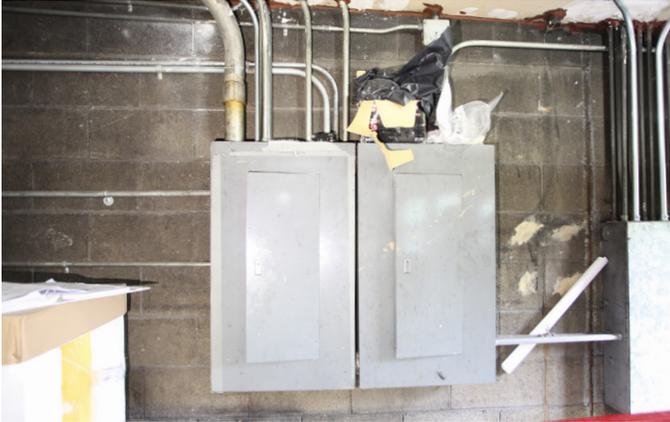
ELECTRICAL SYSTEMS AT END OF USEFUL LIFE

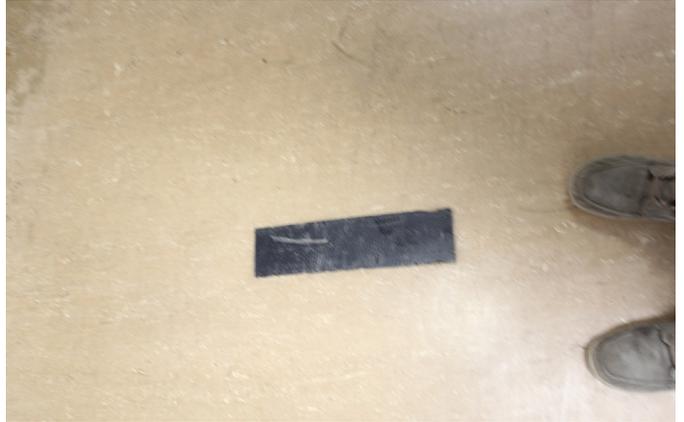
TILE FLOORING FAILING & EXPOSED MASTIC

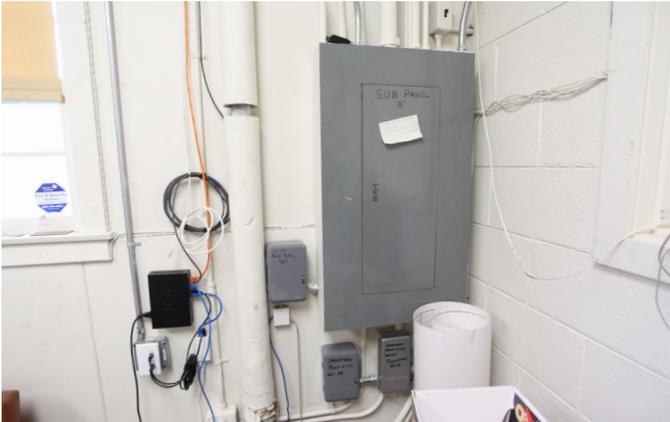
OUTDATE ELECTRICAL

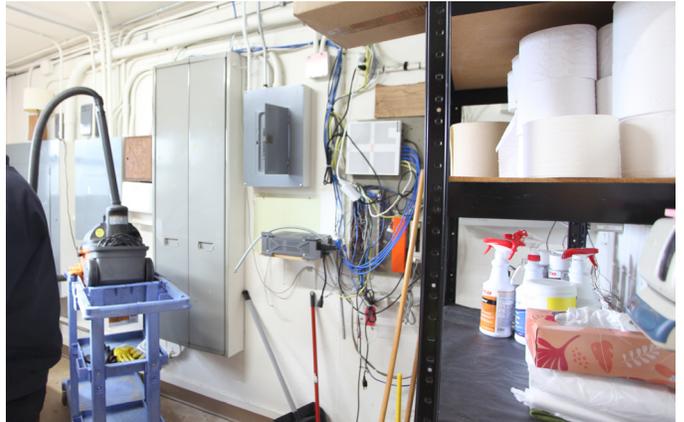
OUTDATED SECURITY SYSTEM

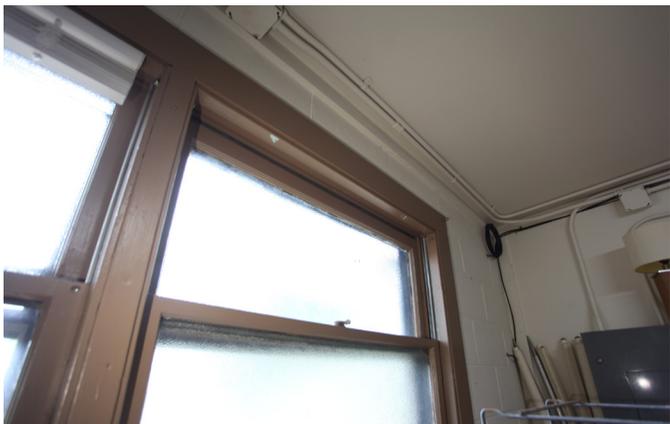
INEFFICIENT ORIGINAL 1950'S WINDOWS

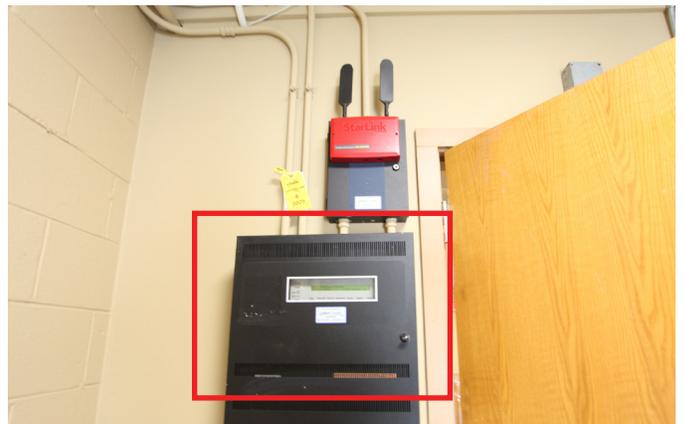
OUTDATED SECURITY SYSTEM

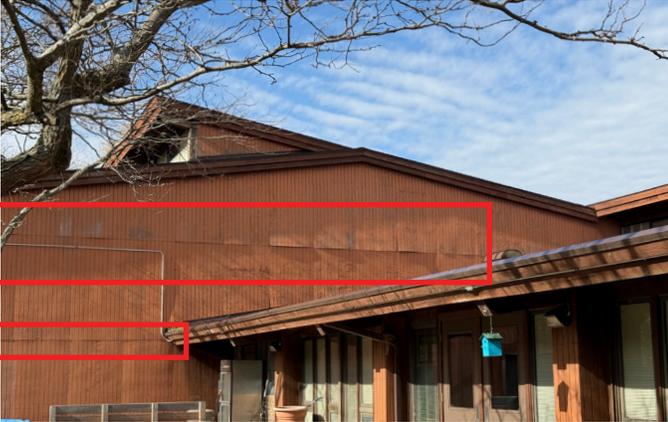
DETERIORATED SIDING - MULTIPLE LOCATIONS

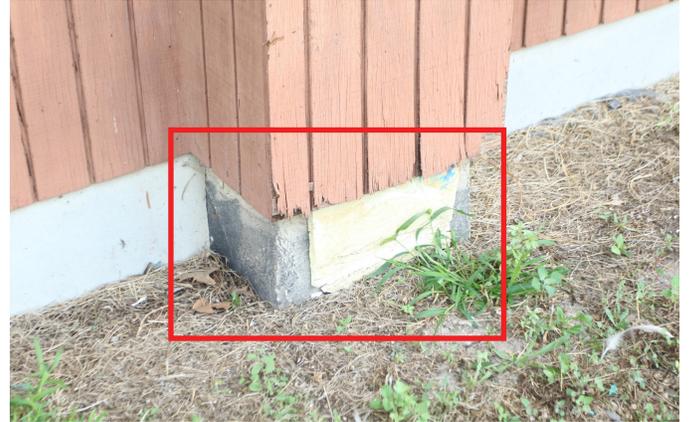
MISSING INSULATION AT FOUNDATION

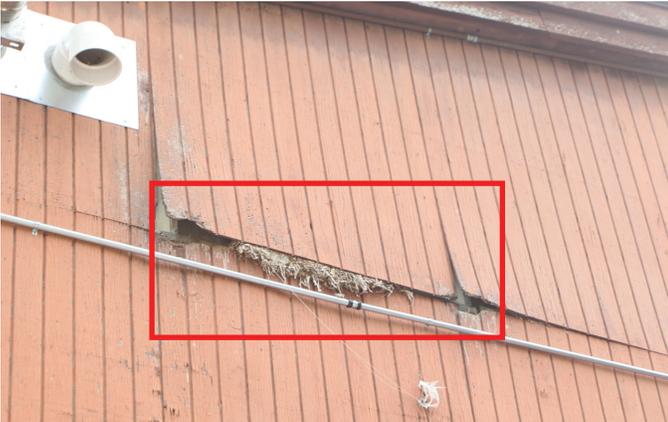
WILDLIFE NESTING IN DETERIORATED SIDING

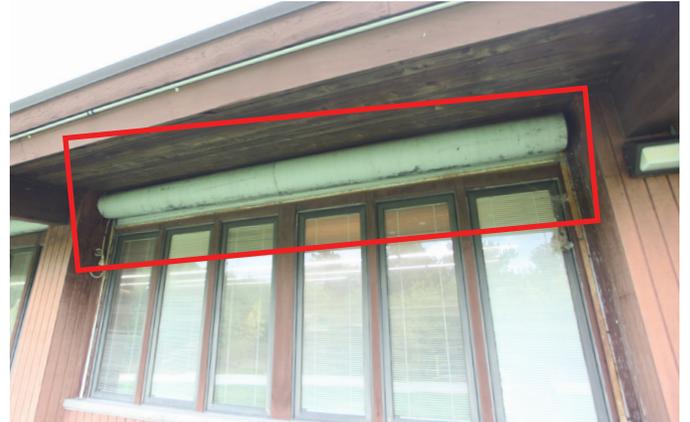
MALFUNCTIONING SECURITY LOUVERS

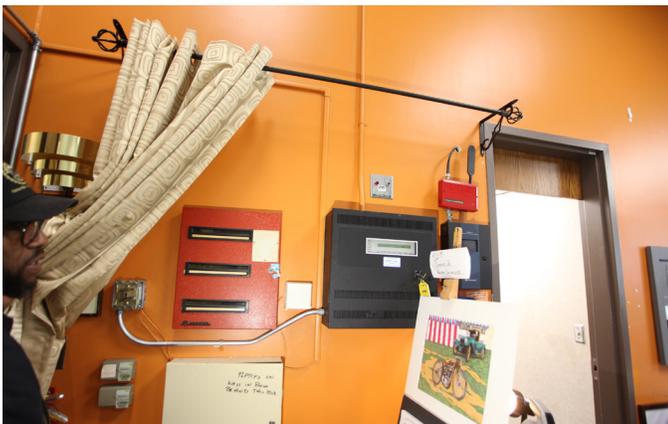
OUTDATED SECURITY SYSTEM

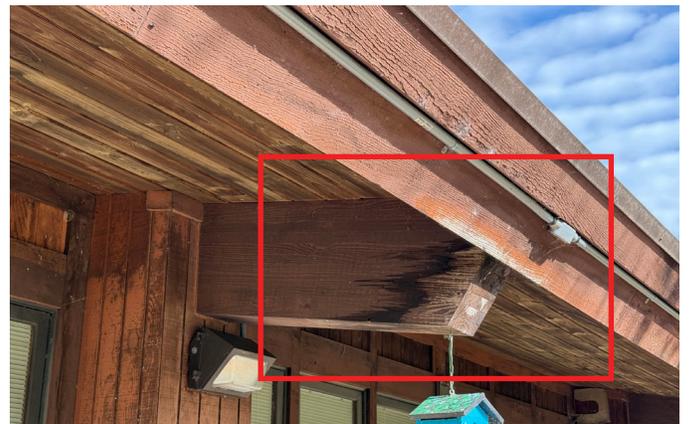
DETERIORATED ROOFING & EAVES

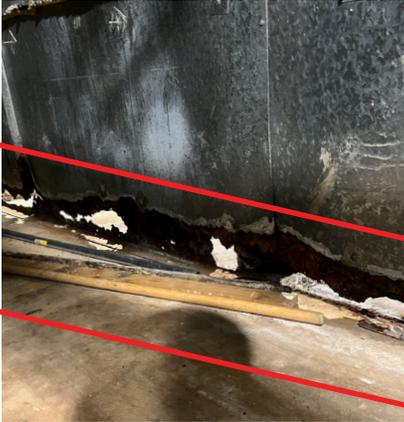
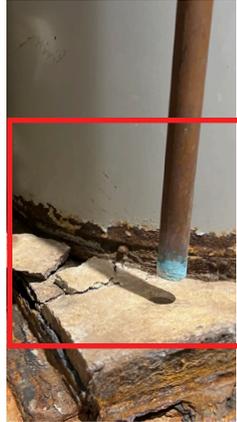
RUSTING MECHANICAL SYSTEMS-EVIDENCE OF REPEATED FLOODING IN BASEMENT

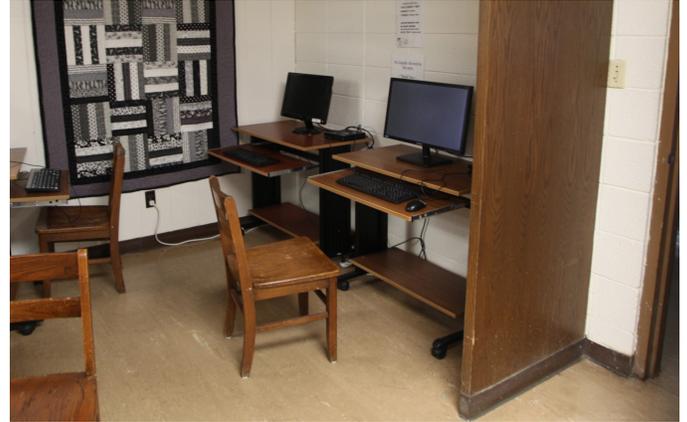
PUBLIC ACCESS COMPUTERS USED FOR HVAC CONTROLS

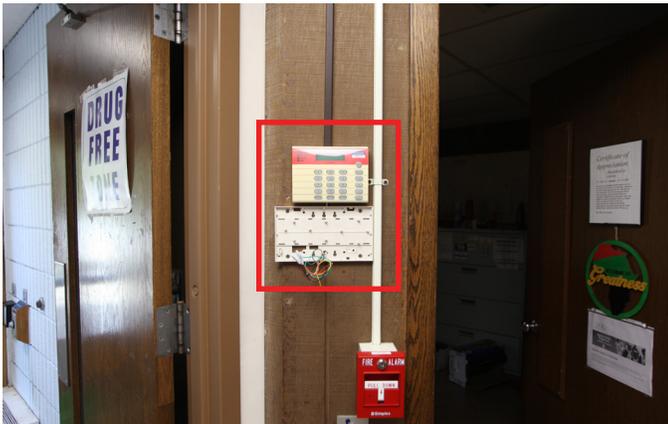
OUTDATED SECURITY SYSTEM

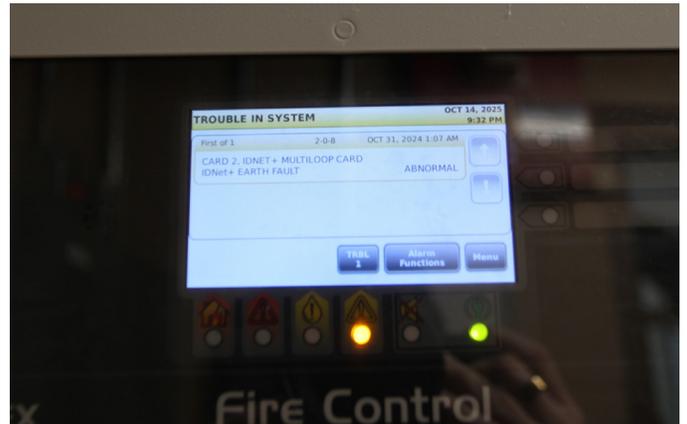
FIRE ALARM PANEL WITH TROUBLE CODE SHOWN

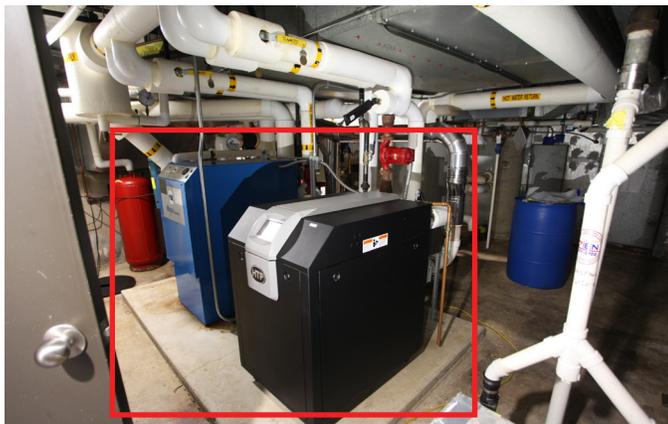
1 OF 2 OPERABLE BOILERS. BLUE BOILER NEEDS REPLACEMENT

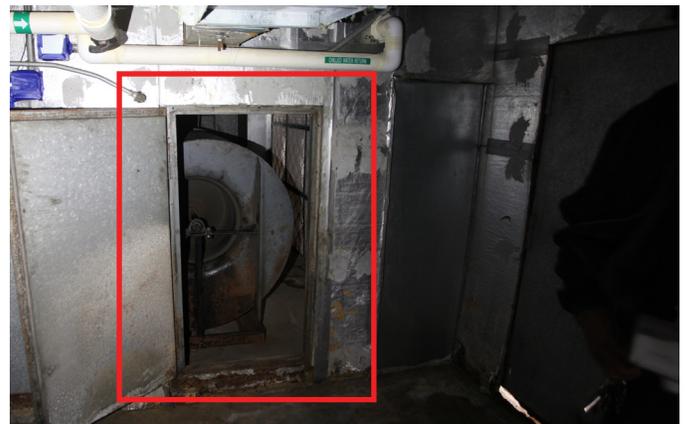
DAMAGED AIR EXCHANGING FAN DOESN'T WORK

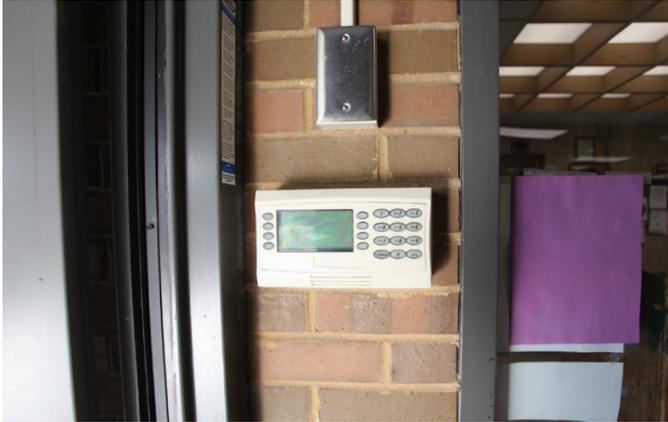
OUTDATED SECURITY SYSTEM

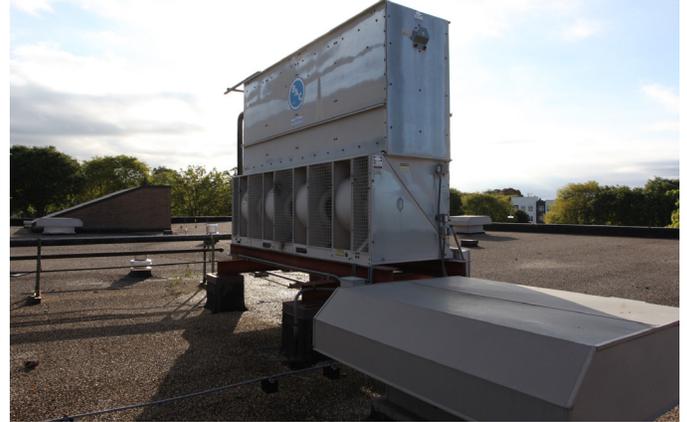
ROOFTOP COOLING TOWERS - NEARING END OF LIFE USE

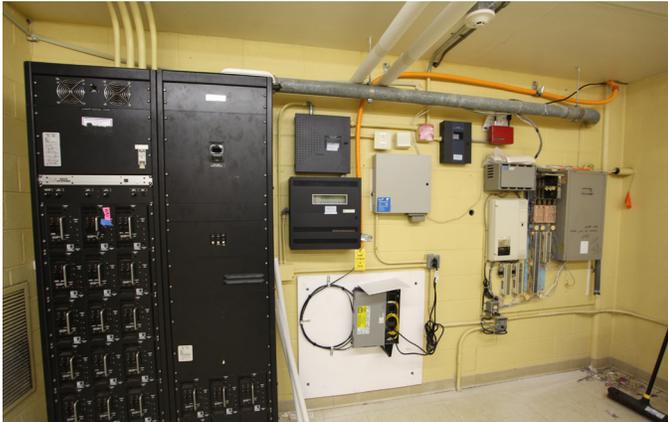
OUTDATED COMMUNICATION SYSTEM - BEING UPDATED WITH CURRENT ONGOING PROJECTS

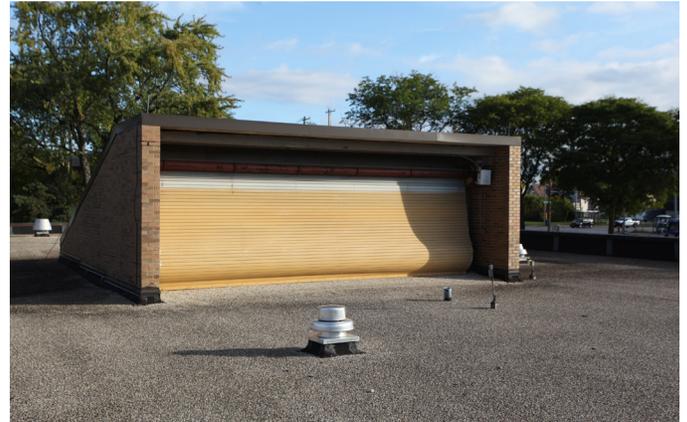
MALFUNCTIONING SECURITY LOUVERS

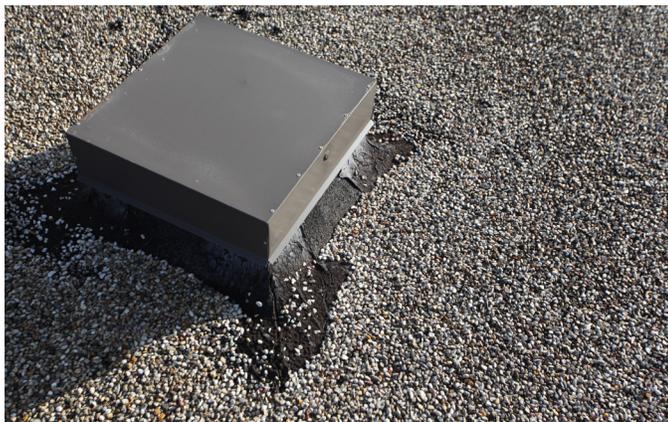
ROOFING MATERIAL AT END OF USEFUL LIFE & FREQUENTLY LEAKS

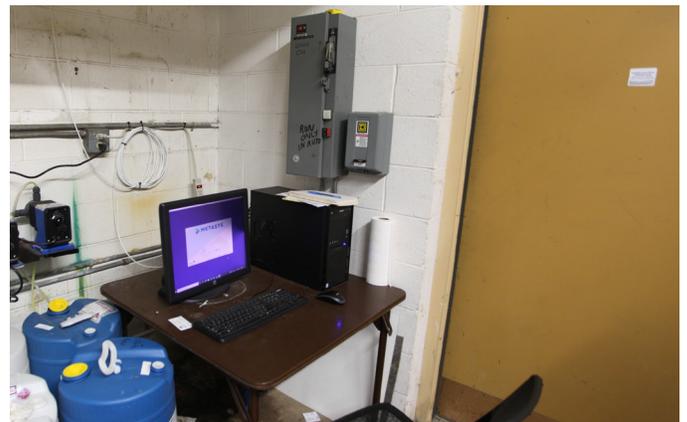
OUTDATED HVAC CONTROLS - BEING UPDATED WITH CURRENT ONGOING PROJECTS
