LIMITED LEAD PAINT INSPECTION

**Coggs Center
1220 W. Vliet
Milwaukee, WI**

RE: Limited Lead Paint Sampling

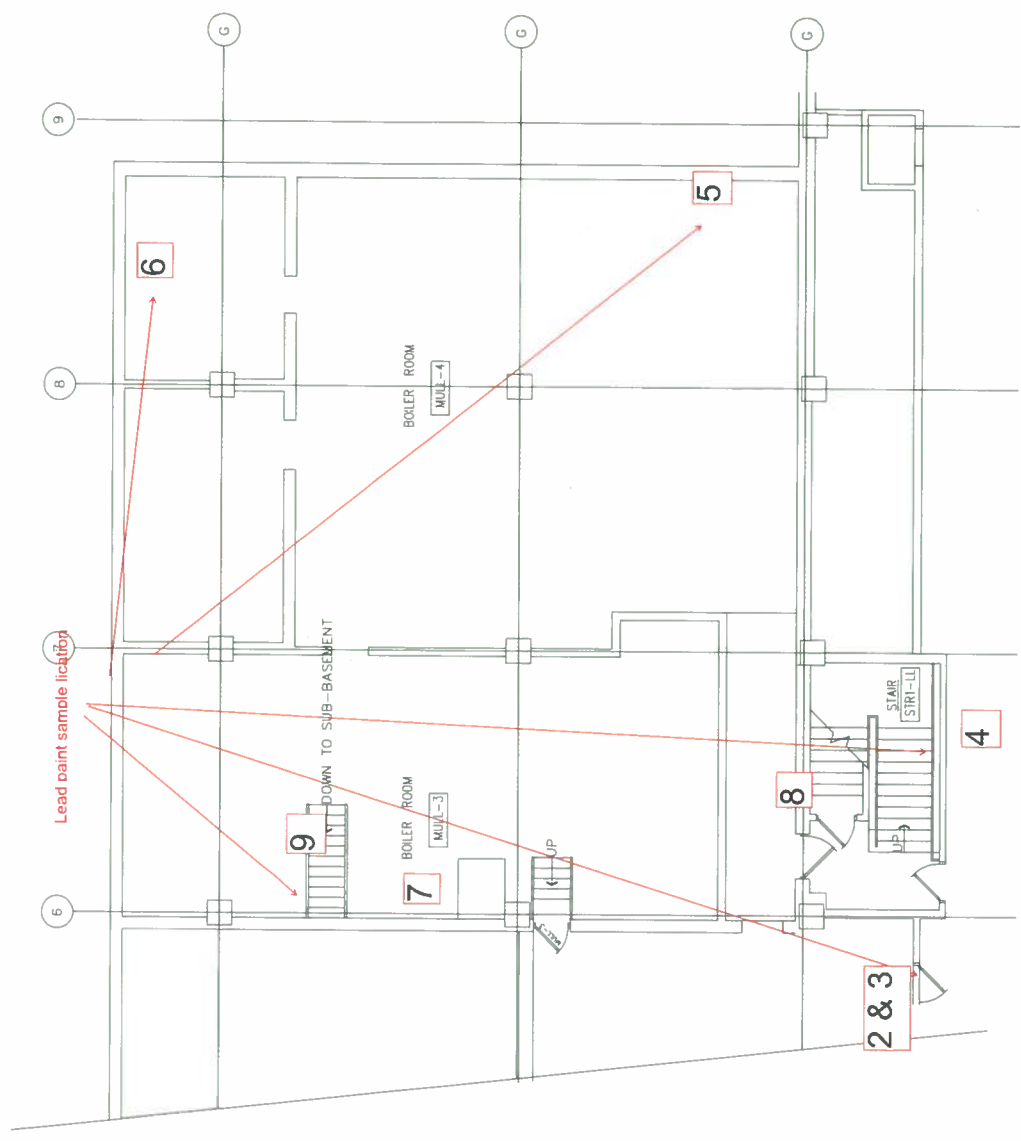
BOILER ROOM PLAN
SCALE: 1/4" = 1'-0"

- All green, white & beige paint in boiler room area are positive
- All white walls, varnish doors and beige door frames in lower level by basement are neg (by E10, D10 escalators)
- Blue paint walls in 1st floor lobby area cannot be sampled due to too many patrons around.
- There are brick walls on 3rd floor
- 3rd floor has the same beige doors & door frames as the other floors
- Cannot take many samples due to too many patrons
- Offices in 200E are the same beige walls
