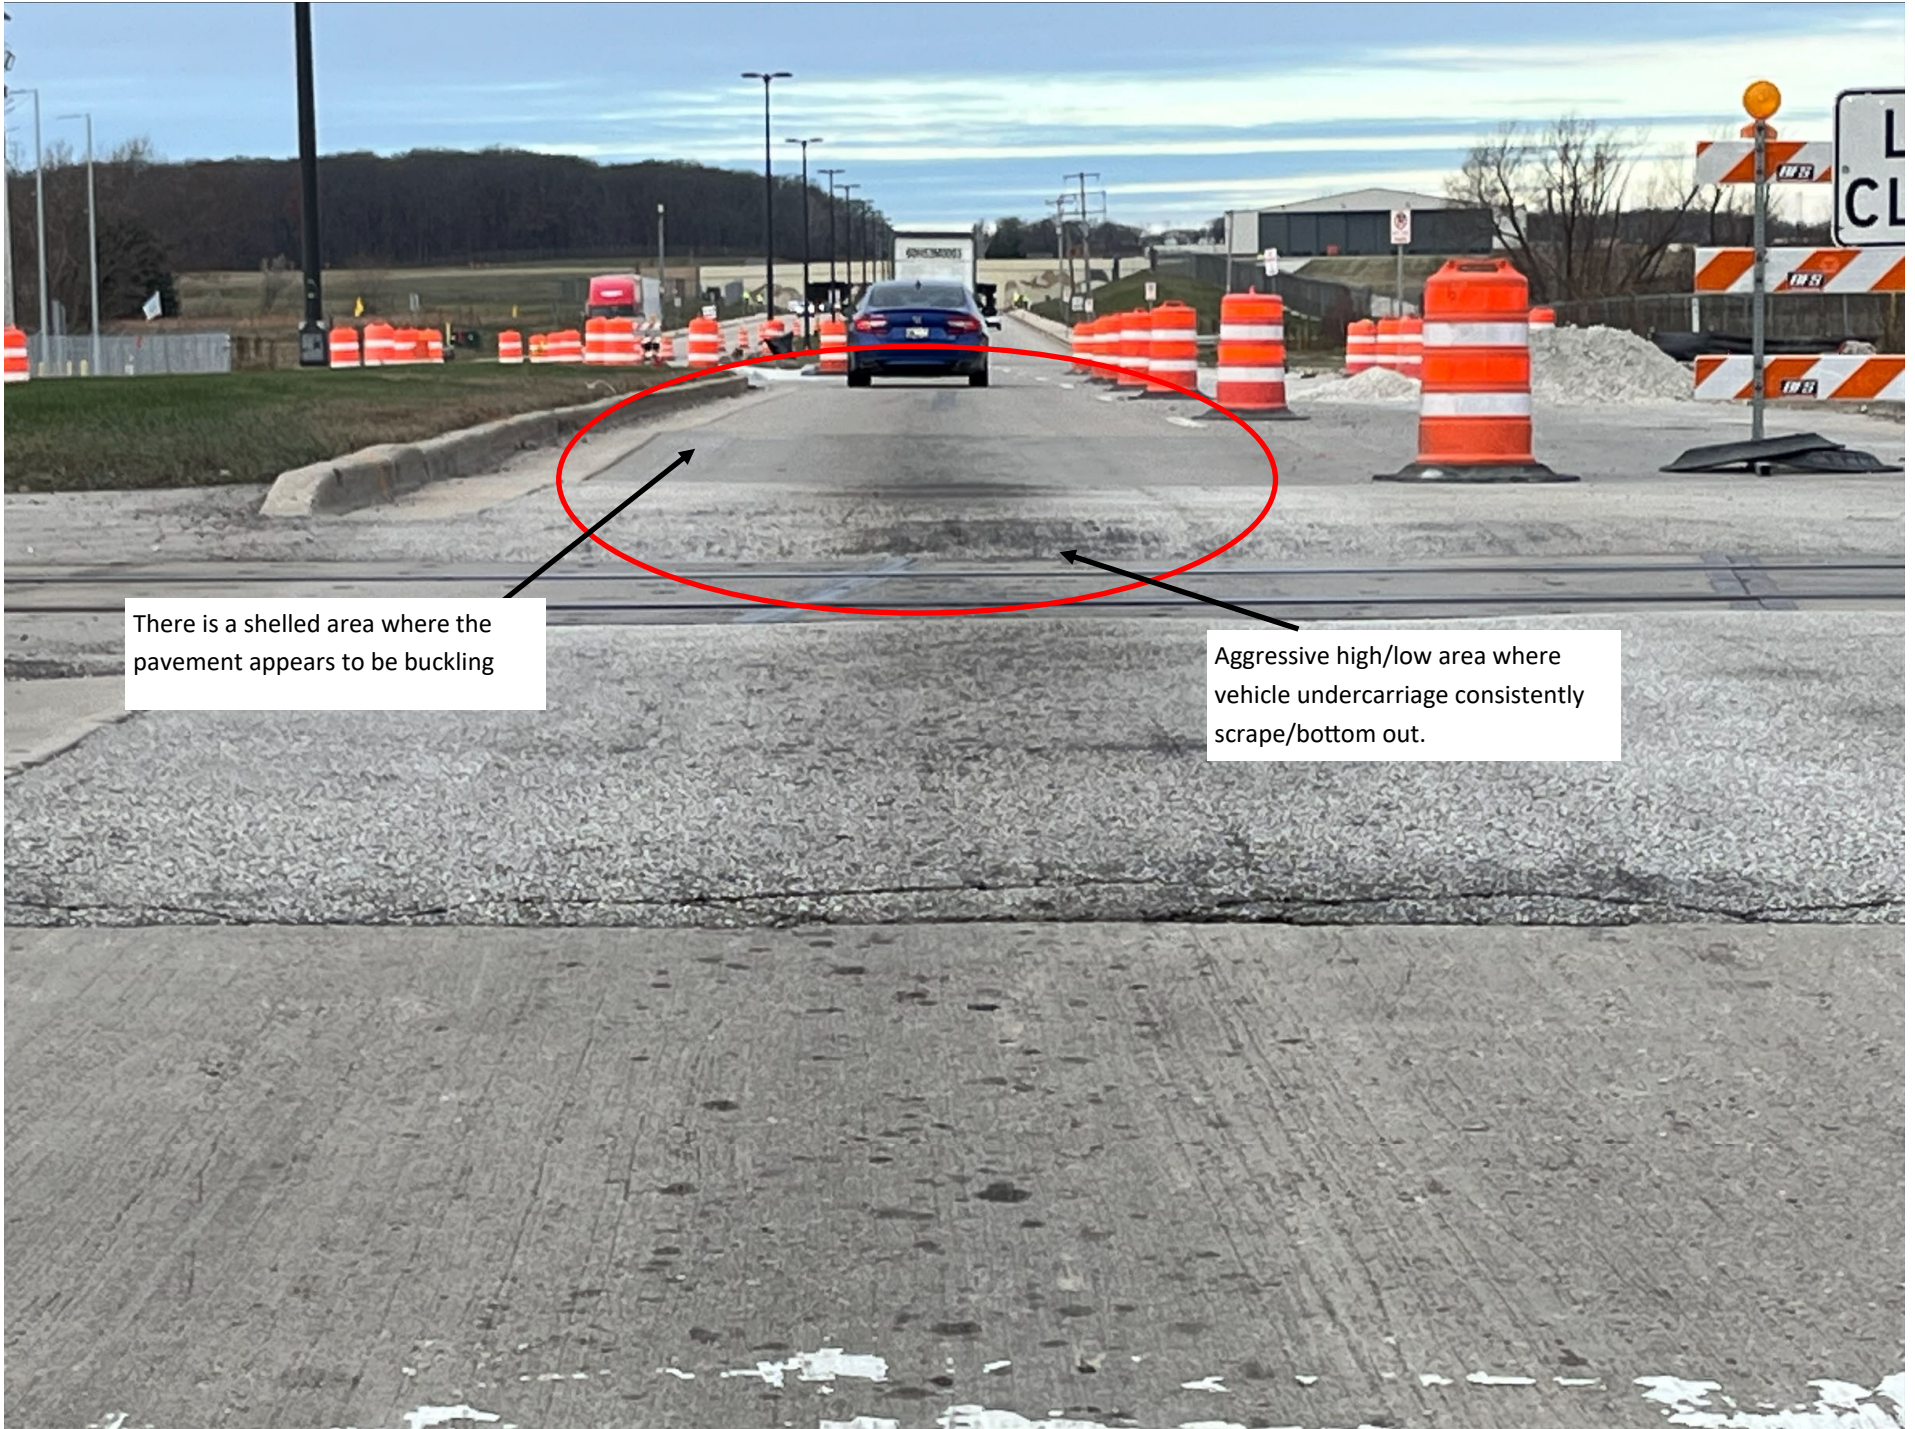
There is a shelled area where the pavement appears to be buckling

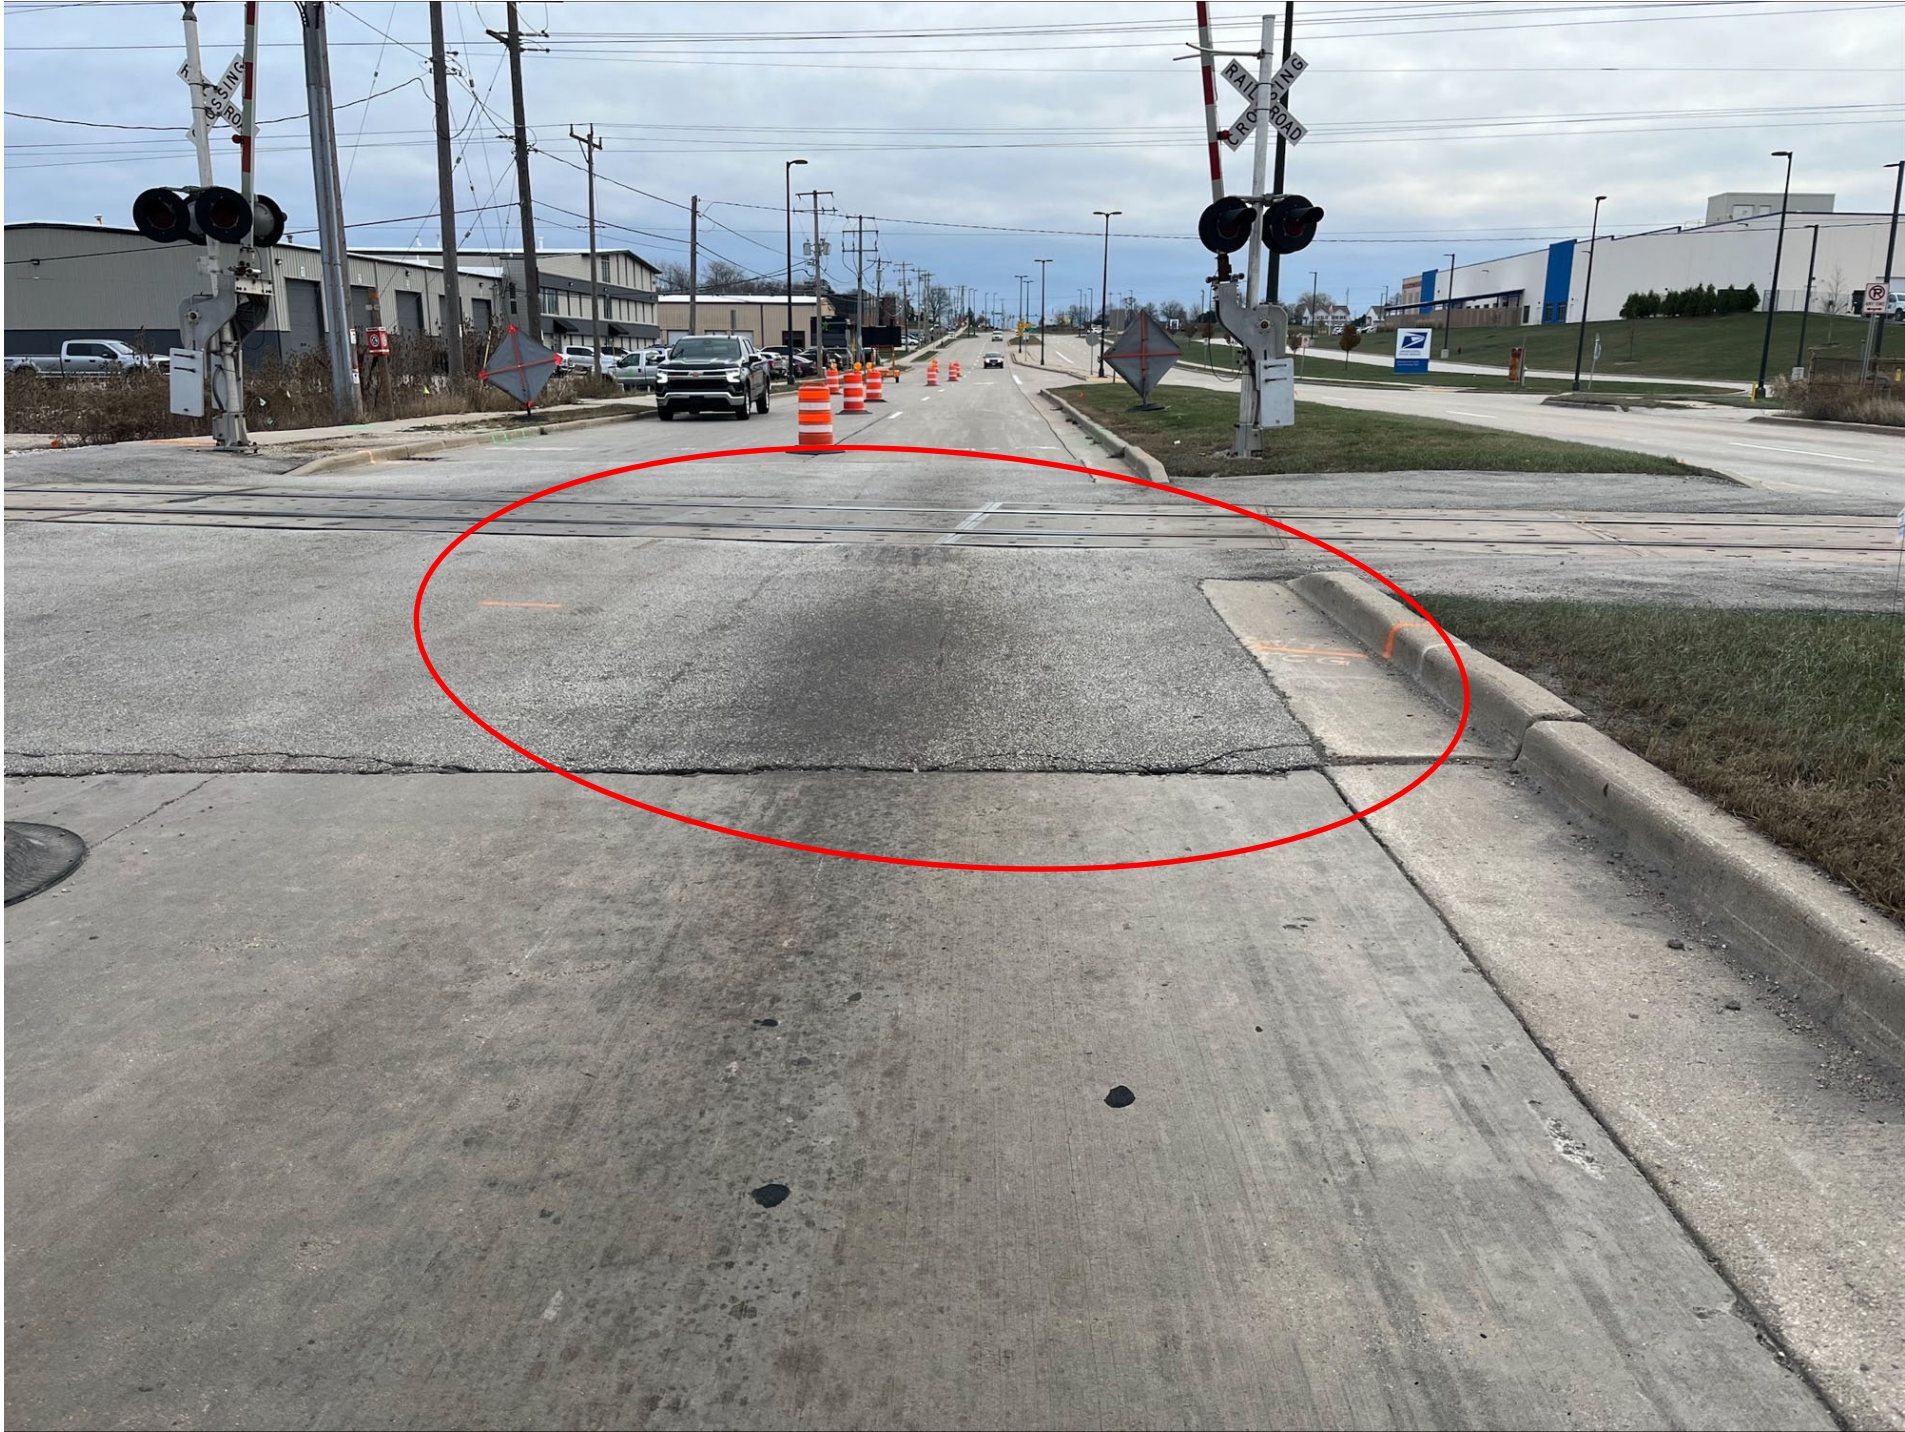
Aggressive high/low area where vehicle undercarriage consistently scrape/bottom out.
