# 105<sup>TH</sup> ANNIVERSARY MILWAUKEE COUNTY **PARKS**

## 5-Year Capital Request

# STATUS OF IMPLEMENTING DEPARTMENT OF AUDIT REPORT RECOMMENDATIONS

Audit Title: A Tale of Two Systems: Three Decades of Declining Resources Leave Milw. Cty. Parks Reflecting the Best and Worst of Times

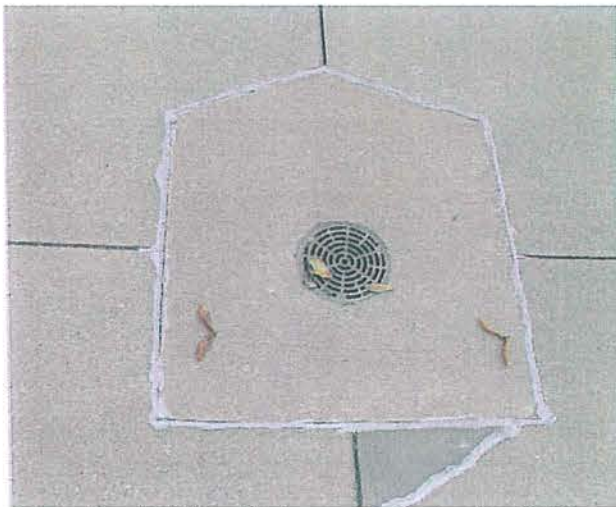
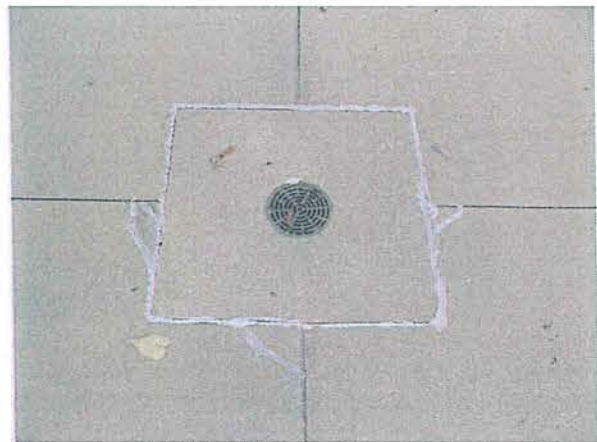
**Deck:** The deck concrete is in good condition since the concrete around the deck drains was replaced in the 2002-2003 off-season. Concrete around two of the deck drain cutouts is spalled with patches, caulk, and cracks.

Carver Family Water Playground    September 2009  
Deck Drain

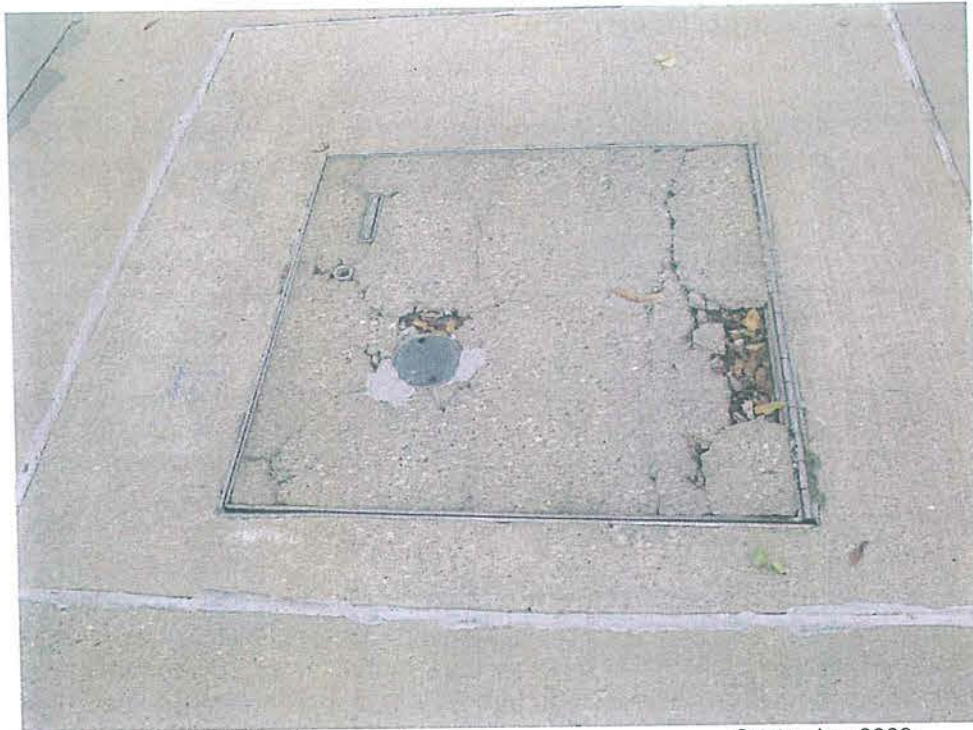
The concrete in the pan cover of the Bilco access door on the north side of the deck is failing.

Carver Family Water Playground  
Bilco Access Door

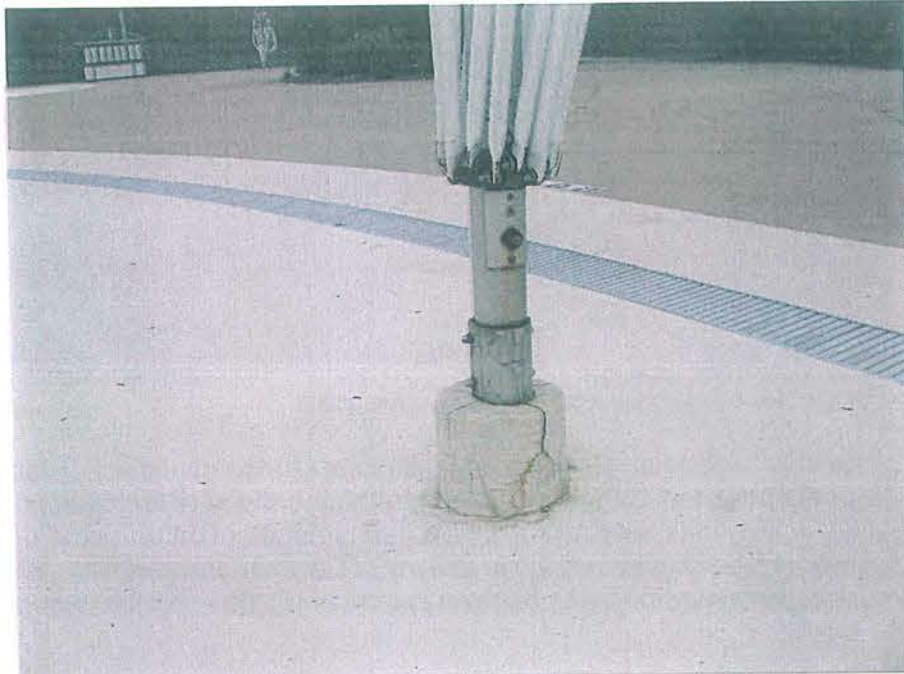
Cool Waters Aquatic Center  
Cracked Concrete Umbrella Base

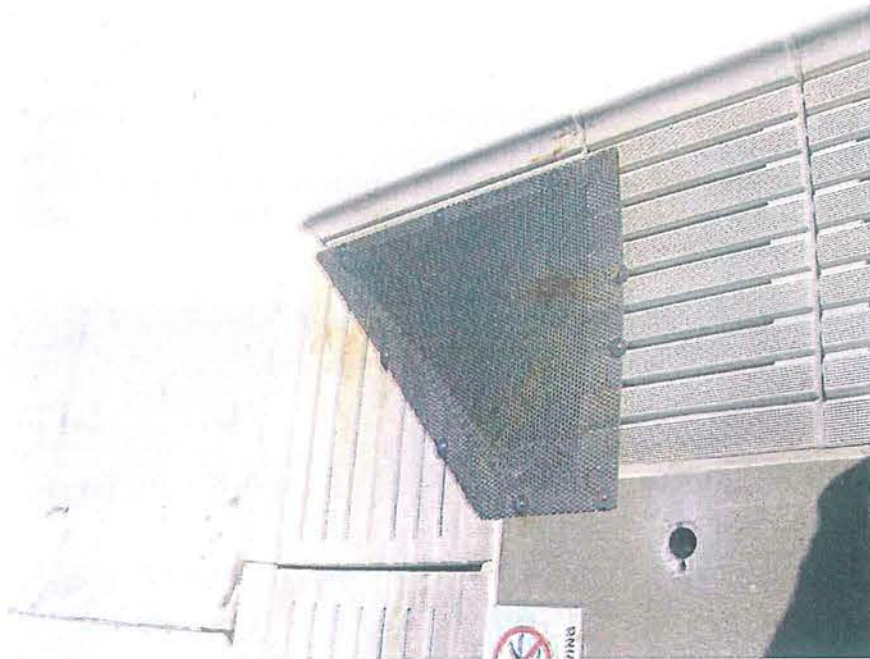
**Precast Pool Coping Stones:** The precast pool coping stones at the Greenfield Park Aquatic Center have failed over the past several years. The company that made the pieces is no longer in business and no replacement pieces exist. The estimated cost for new coping stones to replace the existing coping stones around the non-zero depth portion activity pool was included in the 2008 capital budget and scheduled for 2010-2011 construction.

Cool Waters Aquatic Center  
Precast Pool Coping Stones – temporary corner piece

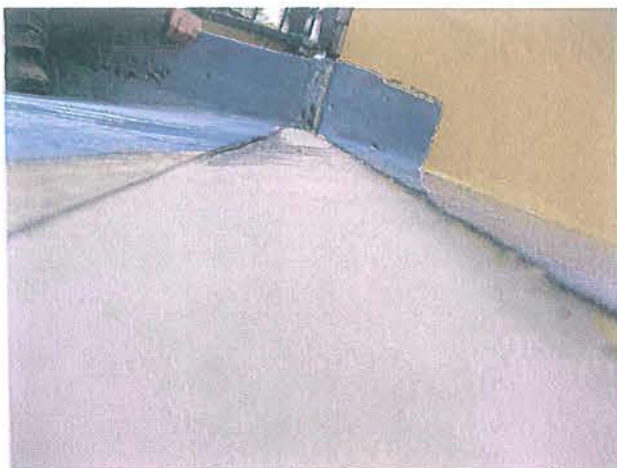
The tot slide was extremely worn and delaminating at the entry well to slide flume connection:

Cool Waters Aquatic Center  
May 2010  
Tot Slide Entry Well to Flume  
Delaminating fiberglass

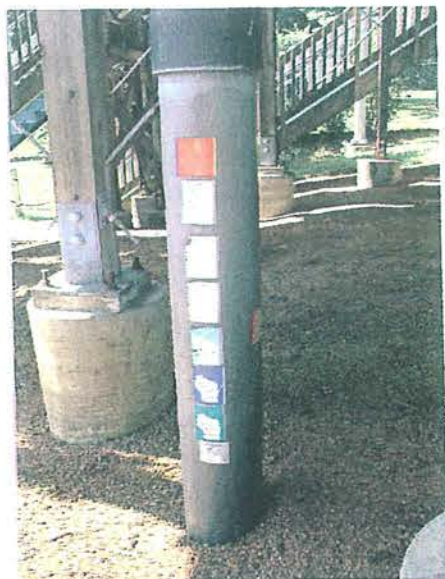
Cool Waters September 2009  
Concrete Footings – no cracks or other damage

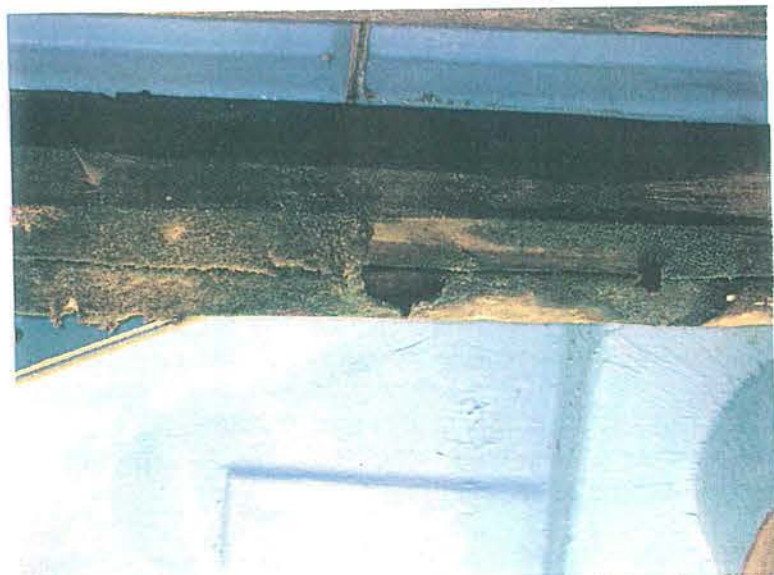
Cool Waters September 2009  
Moss growing on timber structural members

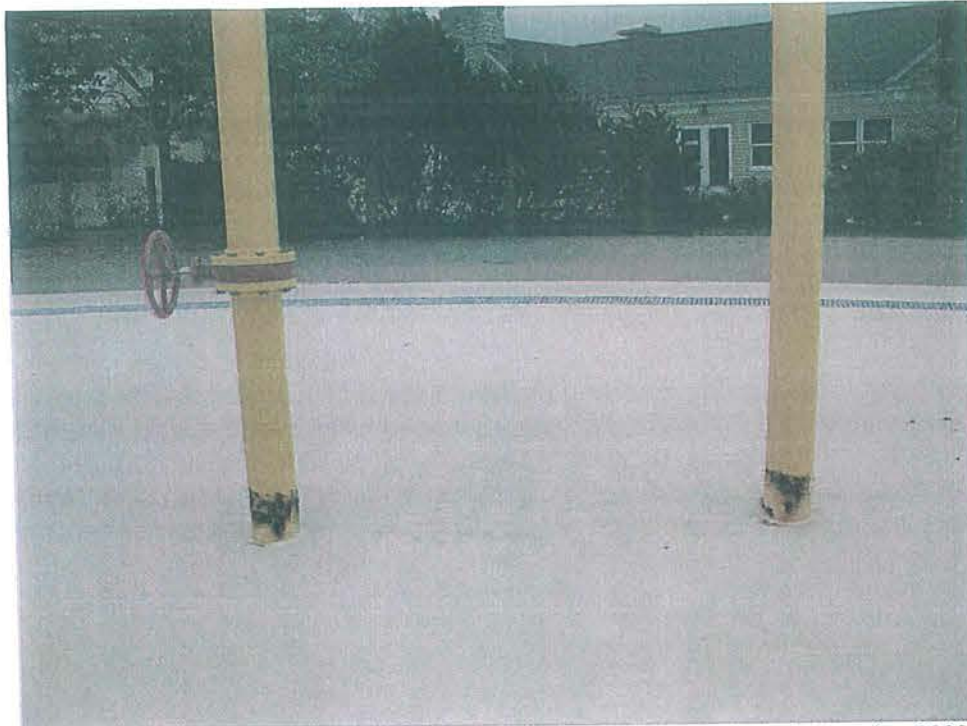
Cool Waters Aquatic Center  
Note rusting at base of pool toys

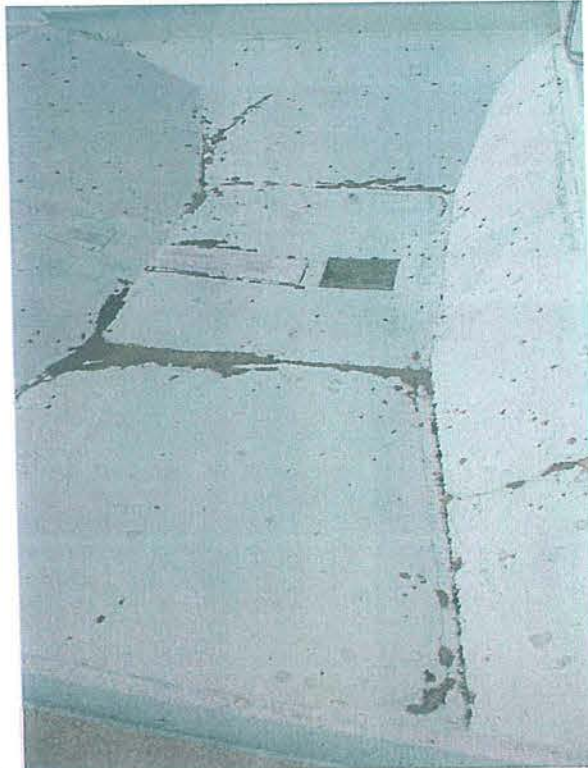
**Pool Tank:** The pool floor has some small cracks and spalls, especially in the diving well.

Grobschmidt (Oak Creek) Swimming Pool September 2009  
Diving Well – note extensive patching and caulking of deteriorated slabs.

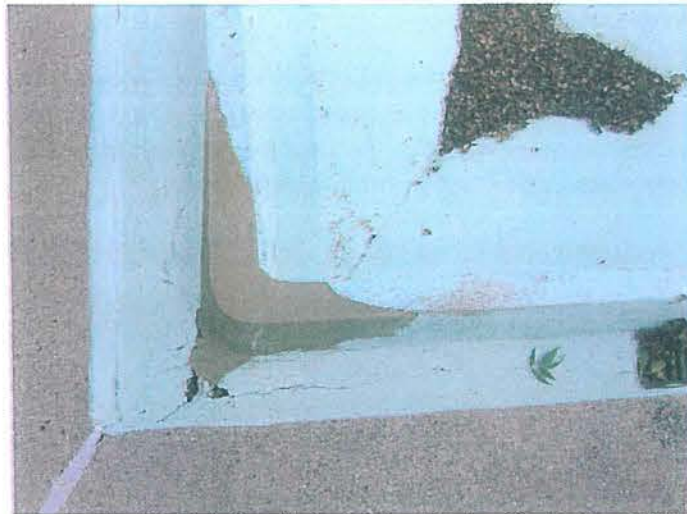
Grobschmidt (Oak Creek) Swimming Pool    September 2010  
SW corner deep area    Repaired concrete gutter lip

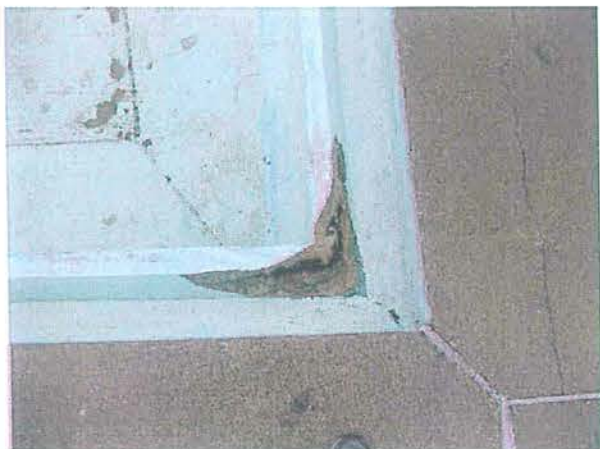
September 2008

Grobschmidt (Oak Creek) Swimming Pool - Scum Gutter NW Corner deep area – note repaired concrete gutter lip

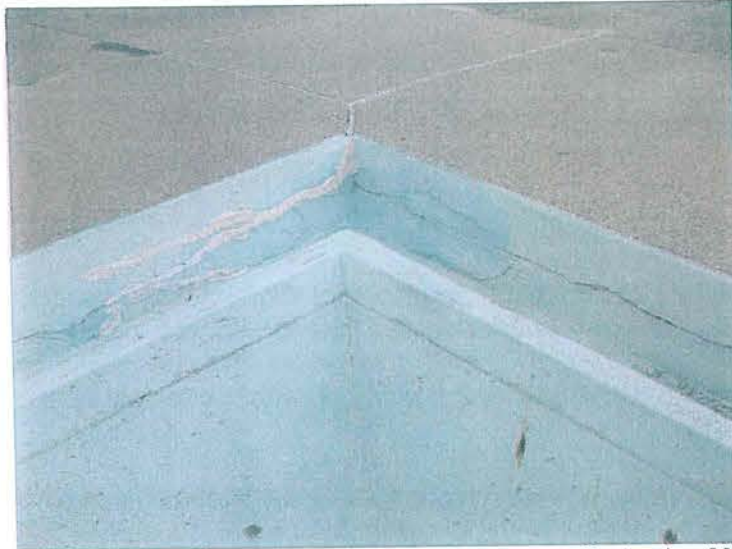
The northwest corner of the shallow area has a long crack in the scum gutter back wall.

Grobschmidt (Oak Creek) Swimming Pool September 2009  
Scum Gutter NW Corner shallow area – note long crack in gutter back wall

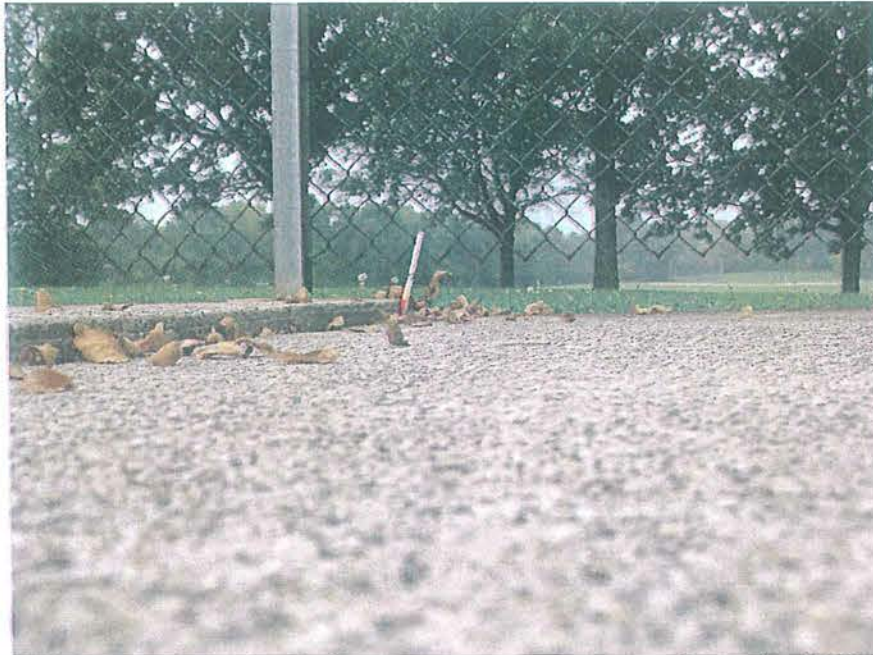
**Deck:** The sundeck is in fair condition. Most of the caulk is hard and separating. At least two slabs need to be leveled. The slabs at the west end of the deck, adjacent to the fence are in very poor condition and need replacement. There are many hairline cracks in the bigger slabs. A T&M Contractor caulked the deck to pool joint in the spring of 2003.

Hales Corners Swimming Pool  
Pool Deck – note out of level concrete slabs

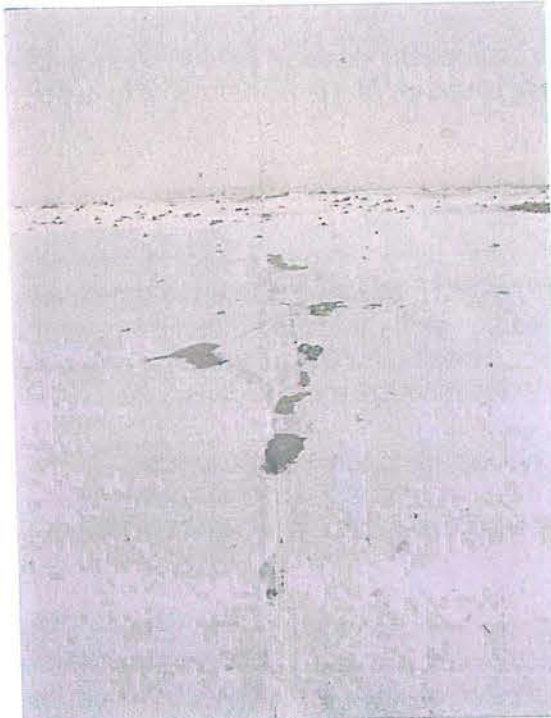
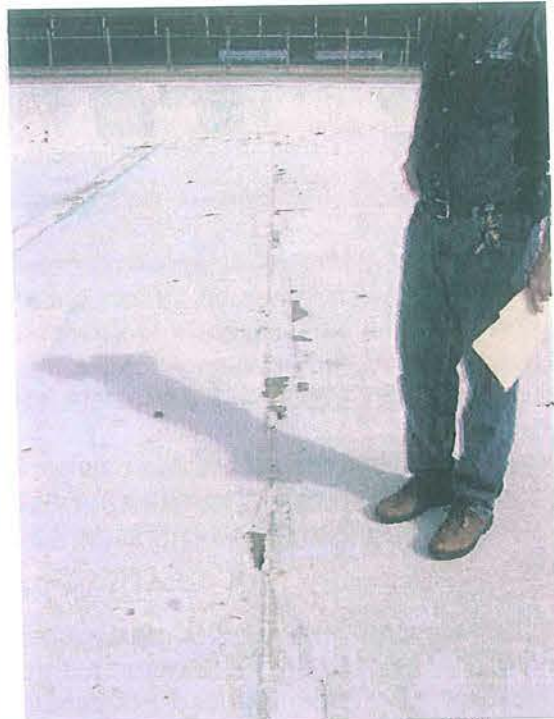
**Pool Tank:** There are several chert pops and spalls in the pool tank. There are numerous spalls and patches that are failing. The pool needs edge repair and joint caulking.

Holler Swimming Pool - Spalls, failed patches, and deteriorated slab edges

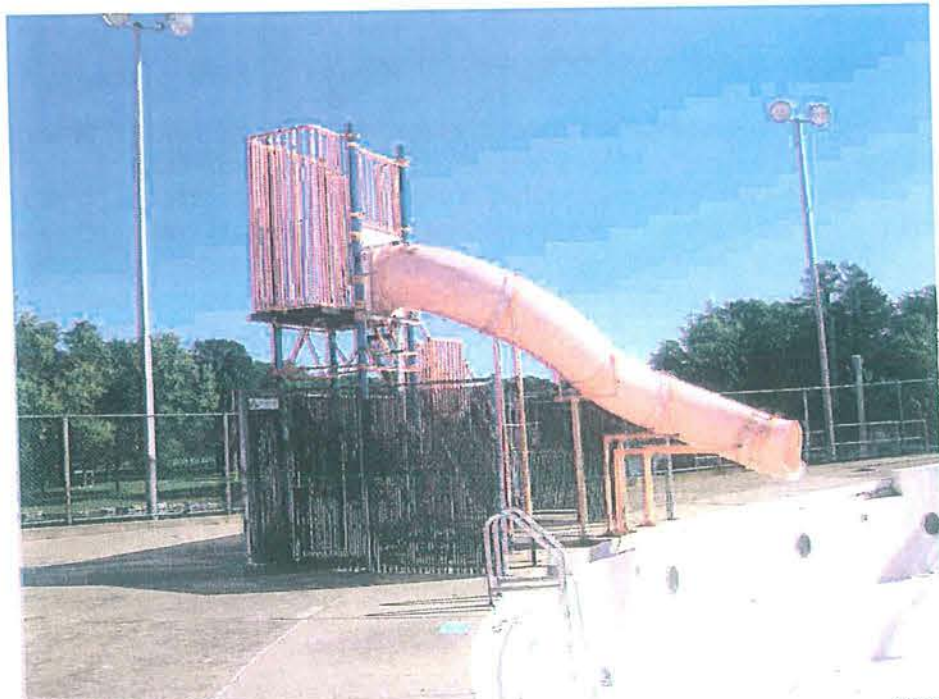
The Jackson Park Pool Slide was not opened in the 2009 and was removed after the pool season. The slide pump intake from the pool was a suction entrapment hazard far more serious than any of the pool drain grates.

Jackson Park Pool Slide

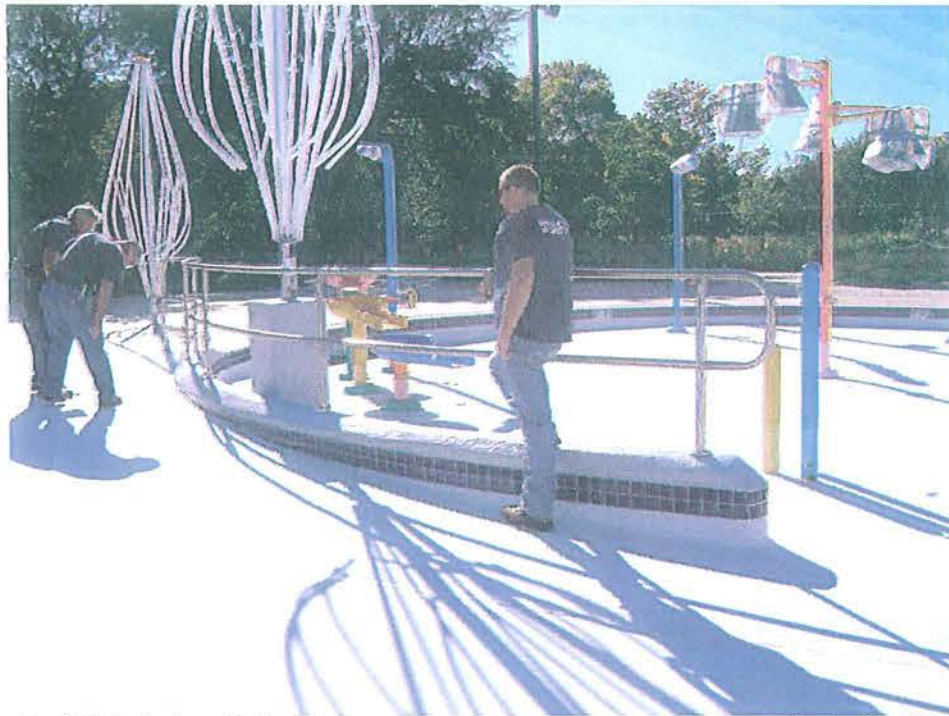
David Schultz Aquatic Center September 2010  
A local contractor fixed the railing near the pool play area in the spring of 2010.

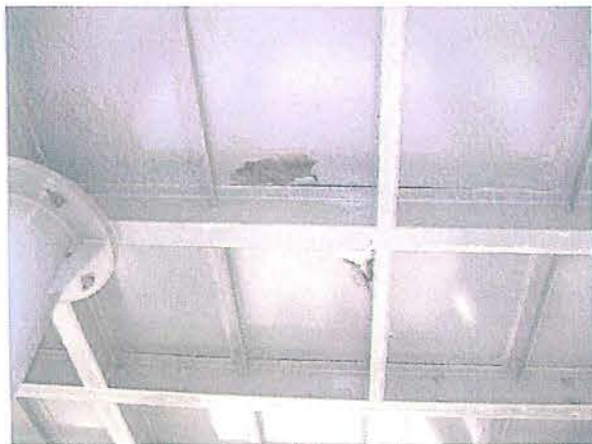
In 2010, there was paint peeling from the bottom of the top slide landing. The bonding wires for grounding the steel is exposed behind the pool wall where the slides enter the pool

David Schultz Aquatic Center September 2010  
Protective Coatings failing below slide tower landings

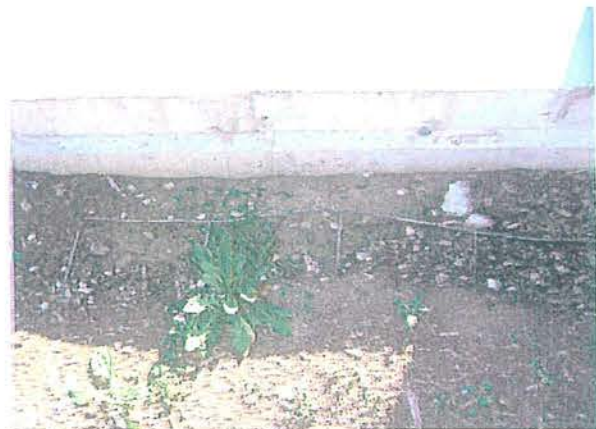
David Schultz Aquatic Center September 2010  
Grounding wires exposed behind pool wall where slides enter pool

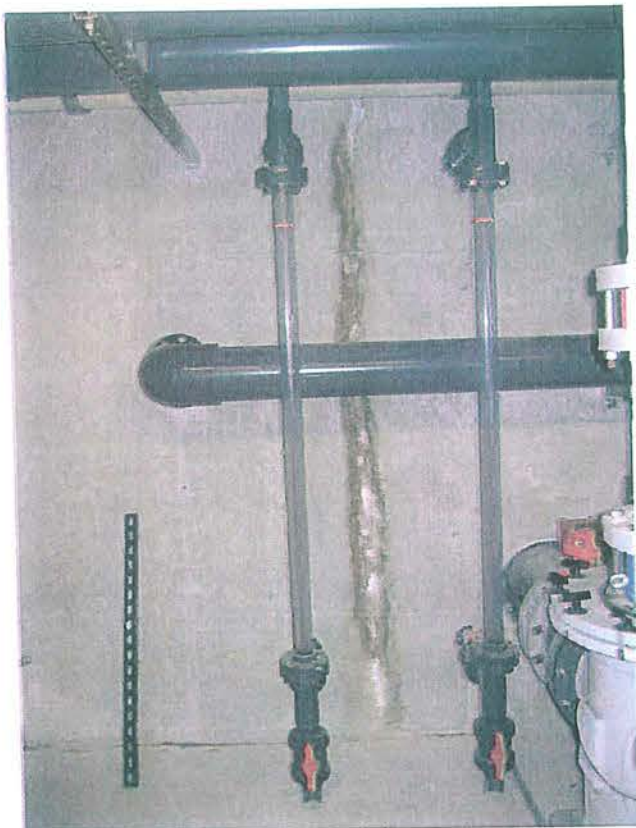
Lincoln Park Aquatic Center  
September 2010

**Equipment Room:** There is cracking in the surge tank wall and a shoddy fix of a leak.

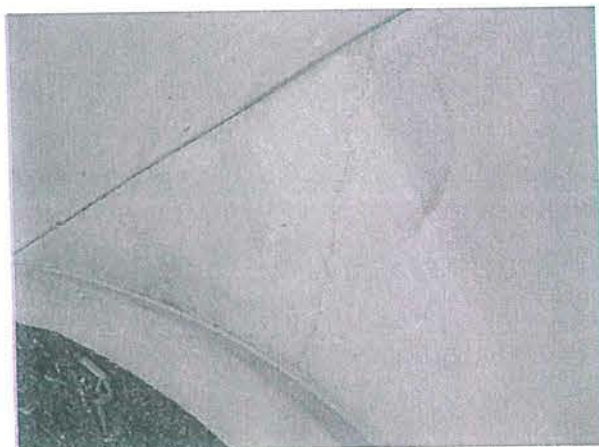
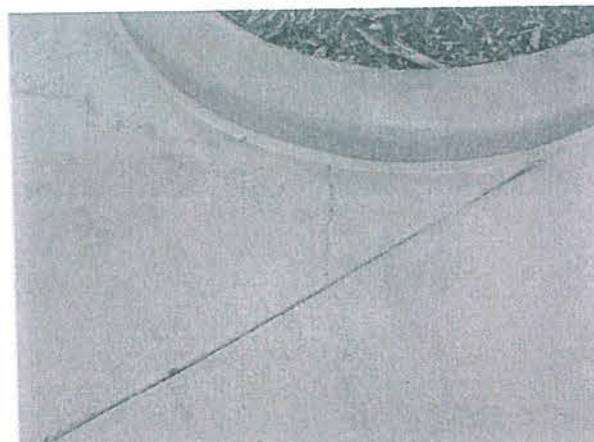
**Deck:** The sundeck concrete has eight slabs with shrinkage cracks. Most are in irregularly shaped slabs with acute angled corners

David Schultz Aquatic Center September 2009  
Shrinkage cracks in new deck slabs

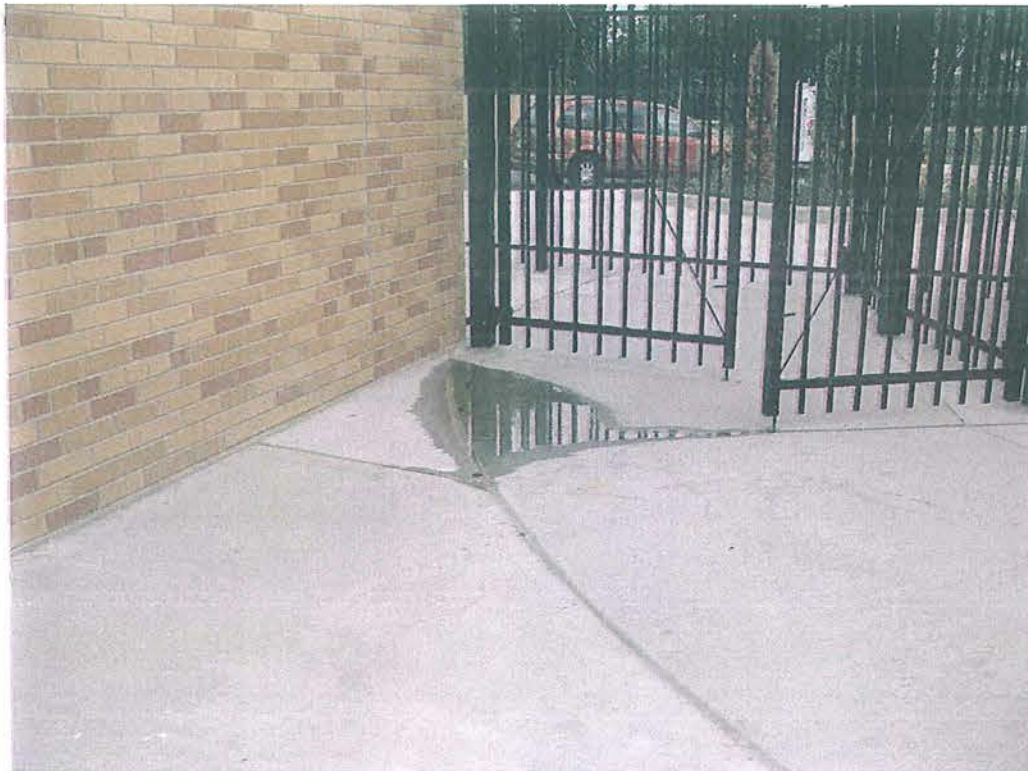
David Schultz Aquatic Center

Water ponds on the deck slabs near the gate.

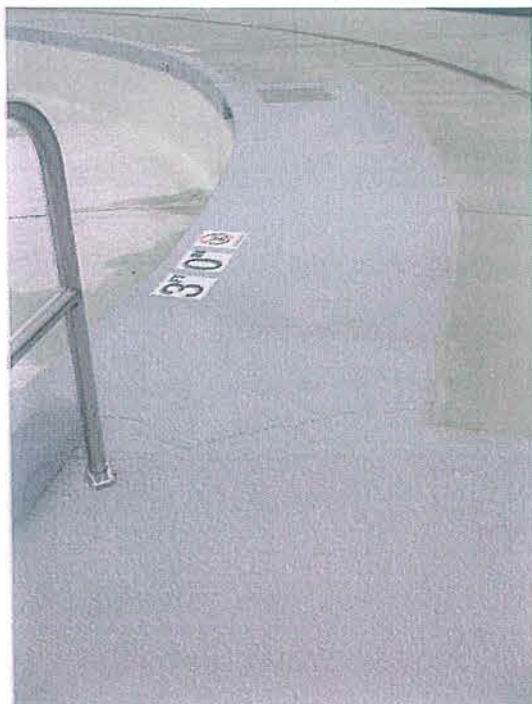
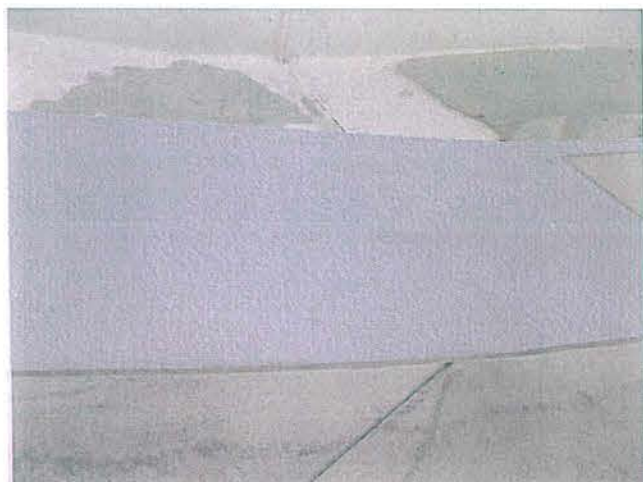
There are cracks in the long slabs above the lazy river weirs.

Cracked Slabs above Lazy River Weir

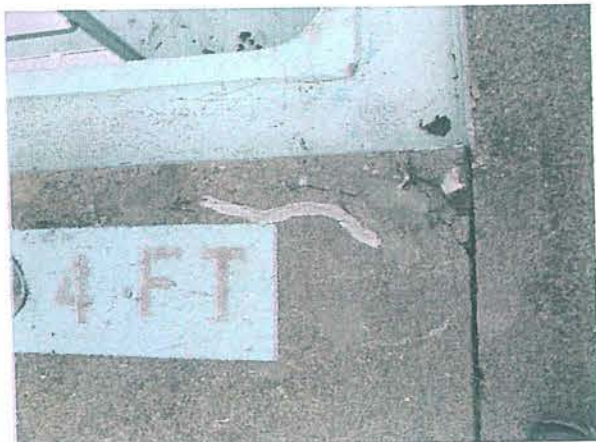
McCarty Park Tunnel Top

The tunnel top concrete is deteriorated around much of the pool, especially along the pool edge where it also serves at the back gutter wall.

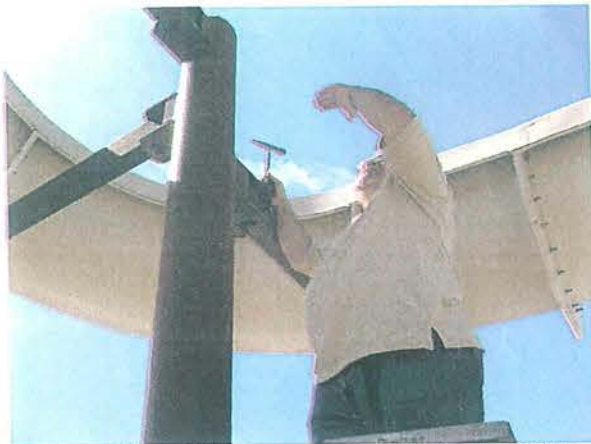
McCarty Water Slide September 2009  
Structural columns for the slide flume

the slide flume need be taken apart, cleaned, galvanized, and protective coated. Members with greater than 10% loss of section should be replaced.

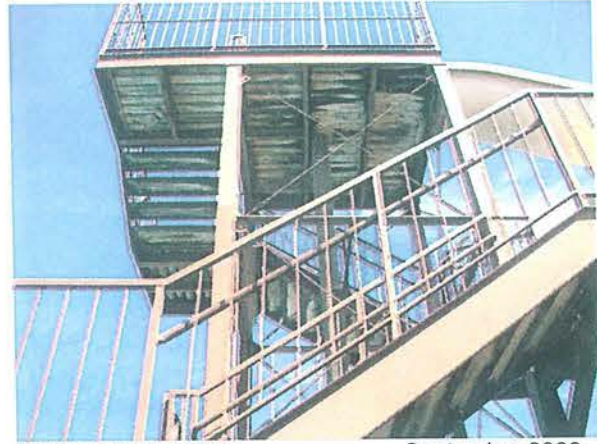
McCarty Water Slide September 2009  
Support tower for the stairs

The major support tower for stairs is made of 6-inch square tubes that are rusting, creating concern for the long-term structural stability of the slide structure. The steel brackets supporting the lumber stairs are rusting. Some step brackets have minor loss of section. On some vertical faces the weld is solid. On some bottom welds there is loss of base metal.

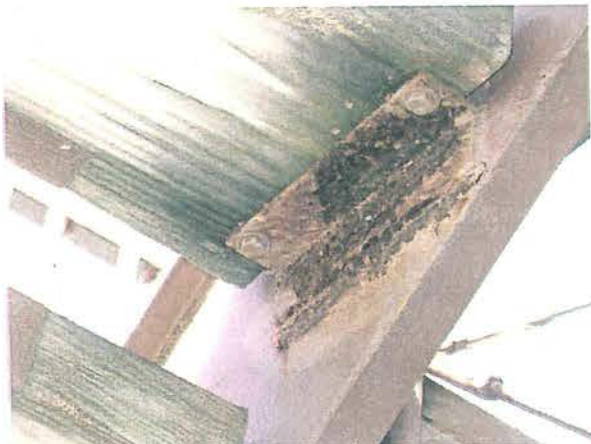
McCarty Water Slide September 2009  
Steel brackets supporting the stair treads

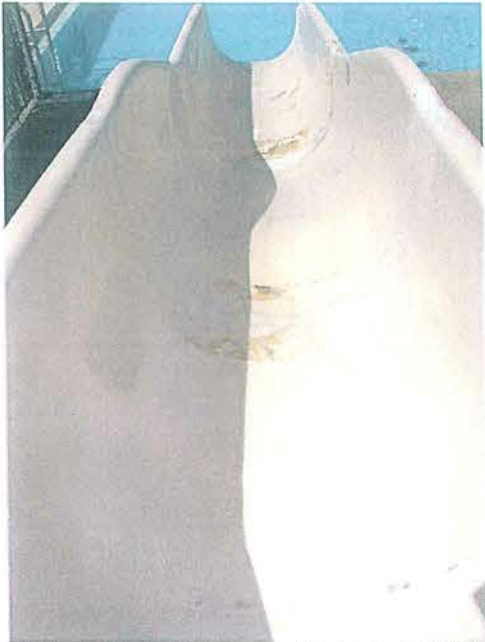
McCarty Water Slide  
Slide flume

The fiberglass slide flume is in poor condition and has several inversions, bumps, cracks, surface delamination, and rough patches. There are at least five different types of patches, some better than other others, some cracked and peeling, and the cementitious ones are very rough. There is one tiny leak. The gel coat is worn down to fiberglass in one spot. The slide is in desperate need of new gel coating.

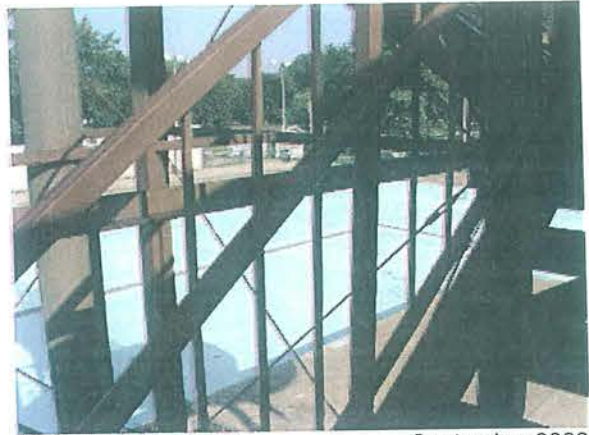
McCarty Water Slide  
Repaired Baluster (new baluster is rusting because  
protective coatings were not applied)

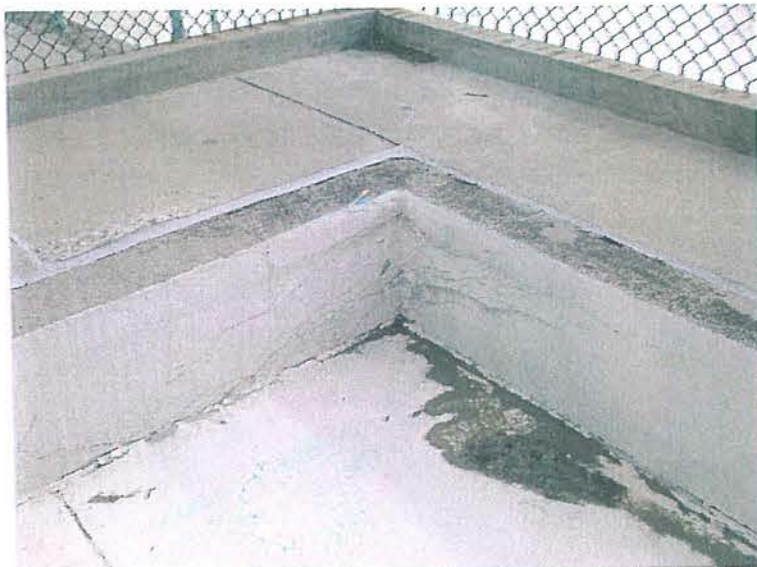
The south wall in wading pool is severely cracked and spalled. Parks maintenance replaced a two-foot section of the wall in the fall of 2004 and an 11-foot section in the spring of 2007. A 10-foot section should still be replaced as part of the long-term work. The southeast and southwest corners are severely cracked and the inlets on the steps are heaving the concrete above.

Sheridan Park Wading Pool - Wall cracking at corner September 2009

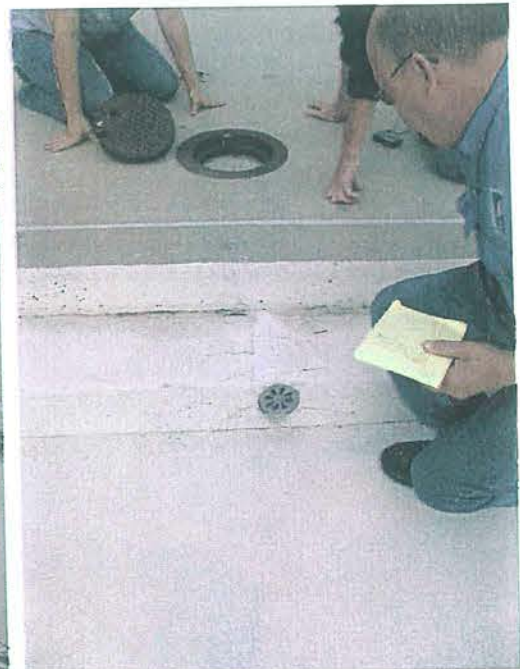
Step heaving at Inlet

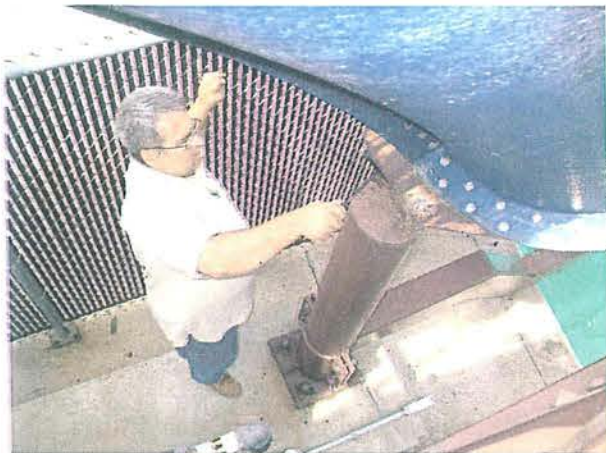
**Water Slide:** The water slide, which is in fair condition, was built in 1992. Steel columns have rusting, but no loss of section. The structural tubing and columns look good.

Sheridan Water Slide September 2009  
Steel columns are rusting, but are structurally sound

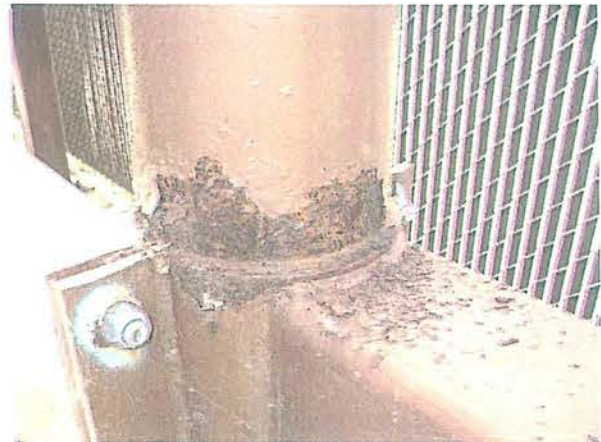
Sheridan Water Slide September 2009  
Steelwork needs blasting and protective coatings

All steelwork is rusting. The entire steelwork structure and handrails need blasting and protective coatings to avoid the need to replace sections that may rust completely if the proper maintenance measures are not taken. This work should be coordinated with carpentry required to replace the rotted timber stair treads (see below). The slide needs to be disassembled so that the steel can be blasted, welded, primed, and protective coated prior to reassembly and installation of the stair treads. The fiberglass slide flume is in good condition with only minor spider cracking.

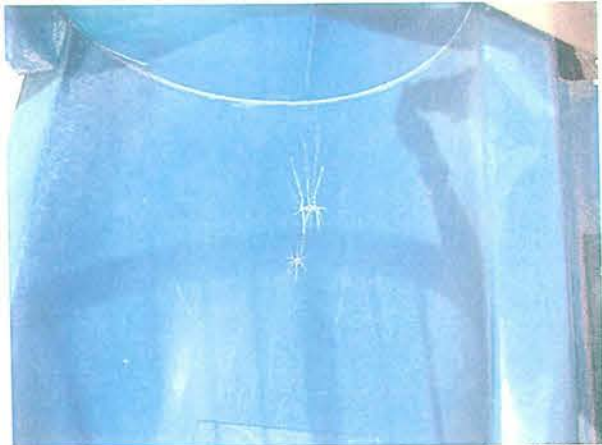
Sheridan Water Slide September 2009  
Slide flume has minor spider cracking

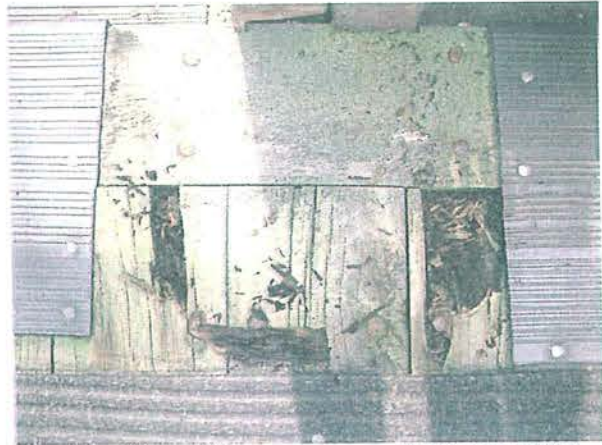
Sheridan Water Slide September 2009  
Timber landings were deteriorated
