# Milwaukee County Parks

- Coastal Asset Inventory
- Coastline Management Guidelines

December 2020

## Milwaukee County Coastal Resources Inventory

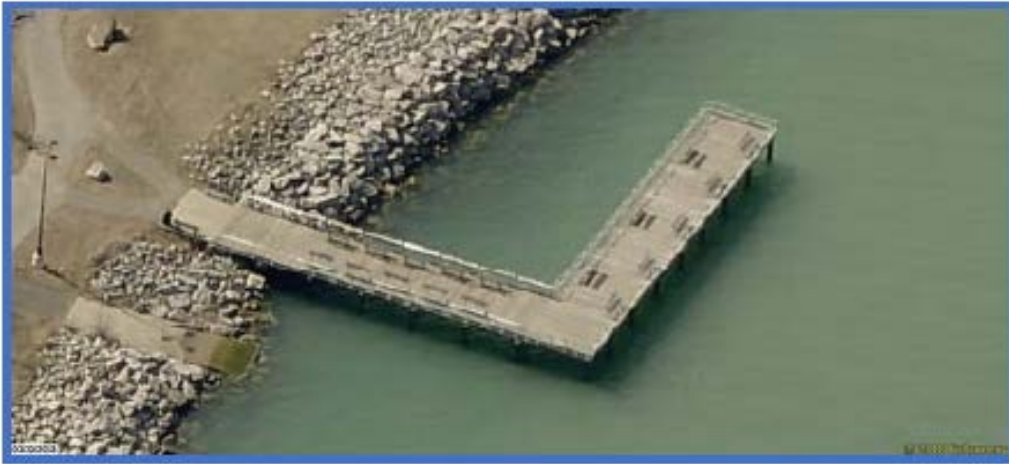
Cupertino Pier – Image Captured May 2018, Source: MCLIO

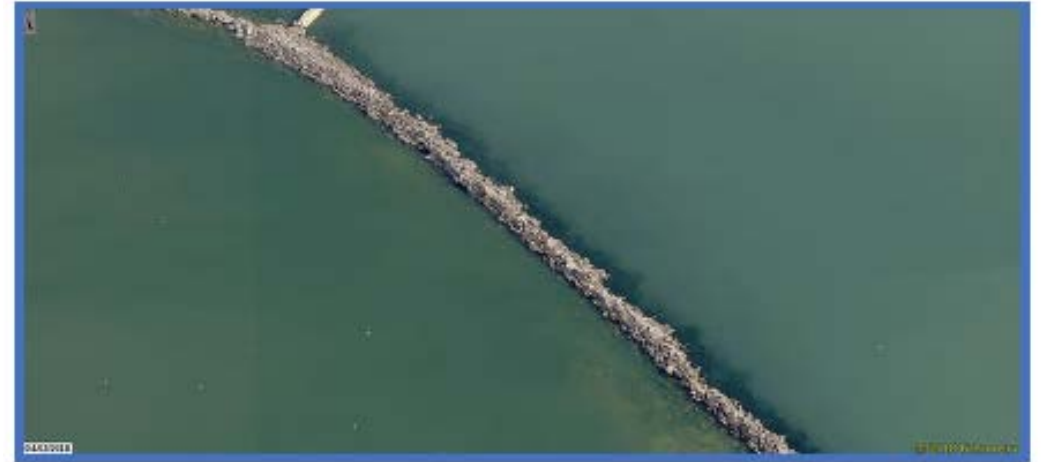
South Shore Breakwater – Image Captured May 2018, Source: MCLIO
