Mitchell Park Domes Historical Timeline and Reports
Department of Administrative Services (DAS) Division of Grants & Special Projects
Updated August 12, 2021

Pierce Engineers and a team of sub-consultants performed materials testing on the precast concrete frame and a foundation condition assessment of the Show Dome at the Mitchell Park Horticultural Conservatory. The assessment work was performed May 16 to June 3 of 2019. The assessment of other domes is not part of the scope of this report.

MITCHELL PARK HORTICULTURAL CONSERVATORY MILWAKEE, WISCONSIN PRECAST CONCRETE FRAME TESTING

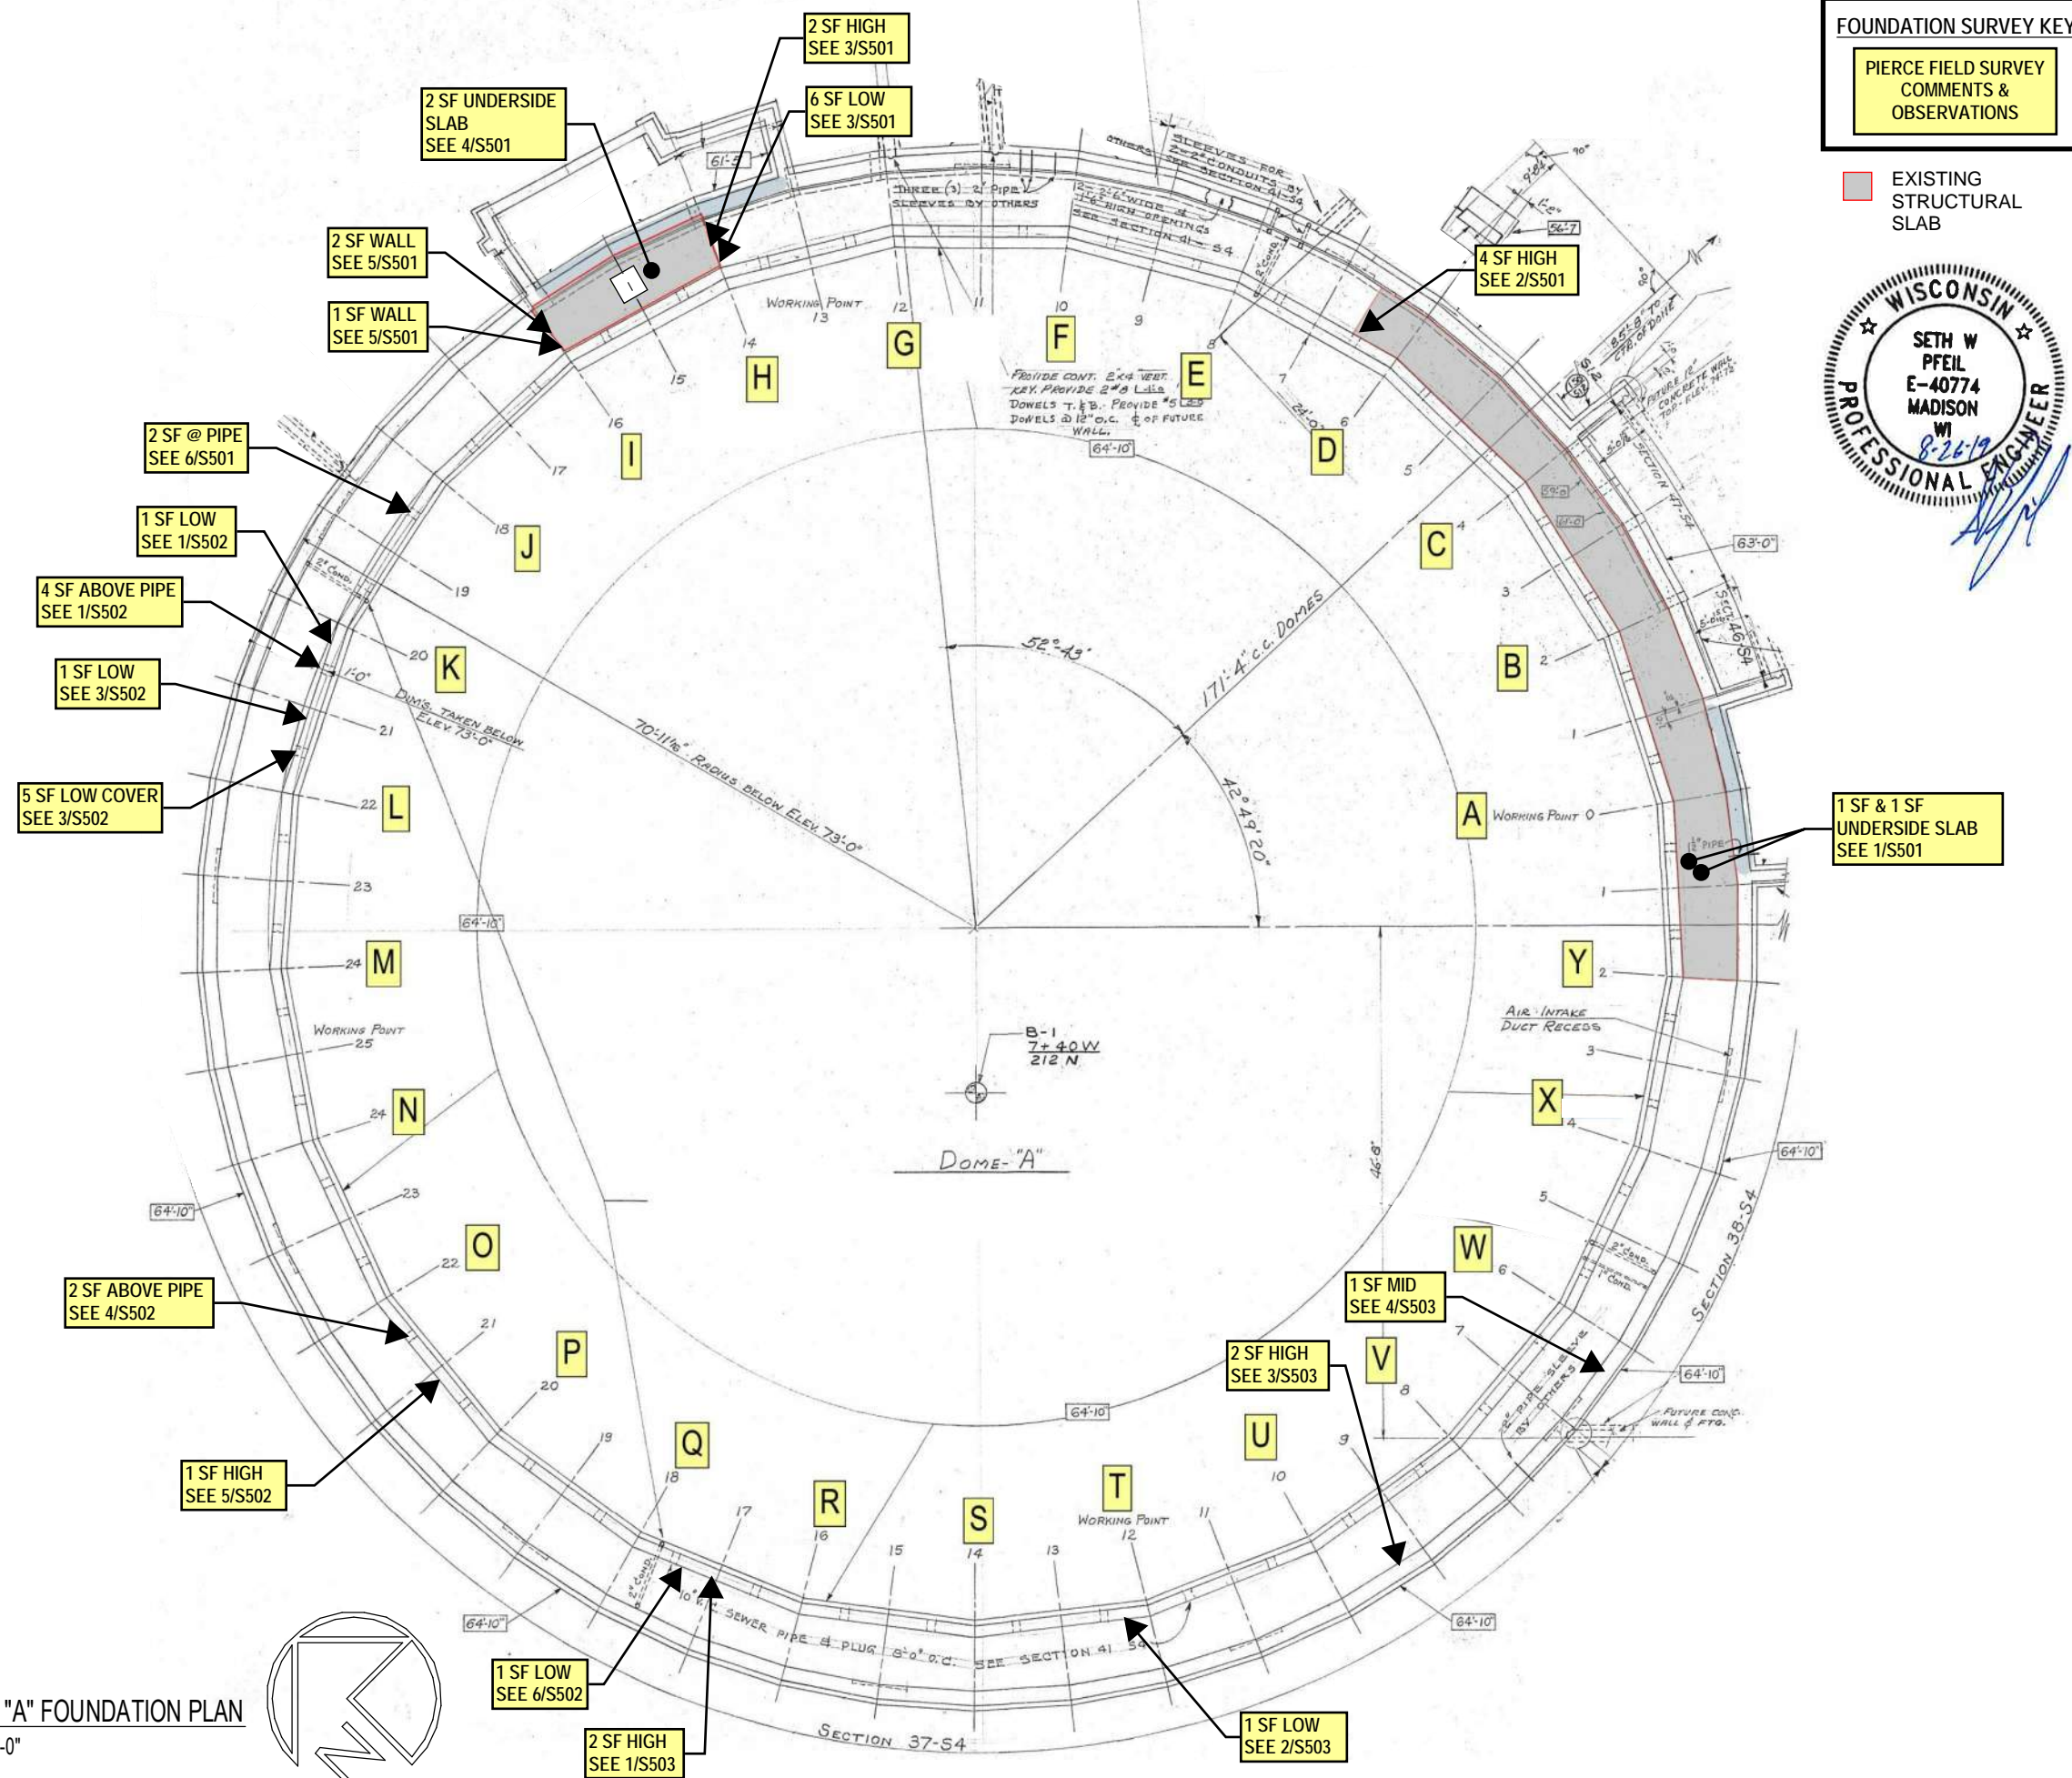
SHOWDOME "A" FOUNDATION PLAN
SCALE: 1/16" = 1'-0"

Delamination soundings are denoted in the foundation plan survey & photos attached in appendix D. Concrete wall delamination noted on plans were minor, most due to low concrete cover where reinforcing is near surface, with the largest area of 5sf. Repair of all concrete wall and slab delaminations can be accomplished by conventional repair methods. Conventional repair of delaminations by removing delaminated concrete to sound substrate exposing corroded reinforcing should be performed, Perform surface preparation of concrete and steel reinforcing within patches via gritblasting to remove loose materials and bond inhibiting materials. Place concrete repair mortar and provide breathable concrete coating for protection of low cover reinforcing.

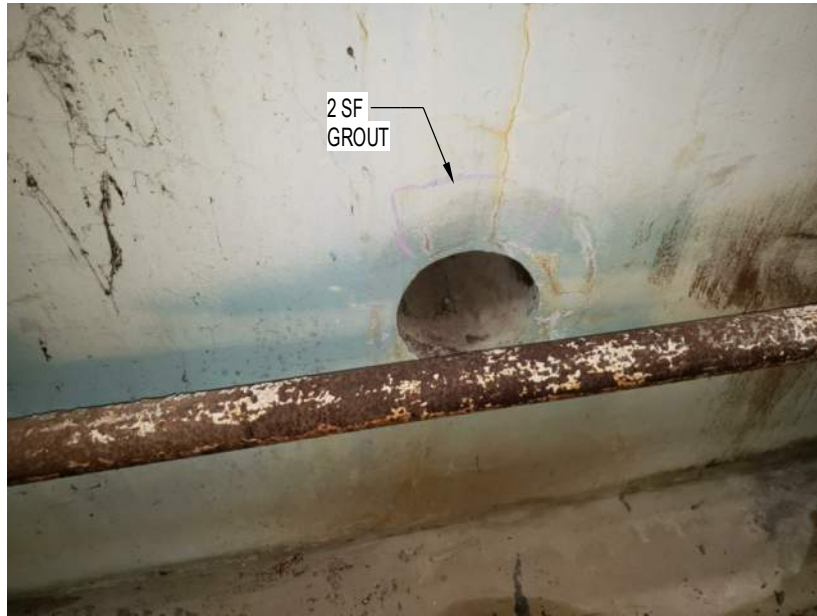
6 S501 J-K - 2 SF GROUT @ PIPE

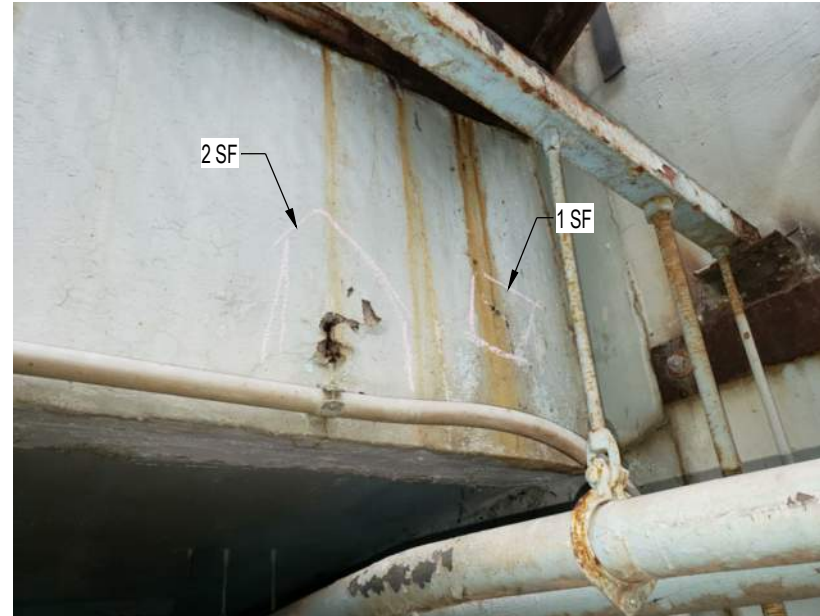
5 S501 I - 1 SF & 2 SF

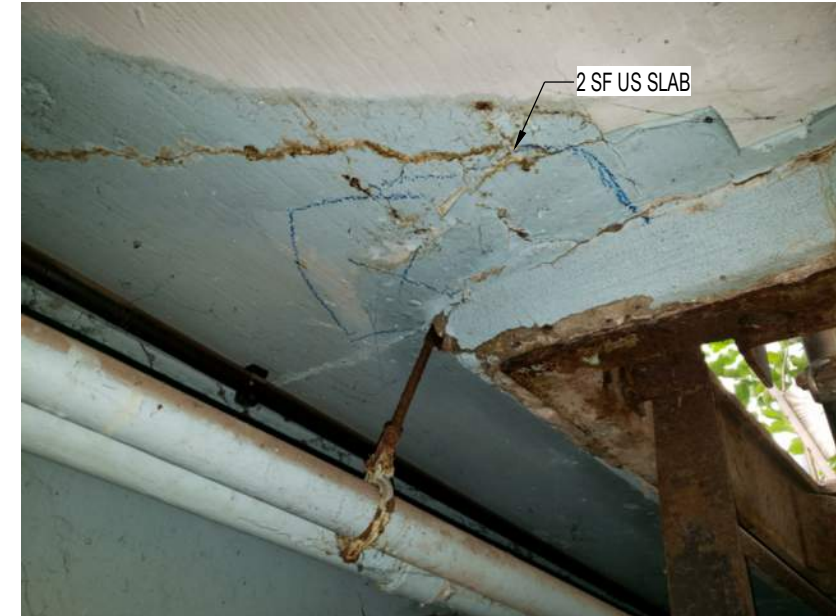
4 S501 H-I - 2 SF US SLAB

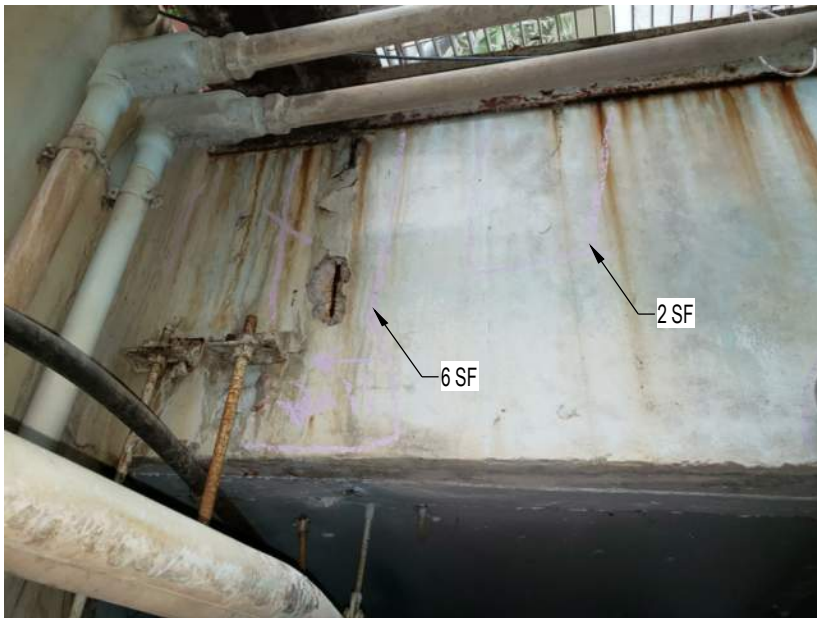
3 S501 H - 6 SF & 2 SF

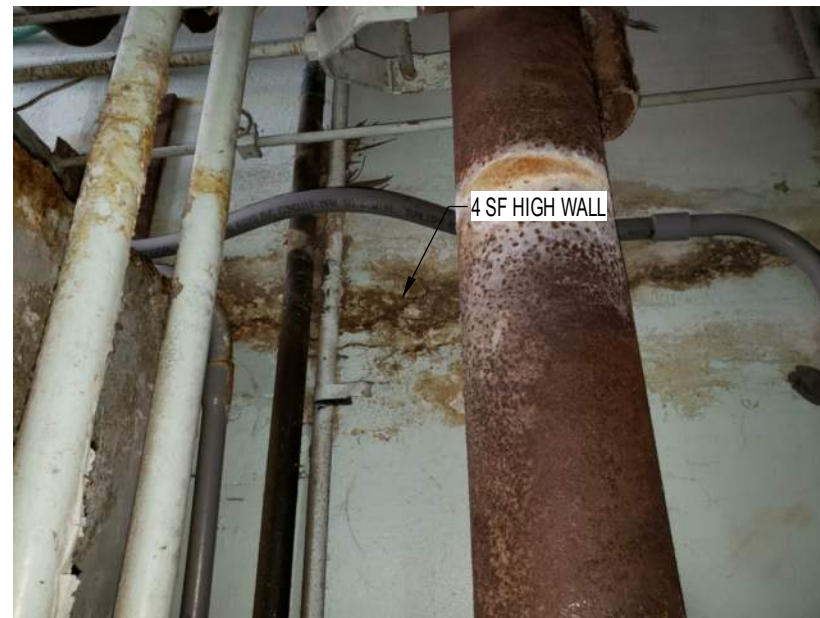
2 S501 D-E - 4 SF HIGH WALL

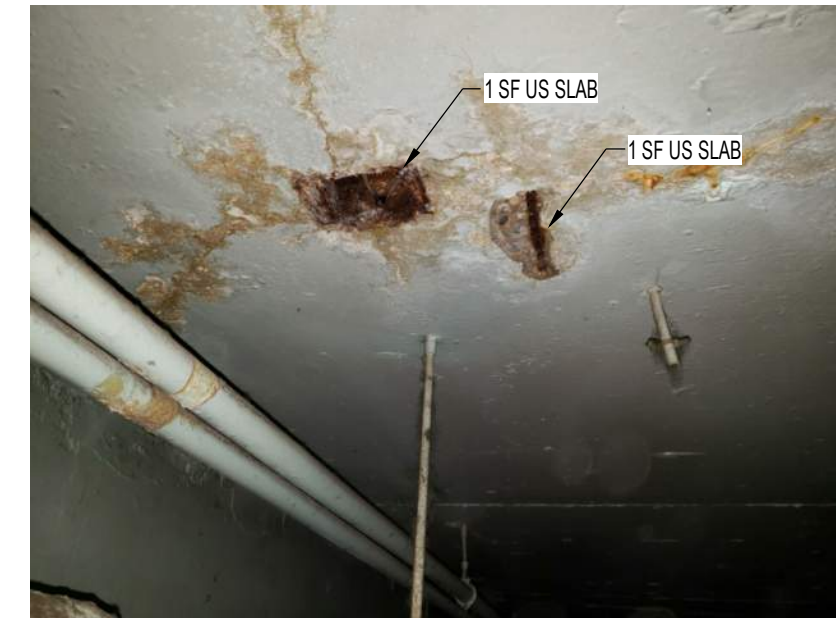
1 S501 Ø-A - 1 SF & 1 SF UNERSIDE SLAB

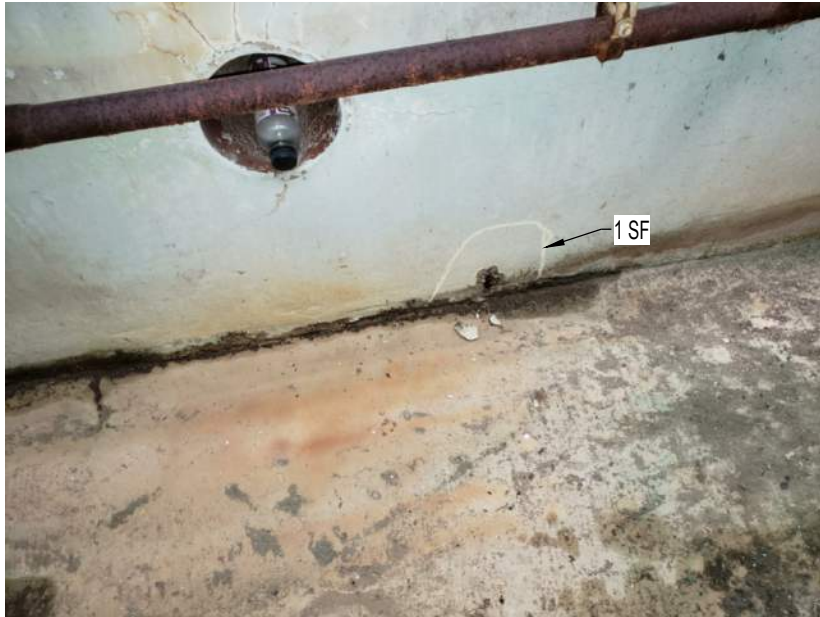
6
S502 Q-R - 1 SF LOW

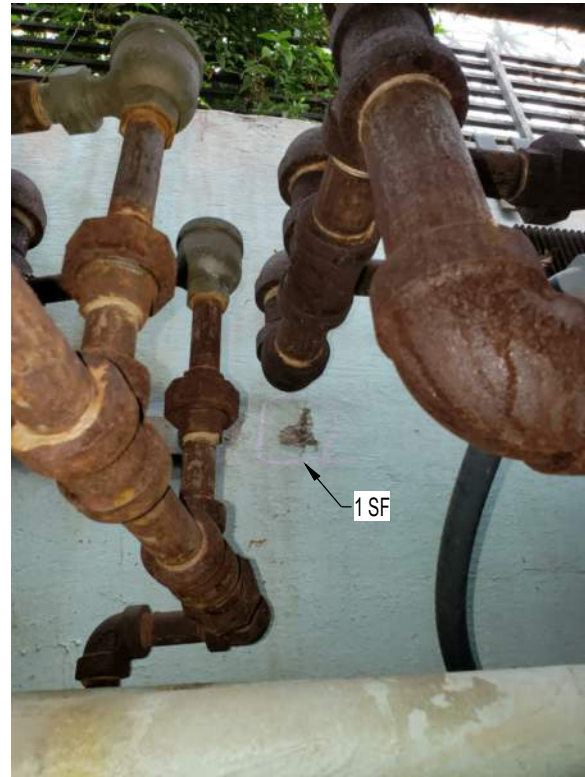
5
S502 P-Q - 1 SF HIGH

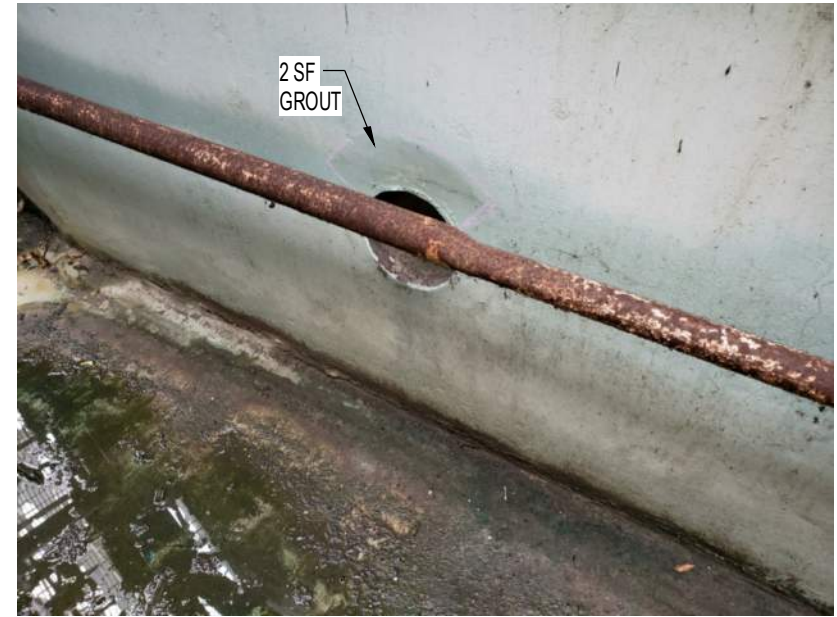
4
S502 O-P - 2 SF GROUT @ PIPE

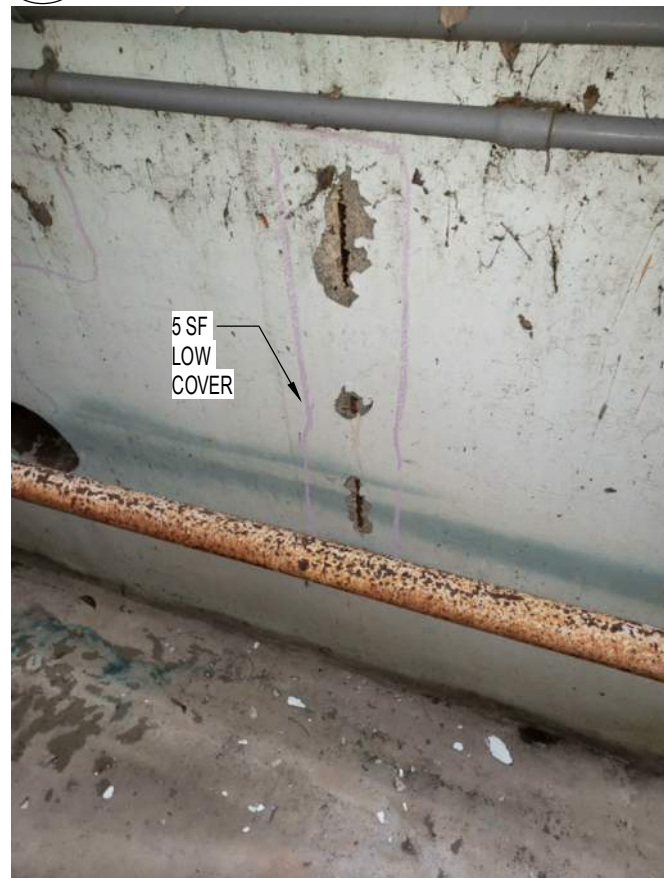
3
S502 K-L 5 SF LOW COVER

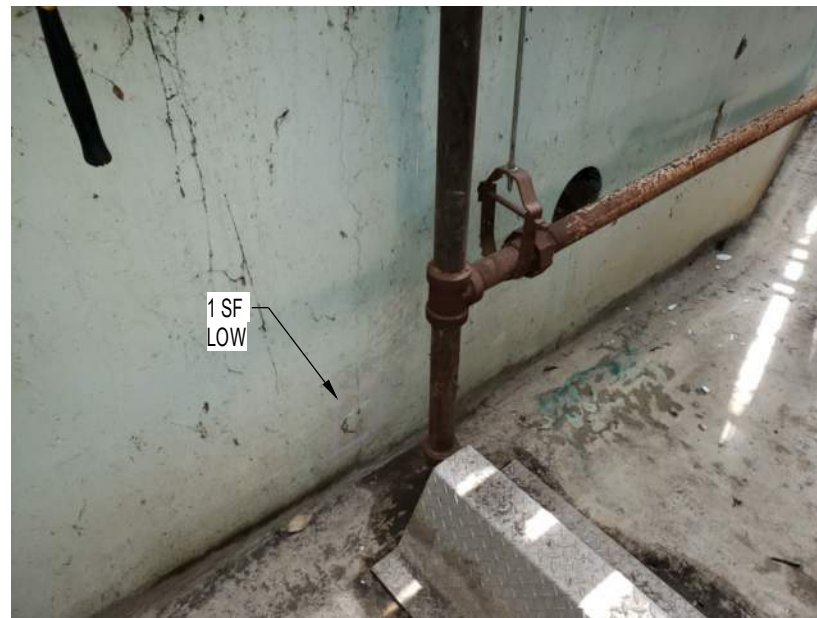
2
S502 K-L - 1 SF LOW

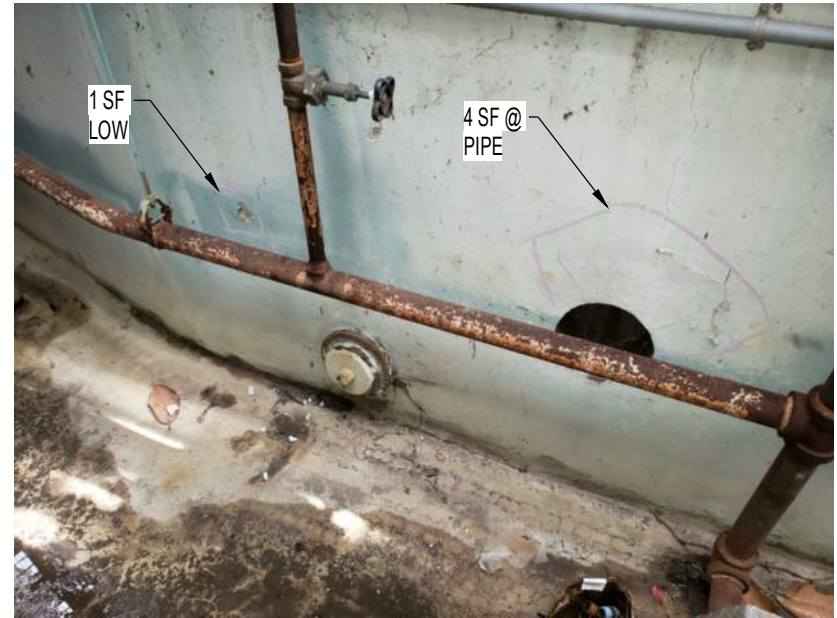
1
S502 J-K - 2 SF @ PIPE PENETRATION

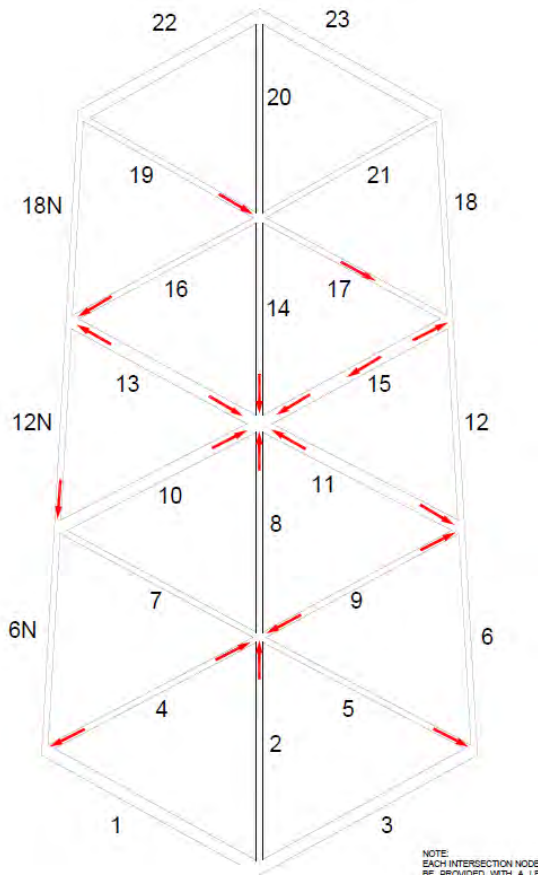
Figure 4: Corrosion Potential Delta Values for Area M

It is clear from the gradient analysis illustrated in Figure 4 and Figure 5 that Joint F has the potential for corrosion activity in both test areas. Joint F was selected in both test areas for concrete removal to expose the embedded weld plates.

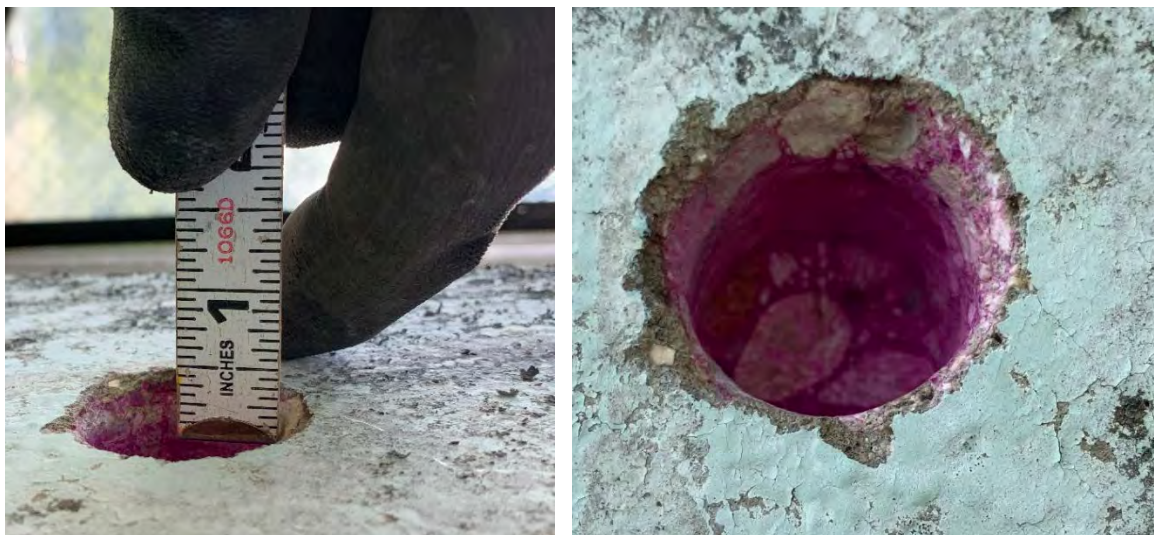
Figure 23: Carbonation Depth Testing

To identify the depth of the carbonation front in concrete, 16 holes were drilled in elements M and Q and sprayed with a phenolphthalein indicator solution to indicate pH. The indicator solution changes to a pink/purple color at pH greater than 9.5. If the concrete is not colored purple or pink, the concrete has a pH less than 9.5. This indicates the depth of carbonated concrete; if the solution turns purple or pink on the concrete then that is an indication of uncarbonated or alkaline concrete. The measured depth of carbonation ranged from 0 to 0.25 inches, with an average carbonation depth of 0.09 inches. Considering the average reinforcement cover-depth of the concrete beams was determined to be 0.9 inches, there is little to no risk of corrosion due to carbonation.

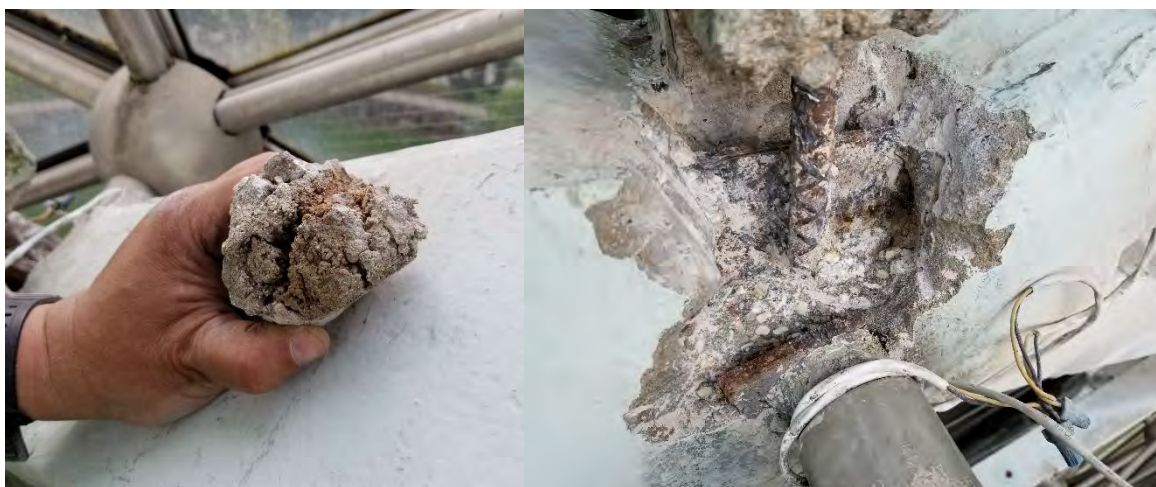
Figure 24: Area M Joint F and Grout Chunk

Joint F was selected because the corrosion gradient analysis indicated that it was likely for corrosion activity to be present. We made the opening by drilling several holes into the concrete joint, then using a small chipping hammer to remove the cover concrete. While doing so we noticed a crack developed in the paint that outlined a square block-out. We placed the chipping hammer on the crack and removed the poorly consolidated grout sample shown in Figure 24. Additional images are provided in Figure 25.
