**2017**  
**Milwaukee County**  
**CMAR REPORT**

## Brief History of past CMAR related efforts

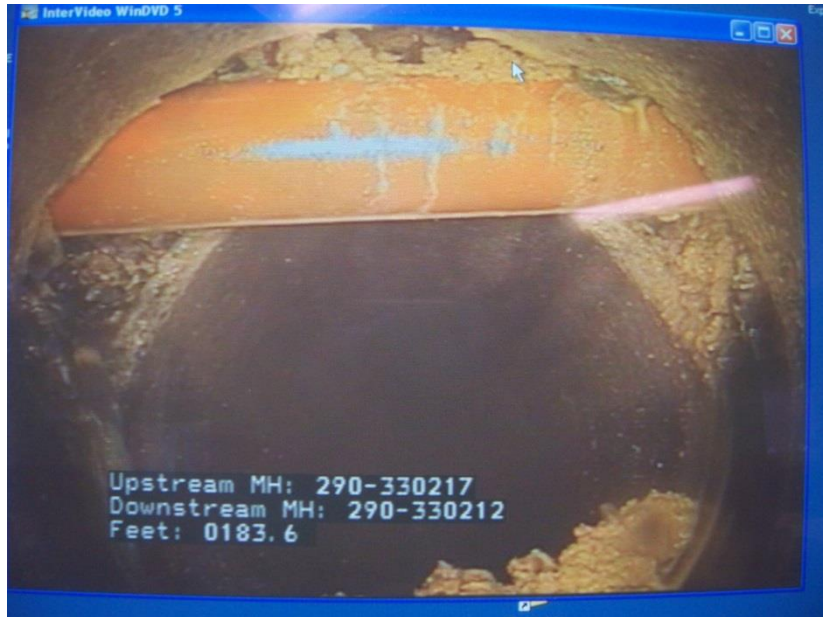
GMIA pipe broken inadvertently by directional drilling & found by televising pipe.

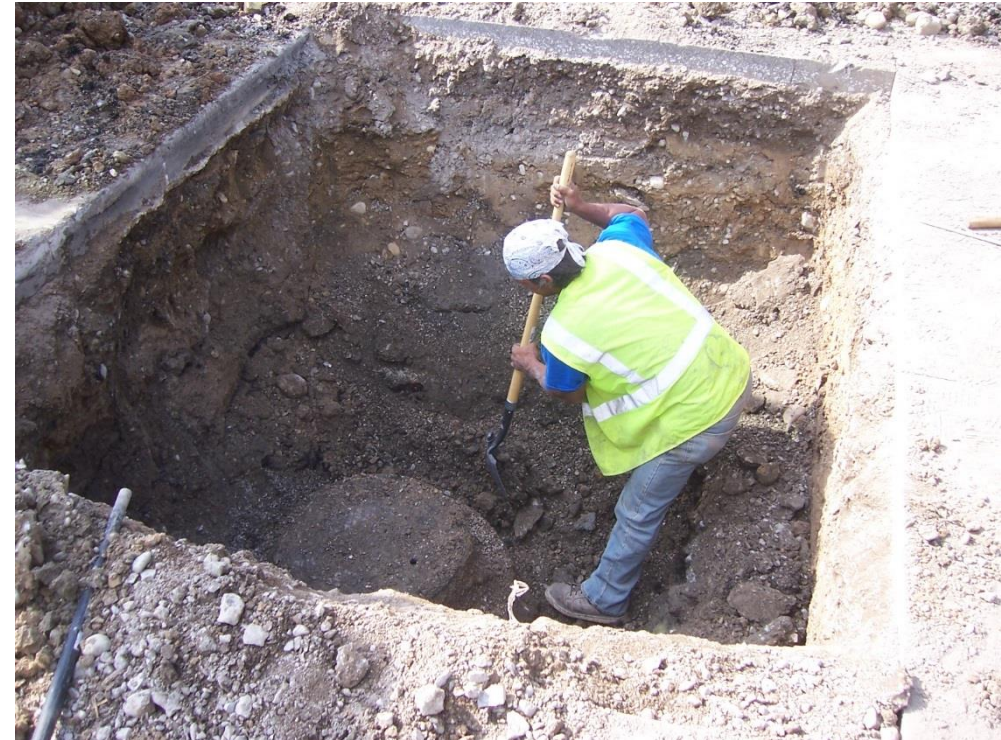
Digging up buried Manhole at Parks

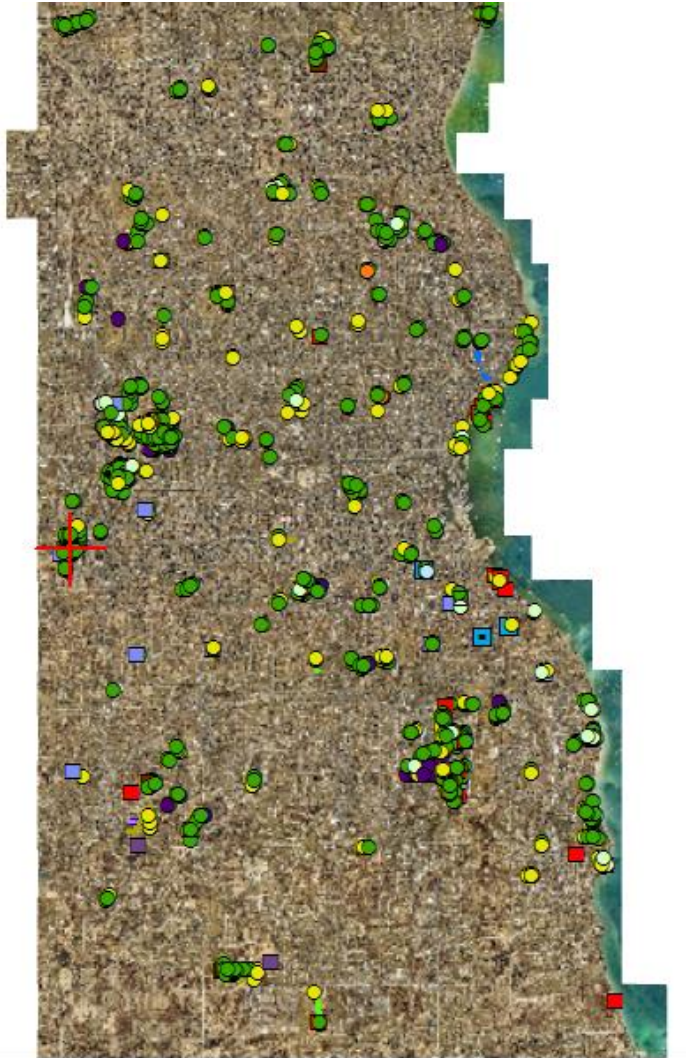
Sewers mapped in GIS for County

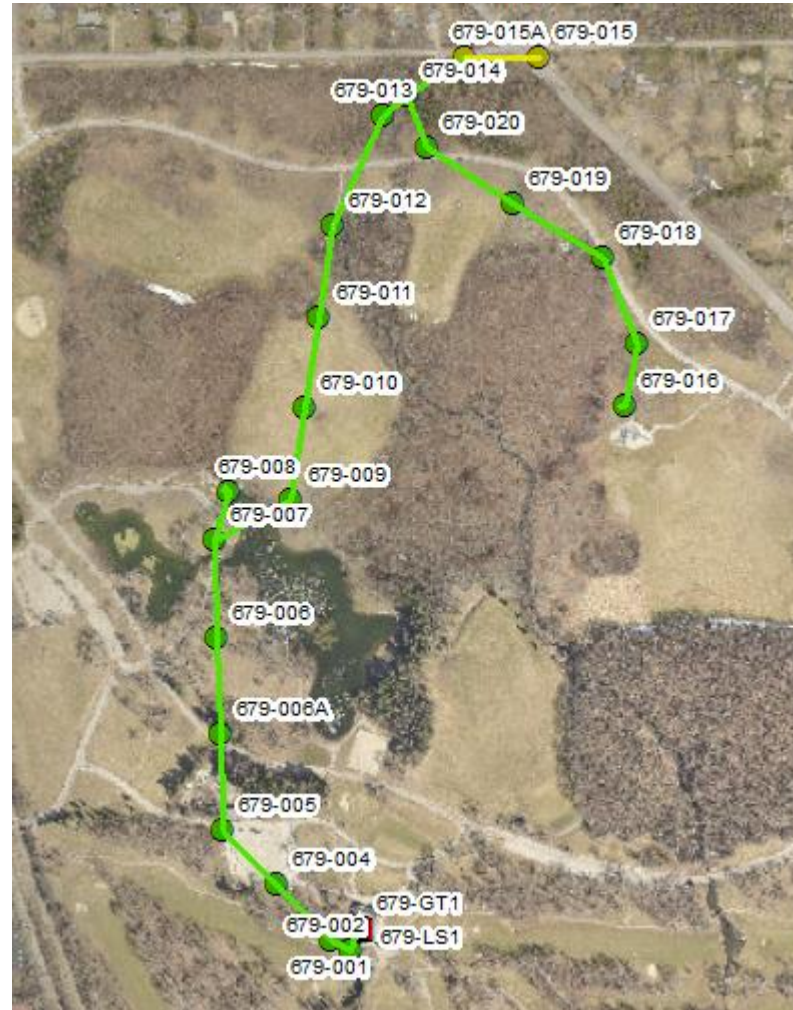
Sewers mapped in GIS at Brown Deer Park

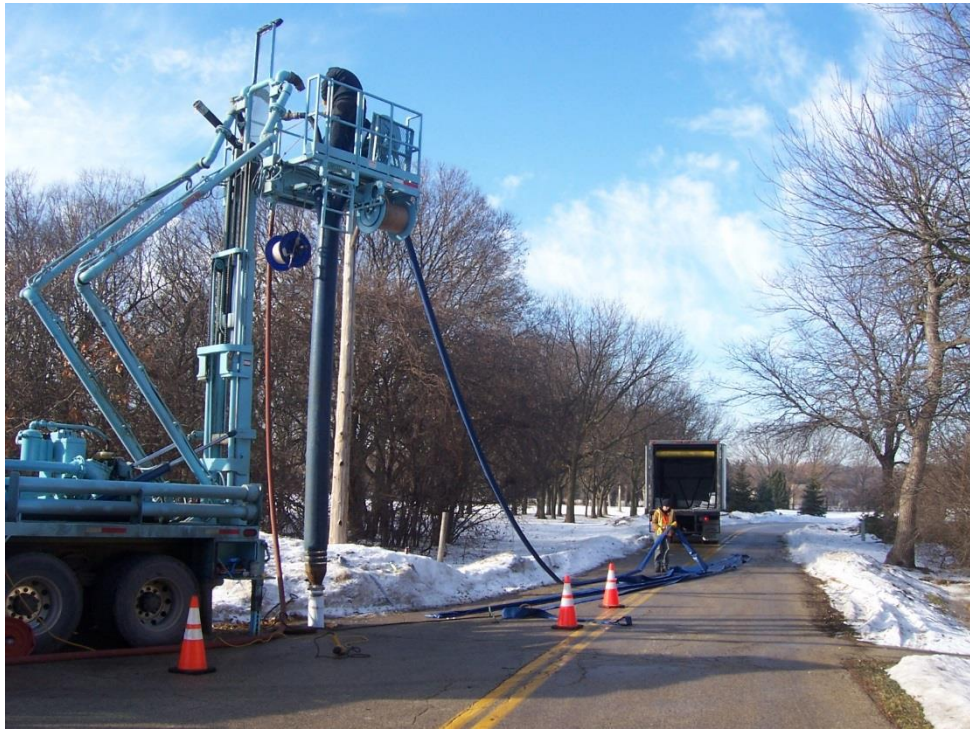
Installing CIPP pipe Liner in Brown Deer Park

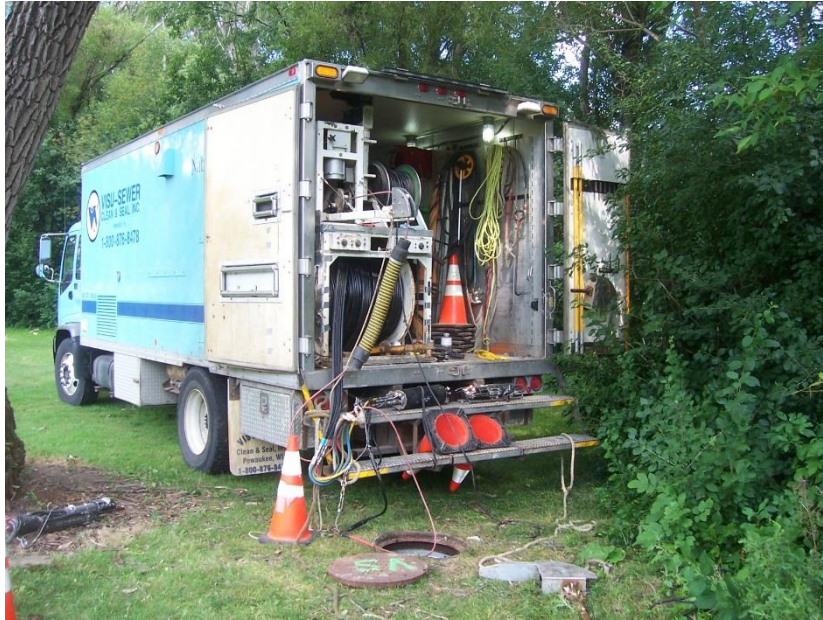
Pipe televising truck

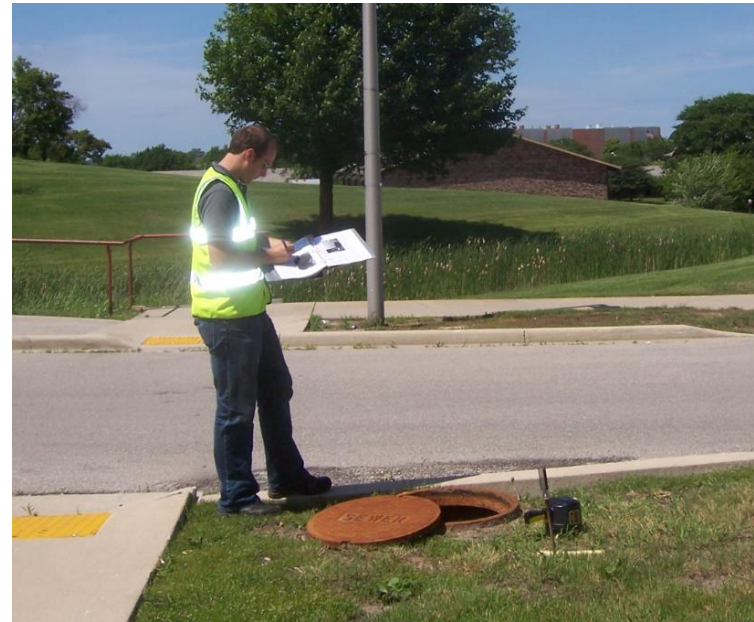
Manhole Inspections
