McGovern Park Senior Center

Information Session
November 11, 2025

Basis for Closure

Remediation Efforts

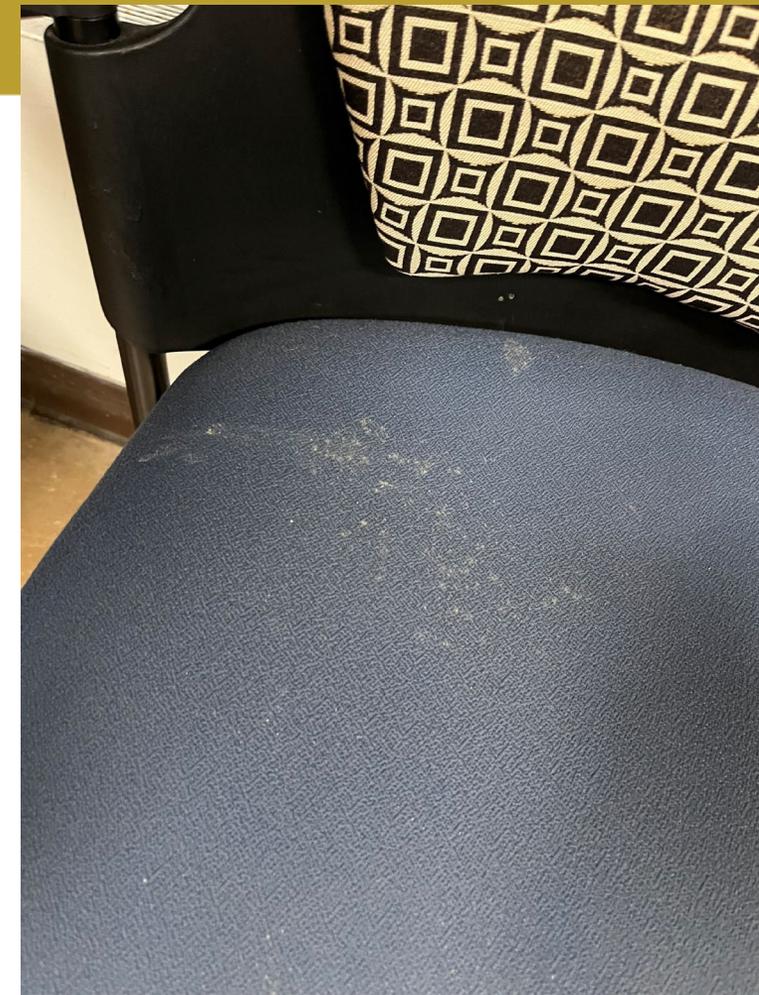
September 25: Air quality consultant inspects facility, samples collected. Mold now visible on main floor surfaces and HVAC.
