## PROJECT APPROACH

### PROJECT UNDERSTANDING

The Lake Park Arch Bridge over Ravine Drive is over 110 years old and constructed of concrete reinforced with a mixture of proprietary steel reinforcement and round steel bars. The bridge has been repaired and/or patched on more than one occasion over its lifetime. Period photographs lead us to understand the ornamental baluster parapet has been removed and replaced, and the metal cross bracing between the bottom flanges of the arch ribs has been removed without replacement.

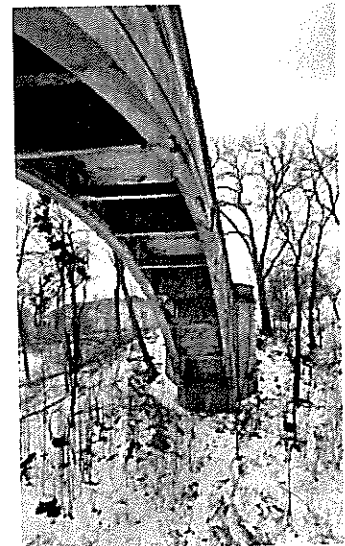
Rehabilitation design efforts will begin with a review of the existing project information, the development of condition assessment drawings, and field work. The ONE team will visit the bridge site to confirm that the conditions of the bridge are consistent with the July 2015 GRAEF in-depth Inspection Report. We will also conduct a laser scan survey of the bridge, the interior of the vaulted abutments and the surrounding topography. We will then develop

a 3D model of the bridge with the laser scan data. The 3D model will provide a dimensionally accurate model to be used for communication, visualization and design.
