# McKinley Beach Study

Draft Final

*Coastal & Environmental Consultants*

*The purpose of this study is to identify measures necessary to improve swim safety, beach sustainability and water quality at McKinley Beach.*

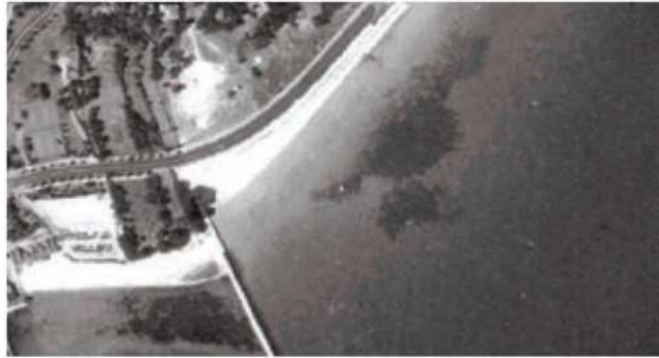
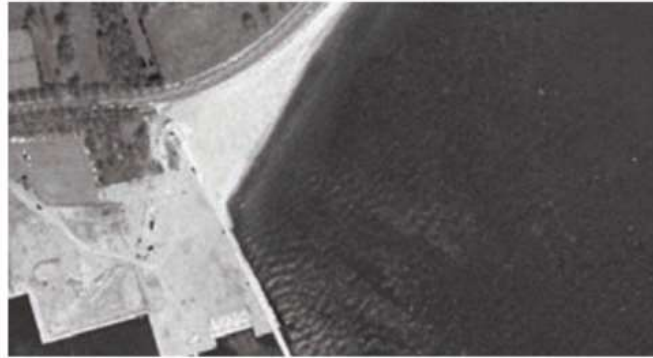
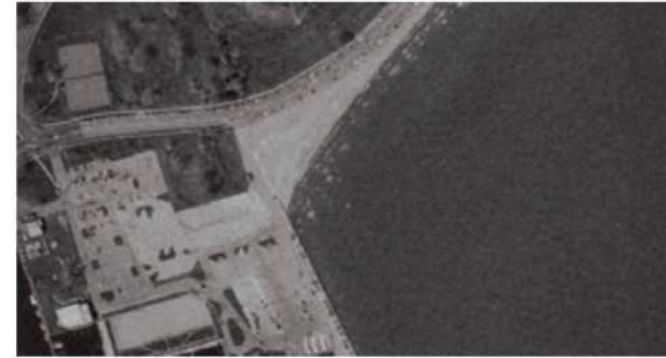
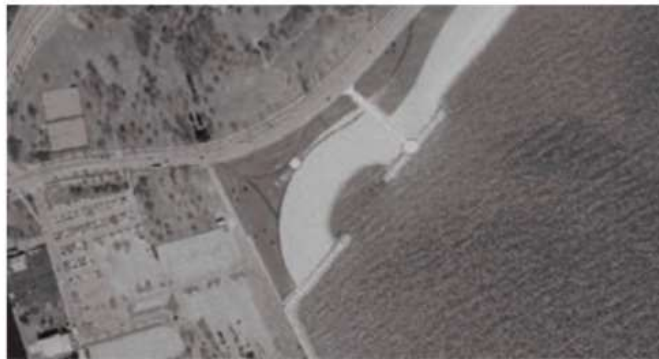
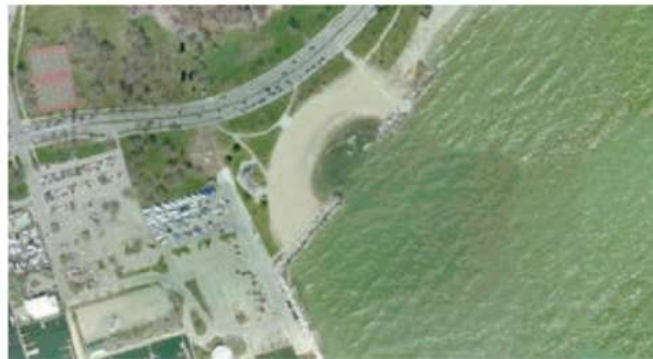
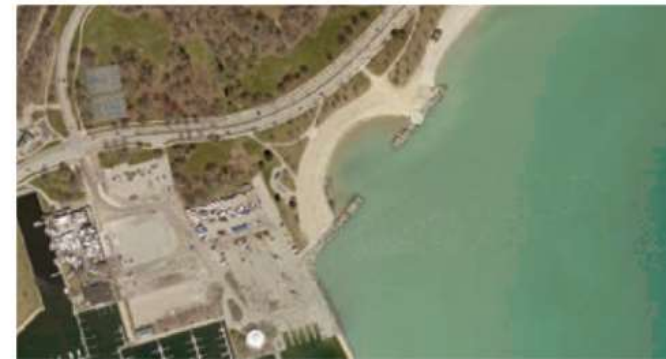
- McKinley Beach Through Time

- McKinley Beach began to form in 1937 when the construction of Government Pier interrupted the “Longshore Currents” which carry sand along the coast.

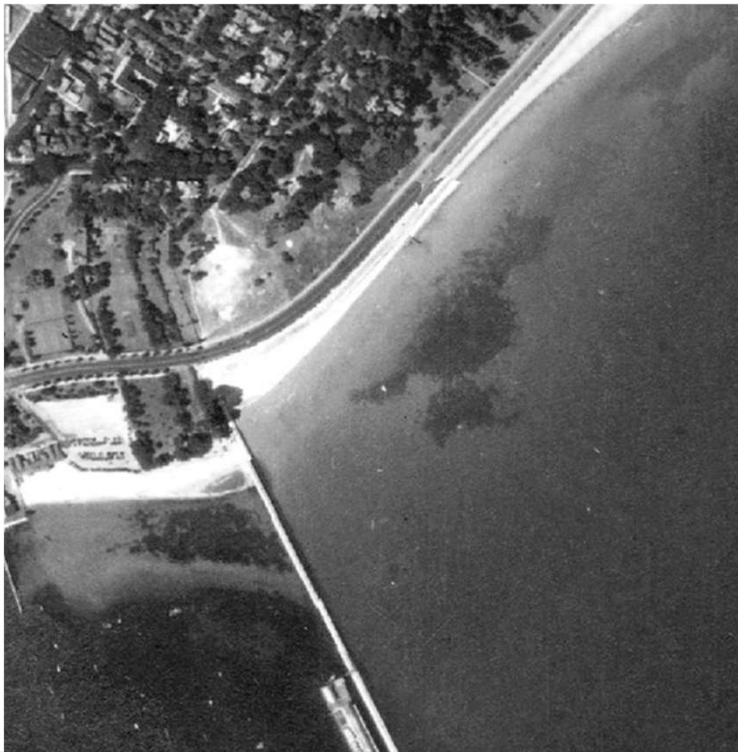
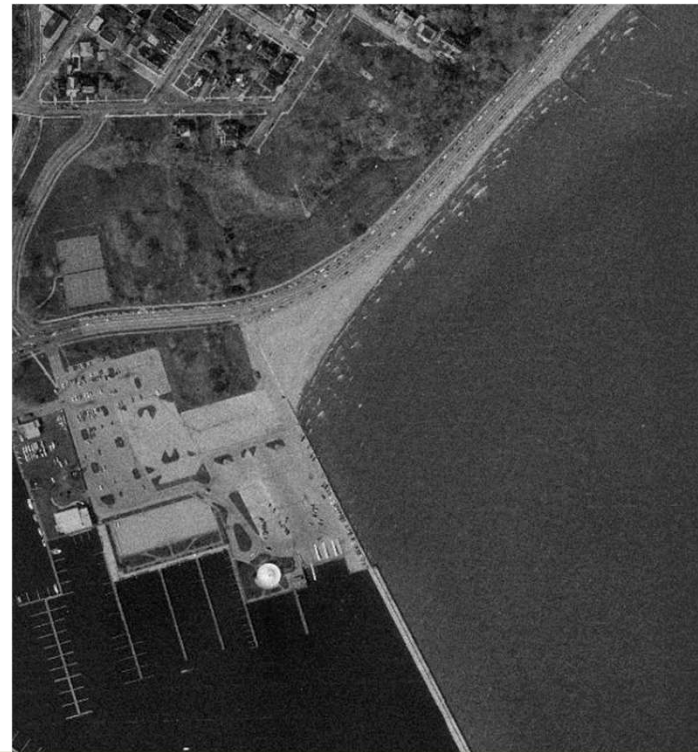
- McKinley Beach began to form in 1937 when the construction of Government Pier interrupted the “Longshore Currents” which carry sand along the coast.

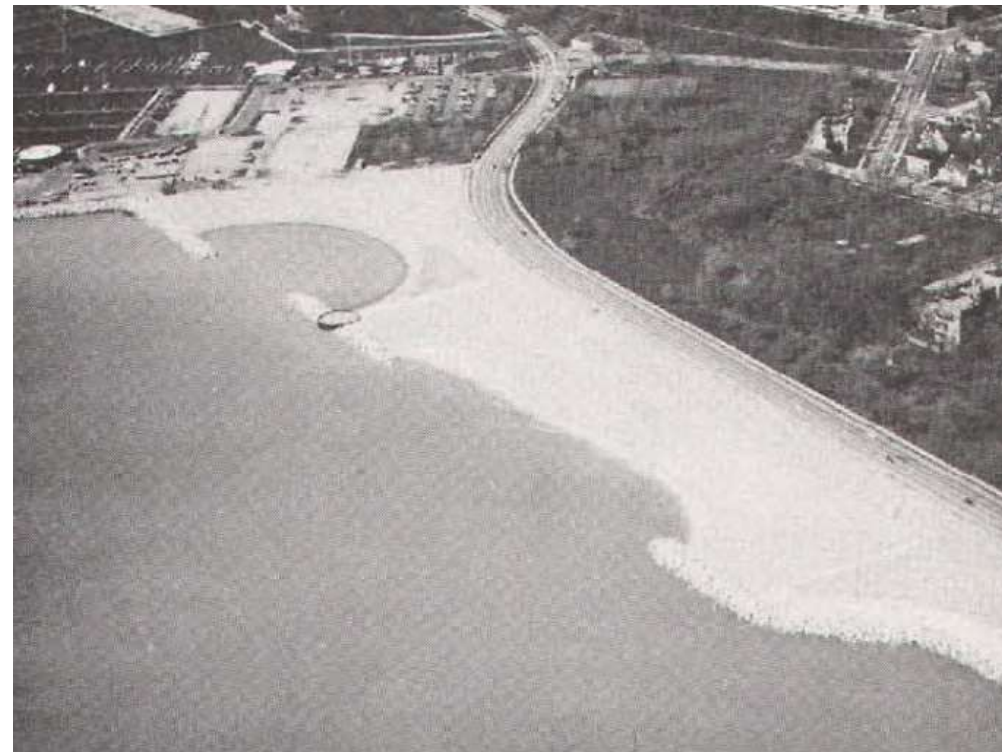
- SEWRPC Guidance Contemporary to Construction

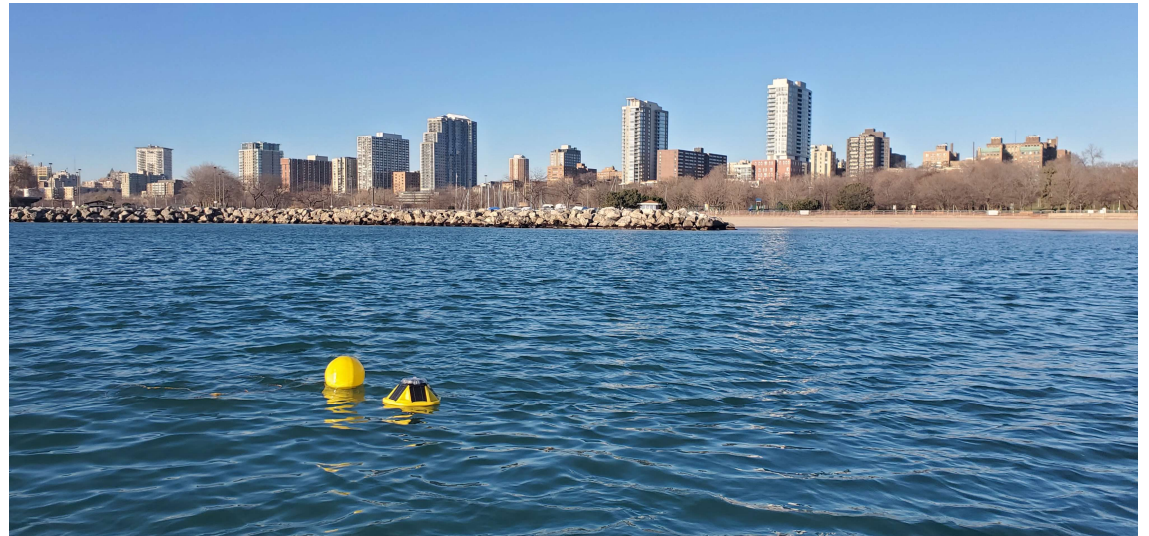
- Wave Buoy
  - RealTime & Logged Data
  - Wave
    - Frequency
    - Magnitude
    - Period
    - Direction
  - Wind
    - Magnitude
    - Direction

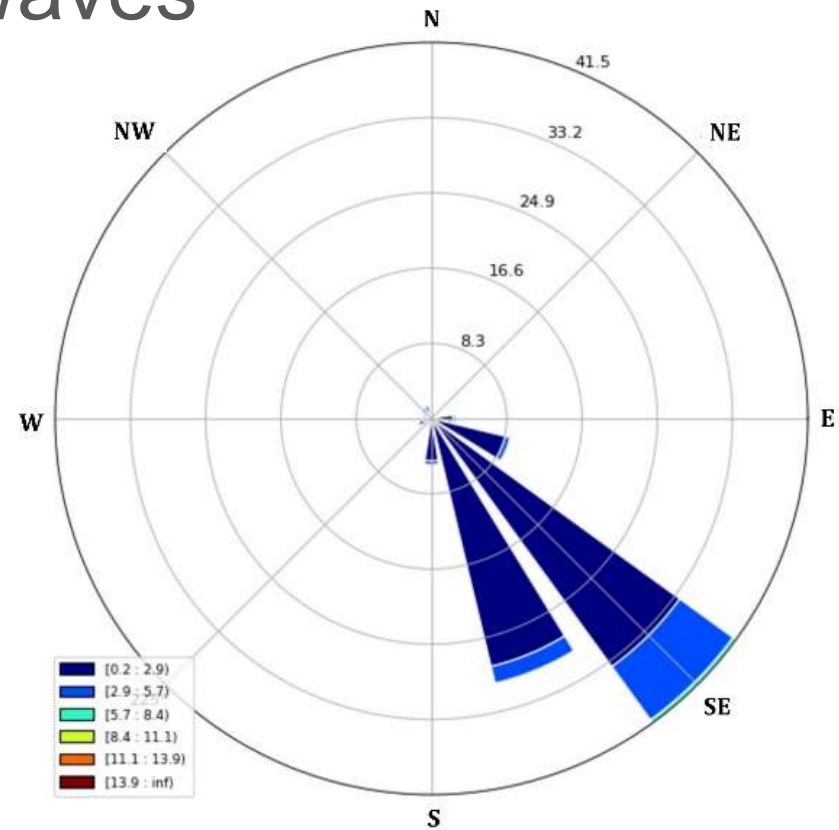
Buoy Wave Rose

<u>Buoy</u>	Significant Wave Height
	(ft)
Minimum	0.16
Q1	0.52
Median	1.05
Q3	2.26
Maximum	14.30
Average	1.59

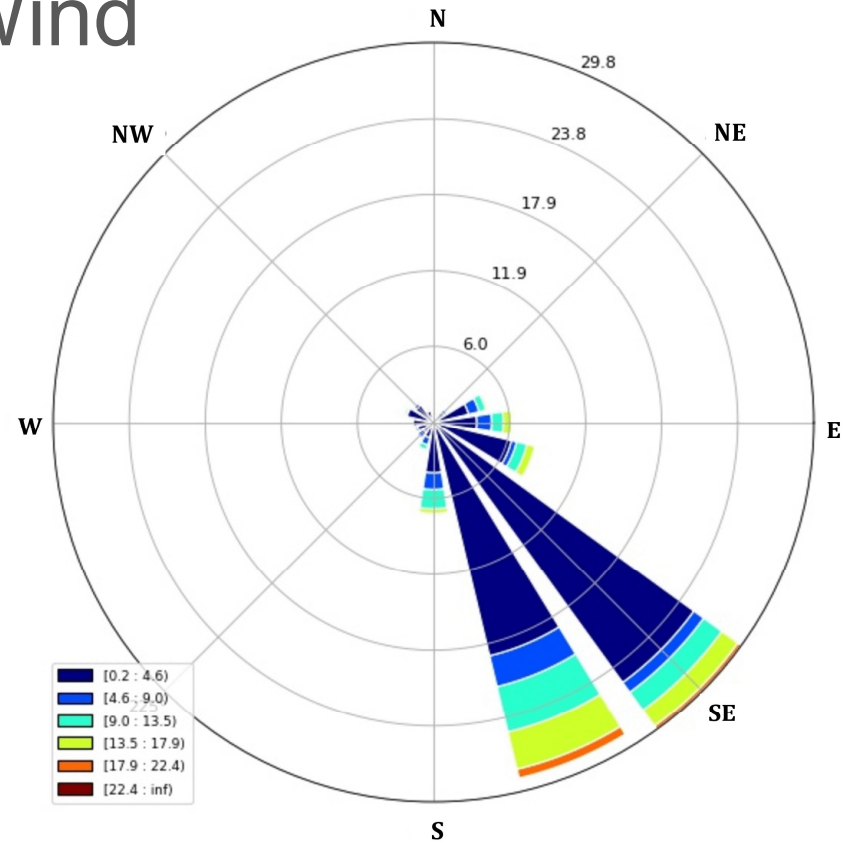
Buoy Wind Rose

Buoy	Wind
	(mph)
Minimum	0.16
Q1	0.85
Median	1.79
Q3	6.26
Maximum	22.37
Average	4.29

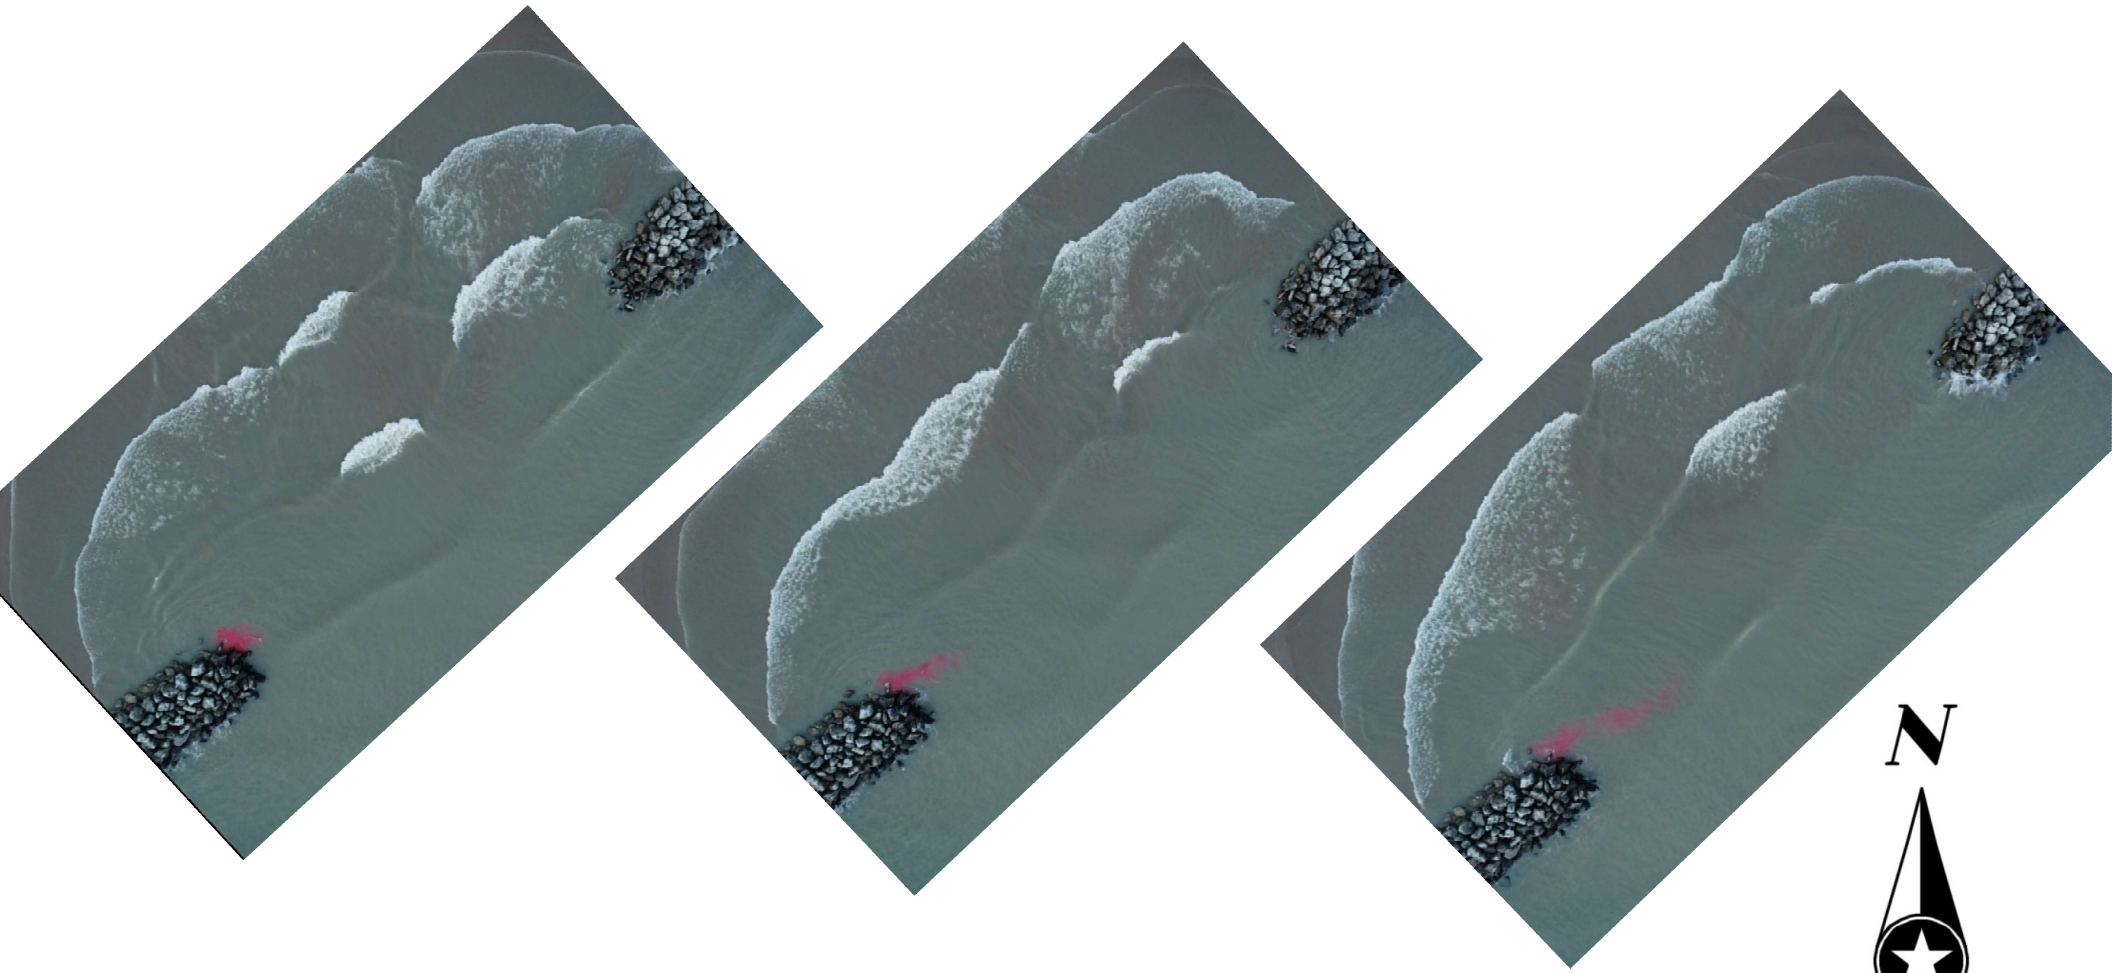
*The dye front is moving from Southwest to Northeast at a speed of approximately 1.76 ft/s.*

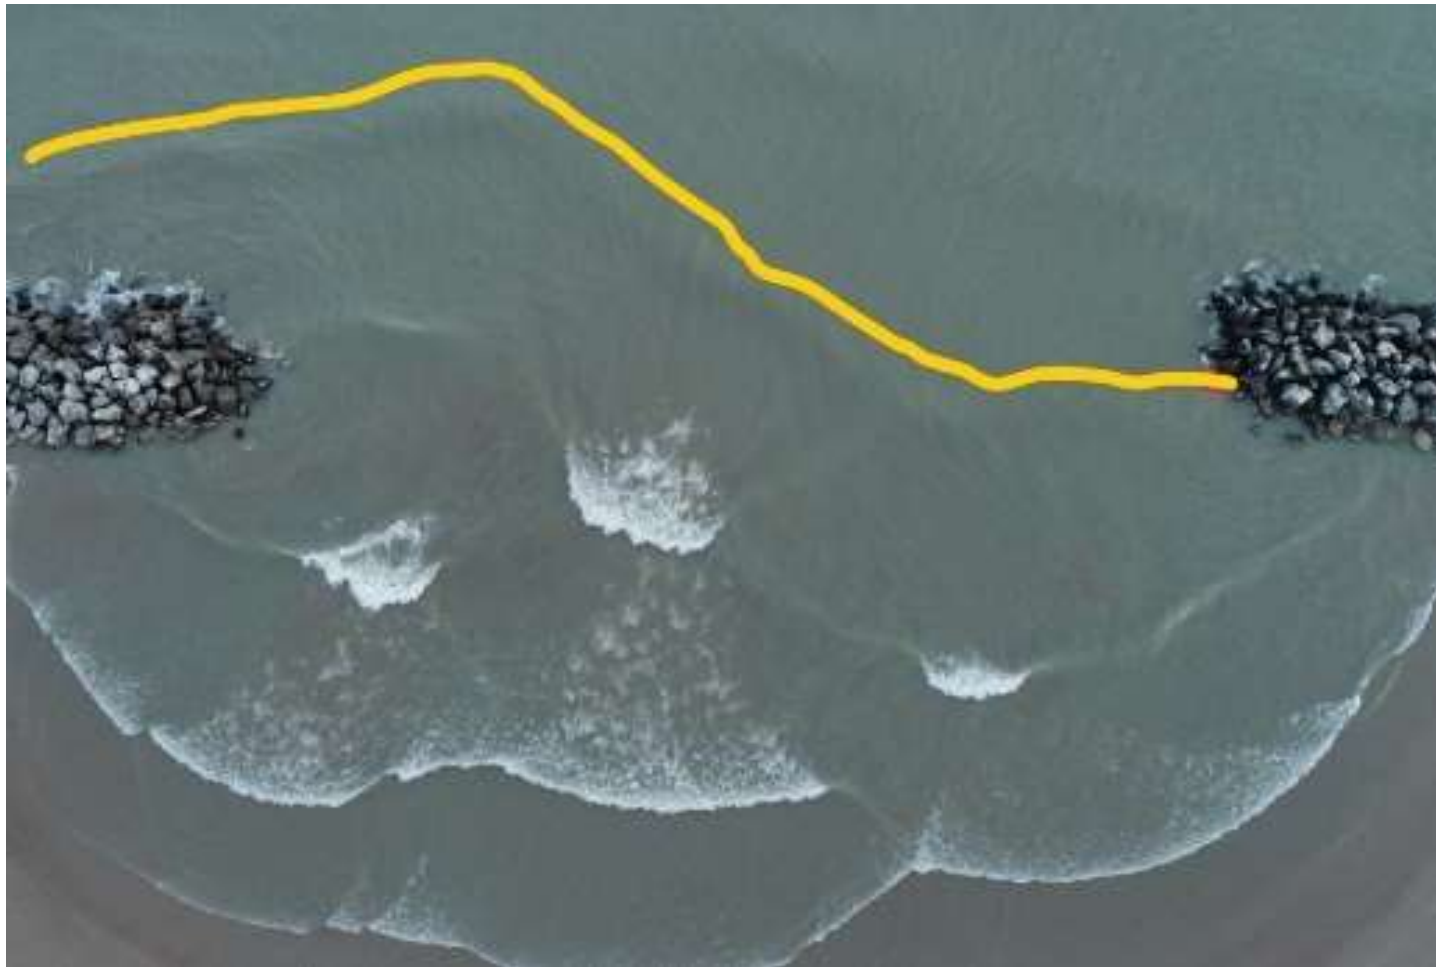
- Wave Reflection and Superimposition

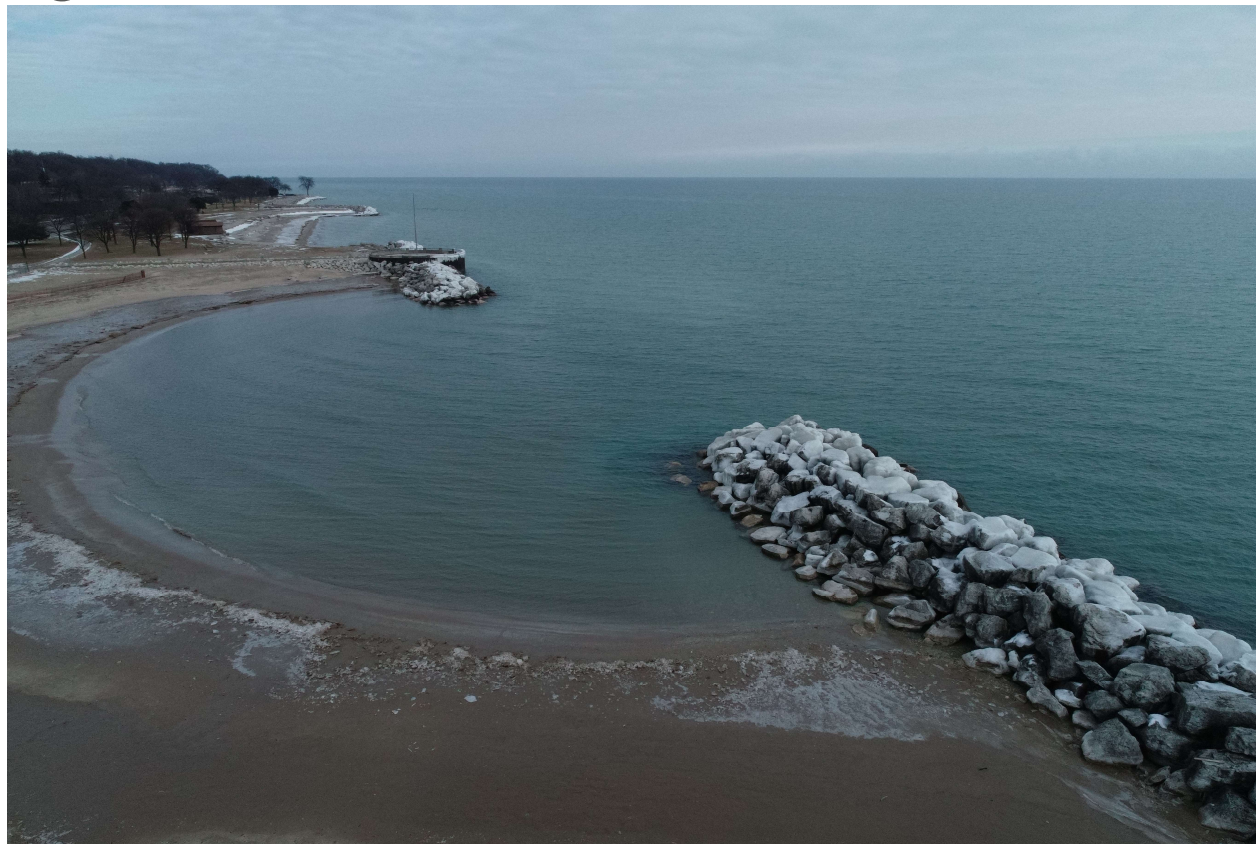
- Beach Condition & Mechanics
  - Erosion
  - Stagnant Water

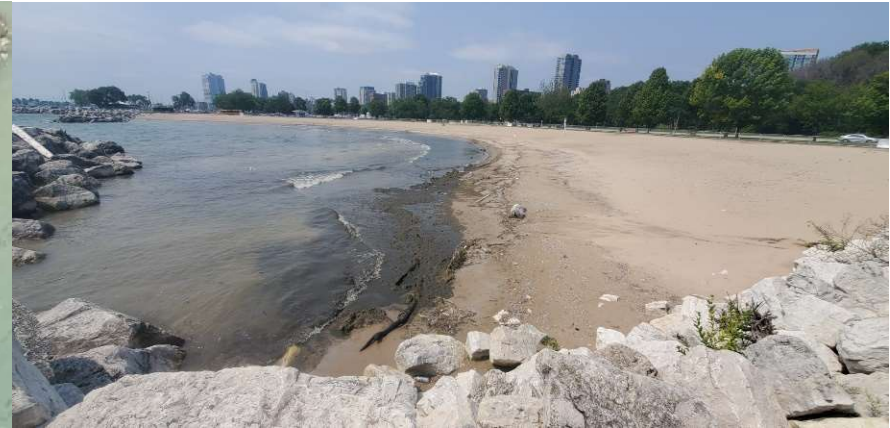
# Concept 1 – Natural/Hard Hybrid

Concept 1 - Nature-Based Design / Hard Infrastructure Hybrid	
Miniature Rubblemound Breakwater	\$400,000
Natural Areas Restoration	\$130,000
Stepped Retaining Wall	\$405,000
South Breakwater Removal	\$200,000
Boardwalk	\$170,000
<b>Total:</b>	<b>\$1,305,000</b>

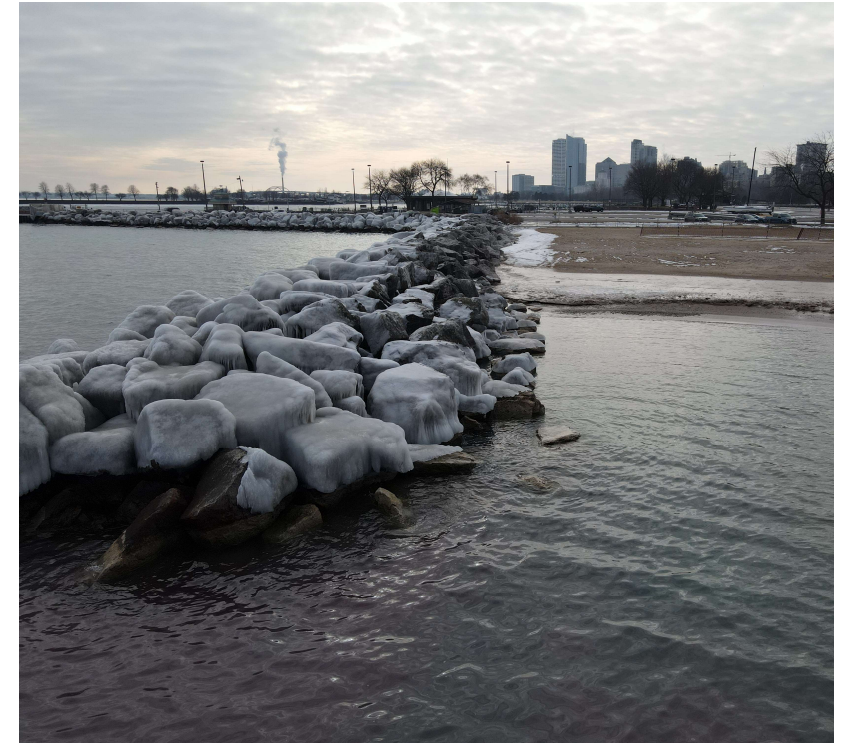
# Concept 2 – Offshore Breakwater

Concept 2 - Offshore Breakwater & Modifications to Existing	
Offshore Breakwater	\$2,200,000
Natural Areas Restoration	\$1,500,000
<b>Total:</b>	<b>\$3,700,000</b>

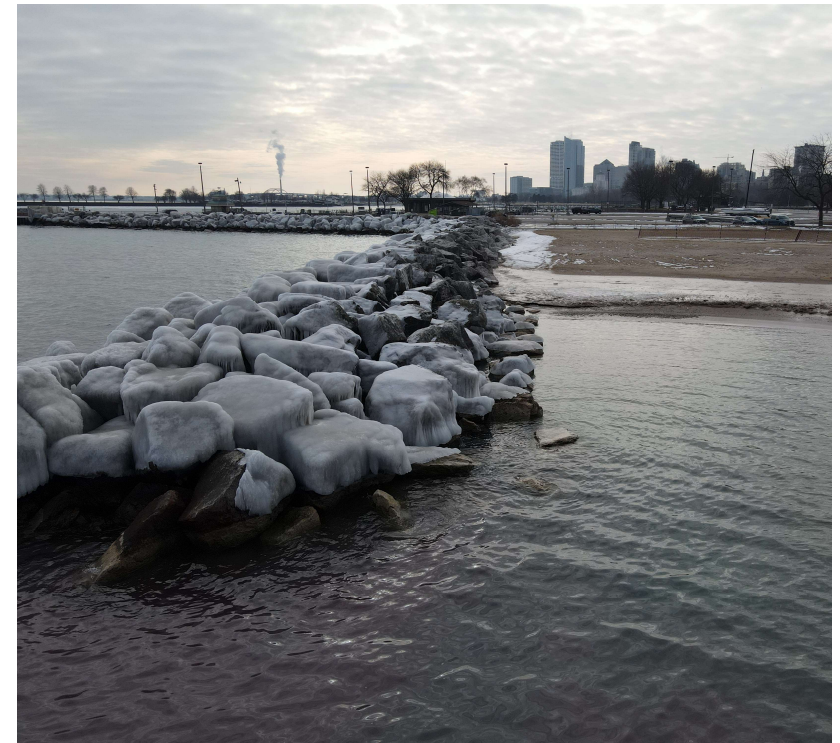
# Concept 3 – Connected Breakwater

## Concept 3 – Connected Breakwater and Natural Restoration

Connected Breakwater	\$1,900,000
Natural Areas Restoration	\$210,000
Beach Fill	\$200,000
<b>Total:</b>	<b>\$2,310,000</b>

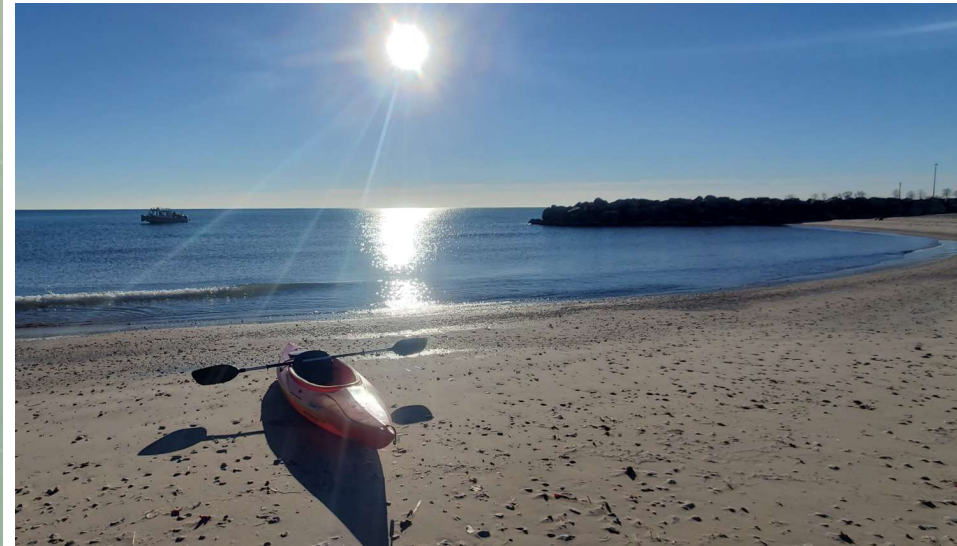
# Concept 4 – Beach Restoration

## Concept 4 - Beach Restoration to Intended Design

Torpedo Sand Fill	\$200,000
Structural Fill Scour Holes	\$50,000
<b>Total:</b>	<b>\$250,000</b>

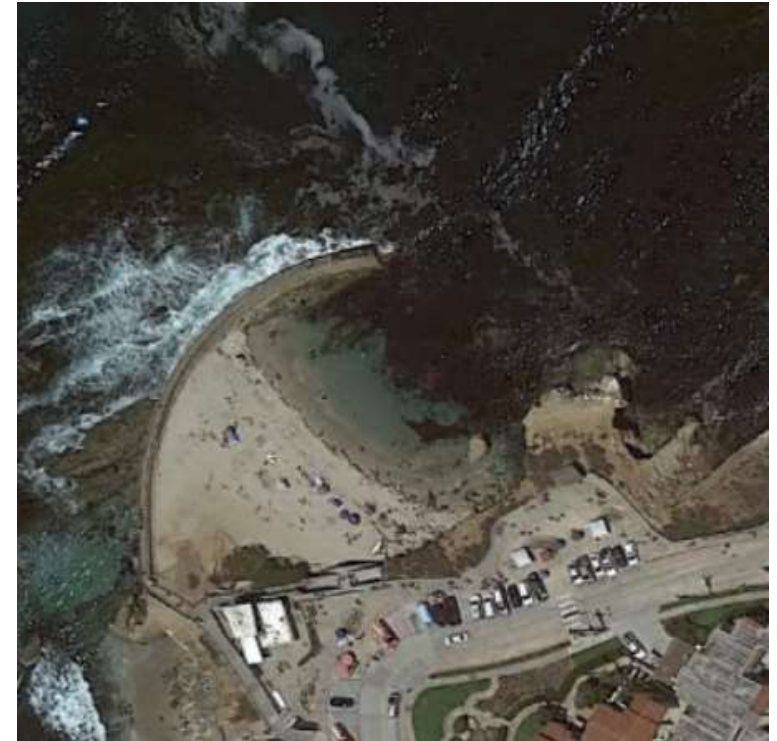
# Concept 5 – Breakwater Pool

## Concept 5 – Offshore Breakwater, Re-Orient Opening

Remove Existing Breakwater	\$760,000
Construct New Breakwater	\$4,140,000
<b>Total:</b>	<b>\$4,900,000</b>
