# Milwaukee South Shore Beach Improvements

## Basis of Design

SmithGroupJJR Project Number: 10451.000

Revision Date: June 11, 2018

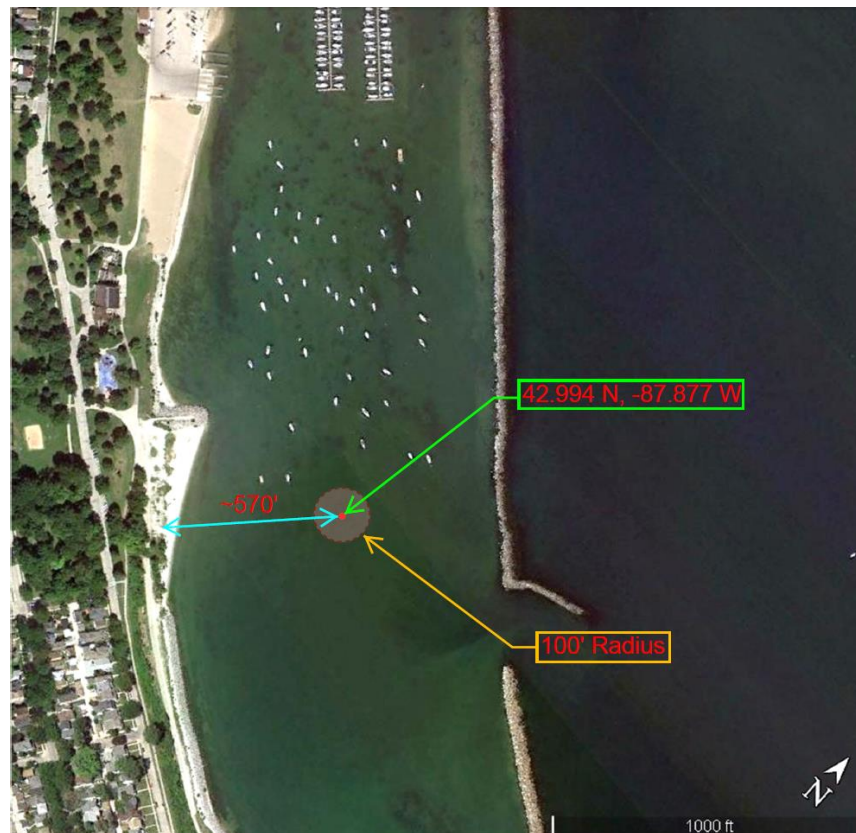
Figure 9: Position of the deployed ADCP behind the breakwater entrance.

The ADCP was programmed using TELEDYNE's suite of tools which are used to set up the ADCP for data collection. A thorough check of the ADCP's battery, compass, time stamp, current, and pressure sensors was done before delivering the instrument to *Pirates Cove Diving Inc.*, a professional diving team that attached the ADCP to a secure housing, and deployed it to the established location shown in Figure 9 at a depth of 11.5 ft.

Since the ADCP wave measurements were taken inside the harbor (Figure 9), offshore wave conditions for the same period of time were required. This information was downloaded from the Nowcast of the Great Lakes Coastal Forecasting System<sup>4</sup> at a Latitude of 43.0400° and a Longitude of -87.8°, as shown in Figure 27.

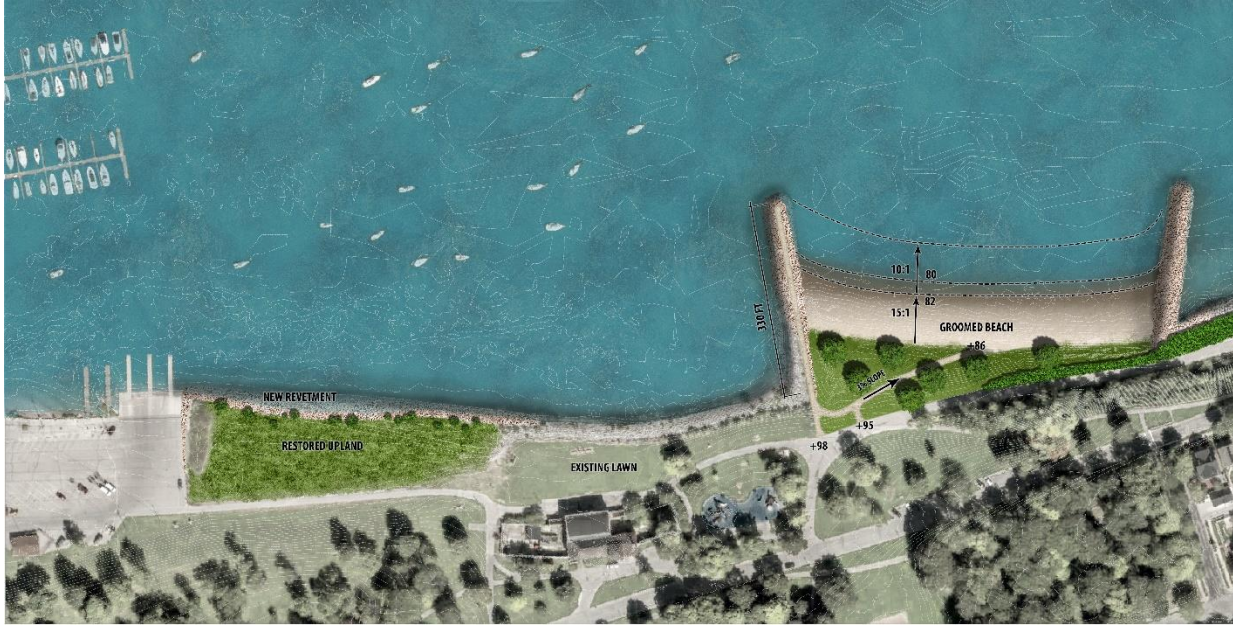
Figure 10: Alternative 1

This alternative provides a beach closer to the breakwater opening, where wave energy and water circulation is highest. (see Section 6.3).

The proposed jetties were sized to provide a beach area that would match the existing dry beach area (~1 acre), which was one of the main constrains that informed the design.

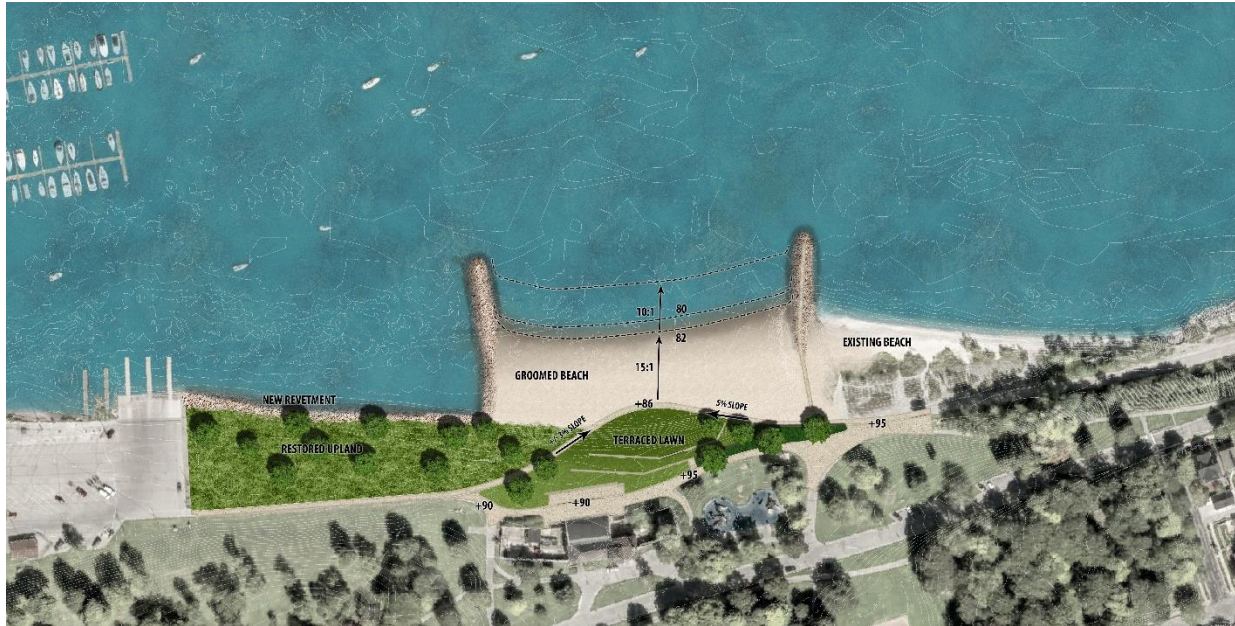
Figure 14: Alternative 2 Planview

This alternative features a beach closer to the existing amenities (restrooms, beer garden), and adjacent to a Terraced Lawn more central to park and pavillion users.

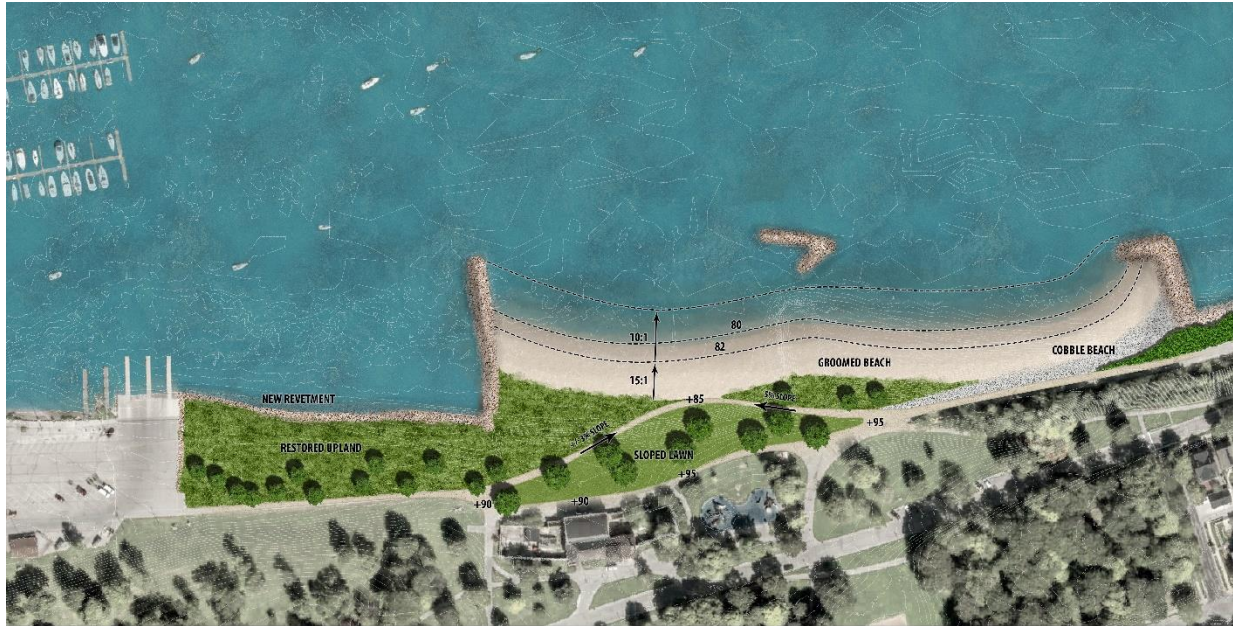
Figure 17: Alternative 3 Planview

This alternative was developed to create a narrower groomed beach that extends further south closer to the breakwater entrance while still providing beach area in front of the pavilion.

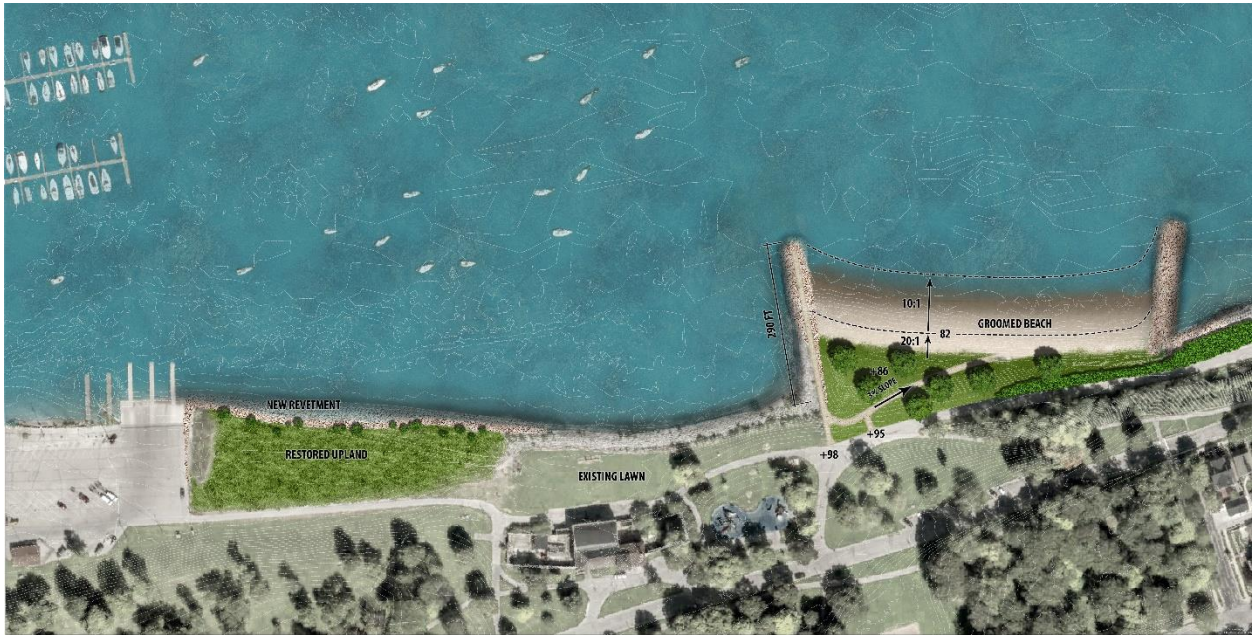
Figure 20: Alternative 4 Planview

Alternative 4 was developed in order to reduce impacts to the lakebed and reduce construction costs. This alternative resulted in a recreational beach area reduced by approximately 40% when compared to Alternative 1.

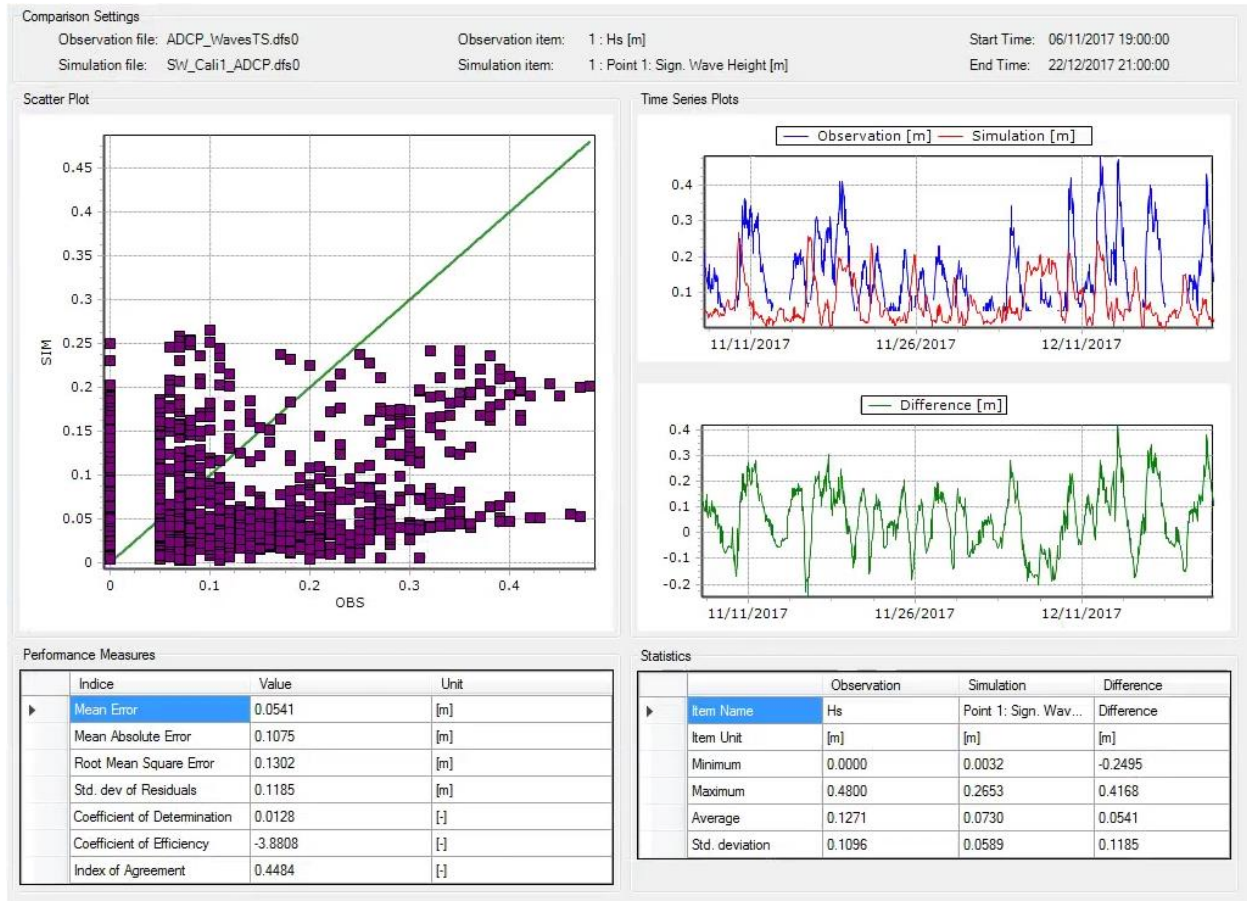
Figure 31: Comparison between the ADCP measured wave heights and the model simulation using the default parameters.

The initial run was completed using the software's default parameters. The results show an underestimation of the wave heights in the model simulations (Figure 31).

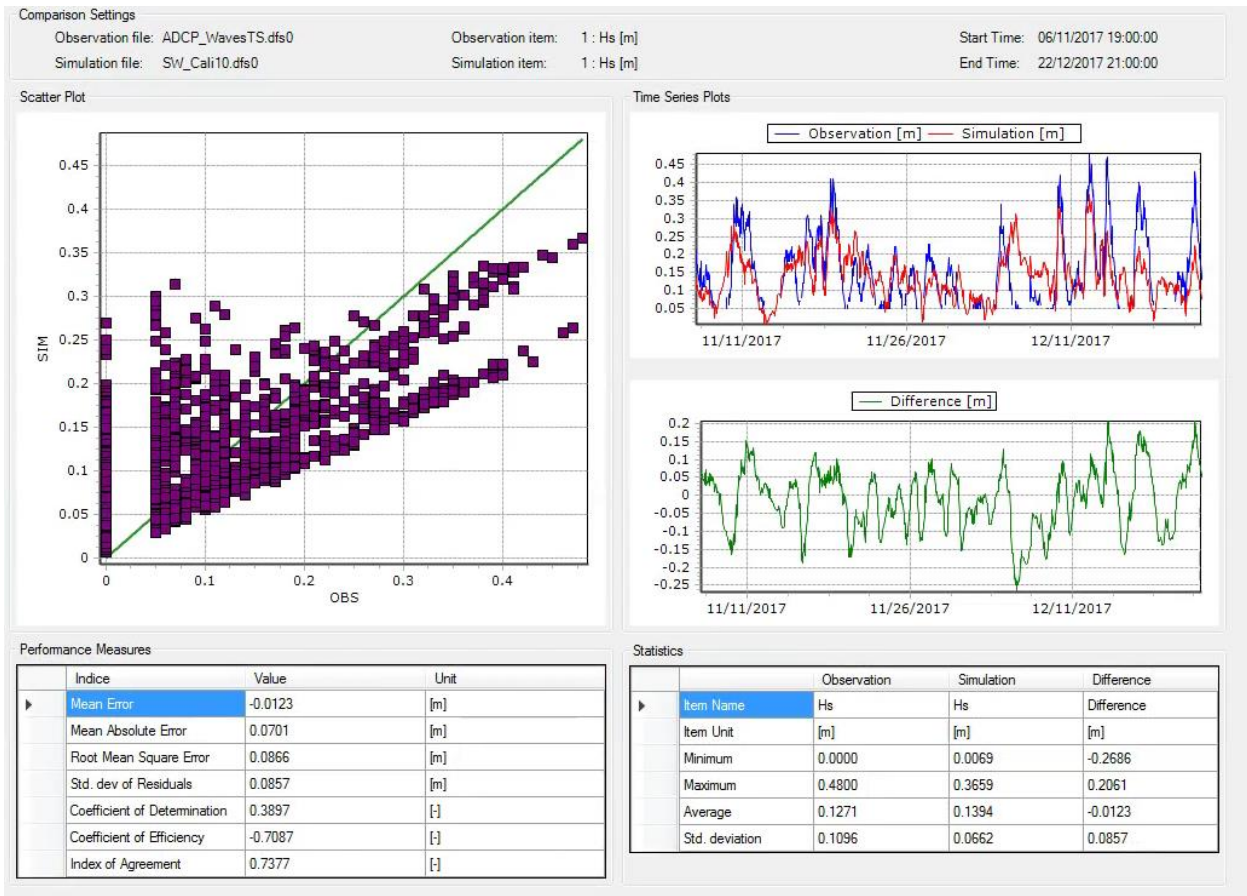
Figure 32: Comparison between the ADCP measured wave heights and the model simulation after the tuning parameters were changed.

Various model runs were completed modifying the tuning parameters until an acceptable difference was reached (calibrated) (Figure 32).

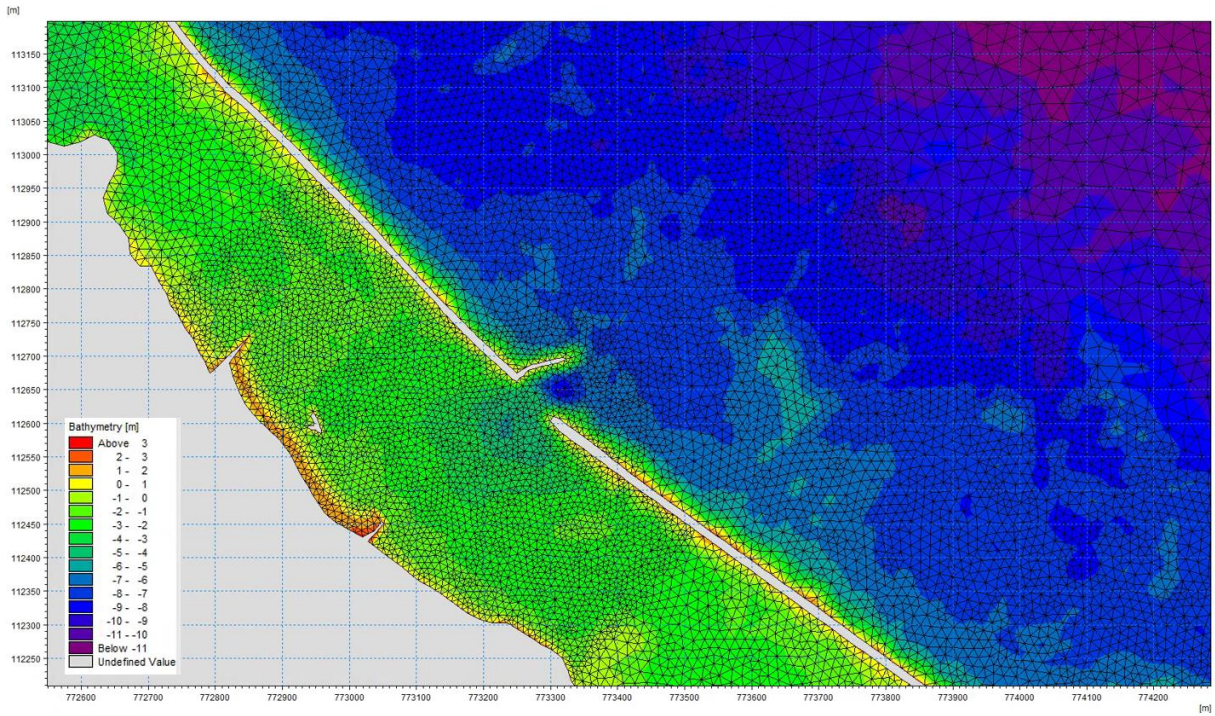
Once the model was calibrated, a digital terrain for each of the beach alternatives shown in Section 5 was created (Figures 33-36).

Figure 33: Digital domain for alternative 1.

Figure 34: Digital domain for alternative 2.

Figure 35: Digital domain for alternative 3.

Figure 36: Digital domain for alternative 4.

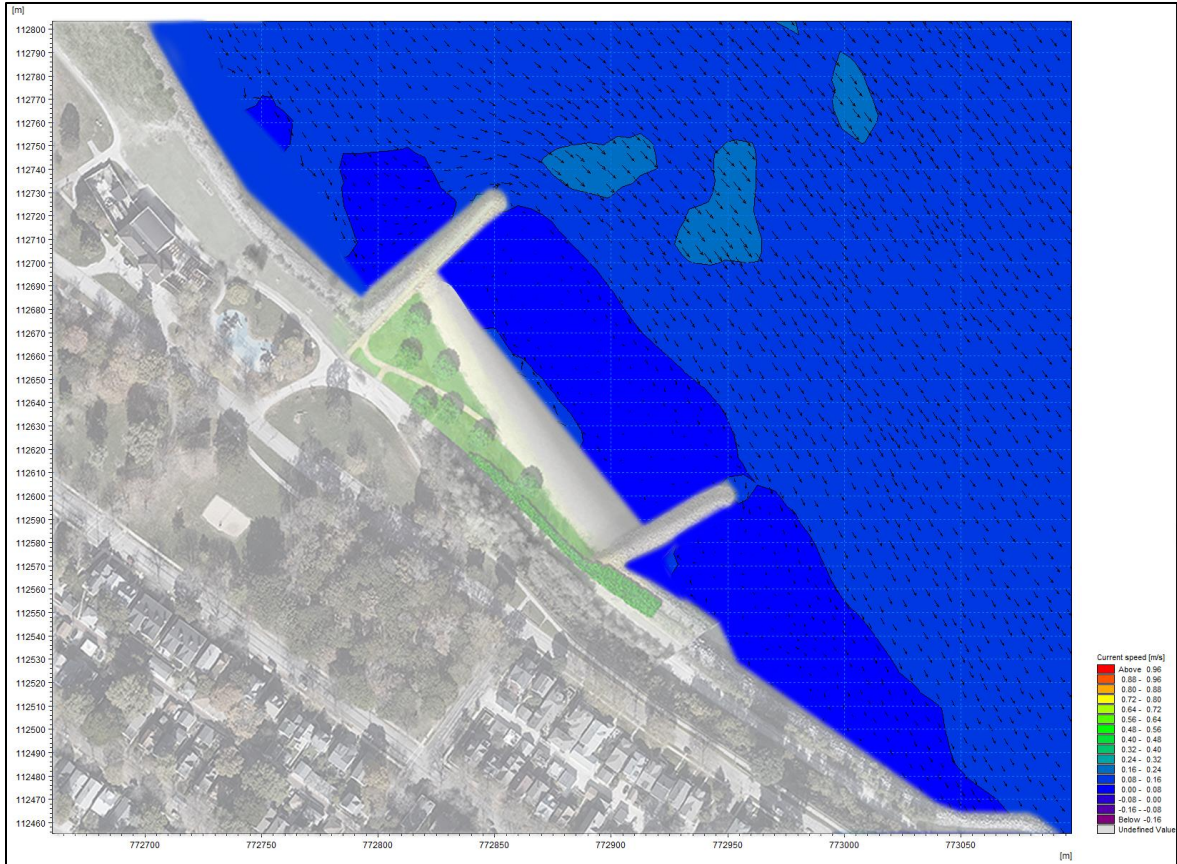
As stated previously, the dominant wind direction in the summer is NNE. When winds are from the NNE, the water currents head towards the NW parallel to the shore. As shown in Table 6, the nearshore current velocities are significantly higher in alternatives one and three than the velocities at the existing location.

Figure 42: Current Speeds caused by winds from the NNE 1year return period event (Alternative 1).

Figure 43: Current Speeds caused by winds from the NNE 1year return period event (Alternative 2).

Figure 44: Current Speeds caused by winds from the NNE 1year return period event (Alternative 3).

Figure 45: Current Speeds caused by winds from the NNE 1year return period event (Alternative 4).

- The NNE is the dominant wind direction during the summer, occurring approximately 8.5% of the time.
- Winds from the NNE and NE directions generate higher current velocities and increased water circulation is observed in the nearshore area. The nearshore water in alternative one, three, and four experience higher current velocities than the velocities at the existing beach location. Current velocities in the nearshore area of alternative two are similar to the existing beach location.

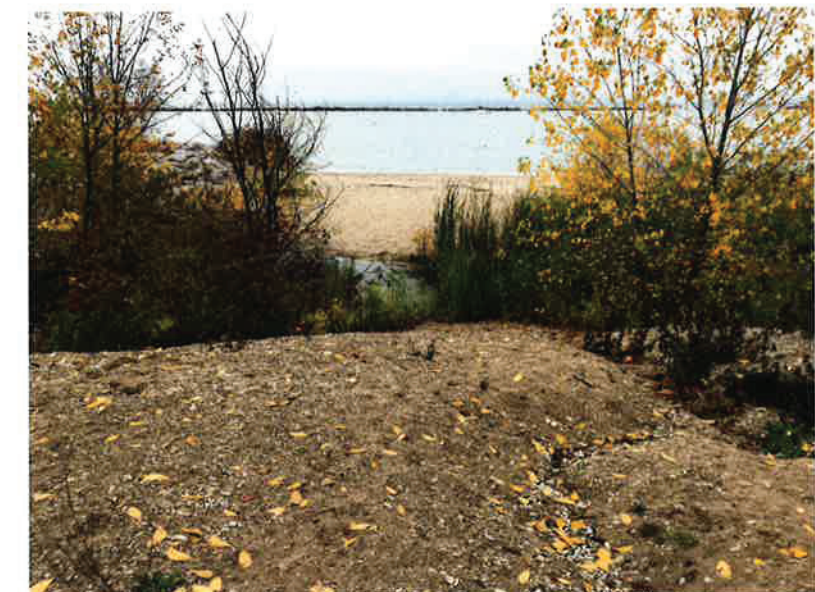
Below– View from above of Wetland A in swale adjacent rock beach

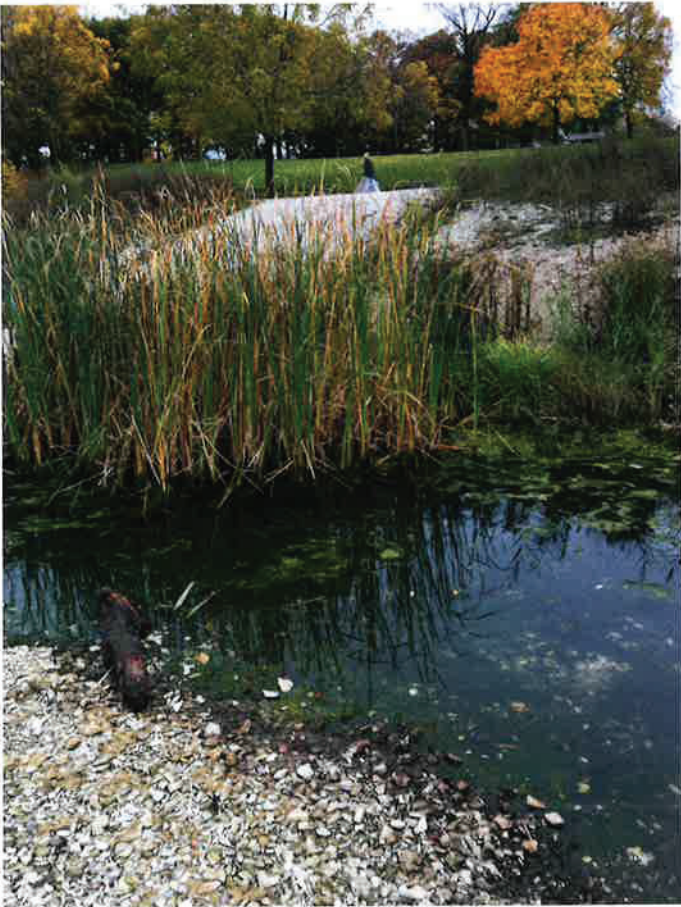
Upper left– Wetland A– three basins within depressions on rocky beach

Upper right– shovel with upland beach rock– no black coating on the left and wetland beach rock with black coating on the right
