Milwaukee County Flushing Channel Project Public Information Presentation

January 2021

Methods of Investigation

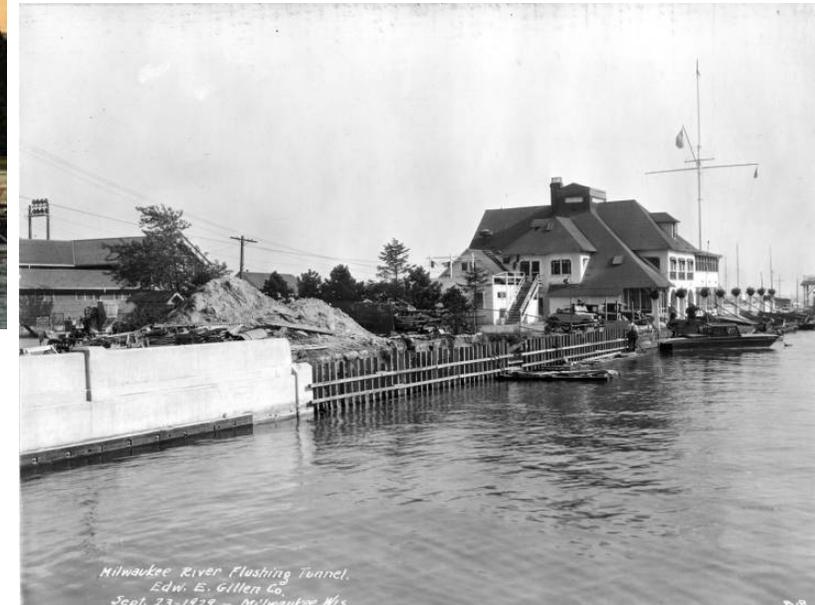
Existing Channel Wall Construction

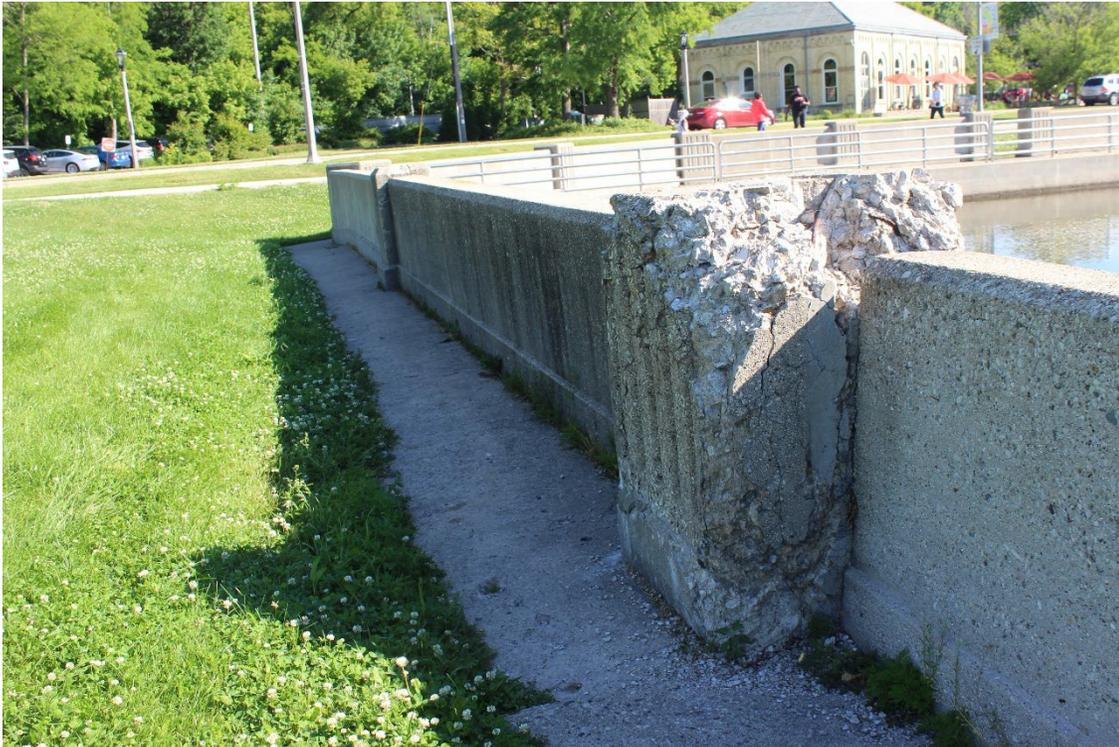
- Existing walls have reached the end of their service life

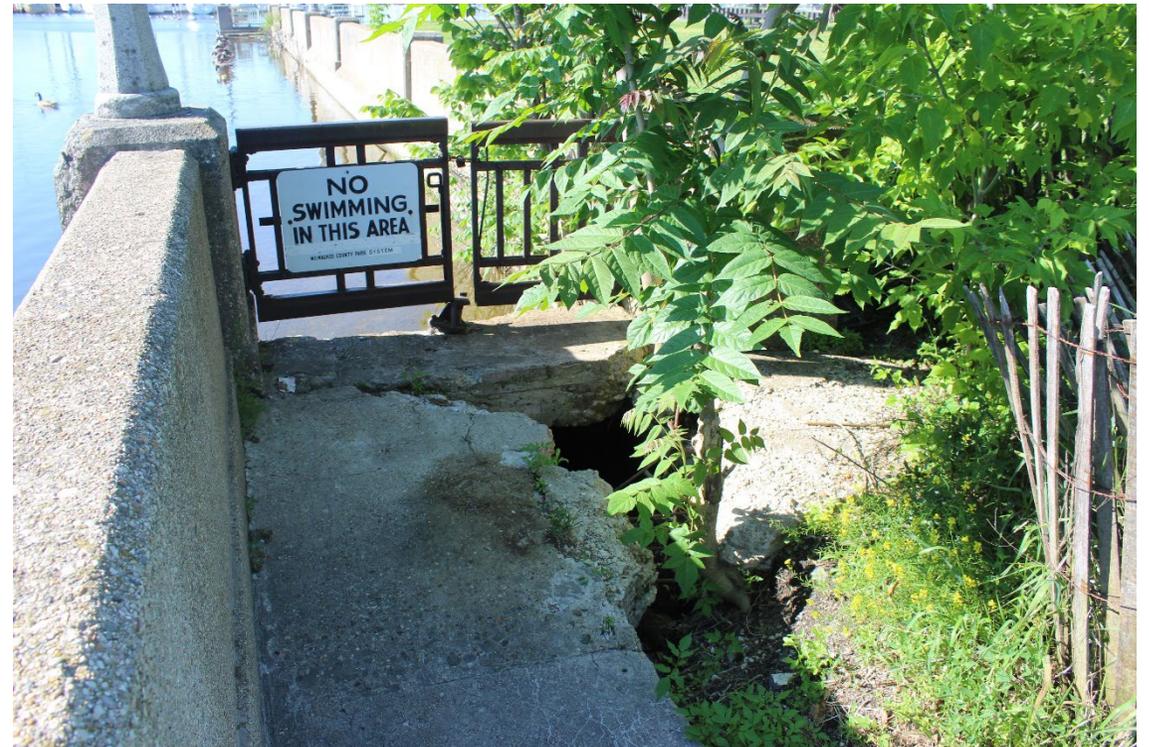
- Material loss behind the wall poses a safety hazard

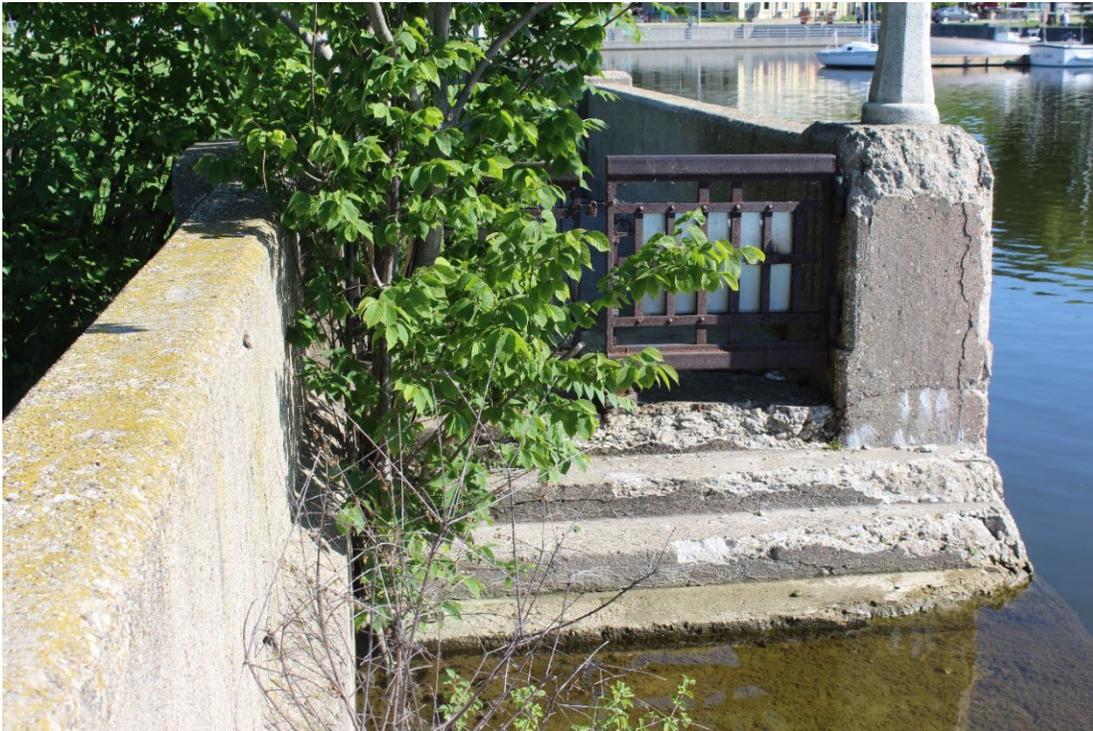
- Settlement
- Concrete wall sections rotating towards the channel

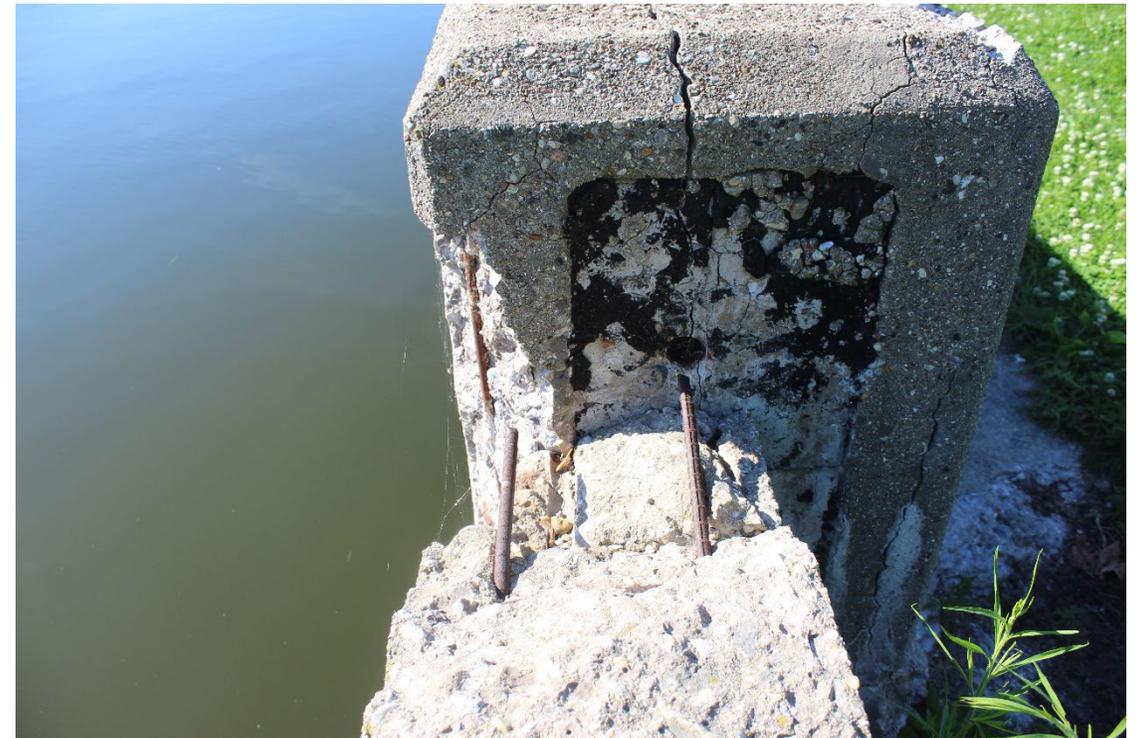
- Deteriorated concrete with exposed steel reinforcement

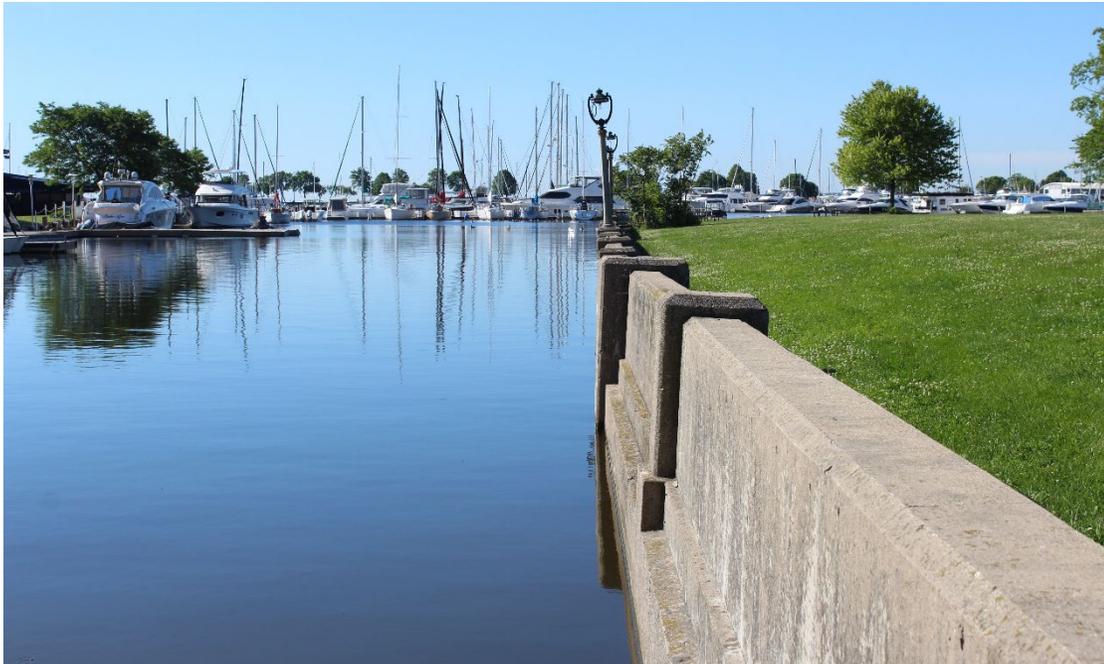
- Timber walls below water level are in severe deteriorated condition
- Sheet pile walls along east side exhibiting corrosion

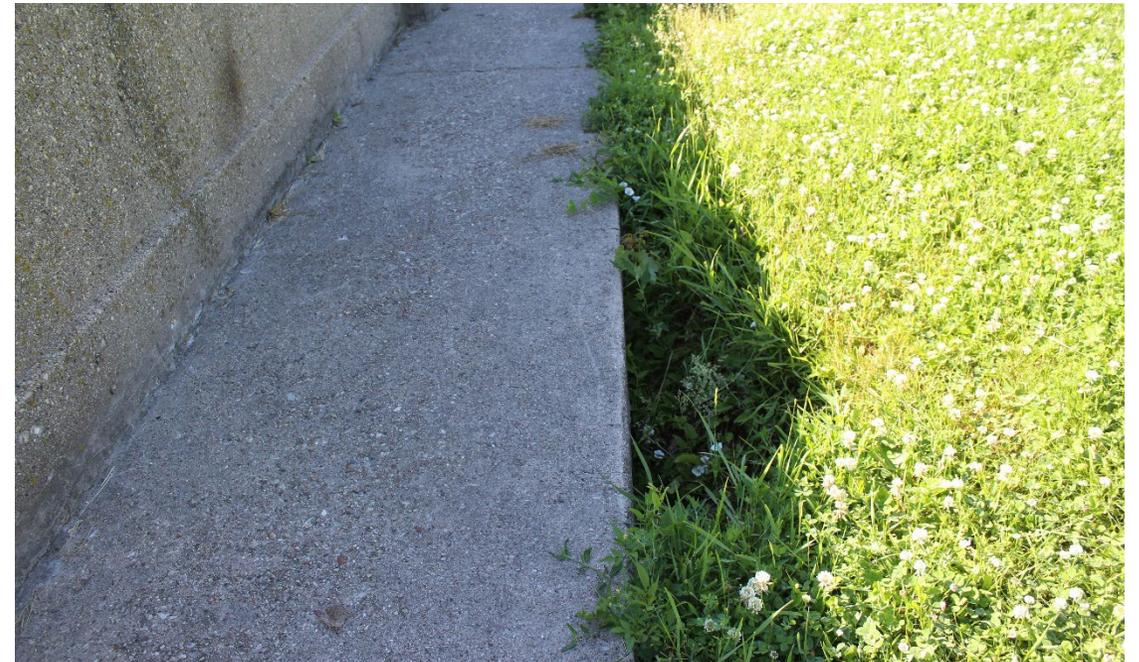
- Holes in timber walls below water are causing sinkholes along the west side of channel

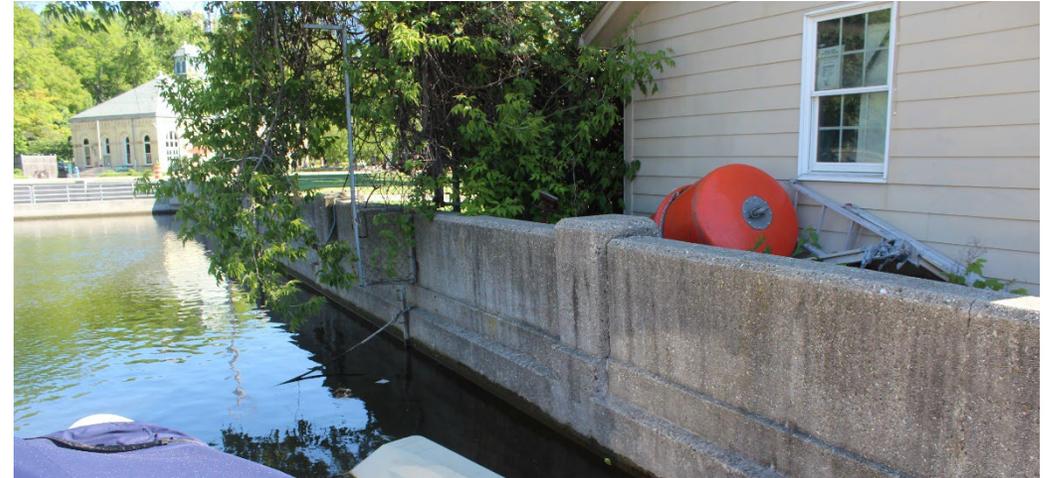
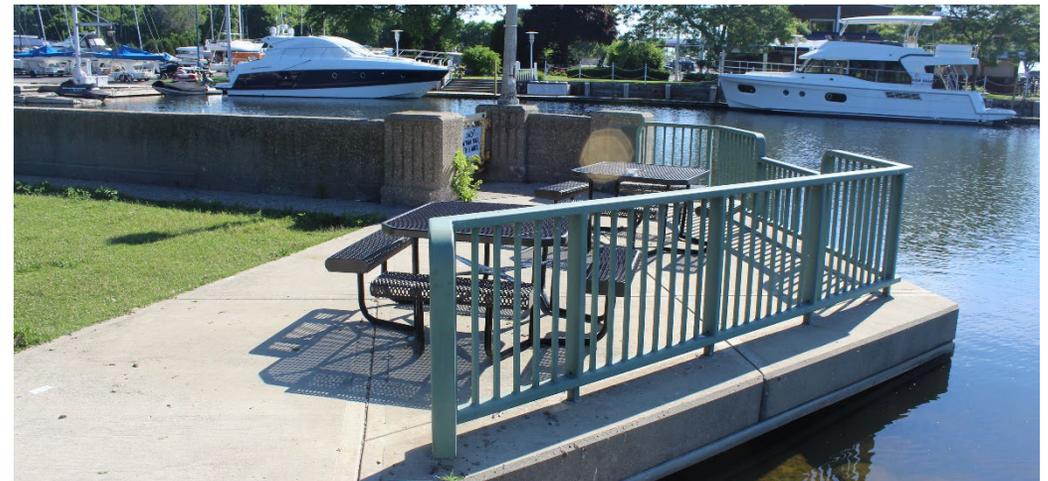
- Design loads and geotechnical factors
- Historically high water level in Lake Michigan
- Proximity of adjacent buildings and amenities
- Varying wall sections and alignments due to previous maintenance
- Milwaukee Yacht Club access and loading area
- Need to preserve historical elements

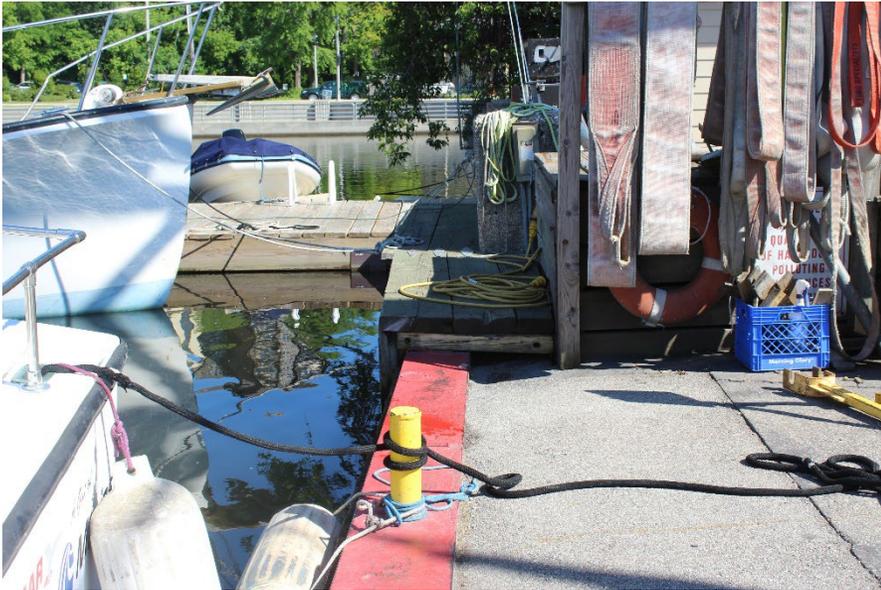
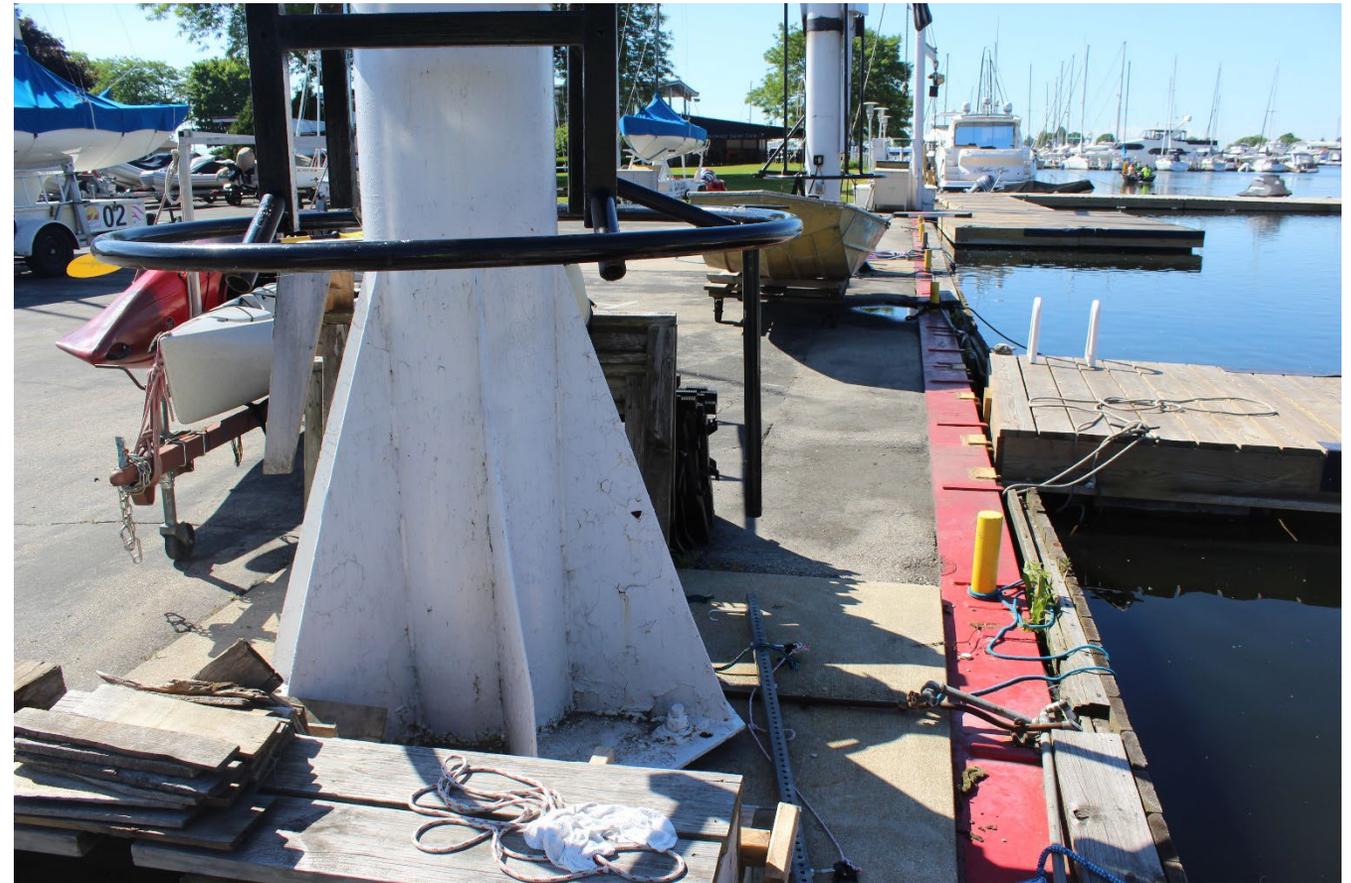
- Milwaukee Yacht Club Factors
 - Varying existing conditions and alignment
 - Existing crane operations
 - Structures/material behind existing sheet pile wall

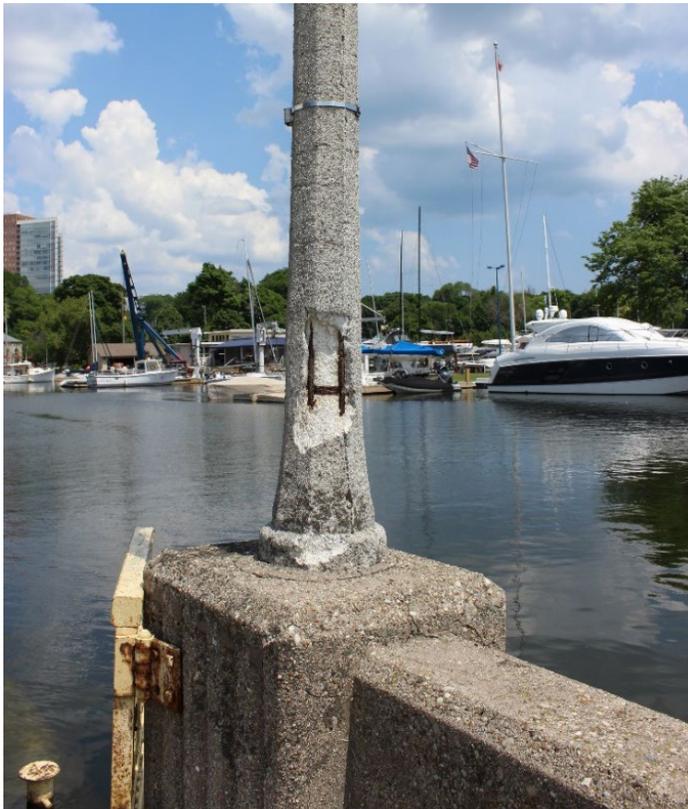
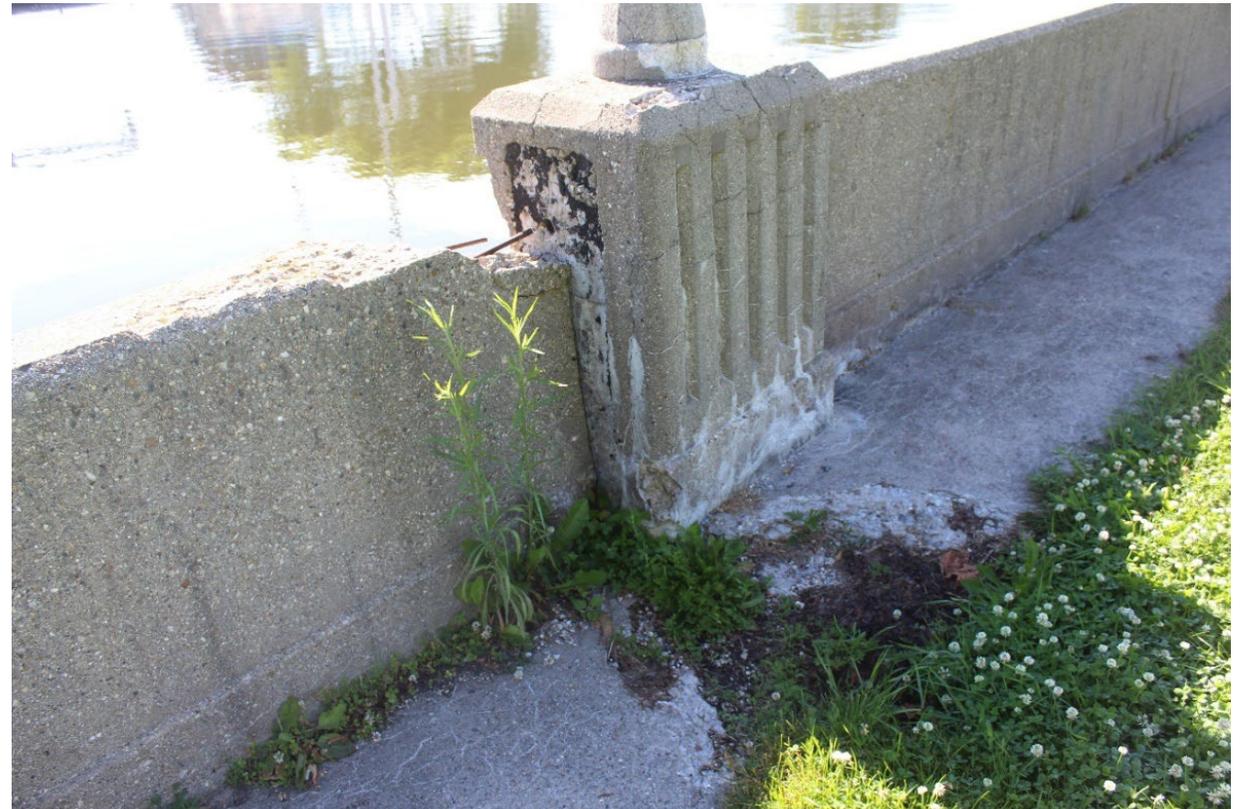
- Maintaining existing walls prohibitively expensive and will have a short service life

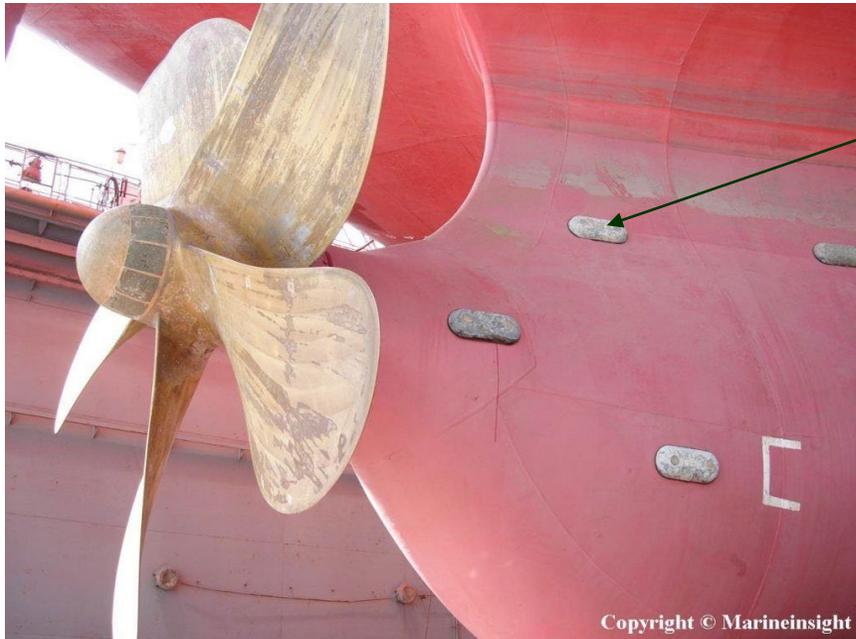
anode

- Cathodic Protection would consist of sacrificial anodes made of zinc alloy which are attached to the existing steel sheet piling.
- Widely used corrosion protection method.

Advantages	Disadvantages
<ul style="list-style-type: none">• Does not require crane relocation• Does not require full rehabilitation of the sheet pile wall• Lower construction cost• Does not require maintenance within selected design life and anodes can be replaced	<ul style="list-style-type: none">• Thorough underwater inspection necessary for design• Anodes should be routinely monitored• Will require eventual replacement of the steel sheet pile bulkhead
