# Lincoln Park & Estabrook Park Milwaukee River Channels Sediment Remediation Project Phase II

Parks, Energy and Environment Committee May 13, 2014

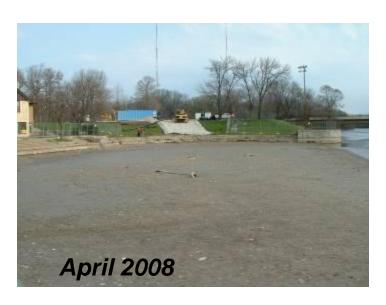
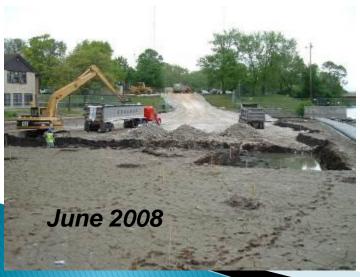
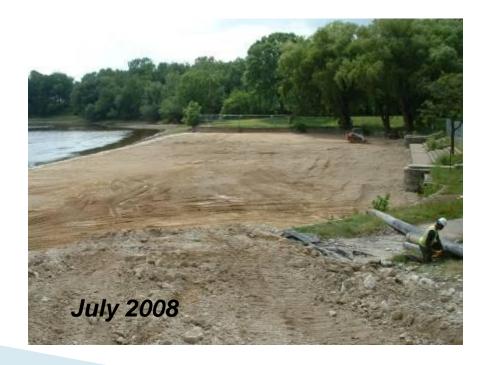
#### Blatz Pavilion

- 4700 cubic yards sediment removed
- 300 lbs of PCB removed
- Completed 2008 (100% state funded)

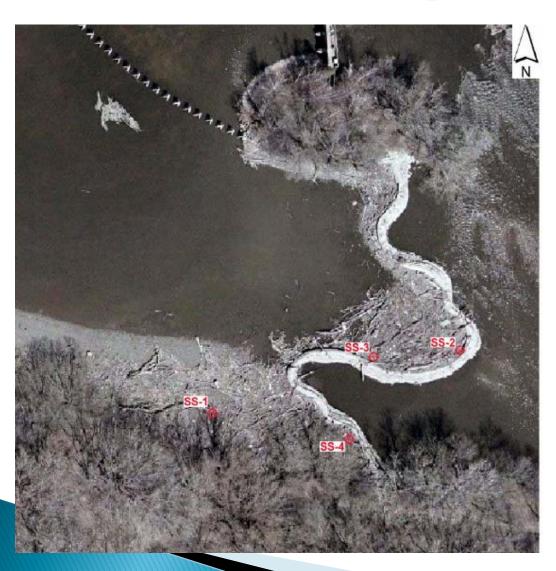
# 2007 Sampling (Himalayan)

- •PCB range <1 39 ppm
  - •Highest PCB concentration at 1-2 foot interval at SS-2
- •Total PAH range 10 62 ppm
  - •Highest PAH at SS-4 at 0-1 foot interval

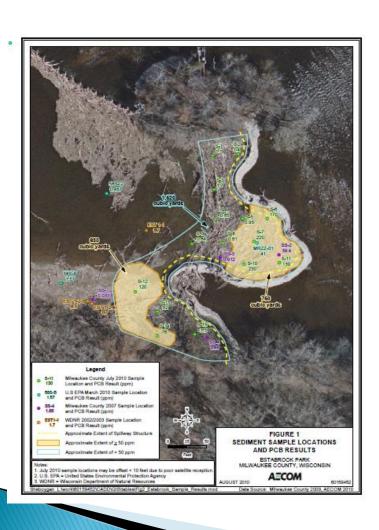
## 2010 Sampling (AECOM)

#### **PCB** Results

- 1400 cubic yards TSCA
- 1800 cubic yards<50 ppm</li>
- Volumes do not include overburden

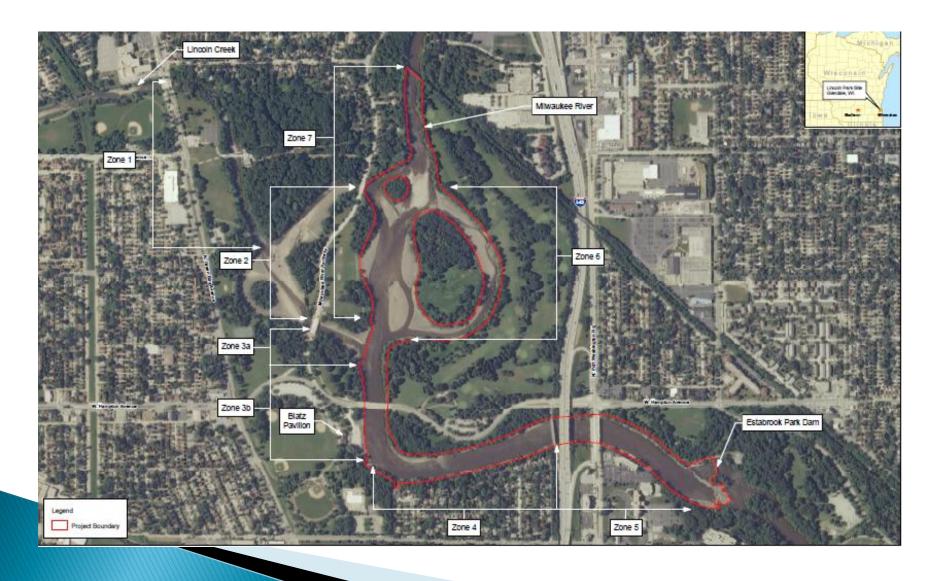
# 2010 Sampling (CH2M Hill)

- ➤ Transects spaced 200 ft where known deposits present
- ➤ Transects every 400 ft in low deposition areas
- ➤ Sediment thickness 0-10.6 feet

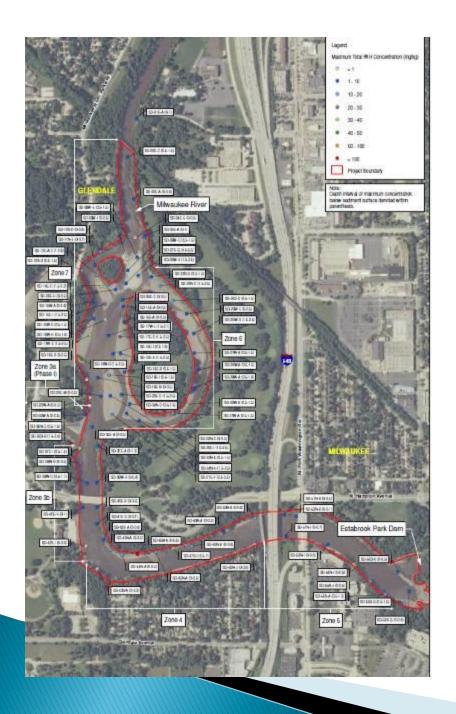
#### **PCB** Results

- > 88 cores collected
- Concentrations range from <1 to 26 ppm
- 16 core locations with PCB > 1ppm

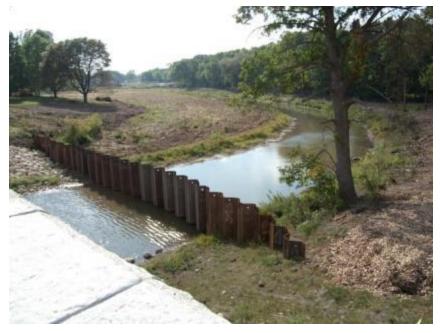
#### **PAH Results**

- Total PAH range from 0.02 –139 ppm
- Most sample locations below 20 ppm PAH
- PAH contamination discovered during Phase I excavation examined further for Phase II by FS monitoring (EA)

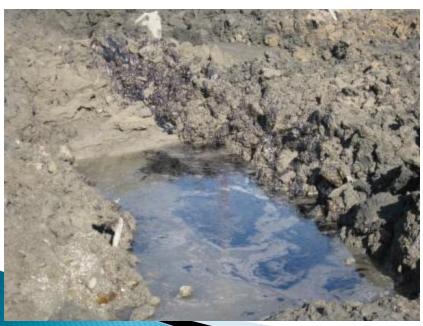
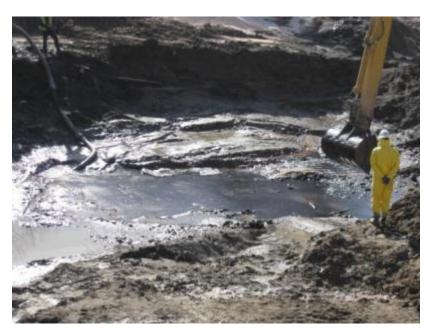
PAH contamination found in Phase I area near north bridge cutoff wall

Sampling on upstream side of sheet pile showed contamination at depth

Cut sheetpile off at sediment grade after excavation to act as cutoff wall

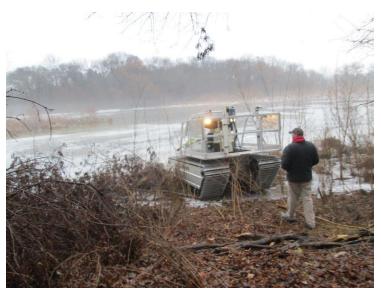
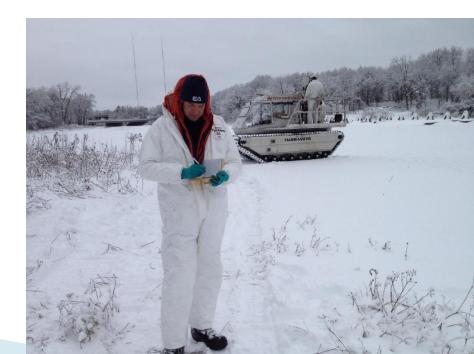
## 2013 Sampling (EA Engineering)

- Bathymetry
- NAPL (North Bridge)
- Sediment Deposit sampling
- Habitat Evaluation

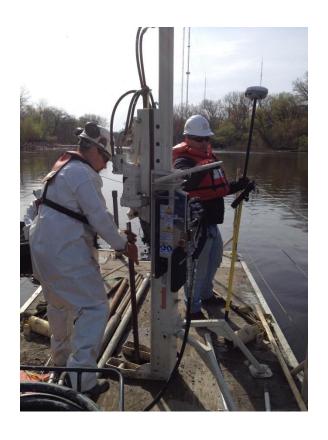
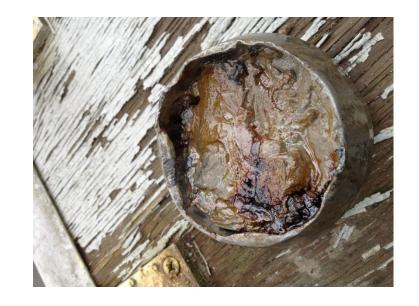
# NAPL Survey

- NAPL Survey 15 cores within NAPL area
  - 3 cores observed/confirmed NAPL
  - 1 additional cores tested positive for NAPL, not in NAPL survey area

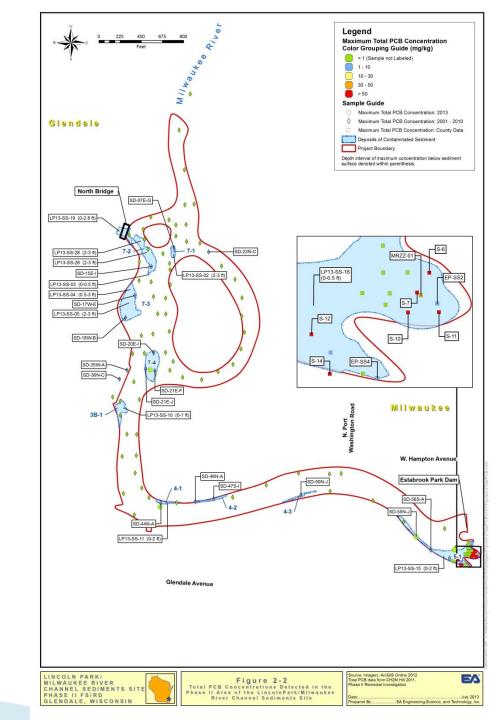
# 2013 Sampling Results

- PCB Survey
  - 137 samples
  - Non-TSCA range1.17ppm 33.1 ppm
  - TSCA found in NAPL area in 3 samples range 79.7 ppm – 162 ppm

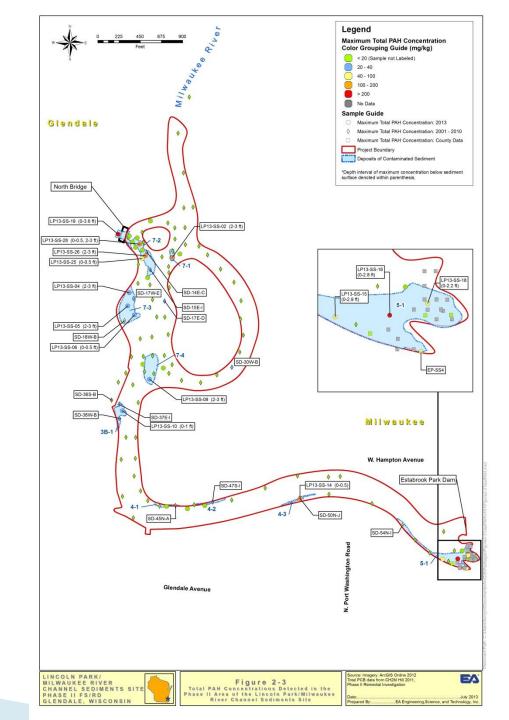
# 2013 Sampling Results

- PAH Survey
  - 131 samples
  - Range 0.01 ppm– 469 ppm

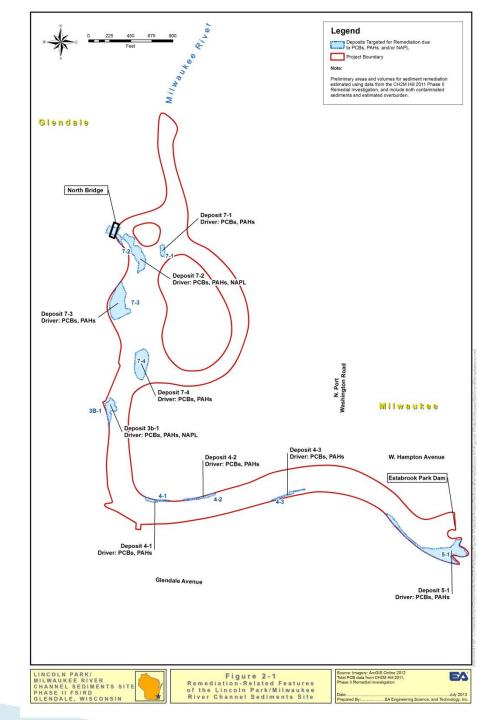
# Excavation Targeted Deposits

- Approximately 35,000 cubic yards of non-TSCA sediment from 9 main deposits
- About 500 cubic yards TSCA
- No remediation needed in east oxbow, or north of the oxbows
- Mechanical (dry) excavation for all deposits except:
  - Southern portion of 7-4 and deposit 4-3

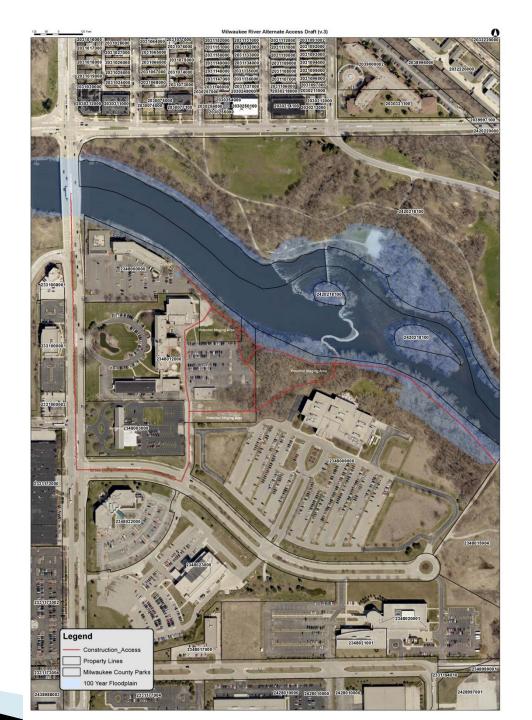
Estabrook Dam **Private** Lands Access Routes

- Milwaukee County owns the entire east bank-Estabrook Park
- West bank is entirely privately owned
- The three impacted private properties have committed to provide permanent access easements
- Easements would provide access for both the Sediment and Dam projects
