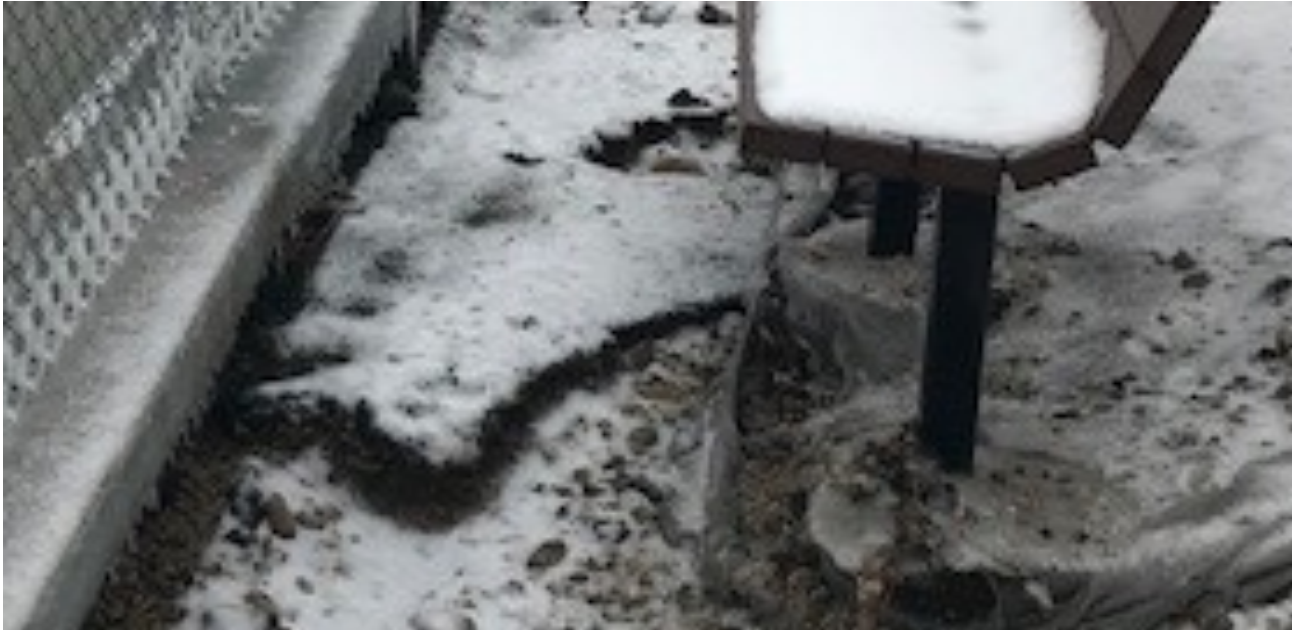
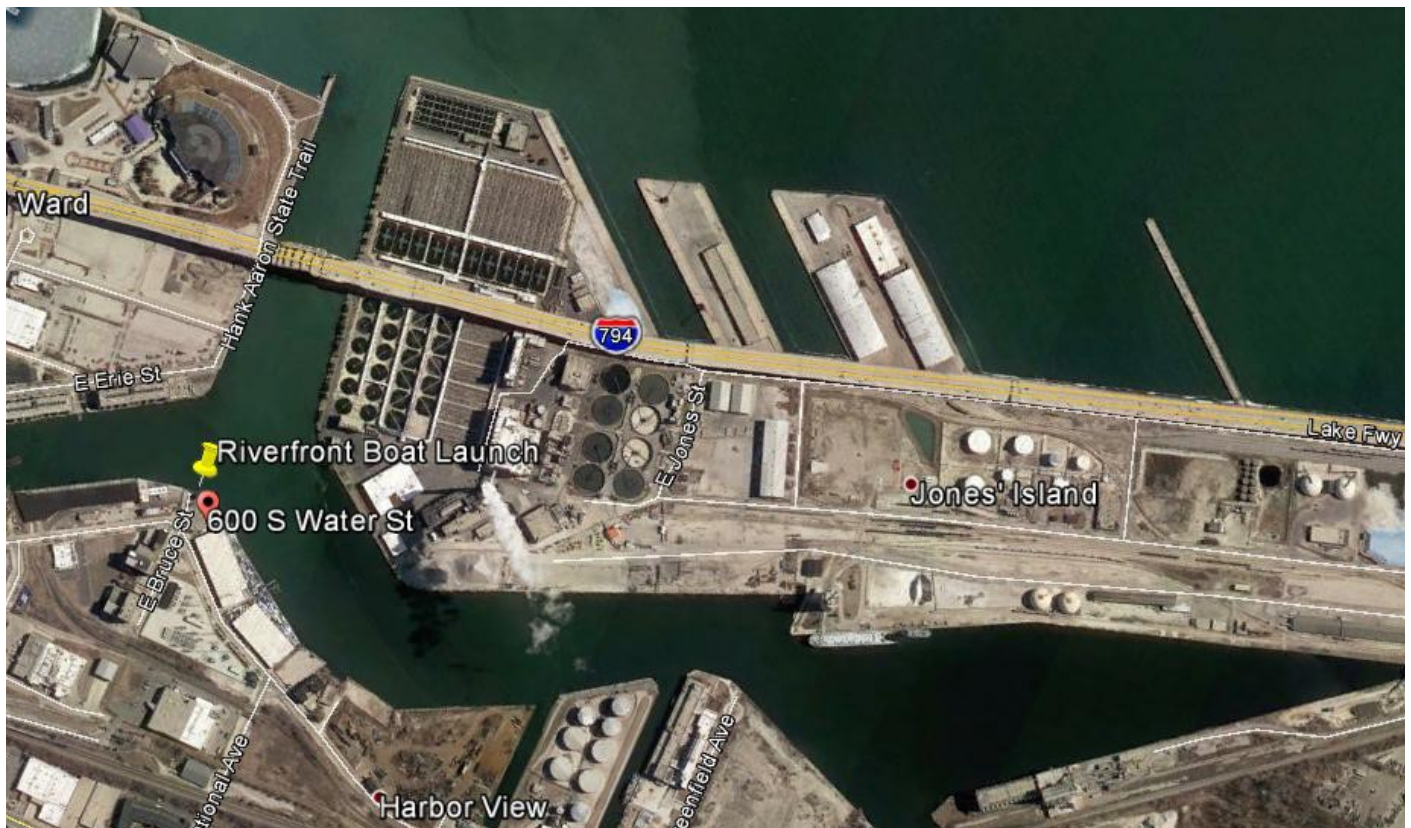
River Front Boat Launch

Asphalt and Fill behind the boat launch ramp has washed into the lake exposing footings and making the area hazardous.

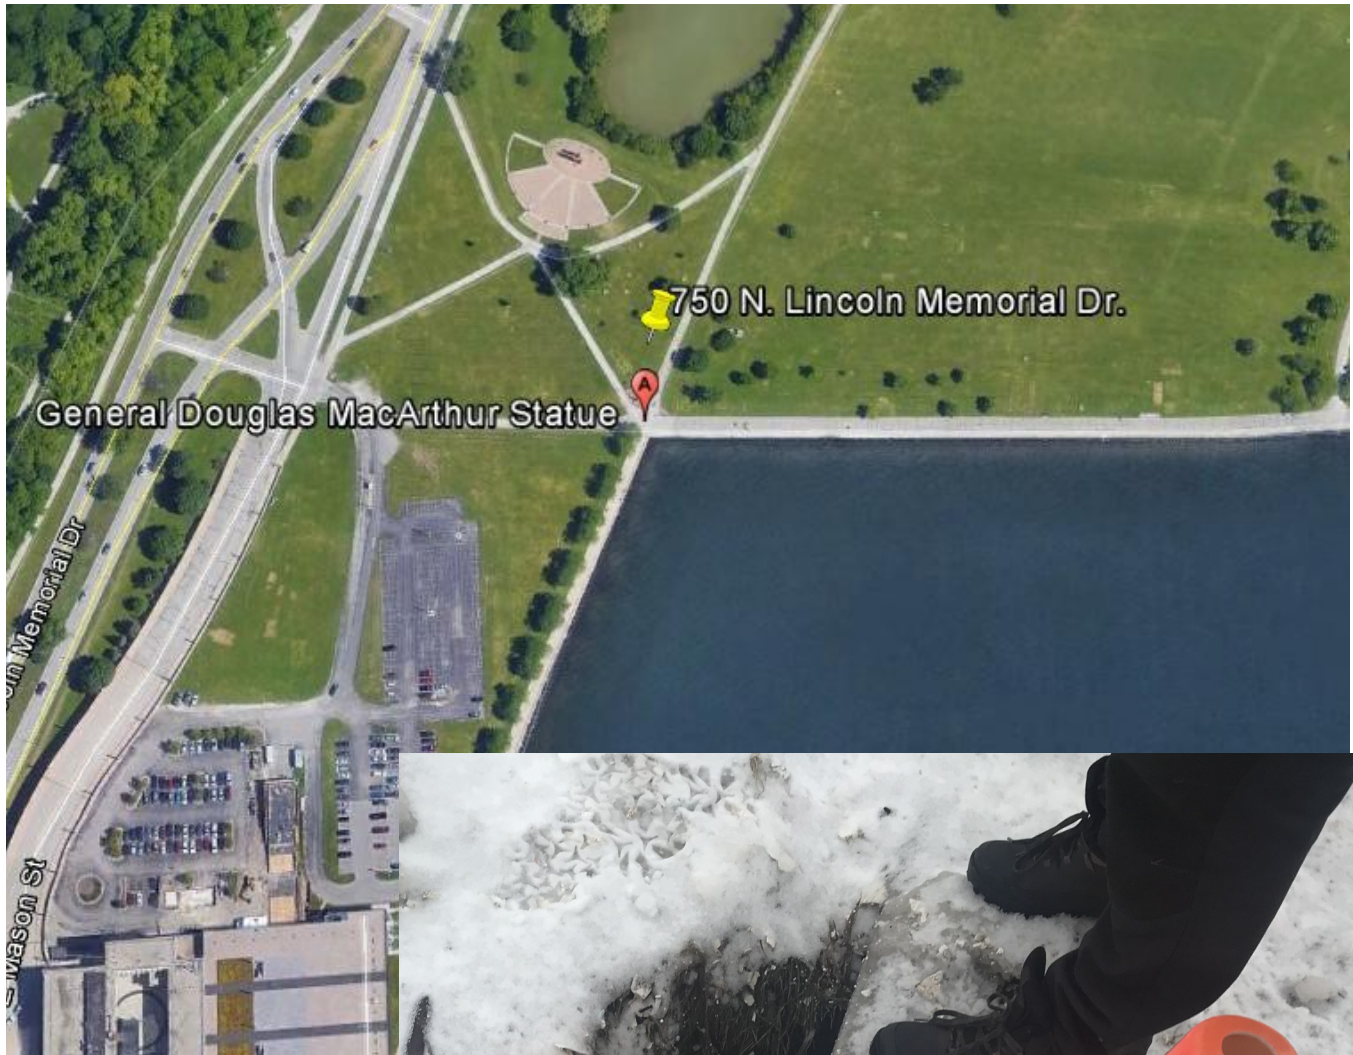
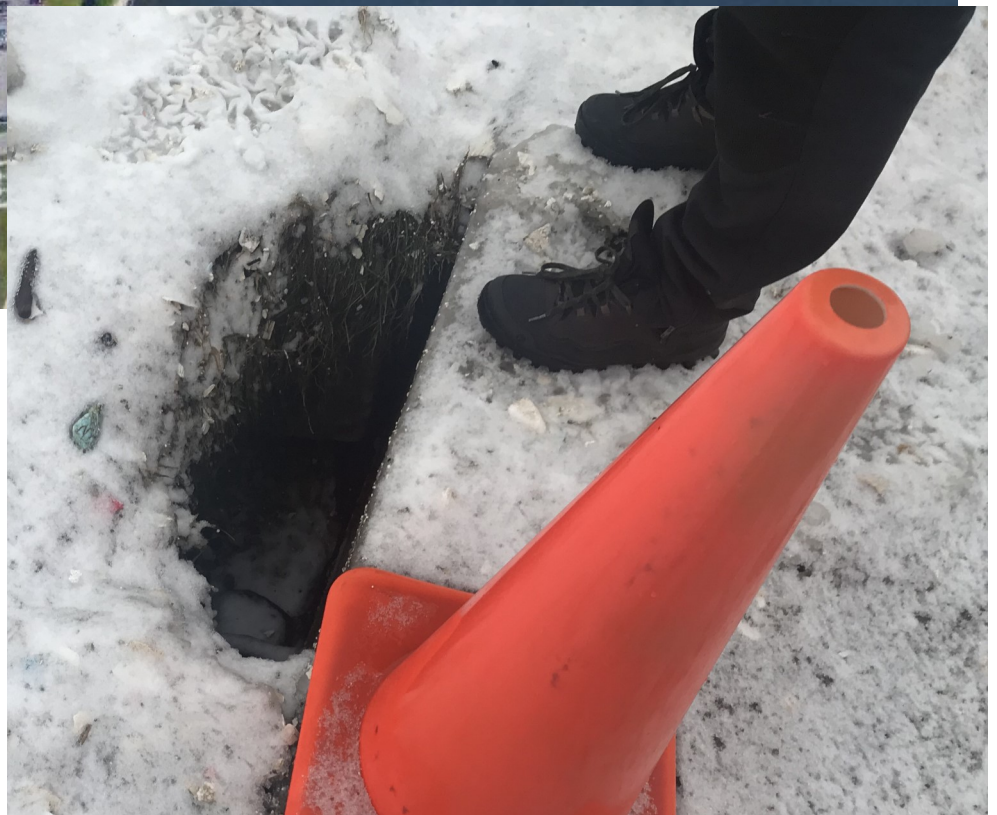
Veterans Park

Where the concrete meets the asphalt is near the Macarthur statue. There is a wash-out that has formed 3 feet wide and 2 feet deep at the moment.

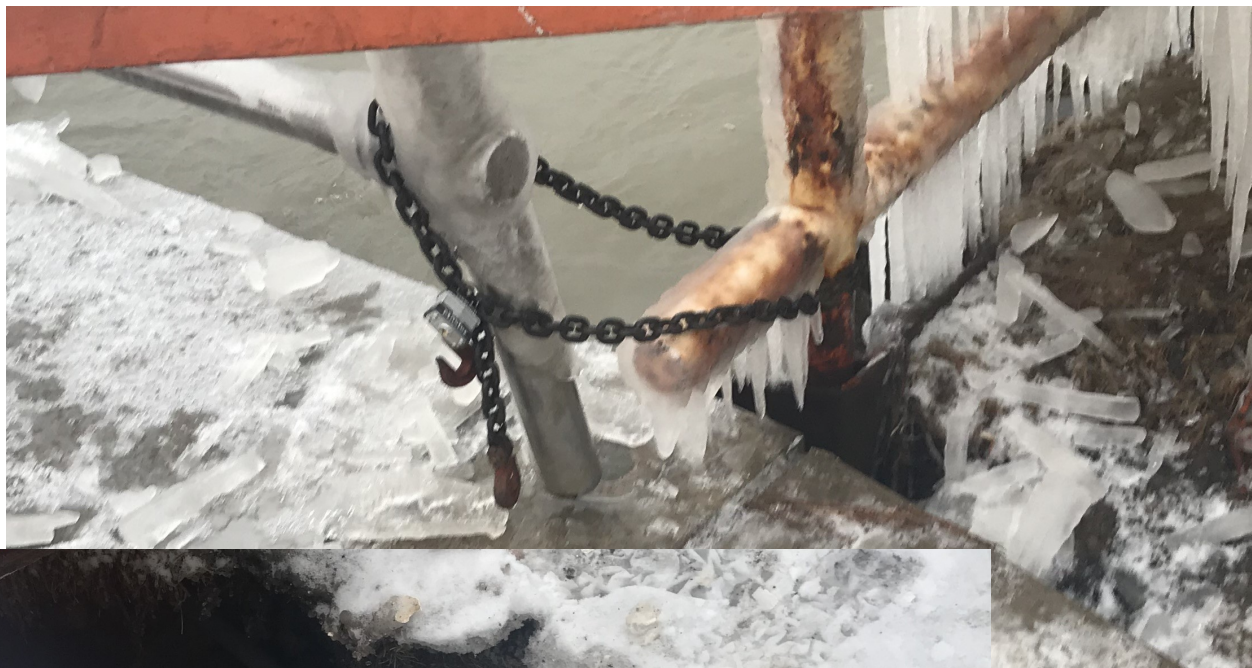
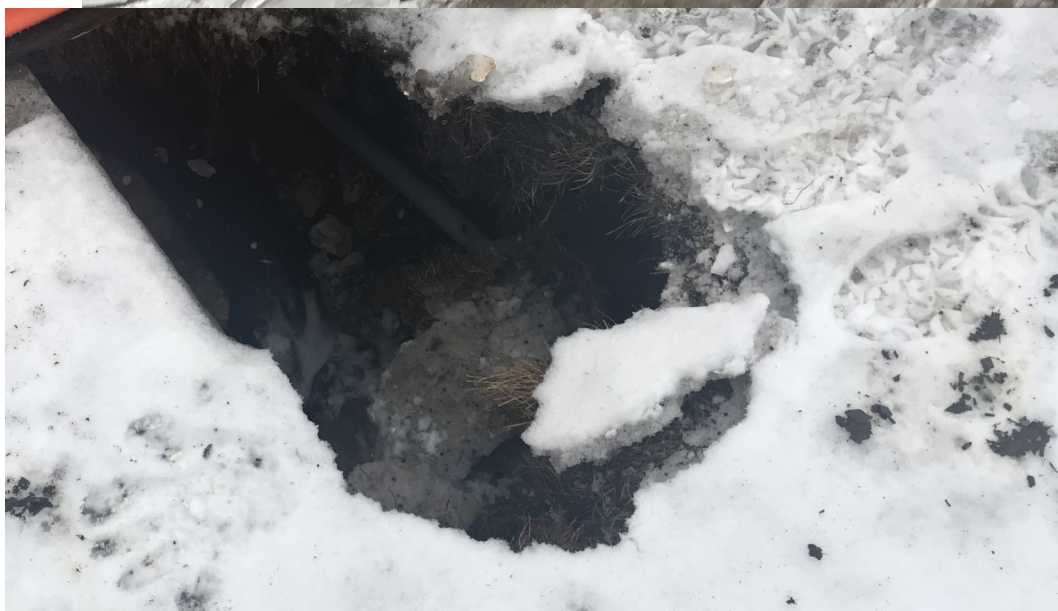
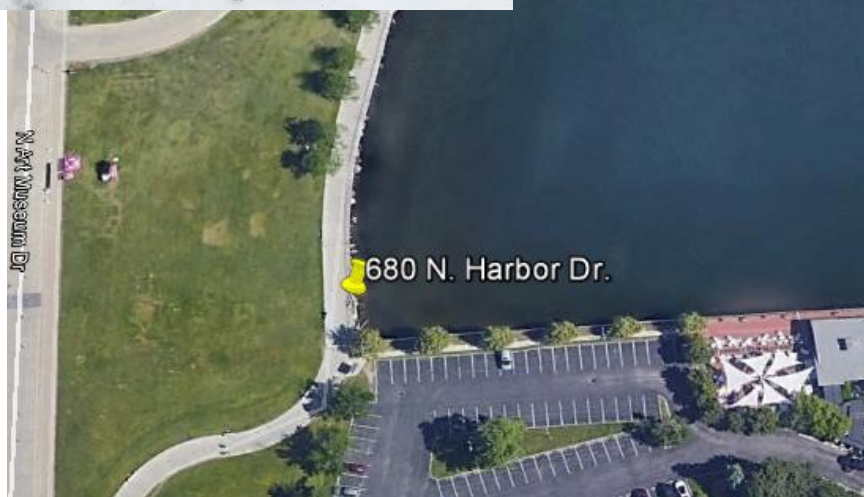
Oak Leaf Trail: Near Art Museum

Lost Railing footings, and sinkholes are starting to appear throughout the length of the waterfront walkway.

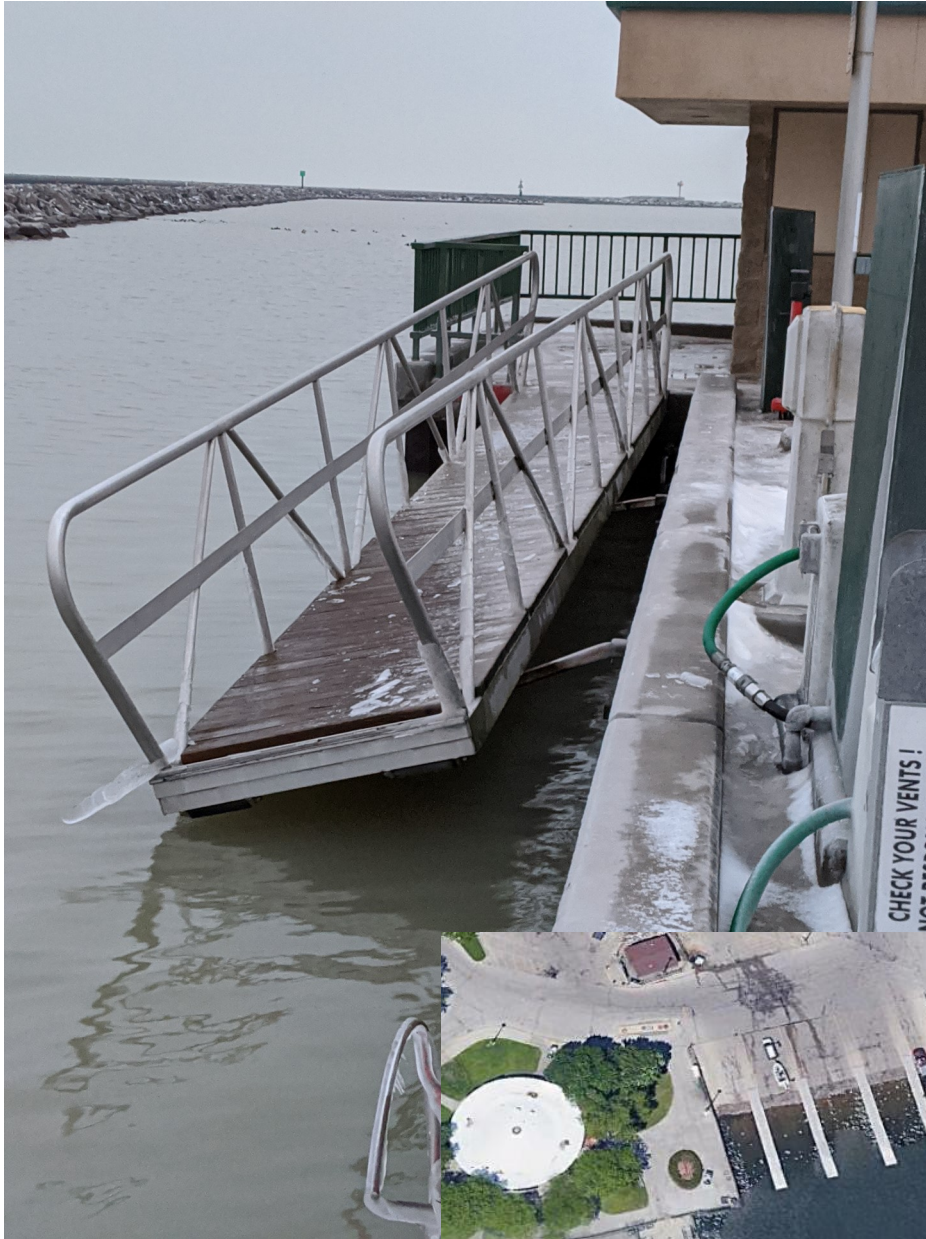
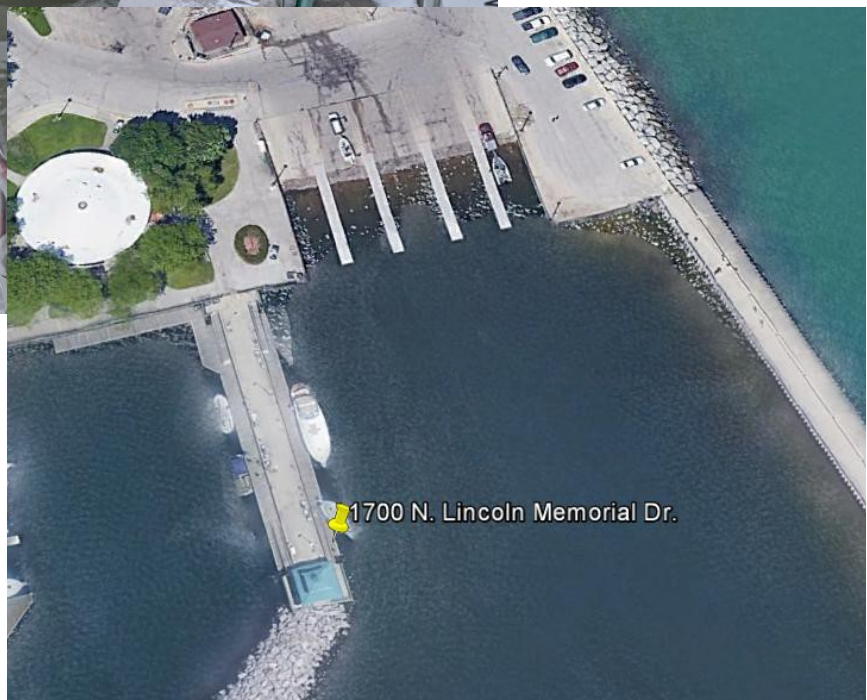
McKinley Marina Gas Dock

Gas Dock Ramp has collapsed. Only two of the supports are left intact.

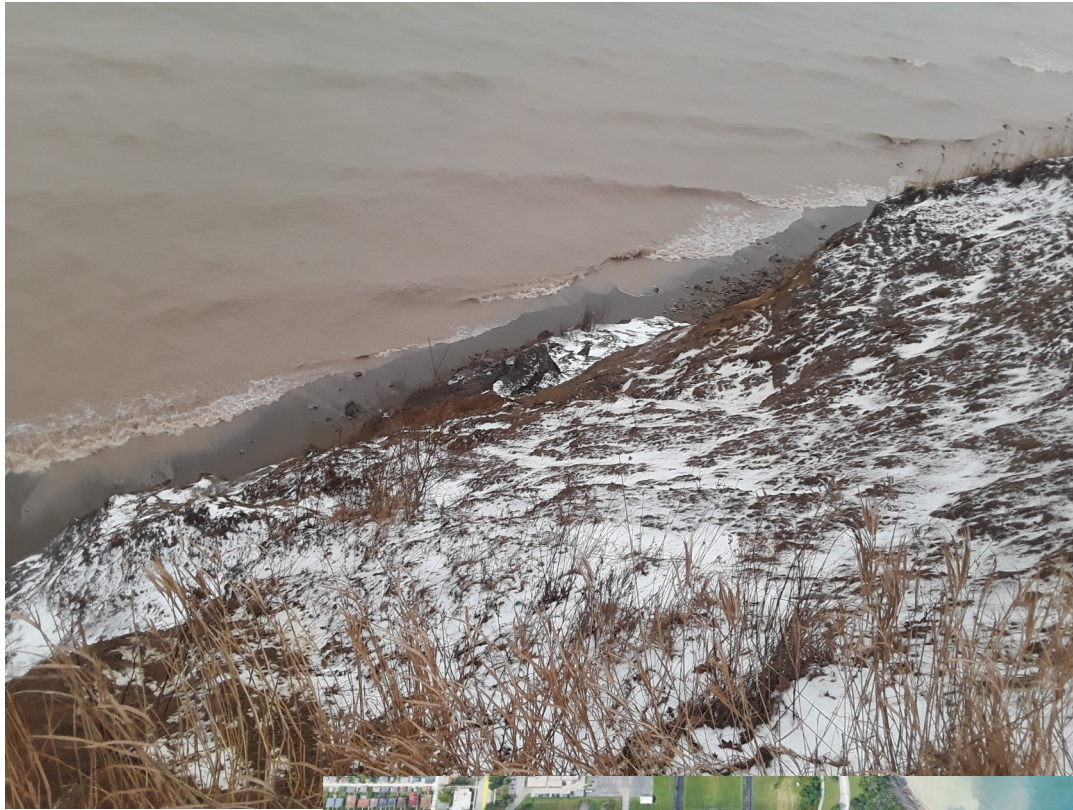
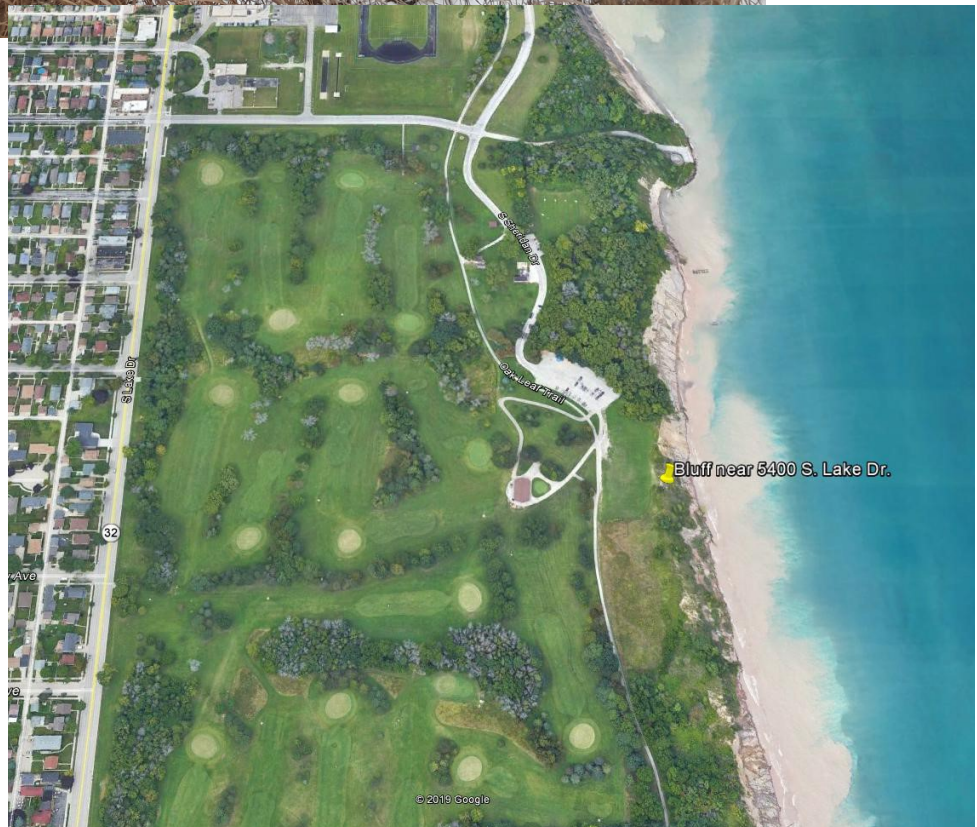
Warnimont Golf Course

A section of the bluff estimated to 20' by 30' directly across from the clubhouse has completely failed.

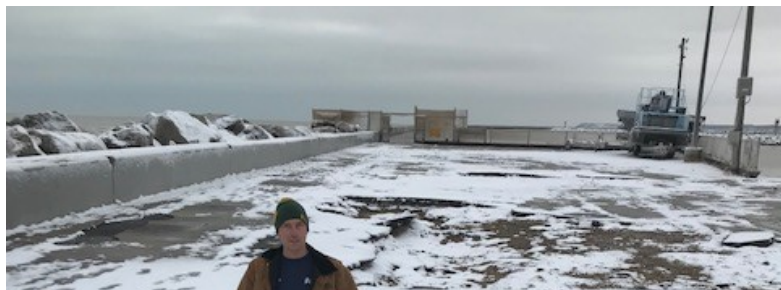
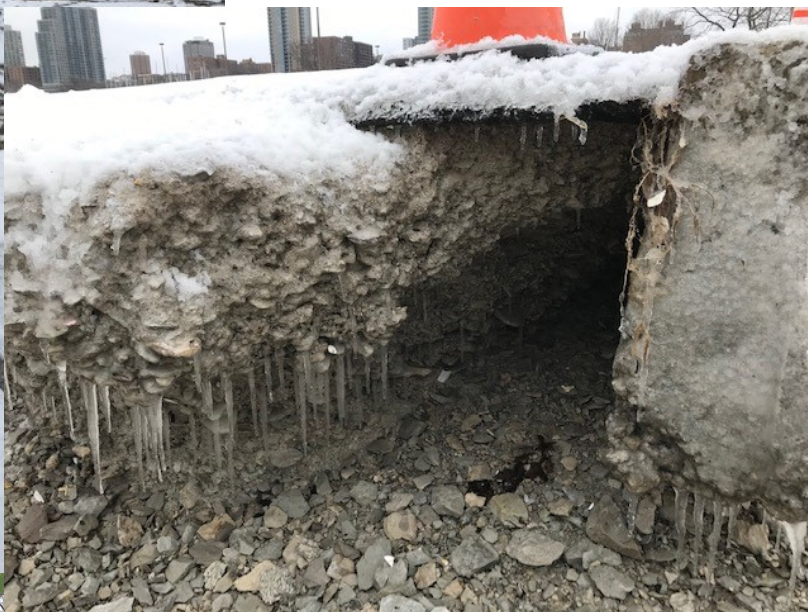
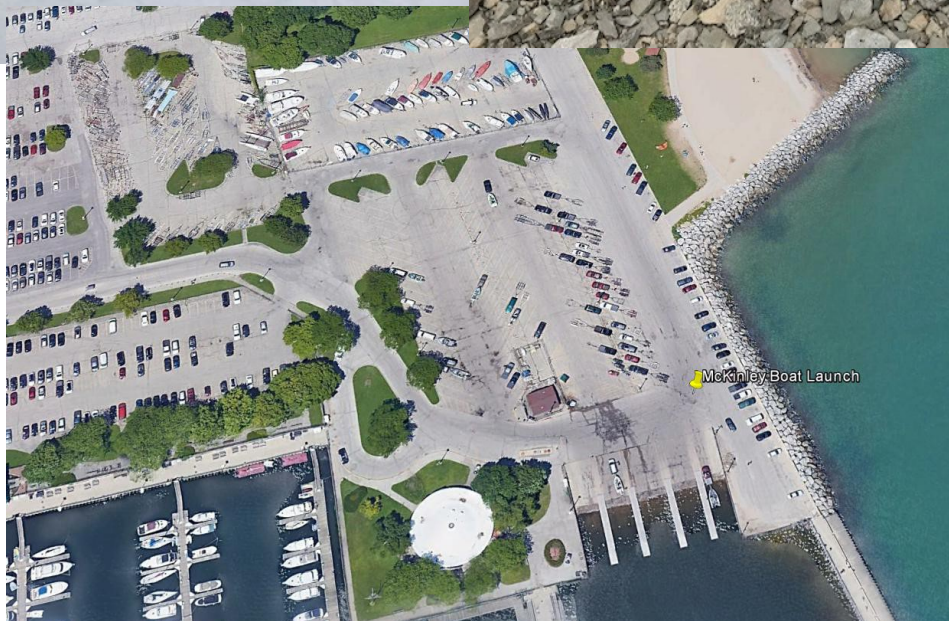
McKinley Boat Launch

The photos sent depict damage sustained due to extreme weather conditions, including high winds and waves, over the course of January 10-12 at McKinley Marina. Sustained wave action from Lake Michigan resulted in the integrity of the McKinley Marina parking lot and boat launch area being severely compromised and a good portion of it rendered unusable to vehicle and boating traffic. This damage also impedes pedestrian access to the government pier (owed by the Army Corps of Engineers). Along with the asphalt surfacing being compromised, waves and water that penetrated the area have resulted in some undermining of the area as well.

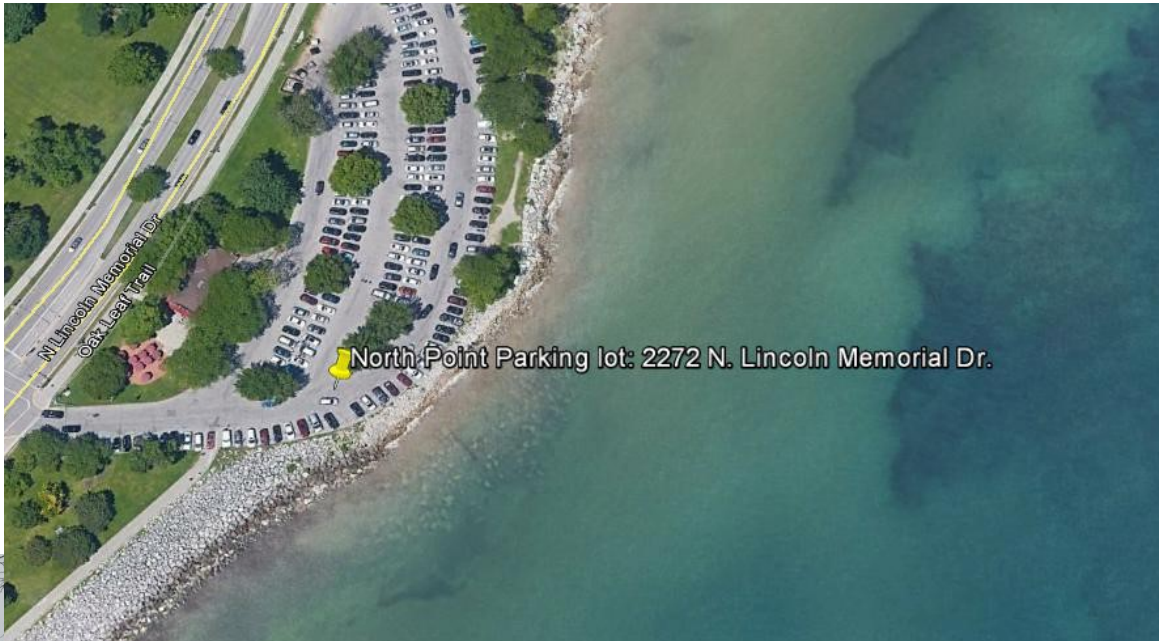
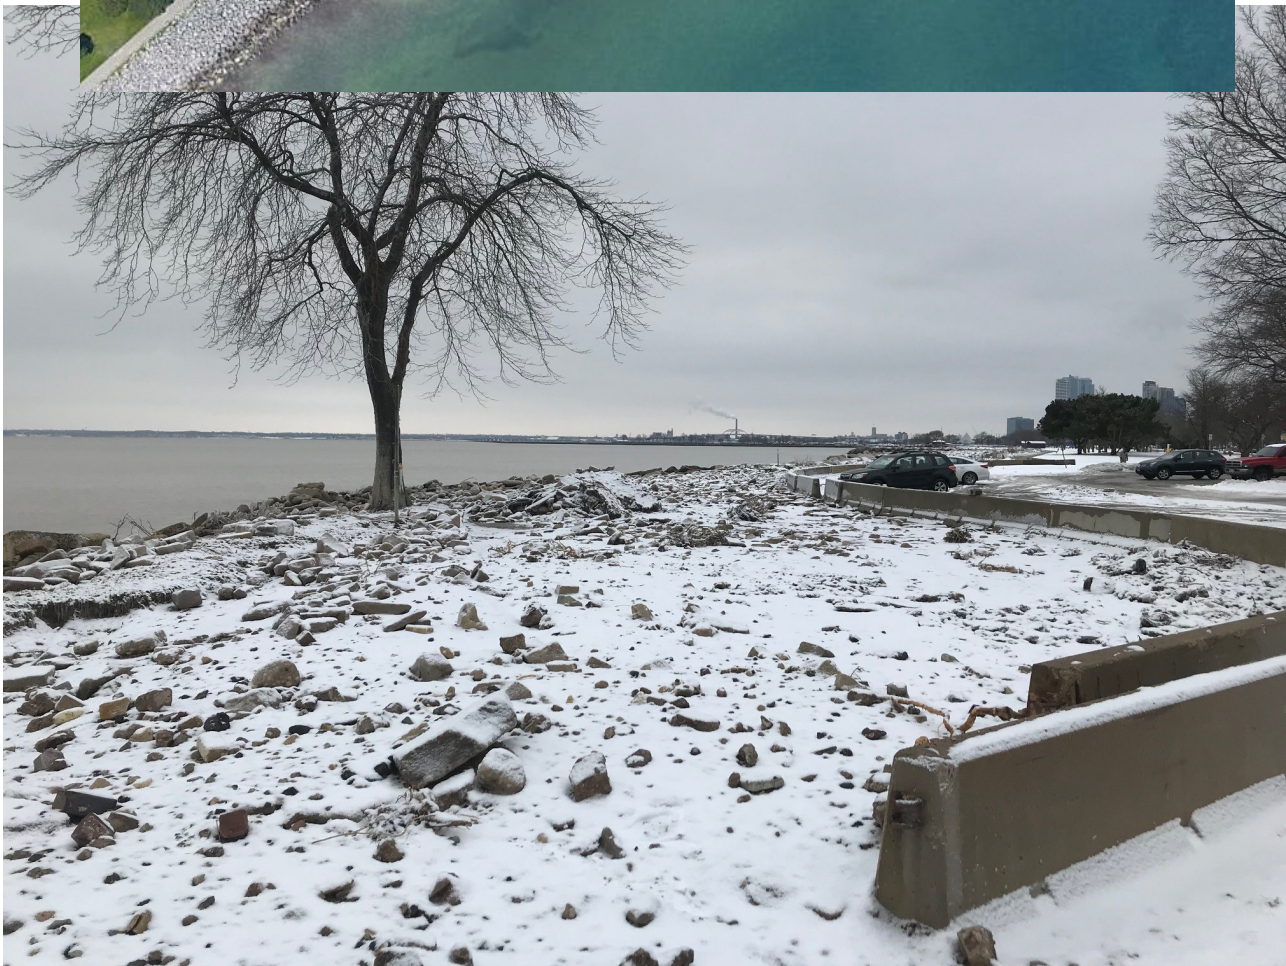
North Point Parking lot

A section of the parking lot estimated 200' x 200' of asphalt has collapsed and washed into the lake.

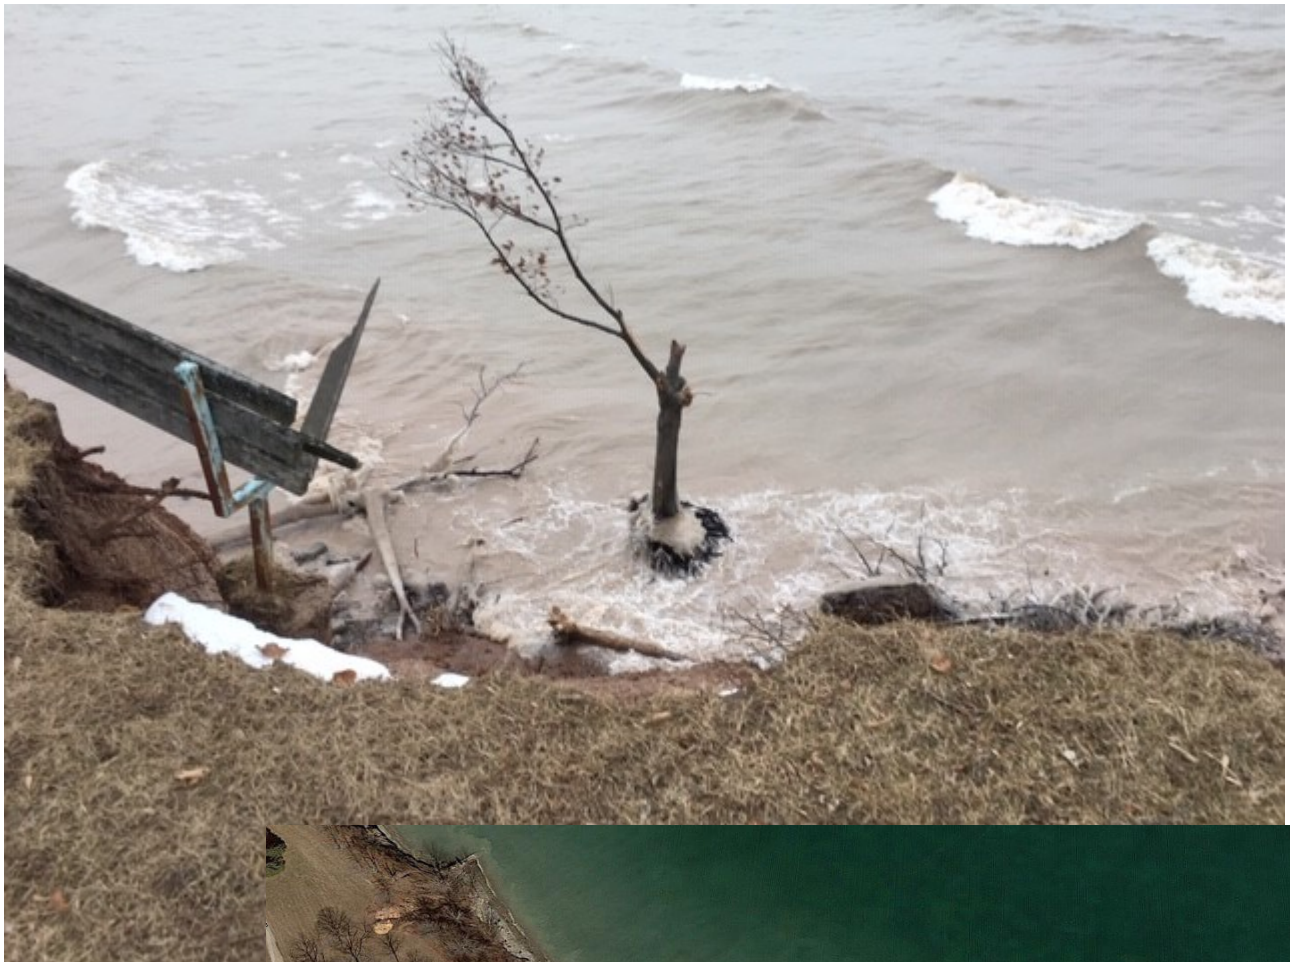
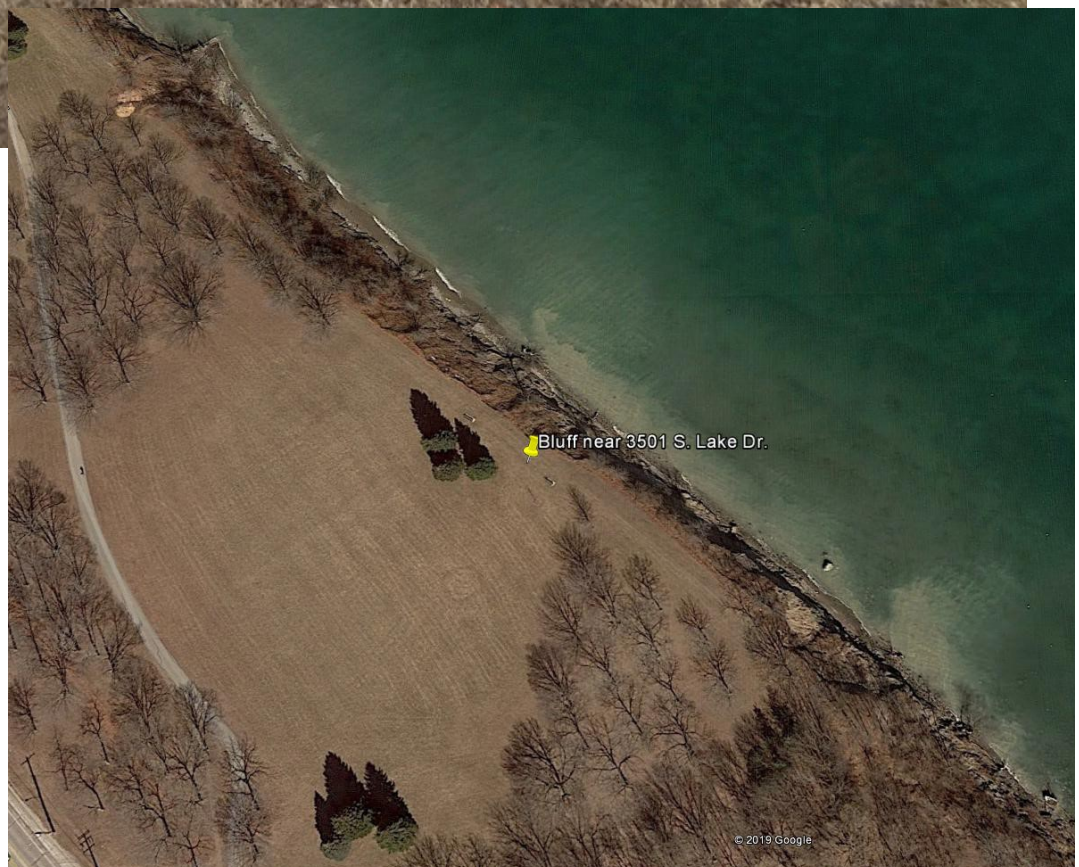
Bay View Park

A section of the bluff estimated 50' x 50' has collapsed into the lake.

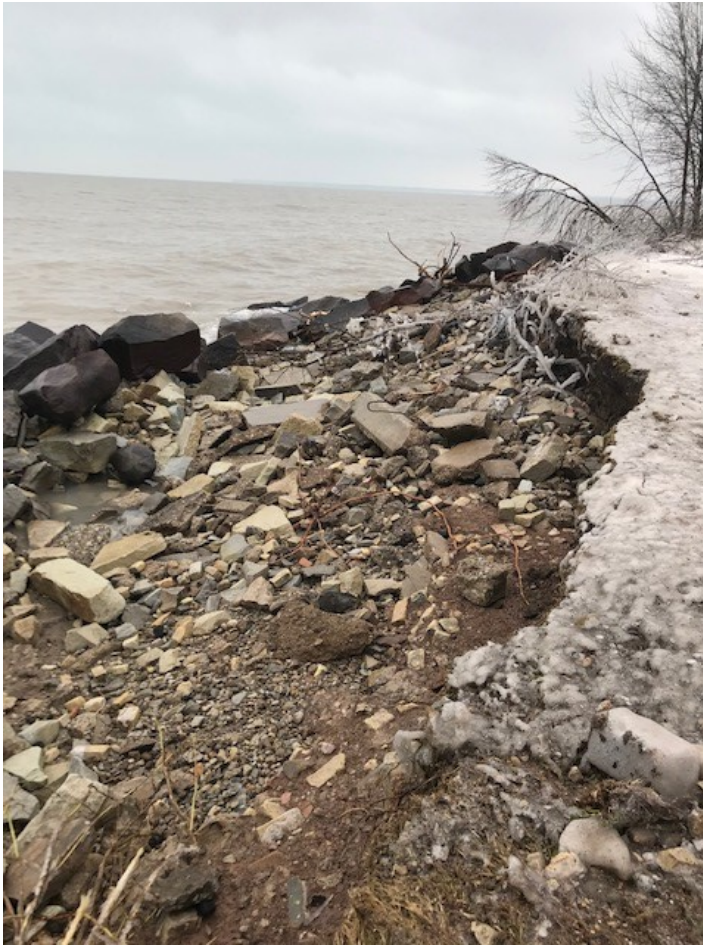
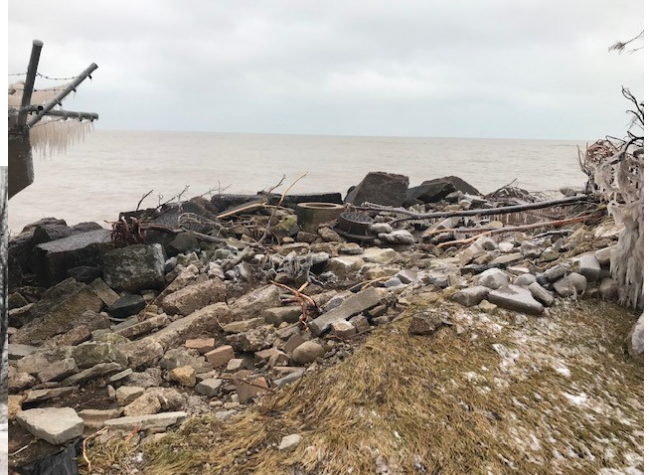
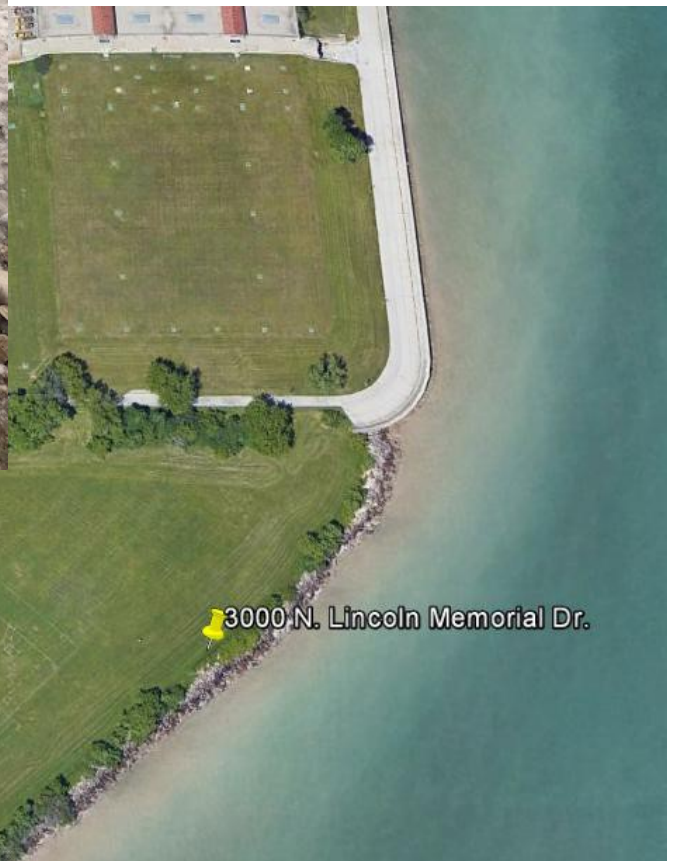
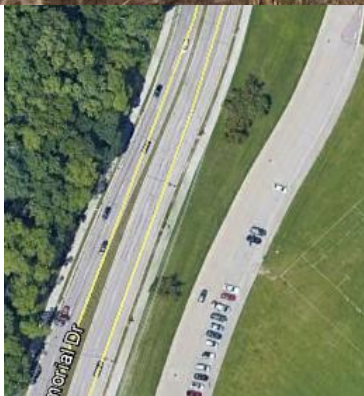
Lake Park

Approximately 600 ft of shoreline was affected, there are multiple areas with varying levels of erosion. The most impacted areas are straight east of the south goal post and on the far North end (where county land meets Waterworks property).
