SUBJECT: Final Case Closure with Continuing Obligations
Expert Automotive Service, 7030 National Ave, West Allis, WI
DNR BRRTS Activity #: 02-41-563932
FID #: 241963150

The property has been used as an automotive repair shop since 1947. Polychlorinated Biphenyl (PCB) contaminated soils are located near the former hoist systems, the suspected source of the contamination. The conditions of closure and continuing obligations required were based on the property being used for commercial purposes.

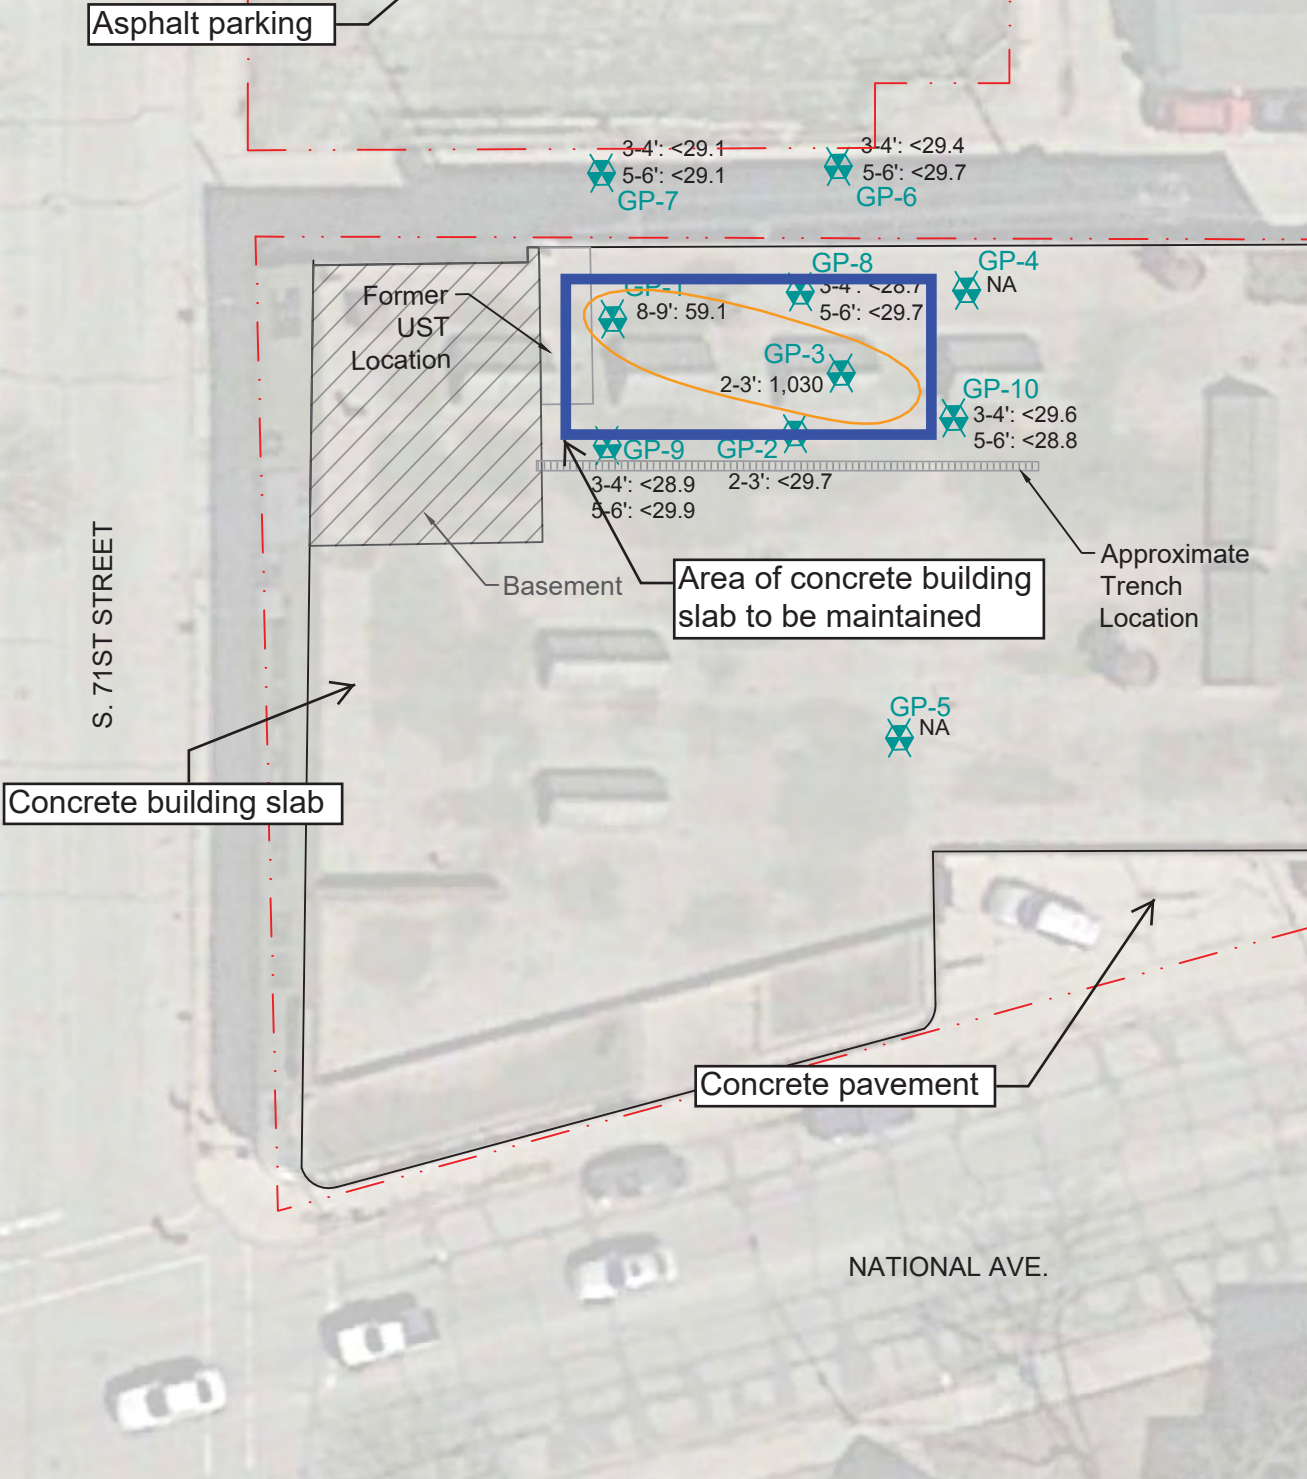
D.2.: Location Map

NOTES:

1. Aerial image from Google Earth Pro downloaded March 19, 2015.
2. ND = Not Detected
3. NA = Not Analyzed

The existing integrated soil barrier consists of existing soil barrier consisting of a concrete building foundation slab. The building foundation covers nearly the entire area associated with parcel number 45-30-272000. The portion of this foundation utilized as a soil barrier and addressed by this maintenance plan is located near the northern wall of the site building, as shown on the **attached Figure D.2**.

The existing soil barrier consisting of a building foundation which overlies affected soil at the Site and as depicted in Figure D.2 will be inspected once a year, normally in the spring after all snow and ice is gone, for deterioration, cracks and other potential problems that can cause exposure to underlying soils. The inspections will be performed by the property owner or their designated representative to evaluate damage due to settling, increasing age and other factors. Any area where soils have become or are likely to become exposed and where infiltration from the surface will not be effectively minimized will be documented.

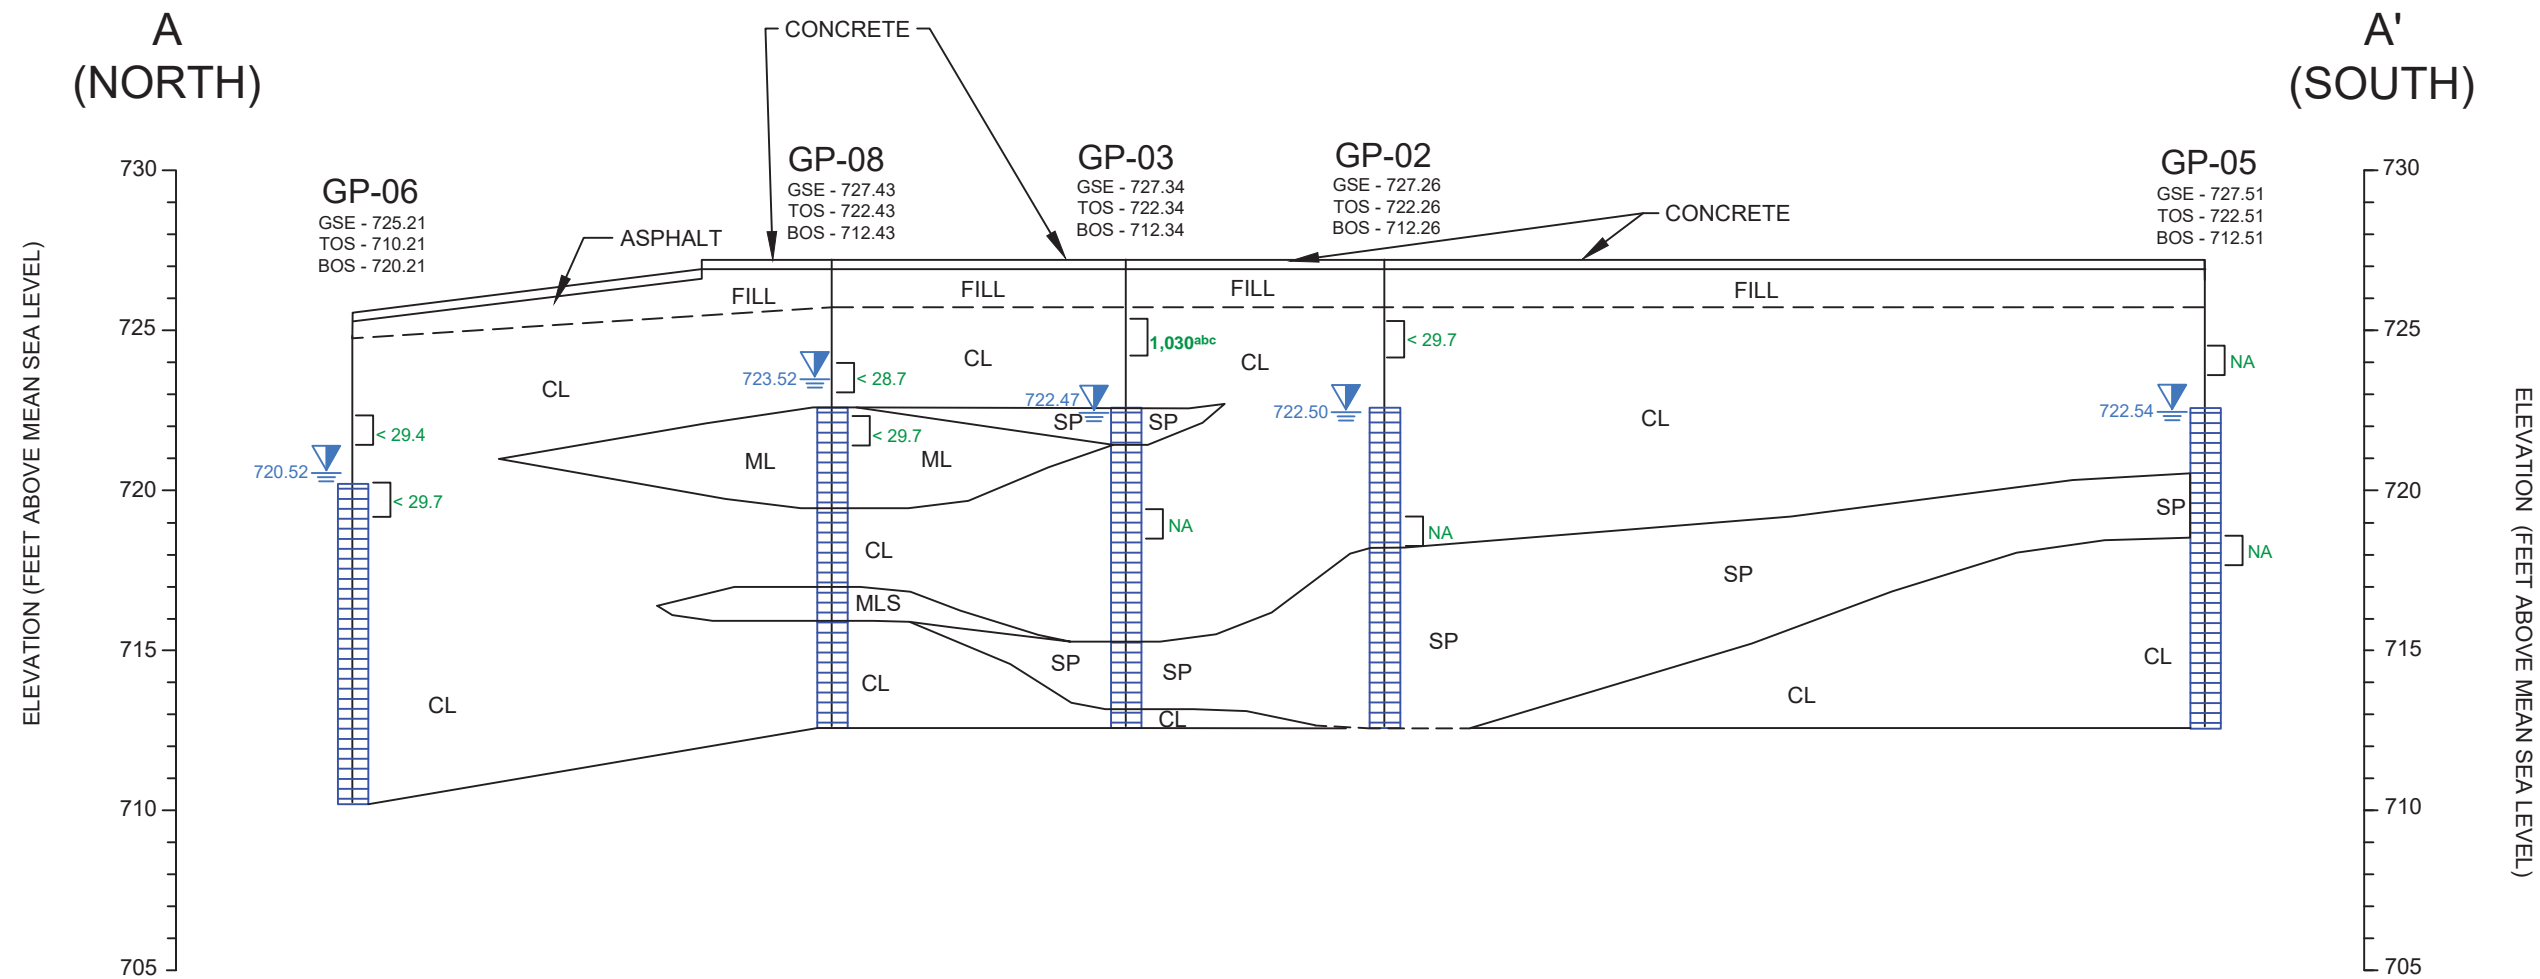
AECOM Milwaukee Office 1555 RiverCenter Dr Milwaukee, WI 414.944.6080	7030 W National Ave West Allis, WI		
	B.3.a.GEOLOGIC CROSS-SECTION FIGURES		
AECOM	Project Number: 60340795	Drawn By: ANS	Date: 1/23/2017

LEGEND	
SP	POORLY GRADED SAND
ML	SILT
MLS	SANDY SILT
CL	CLAY
GSE	GROUND SURFACE ELEVATION
BOS	BOTTOM OF SCREEN
TOS	TOP OF SCREEN
NA	NOT ANALYZED (FOR PCBs)

- ii. Describe the composition, location and lateral extent, and depth of fill or waste deposits on the site.
Approximately 1.5 feet of fill material is identified on the geologic cross-sections, and is depicted on Figure B.3.a. Based on the soil boring logs, black foundry sand was encountered in soil boring GP-10 to a terminal depth of approximately 0.8 feet.

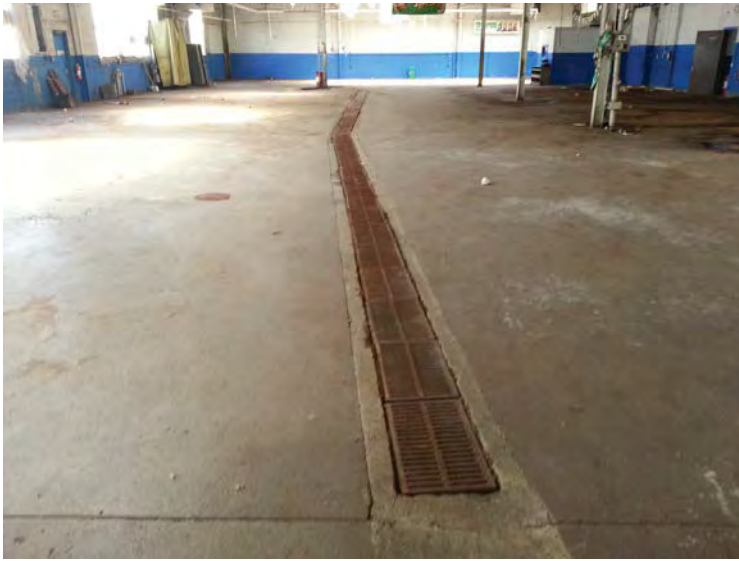
PHOTOGRAPH 7:

Trench drain in service area

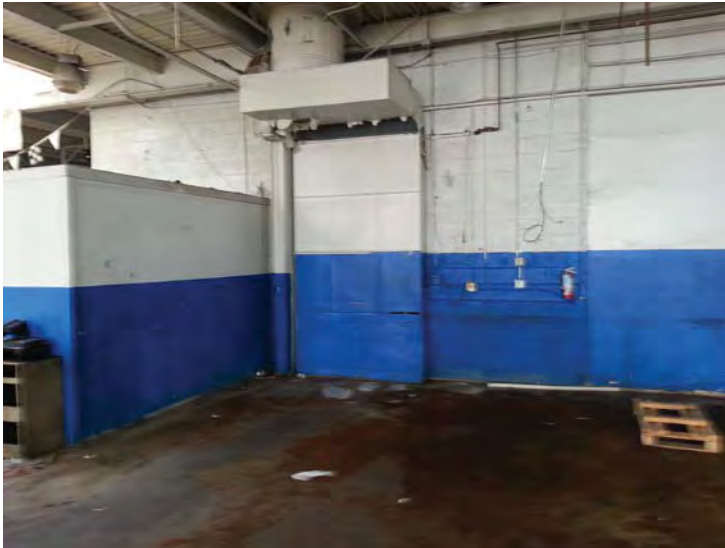
PHOTOGRAPH 8:

Ventilation system in service area

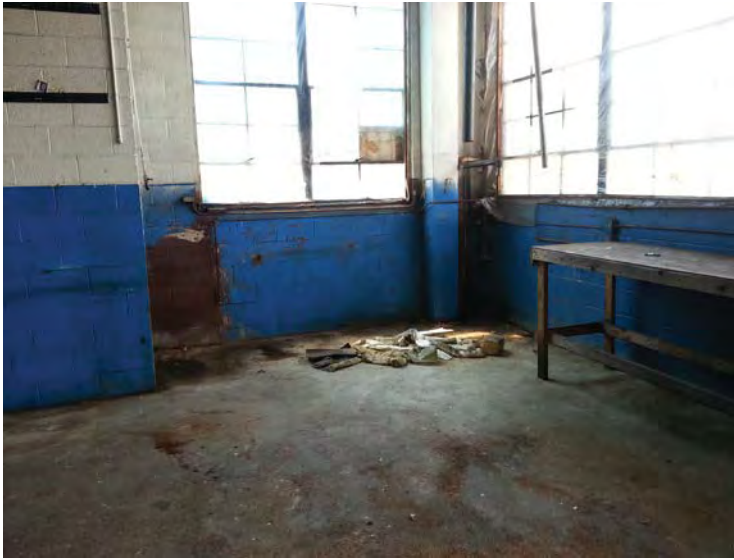
PHOTOGRAPH 9:

Location of former 300-Gallon waste oil AST and other waste storage

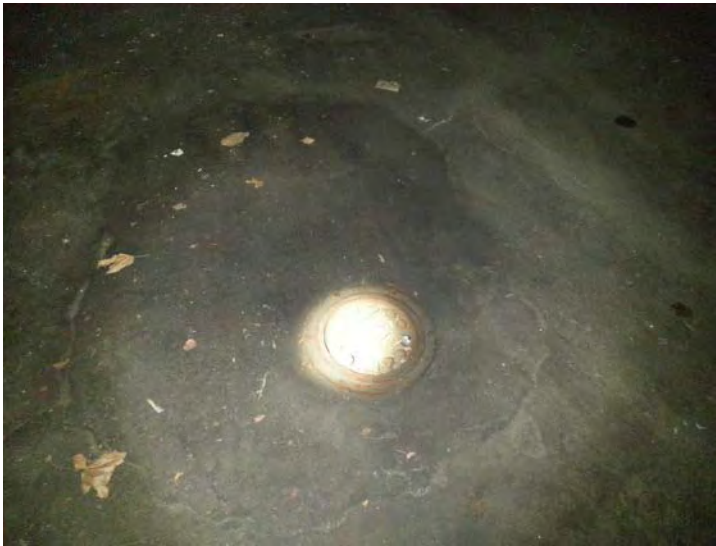
PHOTOGRAPH 10:

Former in ground hoist

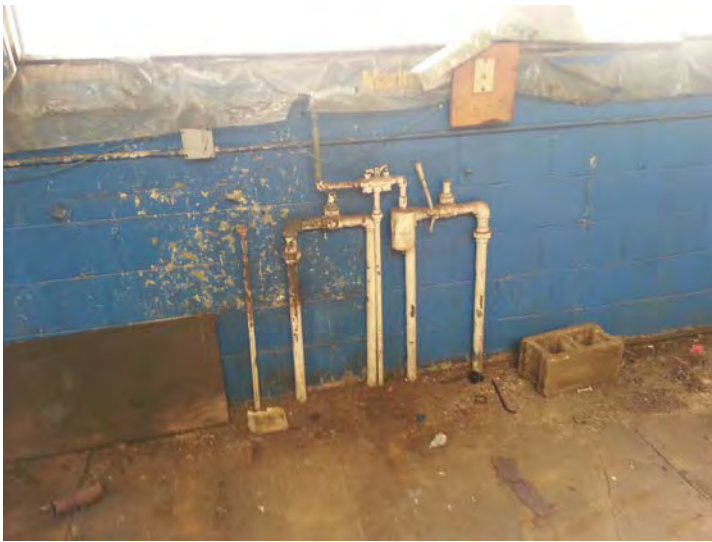
PHOTOGRAPH 11:
Former in ground floor hoist
controls on North wall
