Subject: Addendum to the Closure Letter of July 12, 2017  
Expert Automotive Service, 7030 W. National Ave., West Allis, WI  
DNR BRRTS Activity #: 02-41-563932  
FID #: 241963150

On July 12, 2017, the Department of Natural Resources (DNR) issued a Final Case Closure letter with continuing obligations for the site identified above. The continuing obligations addressed potential exposure to polychlorinated biphenyls (PCBs) that remain in soil. Changes to the requirements of the case closure letter are identified in this addendum, in the Revised Conditions of Closure section, and are issued under Wis. Stats. § 292.12 and Wis. Admin. Code chs. NR 725, 726 and 727. Other continuing obligations included in the final case closure letter remain in effect. This addendum is the final approval of the request submitted to the DNR on December 11, 2017, following completion and documentation of actions taken.

This document is the Maintenance Plan for the existing soil barrier consisting of a building foundation at the above-referenced property in accordance with the requirements of s. NR 724.13 (2), Wis. Adm. Code. The maintenance activities relate to the existing integrated soil barrier cons

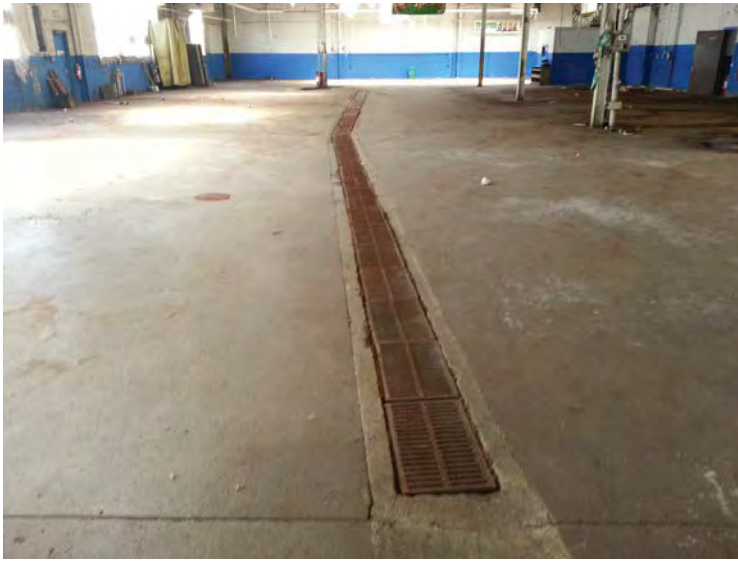
**PHOTOGRAPH 7:**

Trench drain in service area

1) the use of the property since 1947 for auto sales/repair; 2) the use of hydraulic lifts in the service area; 3) a trench drain located in the service area; 4) the use of a former 300-gallon AST; 5) the documented waste storage areas; and 6) historic use of parts washers. Based on AECOM's review of the historical activity at the site, additional Site Investigation activities were conducted to determine if any of the above property uses resulted in a release to soil and/or groundwater at the subject property.

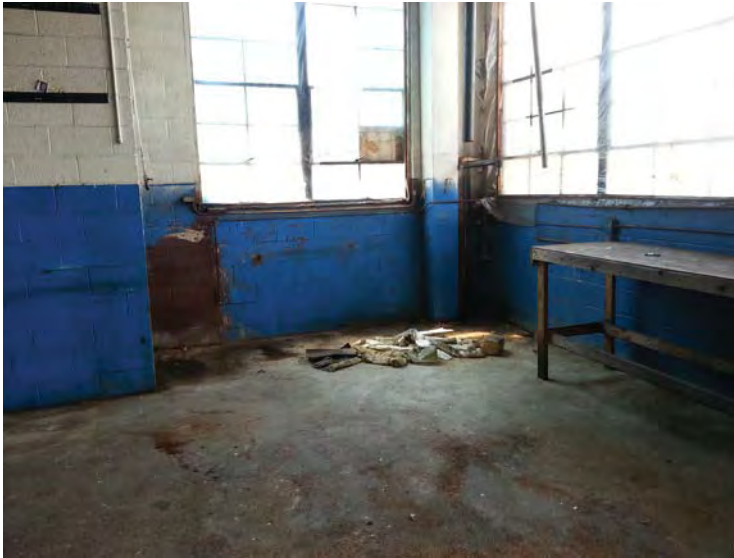
**PHOTOGRAPH 9:**

Location of former 300-Gallon waste oil AST and other waste storage

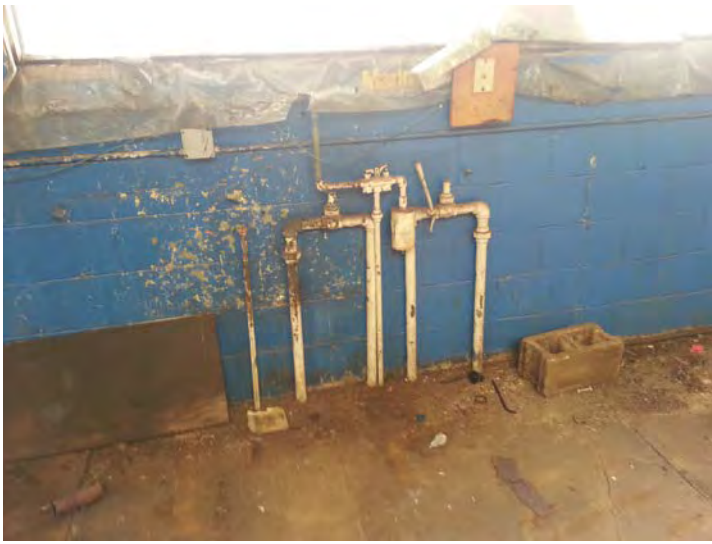
**PHOTOGRAPH 11:**  
Former in ground floor hoist  
controls on North wall
