# Mitchell Park Horticultural Conservatory Domes

Peer Review — Precast and Cladding

**WJE** | ENGINEERS  
ARCHITECTS  
MATERIALS SCIENTISTS  
Wiss, Janney, Elstner Associates, Inc.

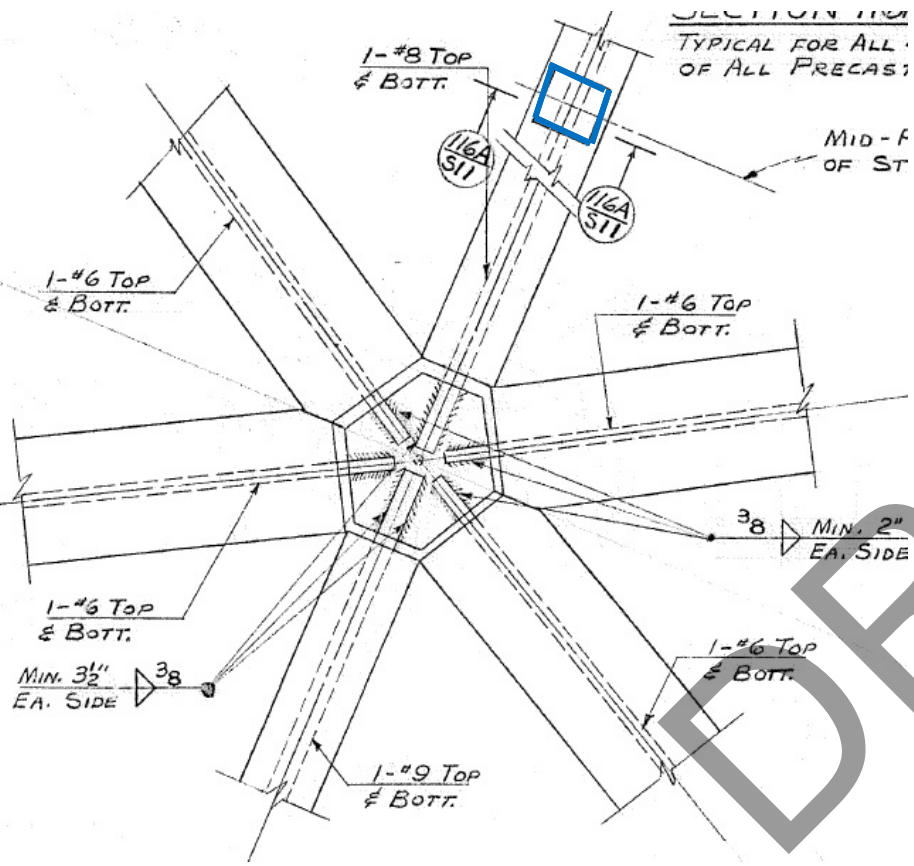
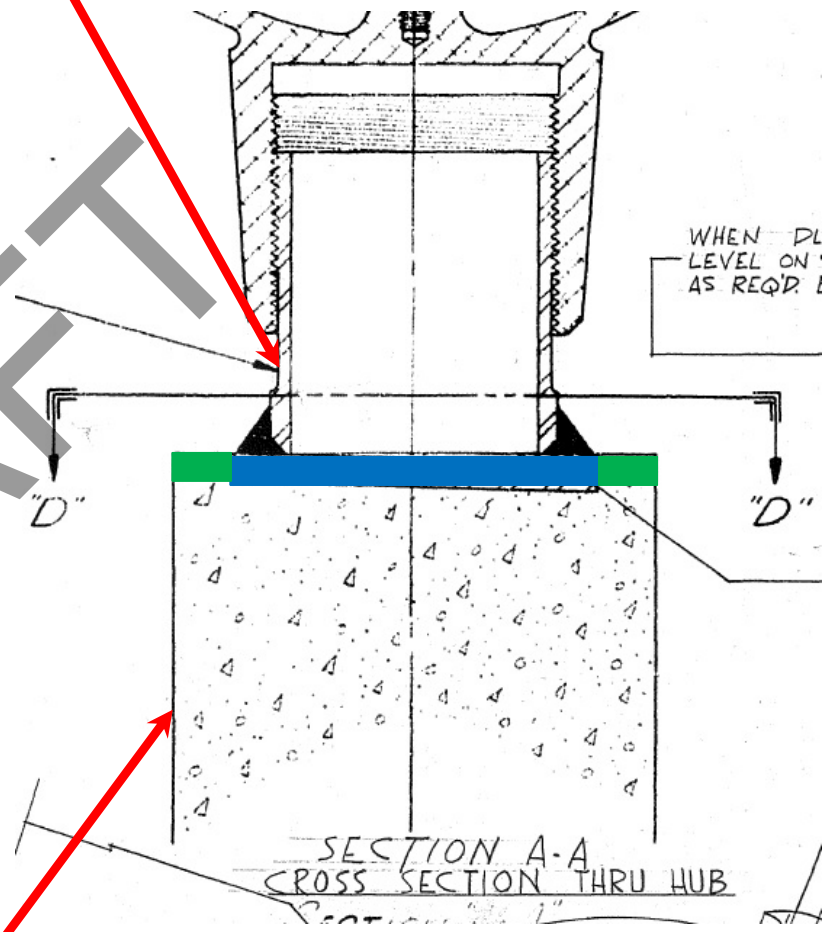
Tube at cladding hub  
welded to embedded plate

Precast member

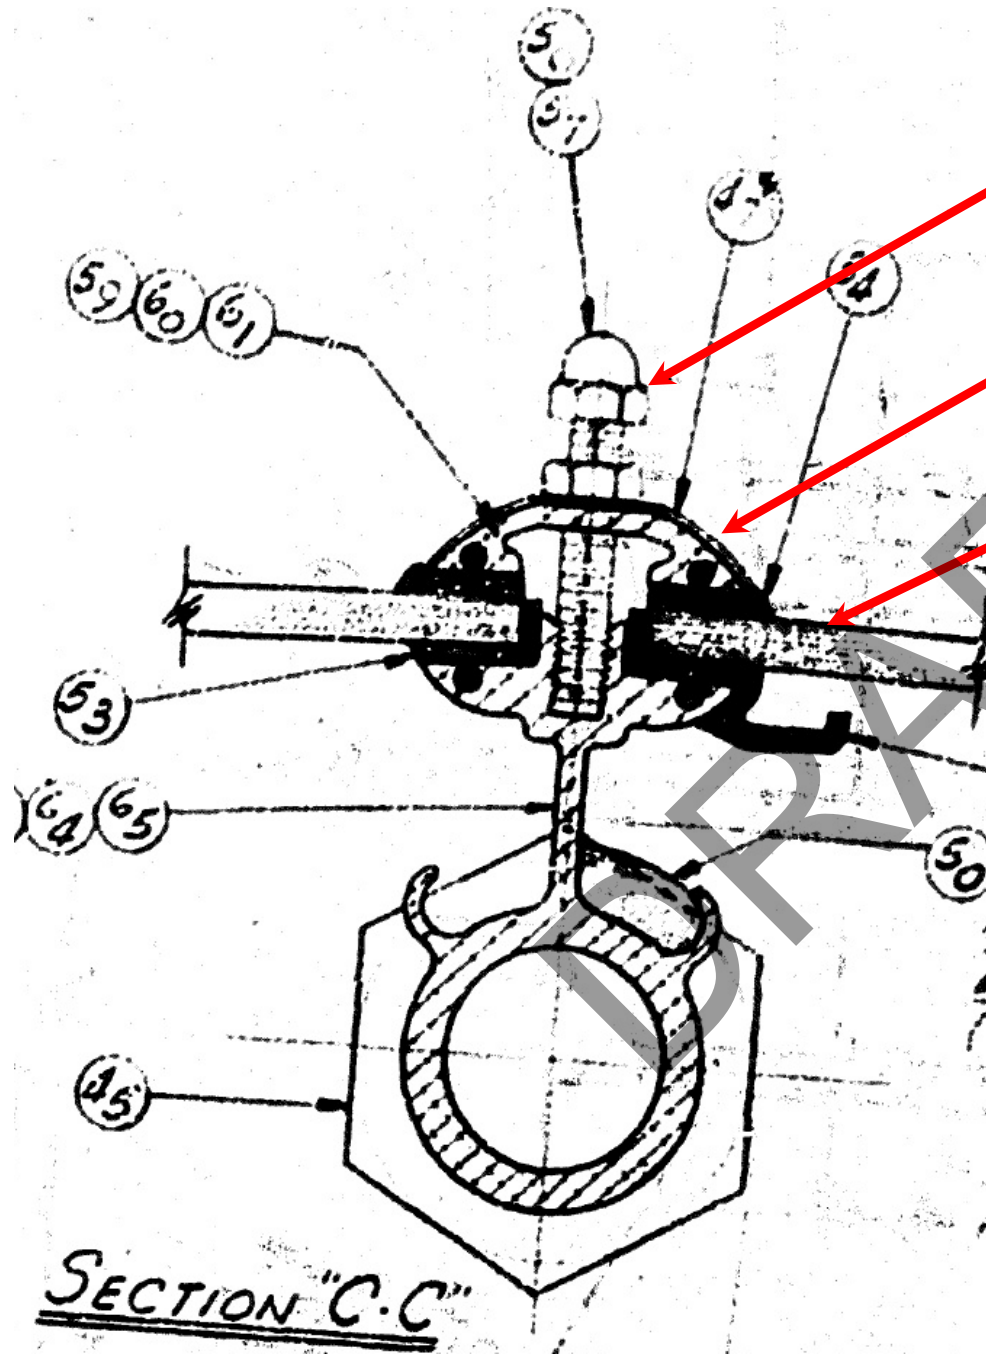
Fasteners

Pressure cap

Glass

Circular hub

Opening in downspout rafter is slightly higher than base of hub

Water is intended to flow down the rafter at each hub and out at the base of the dome

GRAEF observed water sitting in the hub below this elevation, which is likely causing water leakage at fittings. A self-leveling sealant can be installed to fill in the “depressed” area (GRAEF repair).
