**MILWAUKEE COUNTY**  
**Interoffice Memorandum**

**SUBJECT:** Caterpillar Site

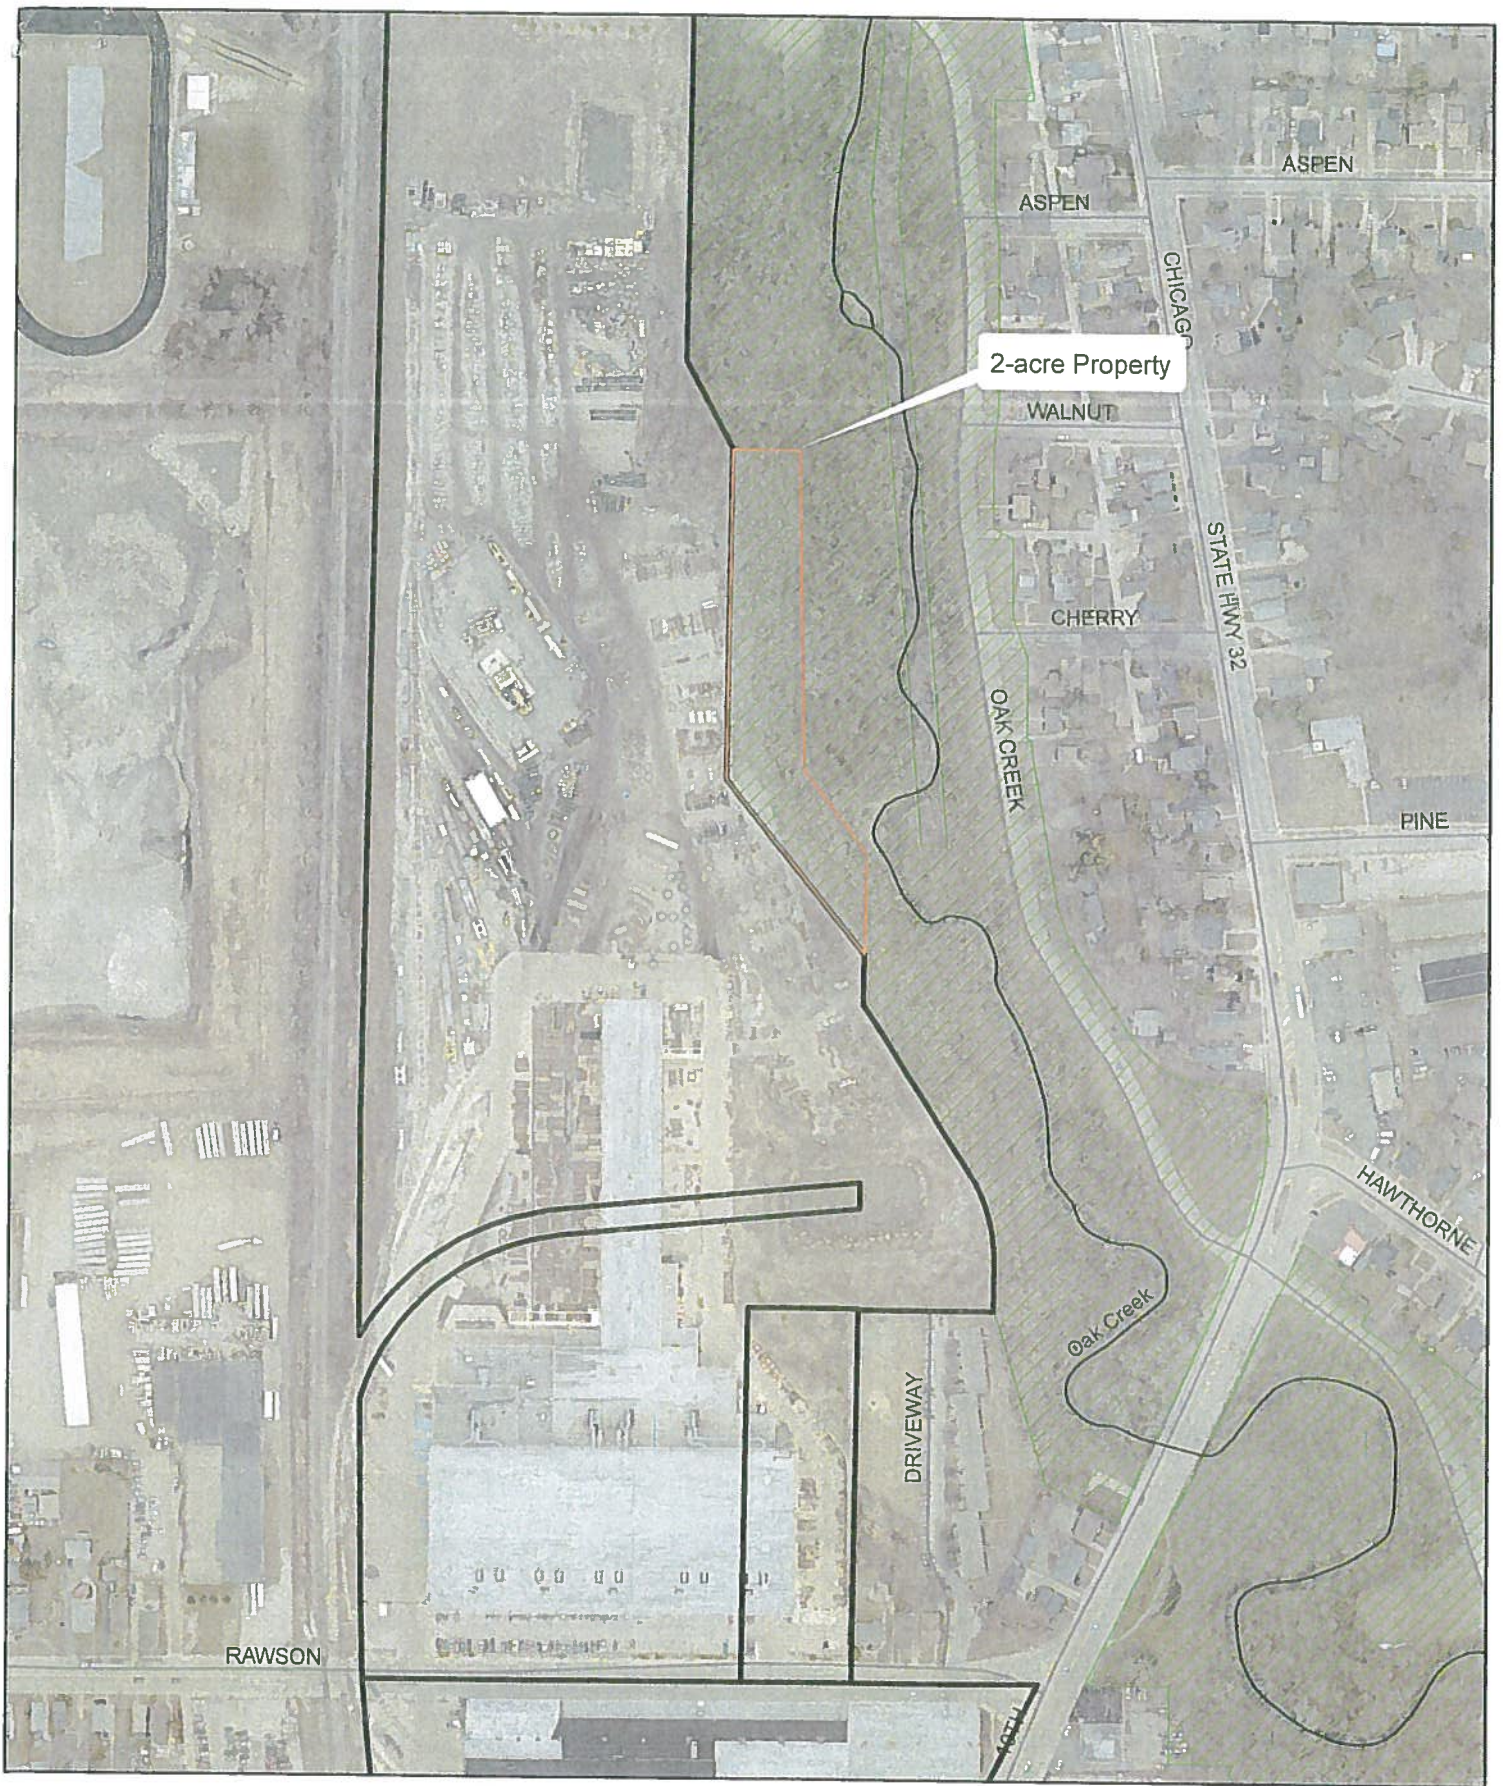
Location of Proposed Parkland Transfer  
Figure 1

Our Environmental Services Unit has performed a review of the environmental conditions of the 2-acre parcel (Figure 1) owned by Milwaukee County Parks which has been encroached upon by Caterpillar and the previous land owner, Bucyrus-Erie. Caterpillar has expressed interest in purchasing the parcel from Milwaukee County. Our review included a tour of the site on Monday January 23<sup>rd</sup> and a review of the WDNR file records on January 30<sup>th</sup>. This memo summarizes our findings and provides several recommendations.
