Ref.: Inspection Findings-Lyons Park Pedestrian Bridges over Lyons Creek

Structure Inspection Report

Structure Number: #1 (Southerly Bridge)

Location: Lyons Park Pedestrian Bridge over the Lyons Park Creek
(Tributary to the KK River)

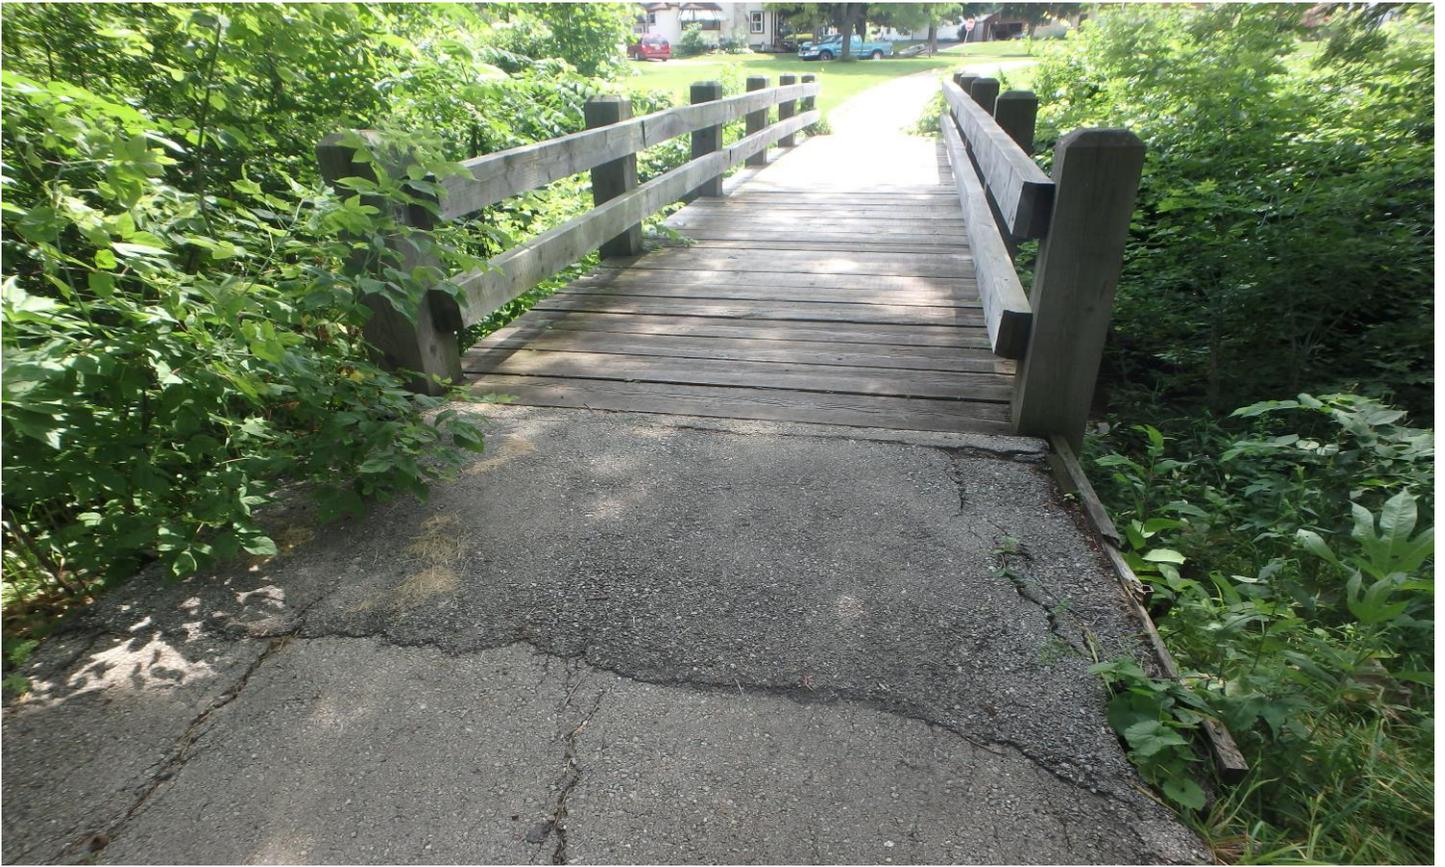
Plan View Looking South

The bridge is generally in good to fair condition with the following deficiencies:

- 1. Opening in railing is in excess of 4 inches.**
- 2. Steel is corroded with minimal localized loss of section.**
- 3. Wood railing and decking surfaces are softening.**

- 1. Clean wood railing and decking and apply preservatives and staining.**
- 2. Clean and paint the structural steel.**

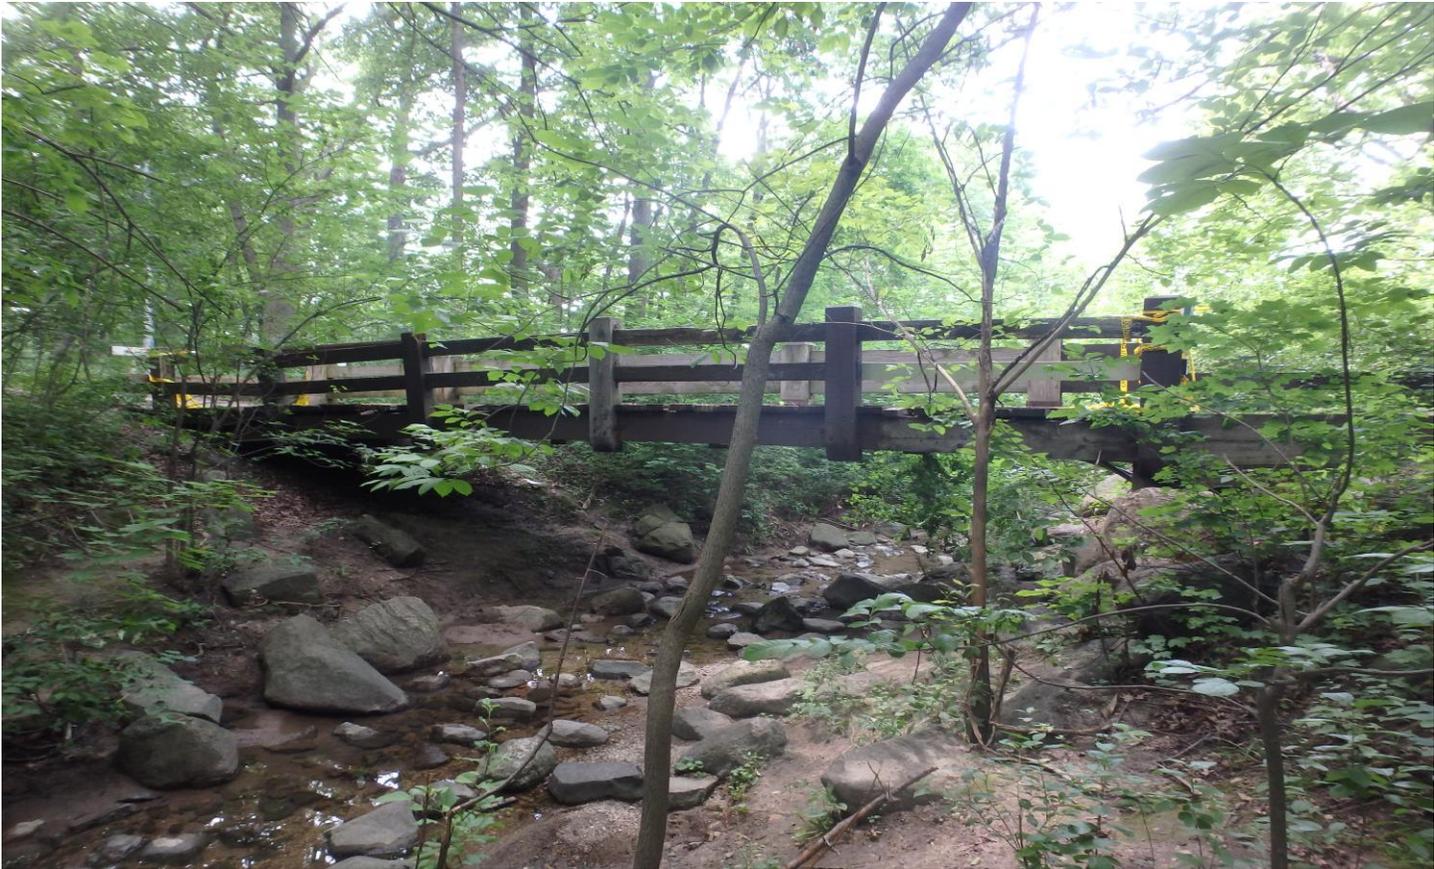
Elevation View

The bridge is closed to the public and is in poor unsafe condition. The bridge require major rehabilitation or replacement.

Rehabilitate or replace.

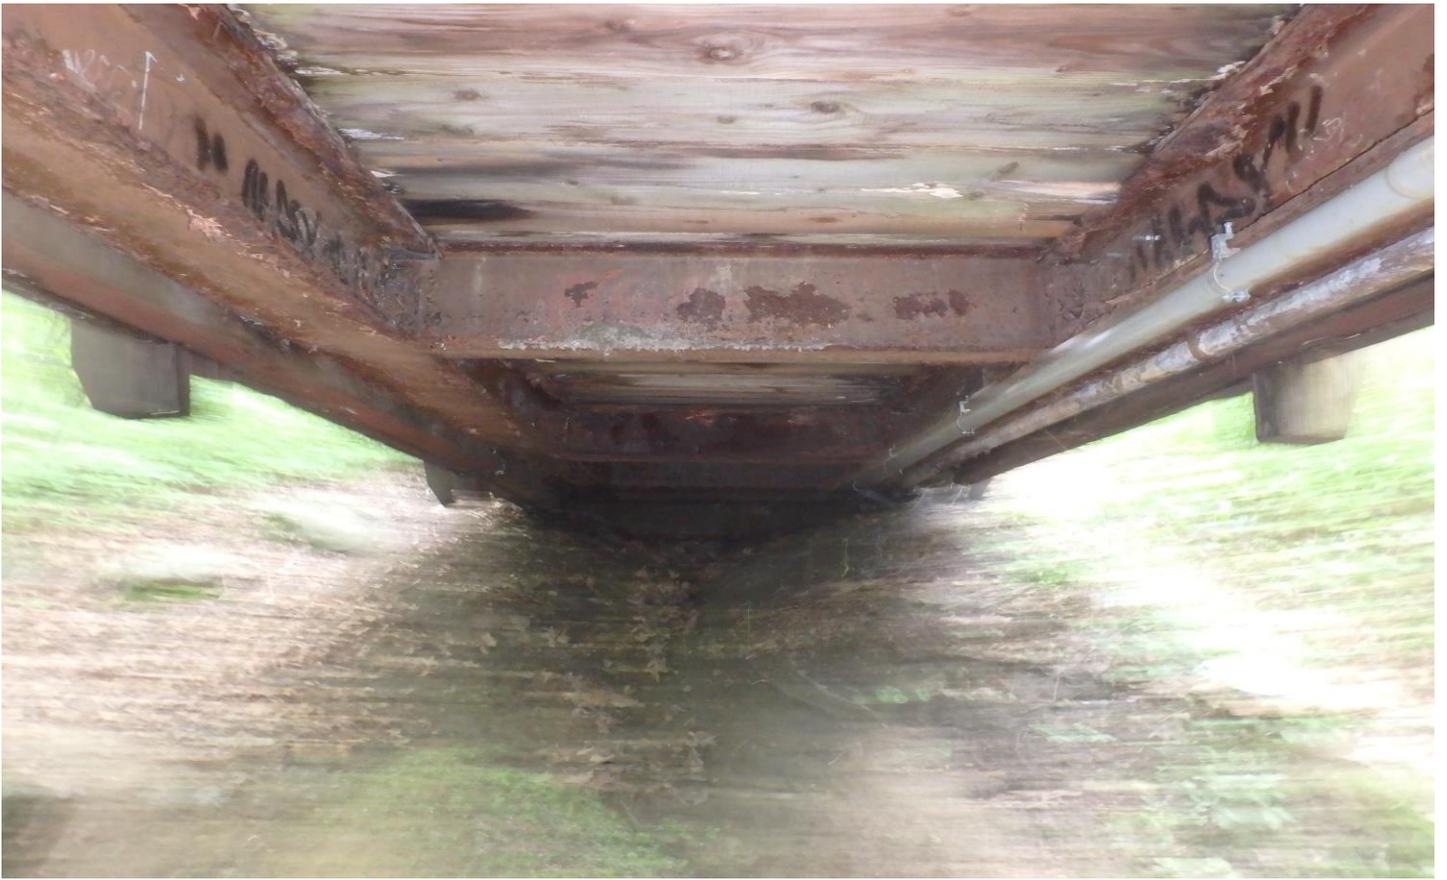
Underside View

Structure Elements	Condition	Description
Superstructure	2	Poor condition with moderate to heavy steel corrosion and localized rotting, missing sections, and cracking of wood decking.
Girder/Stringer	2	Painted steel I-beam are corroded with localized minor to moderate loss of section. Paint system has failed. No sign of distress.
Floor Beams	N/A	
Diaphragm & Bracing	2	10" I-Beams
Slab / Deck	2	Wood planks
Substructure	4	Generally in good to fair condition.
Column	N/A	
Bracing	N/A	
Footing	N/A	
Abutment	4	
Wing Wall	N/A	
Retaining Wall	N/A	
Railing	1 NTS	Poor and failed condition. Not to Standard.
Riding Surface	N/A	
Approaches	3	Asphaltic approach pavement in fair condition with scattered cracks and localized rutting
Geometry	3	Bridge abutment in water during heavy rain events
Waterway	Adequate	No sign of erosion, scour, and/or bank stability
Utility	4	Two 2" metal conduits hung on the underside

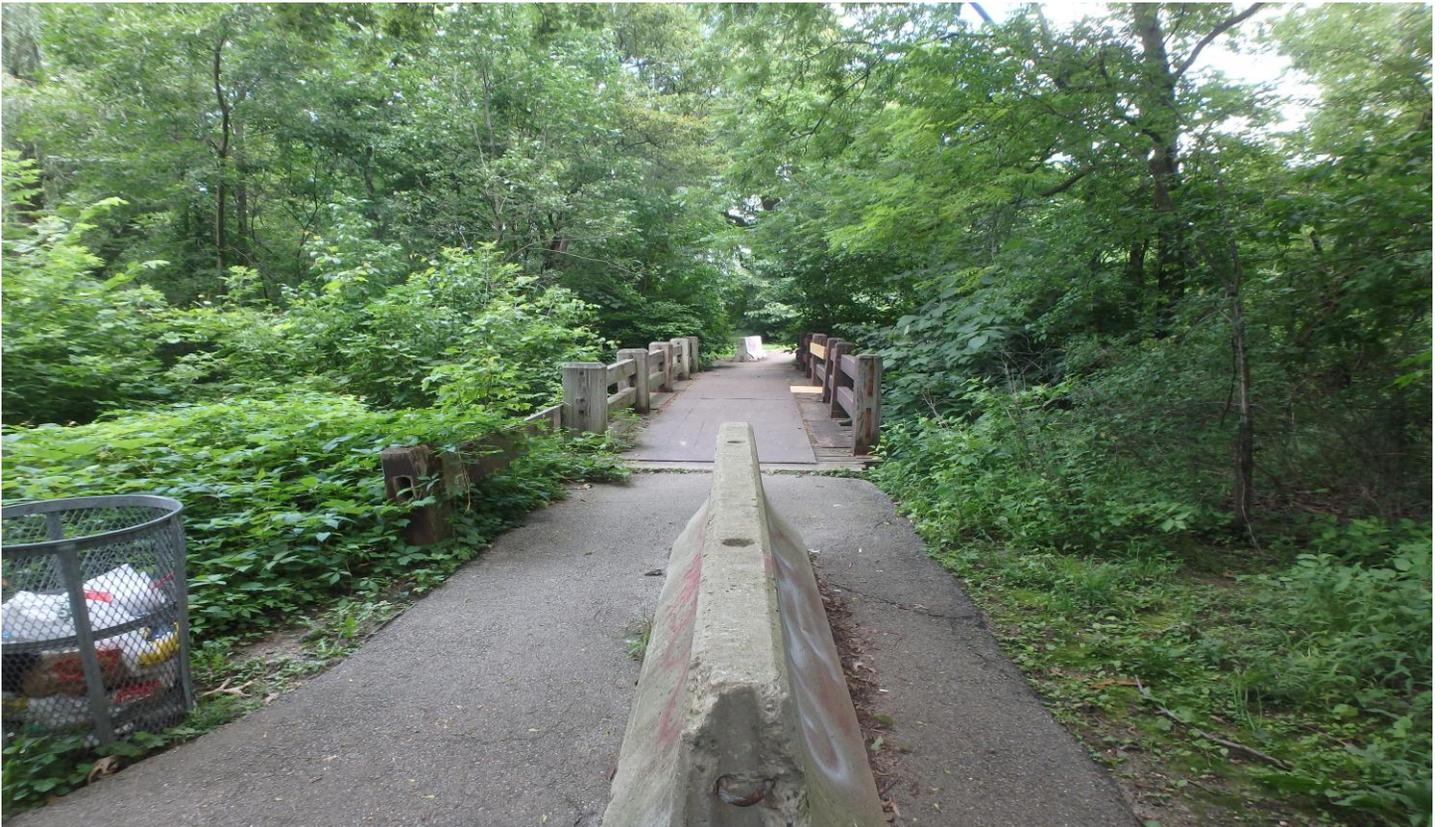
Plan View Looking North

The bridge is poor condition. The bridge require major rehabilitation or replacement.

Rehabilitate or replace. Most likely, this is the last year to remain open to the public without major repairs.

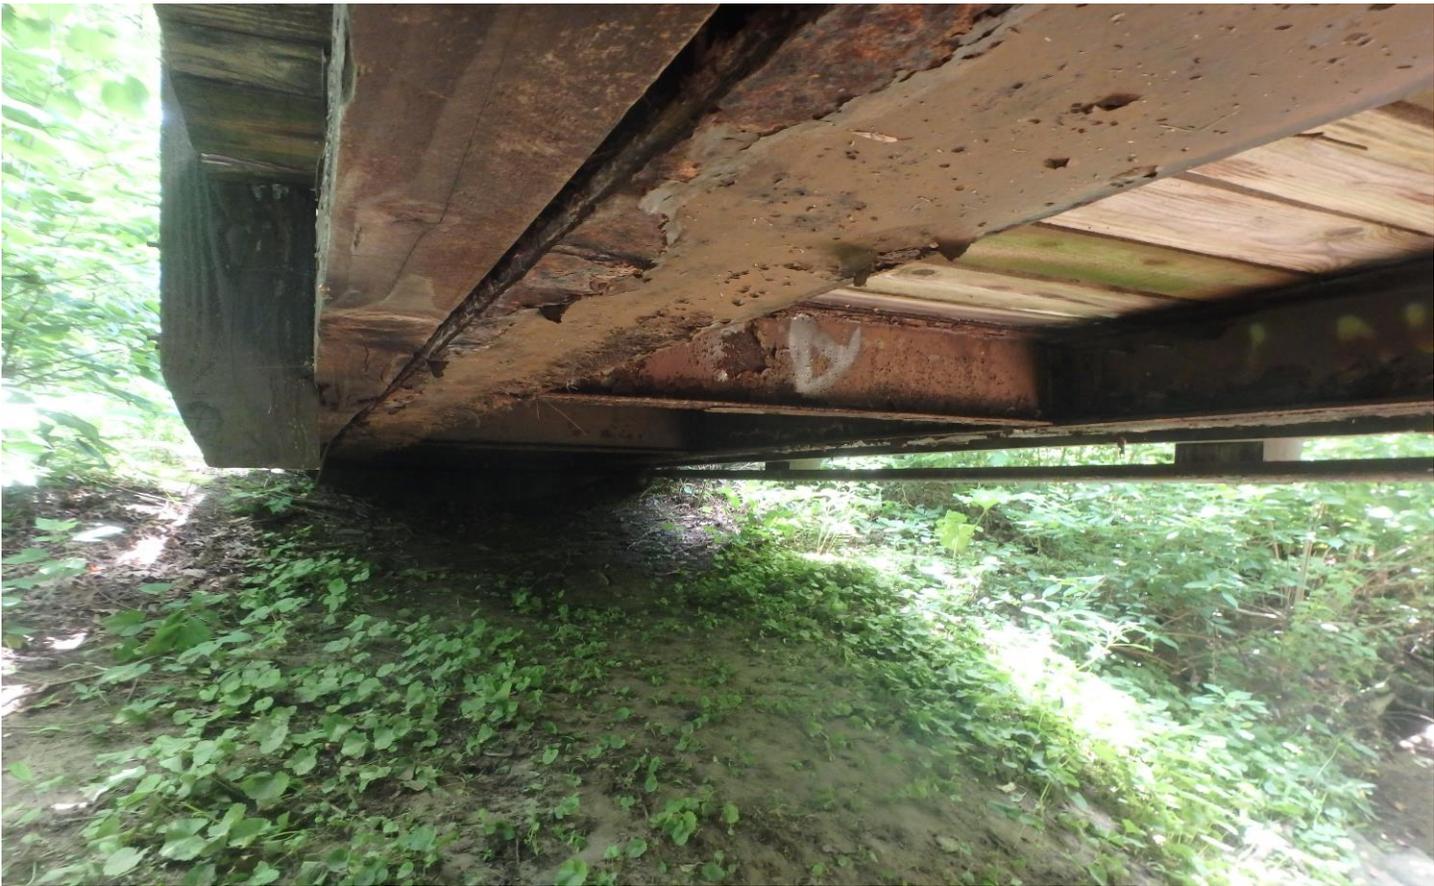
Underside

Structure Elements	Condition	Description
Superstructure	2	Poor condition with moderate to heavy steel corrosion and localized rotting, missing sections, and cracking of wood decking.
Girder/Stringer	2	Painted steel I-beam are corroded with localized minor to moderate loss of section. Paint system has failed. No sign of distress.
Floor Beams	N/A	
Diaphragm & Bracing	2	10" I-Beams
Slab / Deck	2	Wood planks
Substructure	4	Generally in good to fair condition.
Column	N/A	
Bracing	N/A	
Footing	N/A	
Abutment	4	
Wing Wall	N/A	
Retaining Wall	N/A	
Railing	2 NTS	Poor condition. Not to Standard.
Riding Surface	N/A	
Approaches	3	Asphaltic approach pavement in fair condition with scattered cracks and localized rutting
Geometry	3	Bridge abutment in water during heavy rain events
Waterway	Adequate	No sign of erosion, scour, and/or bank stability
Utility	3	Corroded 2" metal conduits hung on the underside
