**MITCHELL PARK HORTICULTURAL CONSERVATORY
DOMES
Peer Review**

Milwaukee, Wisconsin

Final Report

WJE No. 2016.2700

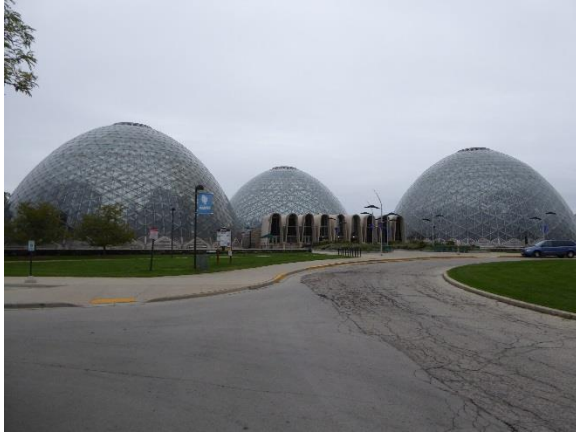
Figure 1. Overall view of the domes

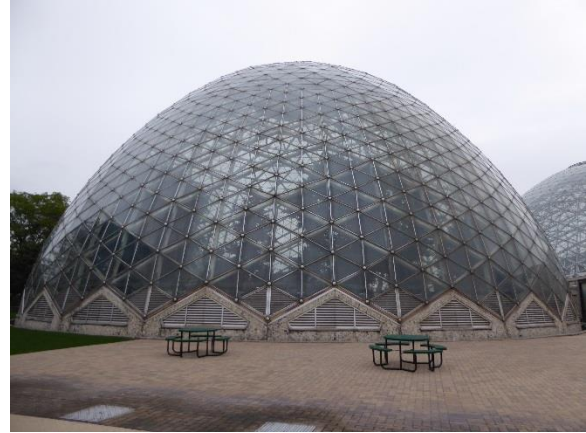
Figure 2. View of the Show Dome

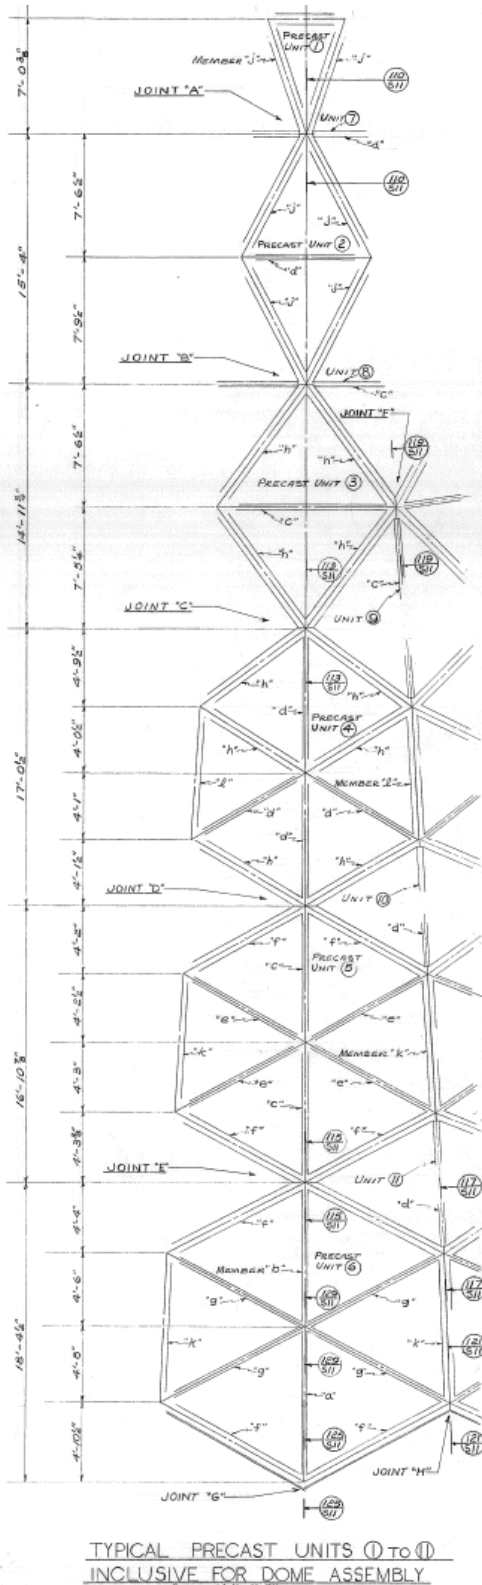
5. The precast concrete frame is comprised of eleven space frame member types (Figure 3). The assembly repeats around the domes 25 times.
6. Precast concrete members are trapezoidal, with the width at the top of each member typically 1/2 inch wider than at the base.

Figure 3. Typical precast concrete members - reproduced from original drawings

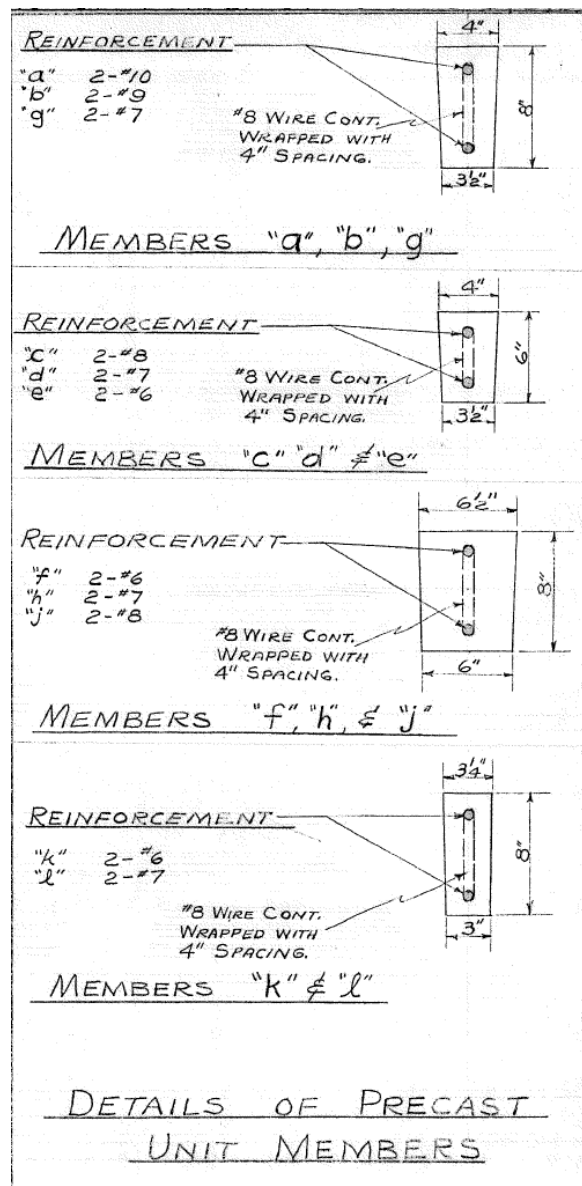
7. Precast concrete members vary in size from a width between 3 inches and 6-1/2 inches, and a depth of 6 or 8 inches (Figure 4). Precast members are reinforced with two longitudinal bars, one each at the top and bottom of the member. The size of the reinforcing bars range from No. 6 to No. 10 bars. The side concrete cover is over 1 inch on smaller members and approximately 2-1/2 inches on larger members.

Figure 4. Details of precast concrete members and reinforcing - reproduced from original drawings

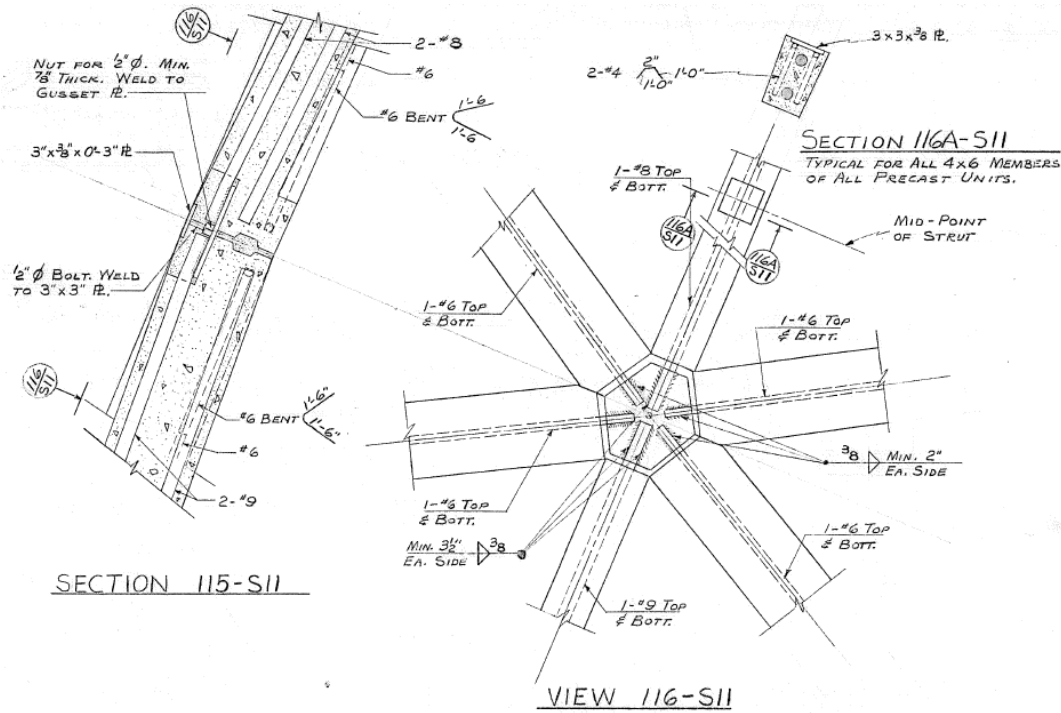
8. Precast concrete members are attached together at joints by welding the end of reinforcing bars in the precast to a gusset plate (Figure 5). Grout is installed over the plate and into the keyway between the precast members.

Figure 5. Typical precast concrete member connection at joint - reproduced from original drawings

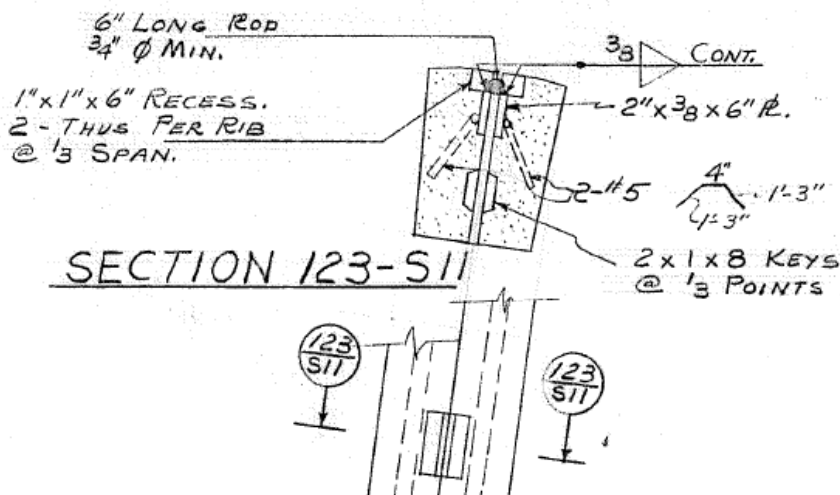
9. Adjacent precast concrete members are attached together by welding a 6 inch long, 3/4 inch diameter rod between embedded plates in each member (Figure 6).

Figure 6. Typical precast concrete connection between members - reproduced from original drawings

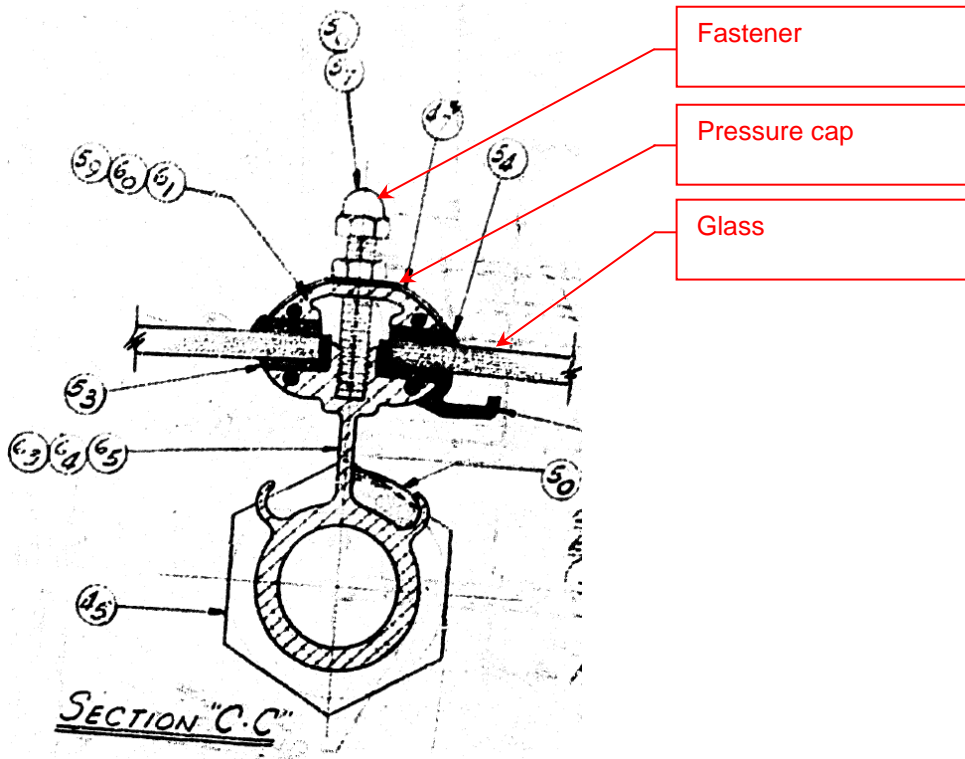
10. The glass is specified to be 1/4 inch patterned wired glass manufactured by the Mississippi Glass Co., St. Louis, Missouri.
11. The glass is held in place with a pressure cap and fasteners (Figure 7).

Figure 7. Section through glass and aluminum frame

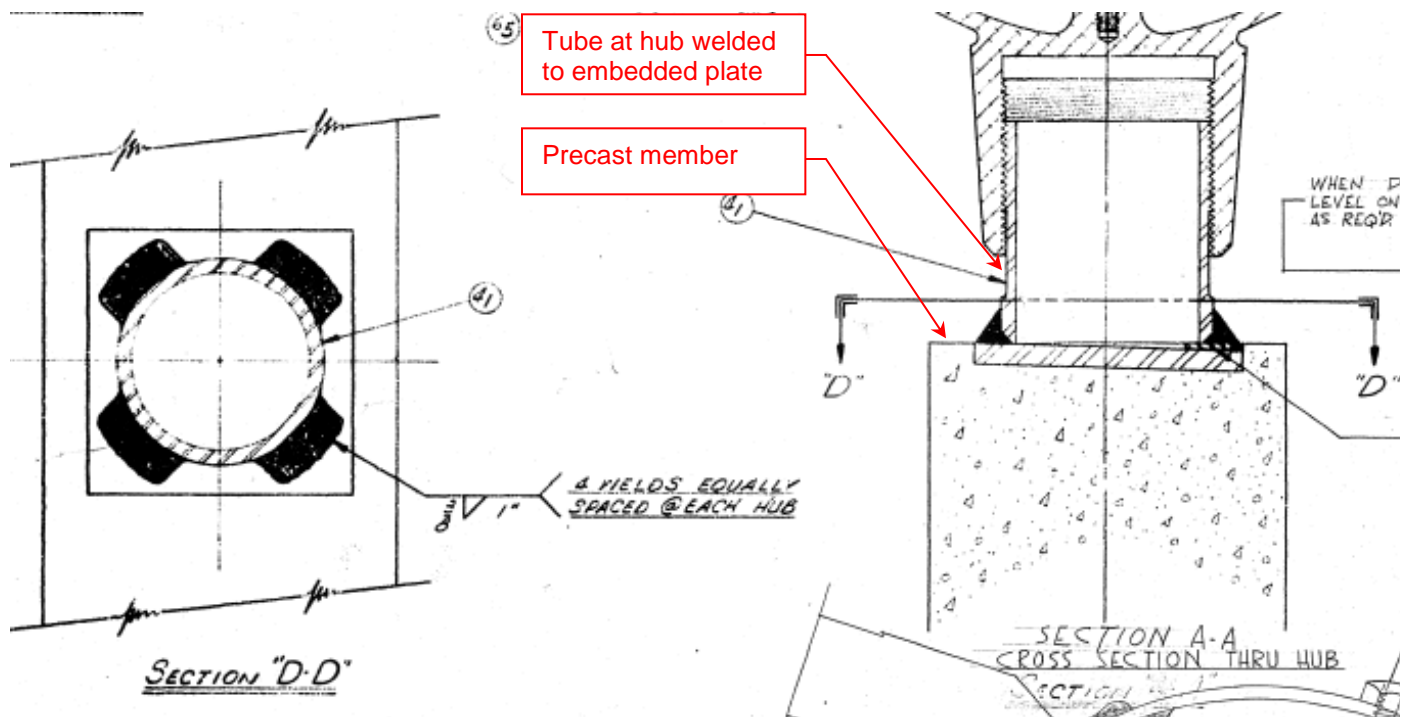
12. The circular hub is welded to an embedded plate in the precast concrete members (Figure 8). The embedded plate in the precast members is flush with the surface of the concrete.

Figure 8. Section through hub from original drawings showing hub welded to embedded plate in precast concrete member
