# 105<sup>TH</sup> ANNIVERSARY MILWAUKEE COUNTY **PARKS**

## 5-Year Capital Request

# STATUS OF IMPLEMENTING DEPARTMENT OF AUDIT REPORT RECOMMENDATIONS

Audit Title: A Tale of Two Systems: Three Decades of Declining Resources Leave Milw. Cty. Parks Reflecting the Best and Worst of Times

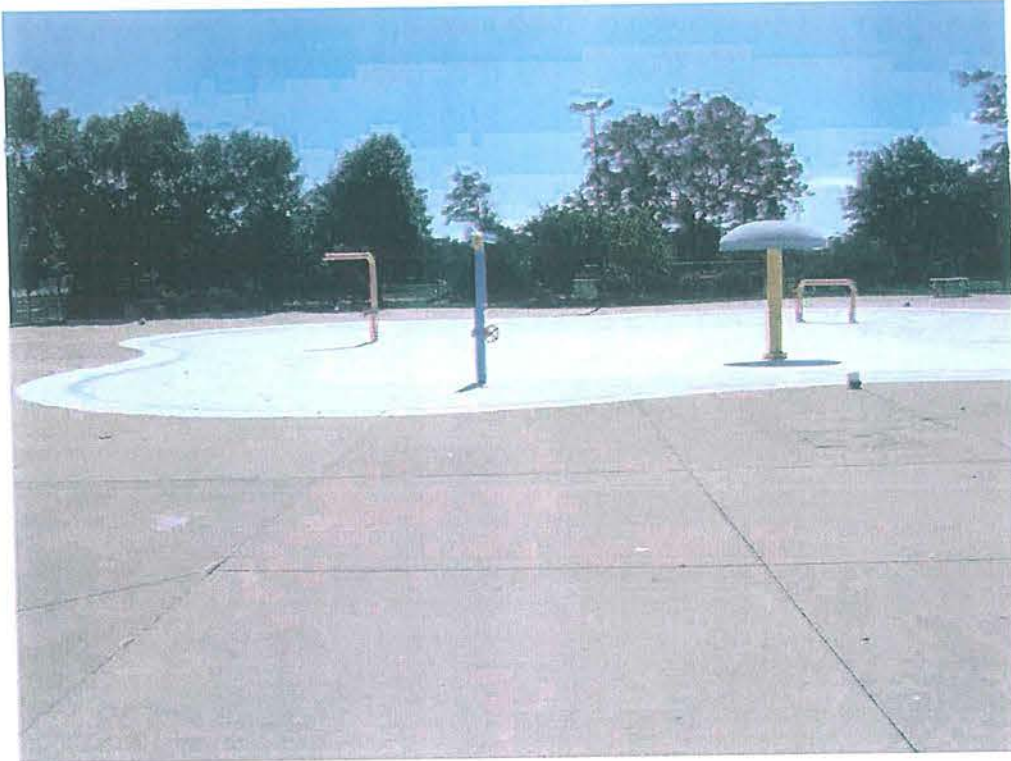
The overall condition of the pool is good (B).

**Pool Tank:** The concrete has many chert pops in the northwest slab, but is in otherwise good condition. The pool was caulked in 1998 and the joints are in good condition. The caulk has a sticky, chalky residue.

**Deck:** The deck concrete is in good condition since the concrete around the deck drains was replaced in the 2002-2003 off-season. Concrete around two of the deck drain cutouts is spalled with patches, caulk, and cracks.

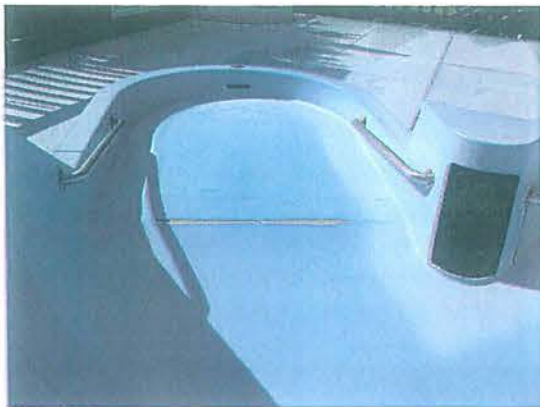
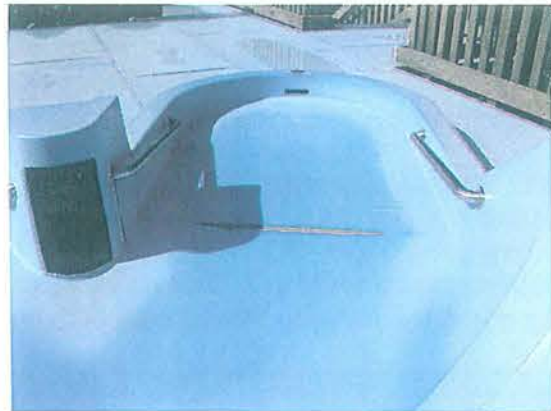
Cool Waters September 2009  
Fiberglass entry well at tome of tube slide

The timber railings were rotting, especially at top of posts. Weak rails at top deck east of tube slide needed to be strengthened immediately. The fiberglass decking was in good shape.

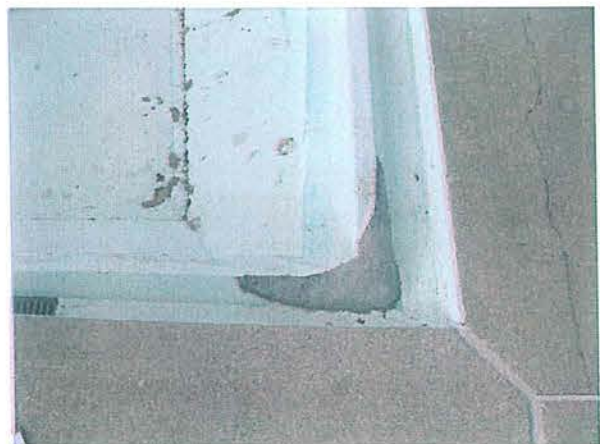
September 2009

The northwest corner of the shallow area has a long crack in the scum gutter back wall.

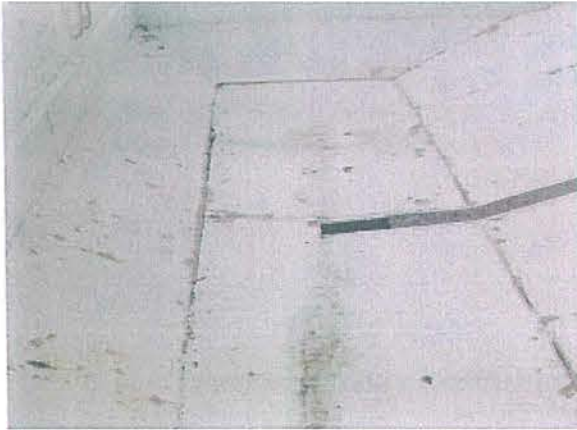
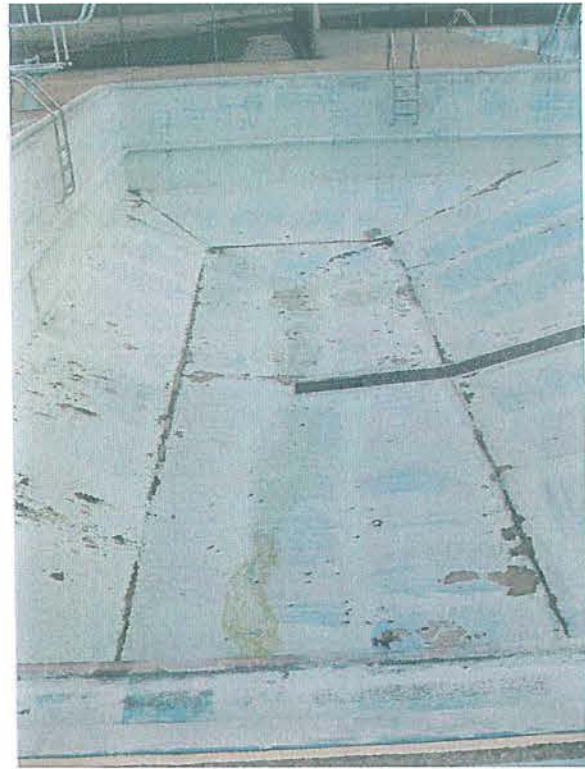
**Pool Tank:** The diving well in this pool is subject to the constant flow of groundwater through the joints and cracks in the concrete. Water also seeps in from the aluminum sides in the diving well from as high as the foot ledge. The groundwater relief valves in the floor of the diving well do not appear to relieve the groundwater pressure. The joints have algae and mold growing in them. Caulk cannot stick in the joints in the diving well due to water seepage. Protective coating on the south wall of the diving well is constantly peeling. Patches in the deep well are lifting along the edges.

Hales Corners Swimming Pool – Diving Area:  
Note peeling and worn protective coatings,  
concrete spalls and patches, deteriorated joints  
and cracks

Any work done to correct the problems in the diving well must address the groundwater issue. Possible solutions include:

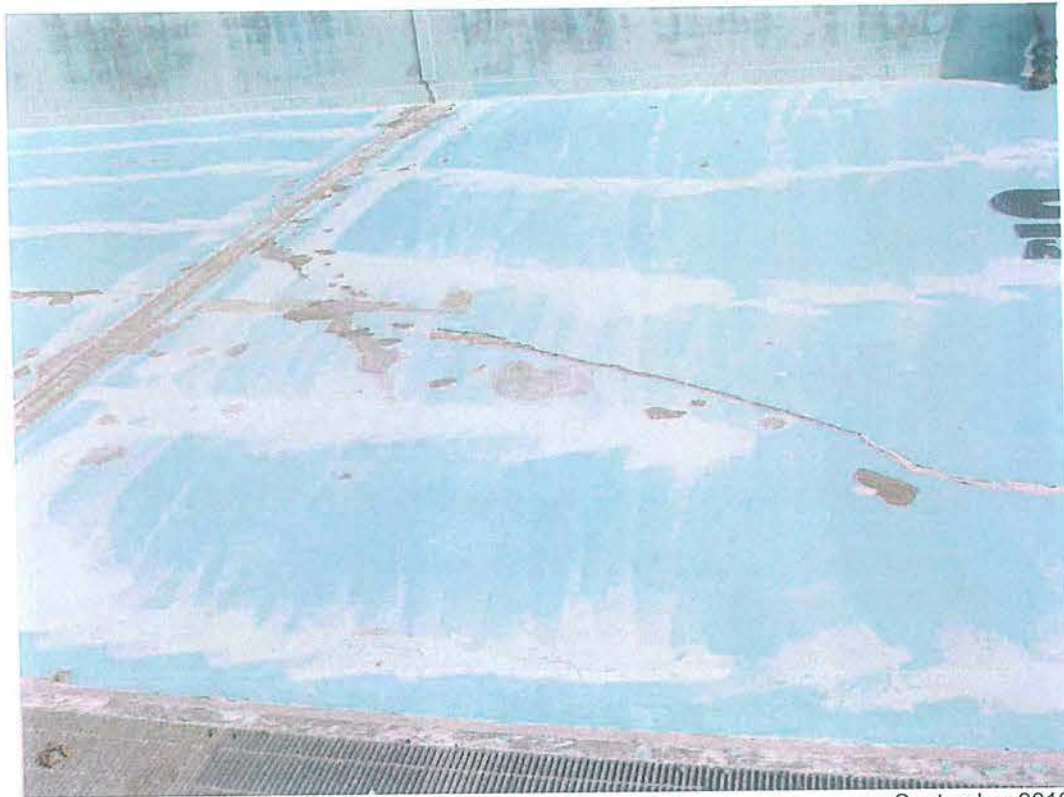
Hales Corners Pool

Masonry repairs and caulk replacement was done in the diving well in June of 2007, just before the pool opened. The shallow pool floor has a few cracks that should be repaired and recaulked. The pool needs a complete recaulking. Lack of expansion joint causes concrete next to edge repair to fail.

In the shallow area, there are cracks missing caulk, failed patches and a need for edge repair.

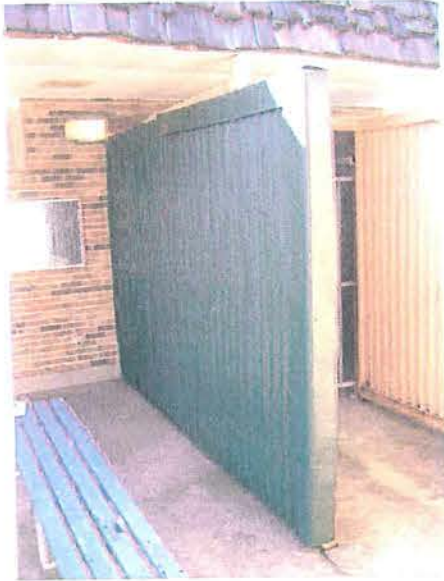
**Dressing Yards:** The dressing yards have transite walls and divider panels. While the protective coatings on the transite are in good condition, the metal frames are extremely rusting and peeling. The benches are coated and look fair because of wear and the over splatter. Slabs look good with some cracks and patches.

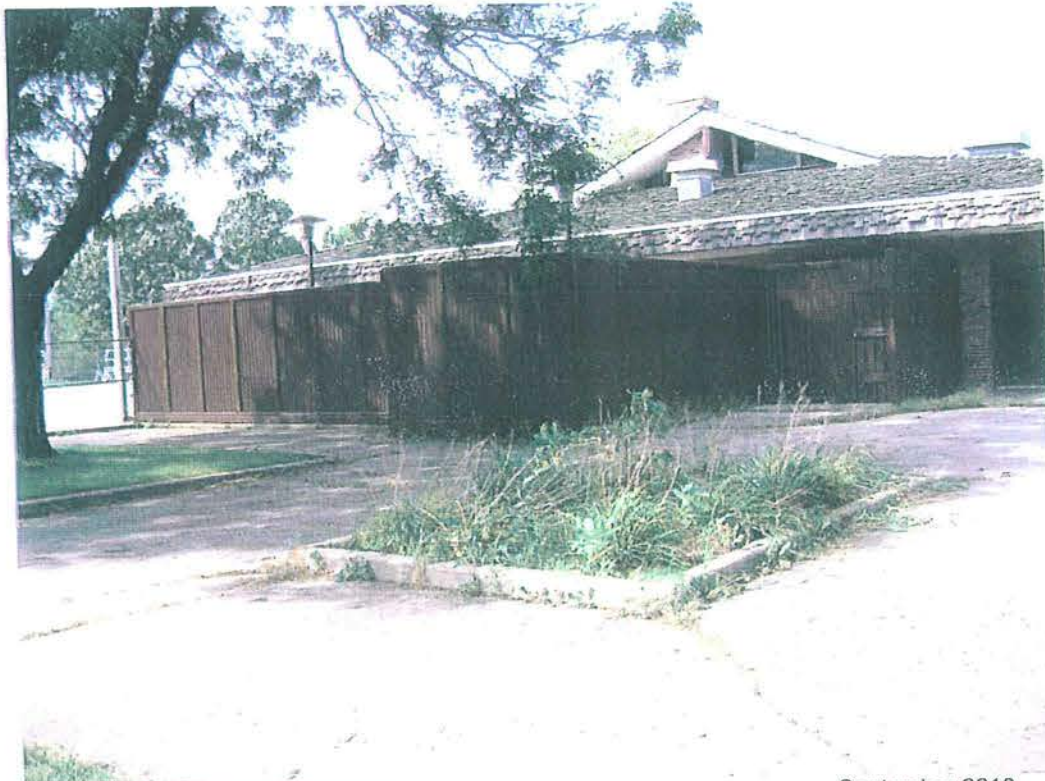
In 2010, the transite panels were encapsulated in brown protective coatings. The application appears to be very good.

Hales Corners Swimming Pool

Protective coatings applied to Transite Panels

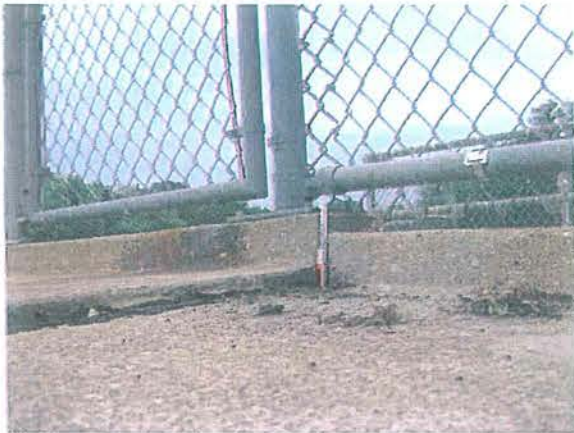
**Deck:** The deck is in fair condition. The deck over the filter room needs replacement. The deck slab south of the filter room has settled about 1.5 inches.

Jackson Park Swimming Pool September 2008  
Deck slabs out of level

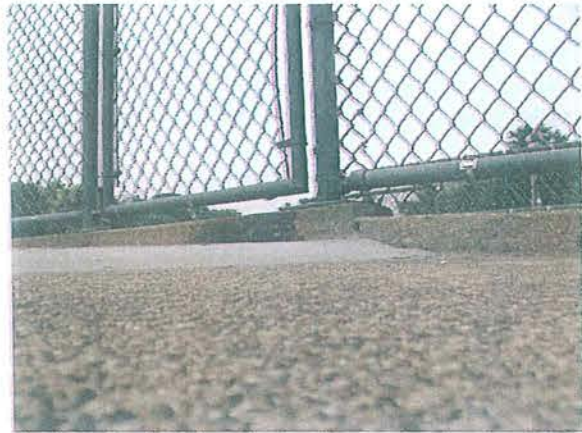
Jackson Park Swimming Pool September 2009  
Out of level deck slabs with transition

The sundeck has spalls, cracks and toe stubs, especially between the waterslide and the building. Several slab corners need rebuilding. There are tripping hazards from slabs out of level at the west and east end of the pool near the fence. Several slab corners are very deteriorated. A section of curb on the southwest side of the deck was replaced during the 2005-2006 off-season and looks fair.

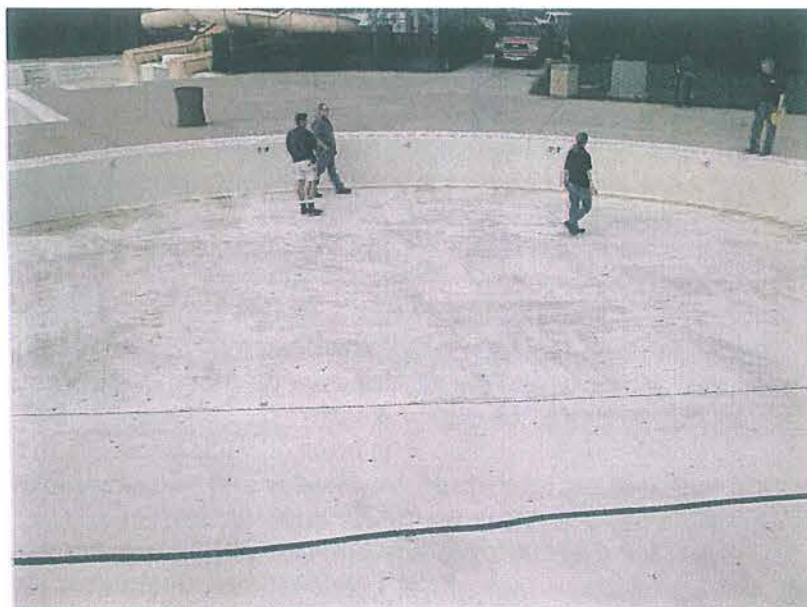
Pelican Cove Pool Tank

**Protective coatings:** The protective coating system has some thin spots and some spots where the protective coatings have peeled to bare concrete. Protective coating on the walls is almost completely worn off and it is in very poor condition.

In the spring of 2008, the northeast wall was coated from the 3'0" depth marker to the 3'11" depth marker.

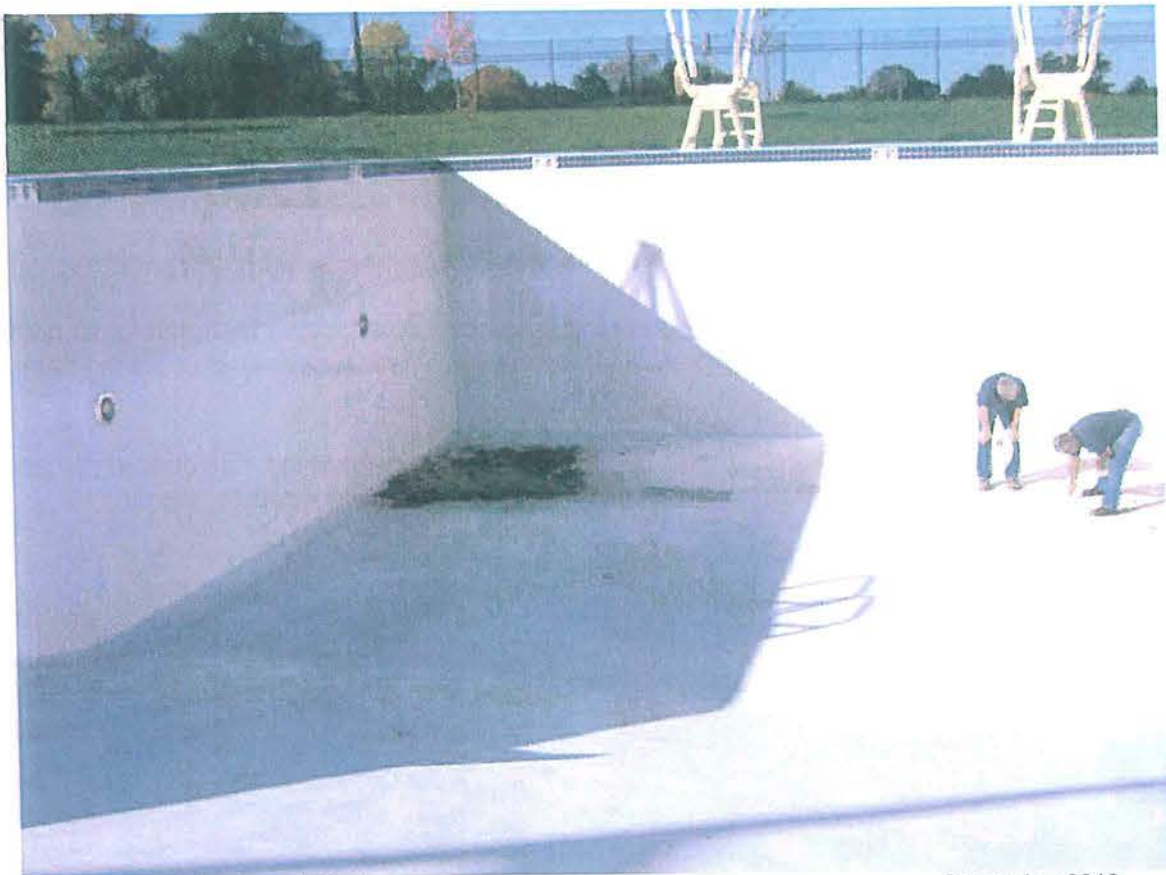
David Schultz Aquatic Center

**Pool Tank:** Both the pool tank and lazy river are in very good condition. There is some cracking in the activity pool floor where it slopes to the diving area.

Water ponds in the southwest corner of the deep area for the pool. Pool operators report that the stain on the concrete caused by the standing water is difficult to clean.

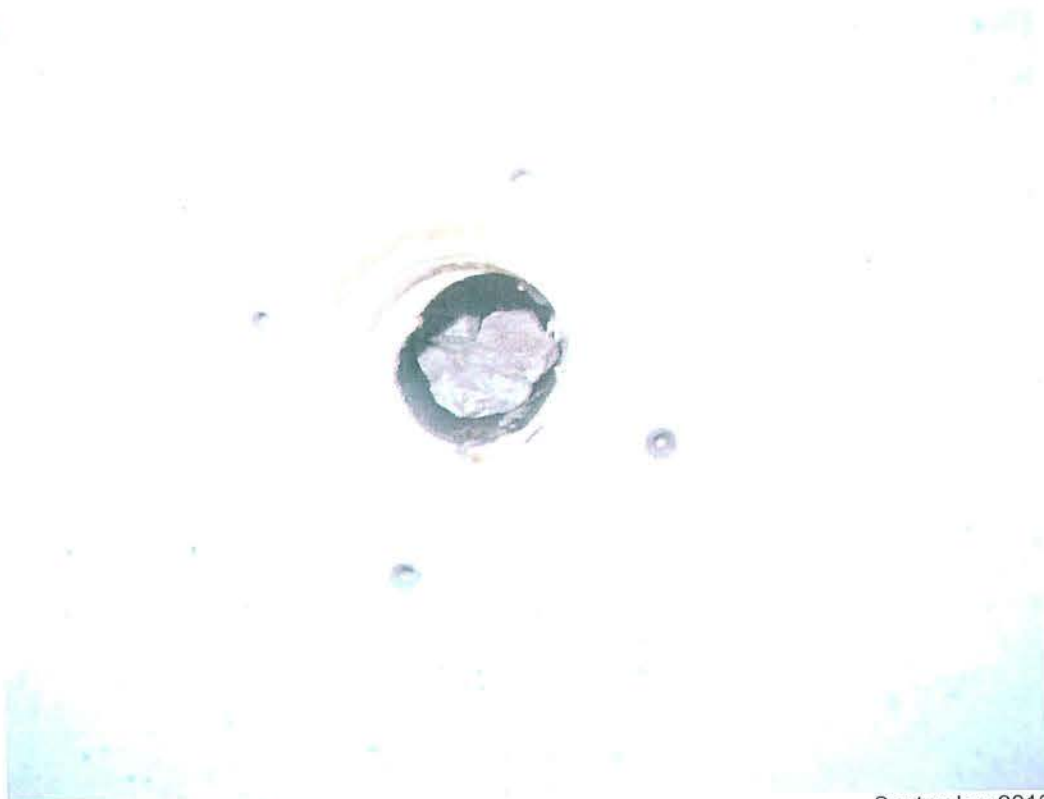
**Piping:** During the 2010 pool inspection, we noticed #1 stones in pool return wall inlet on south wall left of yellow slide.

David Schultz Aquatic Center

Small Stone in Pool Return Wall Inlet

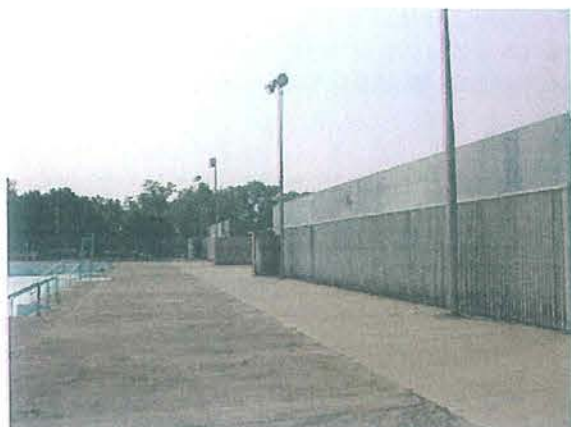
McCarty Park West Side Deck September 2005  
Note bare & discolored transit panels

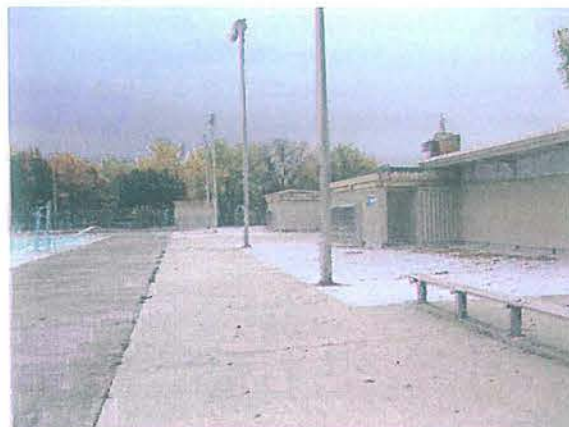
McCarty Park West Side Deck September 2008  
New Dressing Yard Panels

Work of the Contract included demolishing the existing outdoor dressing yards and showers and replacing with new changing areas and showers. The existing basket checking shelters were converted to male and female dressing rooms, admission and concession area, family changing area and restroom, and storage. Outdoor showers were rebuilt with partitions connecting the bathrooms to the new dressing rooms. The existing wading area toilets were relocated and enclosed with new partitions. Fencing and gates were installed to configure a new entryway to the pool. Work included demolition, plumbing, concrete, partitions, masonry, carpentry, roofing, fencing, and landscaping. The shower room floor was coated as specified in the spring of 2009. and still looked good at the fall 2010 inspections.

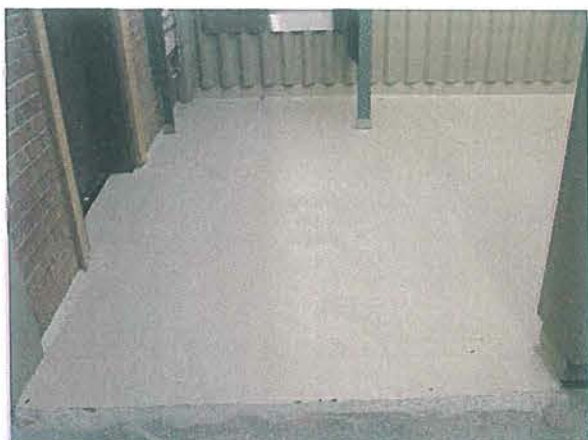
South (Men's Side) September 2009  
McCarty Park Shower Room Floor

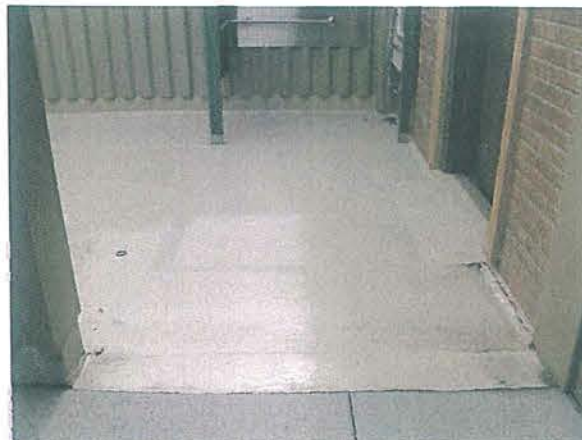
North (Women's Side) September 2009  
McCarty Park Shower Room Floor

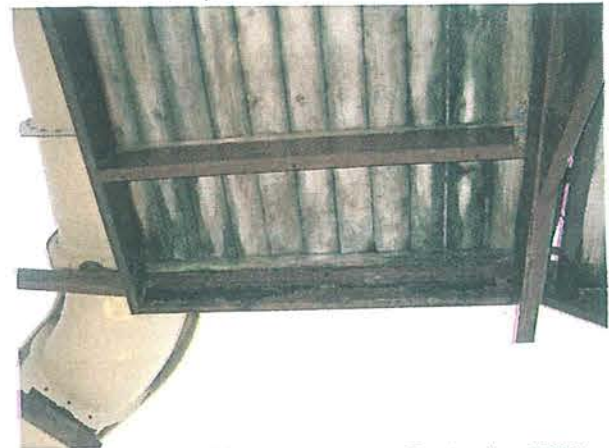
McCarty Water Slide September 2009  
Underside of stair landing

For the deck support angle on the backside of the frame, part of the weld is failing and there is moderate loss of section.

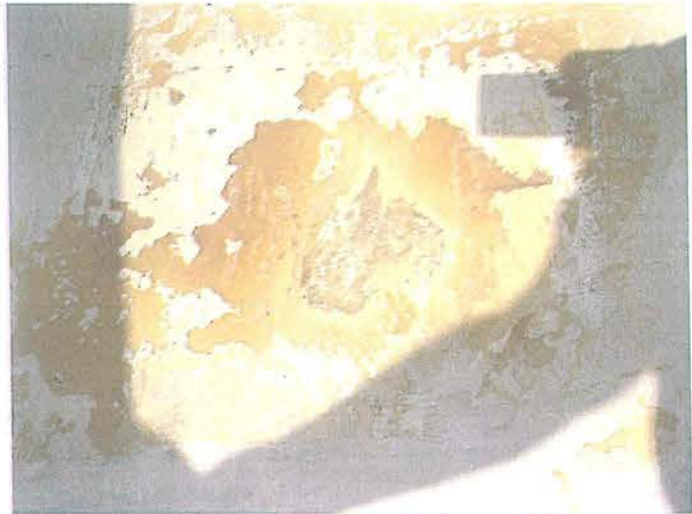
McCarty Water Slide  
Surface of slide flume

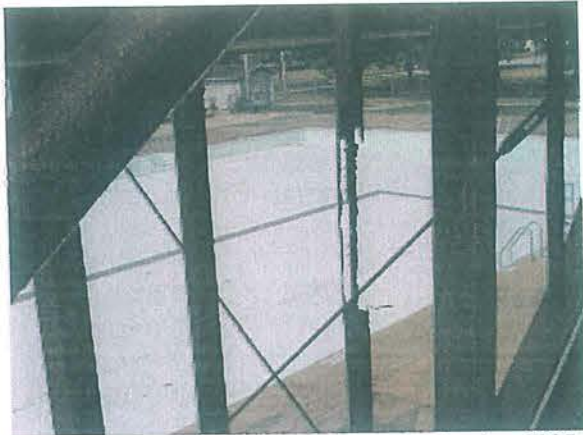
In 2007, the slide entry well had a lot of movement (it is squishy) due to water getting between the laminated layers. The steel components of the slide structure need protective coatings or they will continue to rust.

McCarty Water Slide  
Baluster rusted through

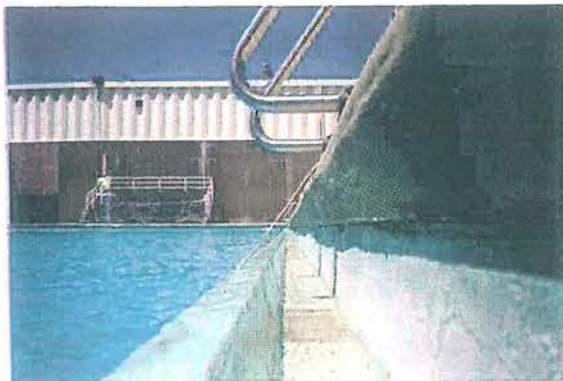
**Diving Pool:** Prior to the liner being installed, the diving pool had full-length cracks in the floor and the wall to floor joint needs caulk. Groundwater flow into the diving pool is constant. In January 2006, the City of Milwaukee Department of Neighborhood Services issued an Inspection Report and Order to Correct Conditions in the Diving Pool. The instructions were to repair and apply protective coatings to the pool tank, repair the gutter and coping, and repair the deck. Park maintenance applied new protective coatings to the top portion of pool walls down to 4-feet below the gutter rim. Where the gutters were spalled, they installed plates.

July 1999  
Wilson Diving Pool Gutter - Before PVC Pool Liner

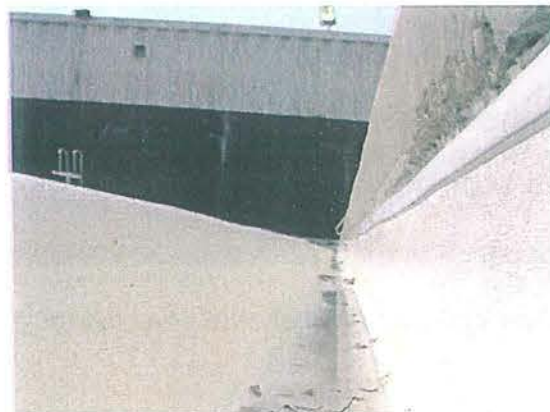
The diving pool scum gutter piping was replaced in the spring of 2007. In order to expose the piping, the deck slabs adjacent to the pool had to be removed. These slabs rested on the top of an asbestos bearing pad on the pool wall. Removal of the slabs required asbestos abatement. Deteriorated sections of the back gutter wall fell apart and were replaced.

September 2009  
Wilson Diving Pool Gutter - After PVC Pool Liner

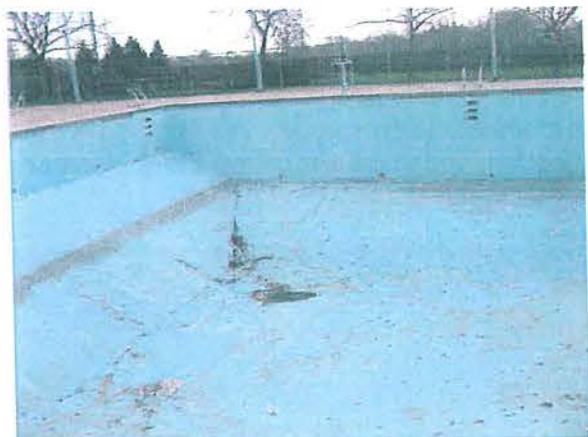
April 2008  
Wilson Diving Pool - Before PVC Pool Liner

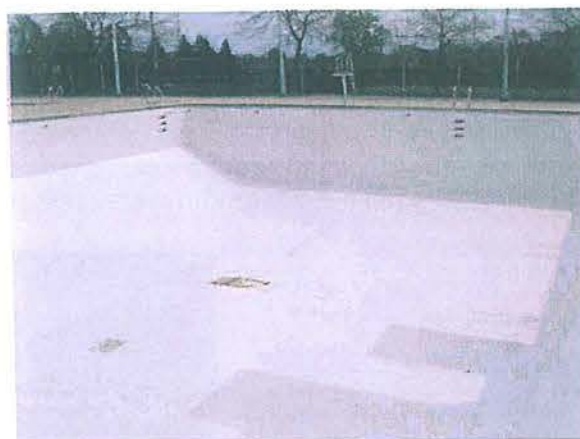
**Diving Pool:** A PVC pool liner was installed in the diving pool in the spring of 2008. The liner is 60 mil thick and has a 15-year warranty from Renosys. After two seasons, the liner has no tears or separating joints. However, after the pool was emptied groundwater collected on the deep well floor under the liner. There were at least 6 water pockets that were not relieved by the ports installed for that purpose. The manufacturer/installer of the pool liner (Renosys) assured us that these pockets of groundwater are not detrimental to the pool liner. When the pool is refilled, the groundwater will be forced out and the membrane will return to its proper place.

September 2008  
Wilson Diving Pool - After PVC Pool Liner

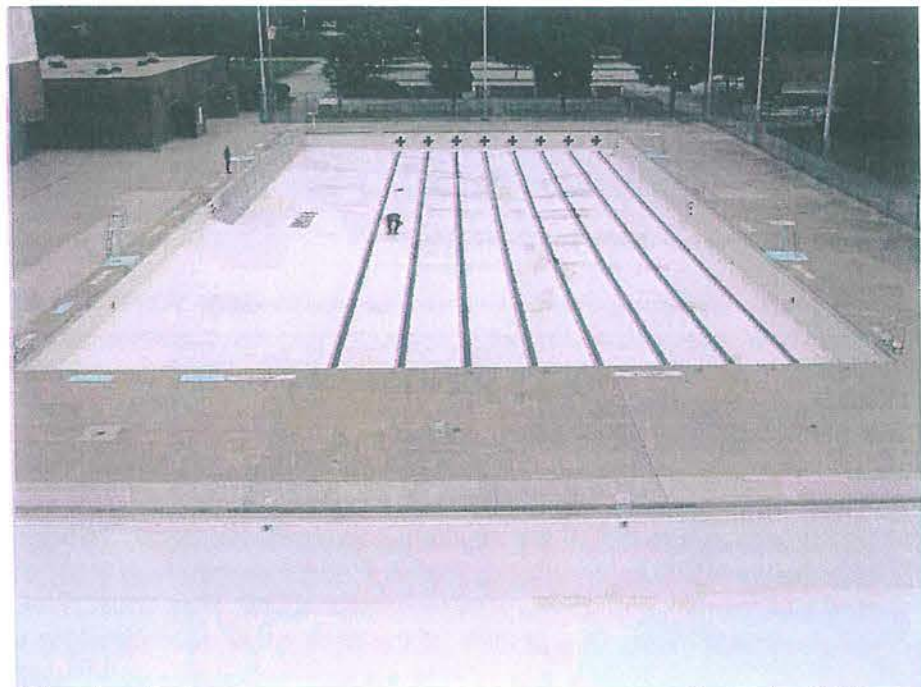
**Lap pool:** Protective coatings were installed in 2006 after the pool floor was reconstructed. The protective coatings are in very good condition despite some chipping paint on the floor. There is thinning and minor chipping of the black lap lane markers, especially on the north wall. This may be due to ultraviolet degradation. In 2010 there were more chips in the coating system, probably due the improper adherence of the paint to the fresh concrete.

Wilson Lap Pool  
after the floor  
replacement and  
new protective  
coatings. The  
handicap ramp is  
being installed on  
far left..
