# Milwaukee County Parks

- Coastal Asset Inventory
- Coastline Management Guidelines

December 2020

## Milwaukee County Coastal Resources Inventory

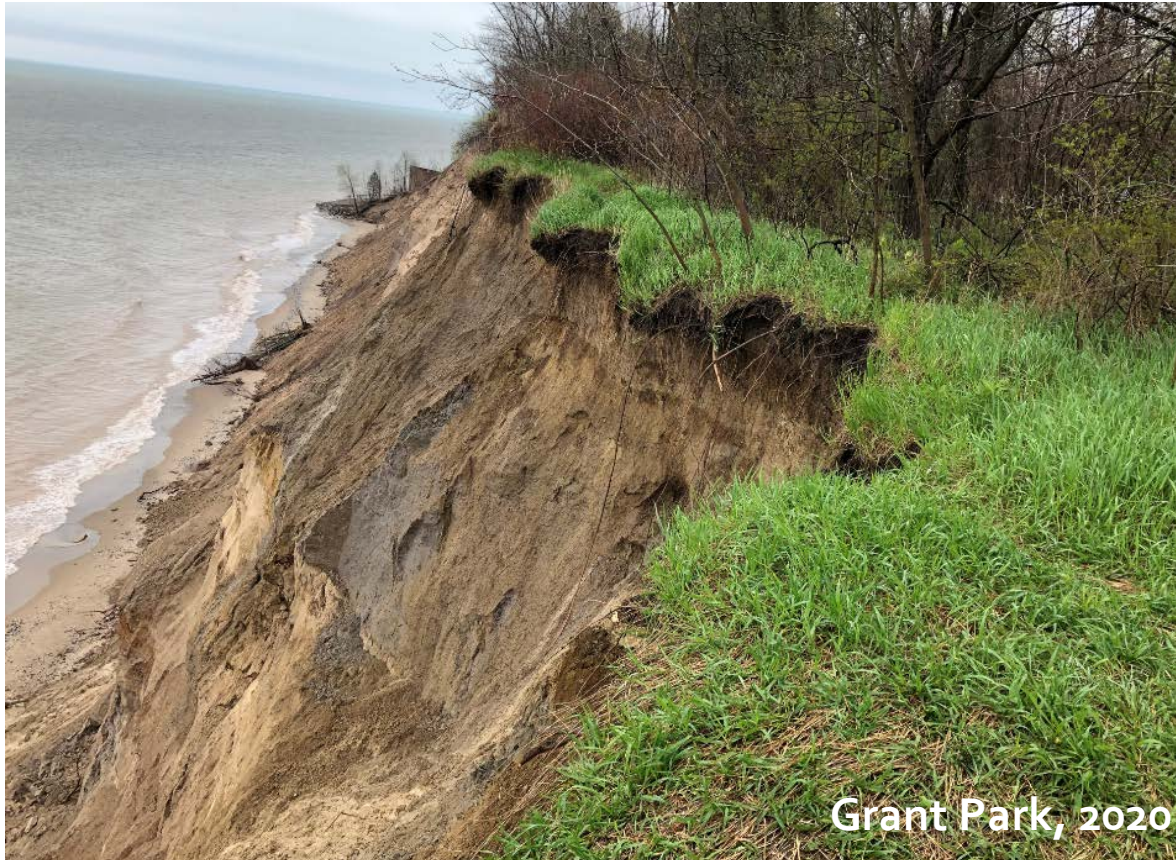
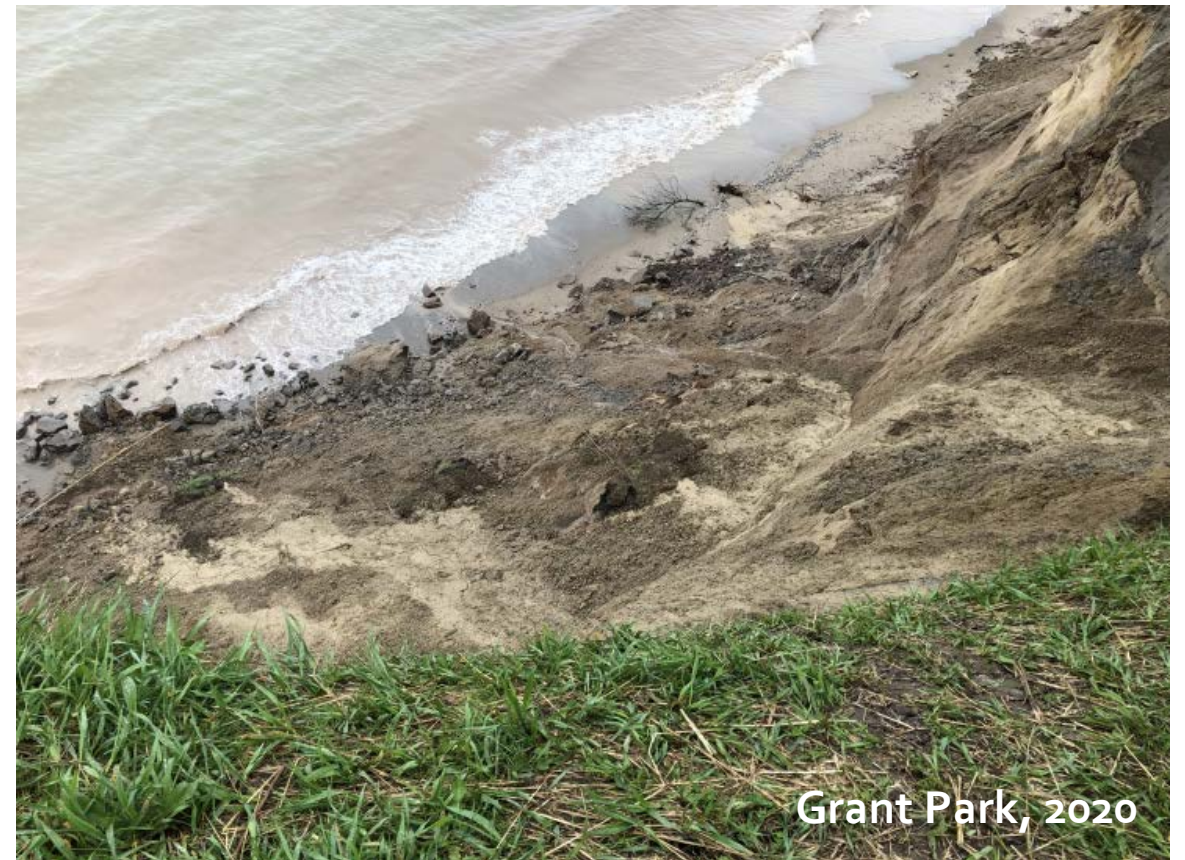
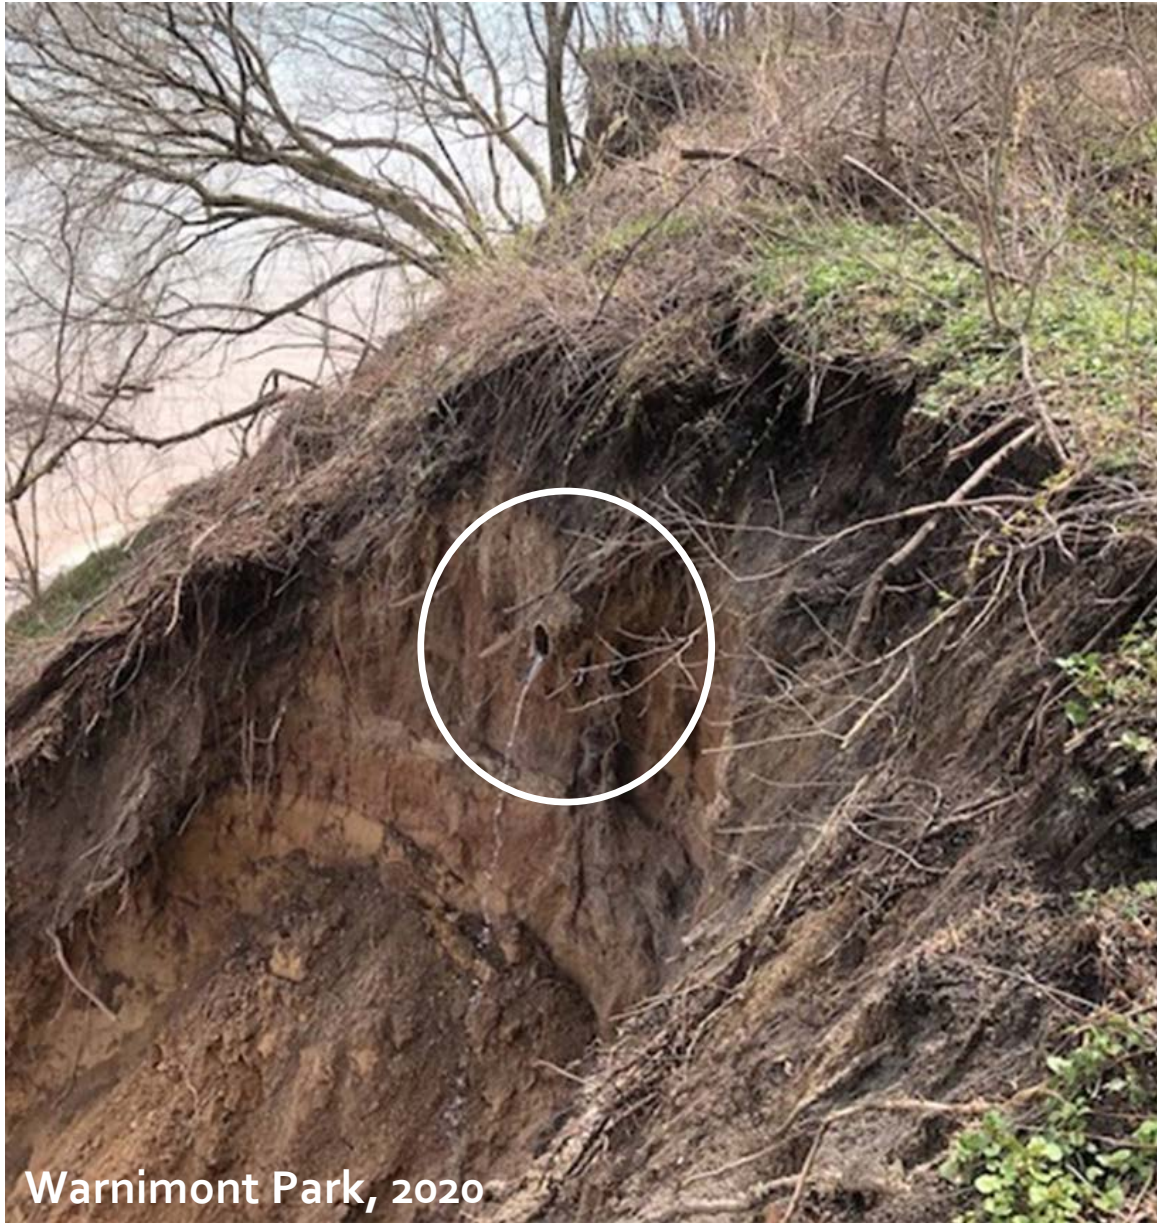
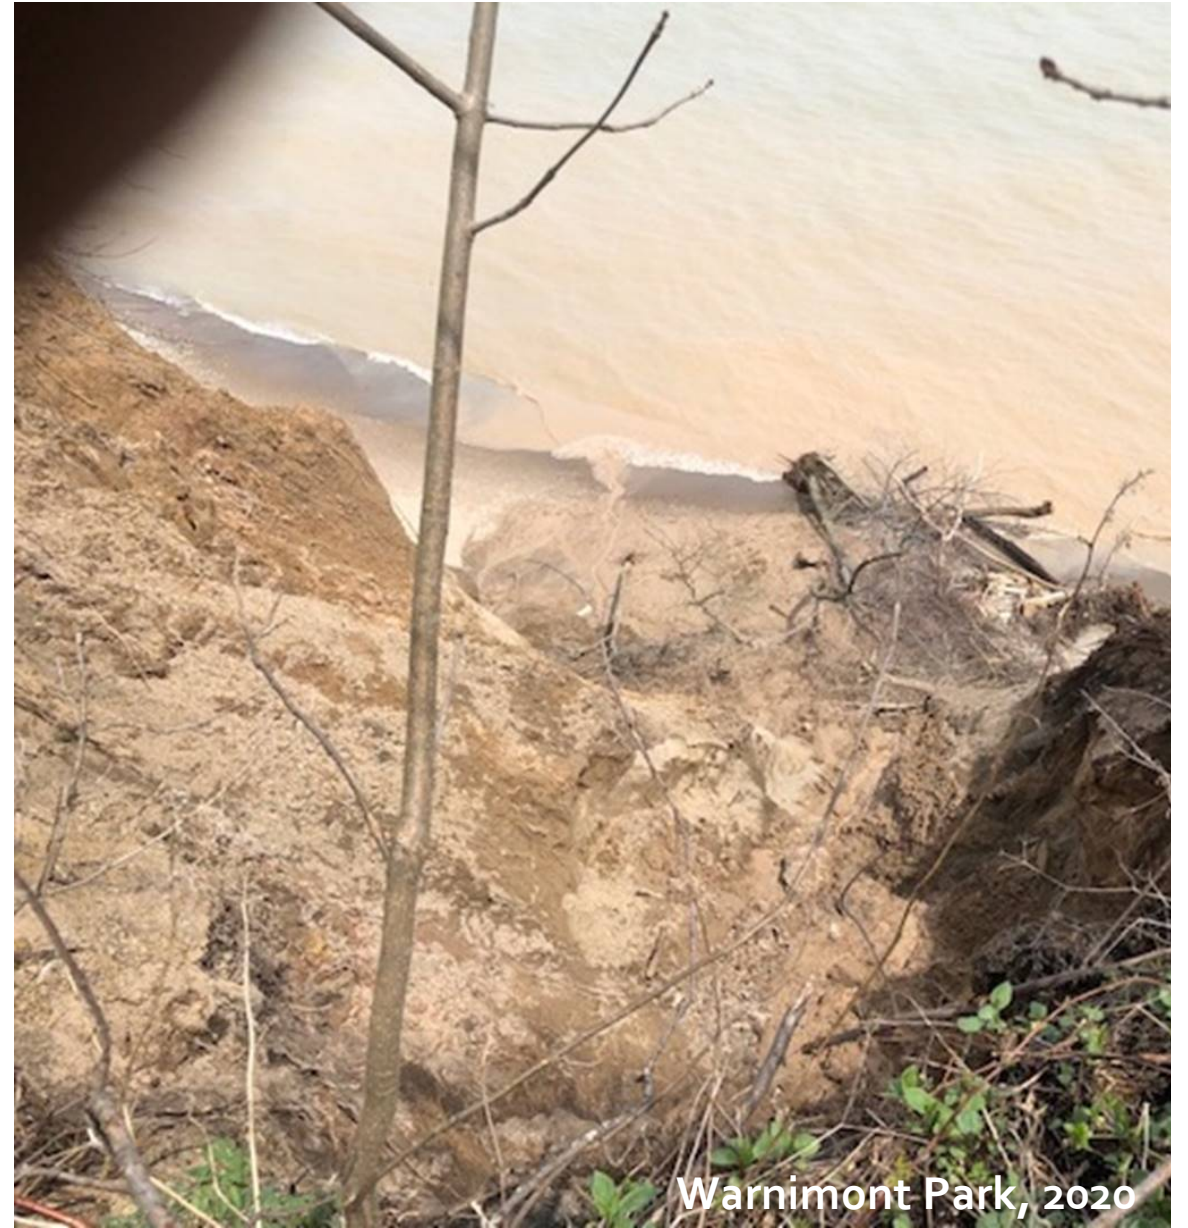
# History of Coastline Damages

- Past declared storm disasters in 2008, 2010, and 2020.
- Continuous coastline impacts cause degradation to bluffs.
