Mitchell Park Domes Historical Timeline and Reports
Department of Administrative Services (DAS) Division of Grants & Special Projects
Updated August 12, 2021

Pierce Engineers and a team of sub-consultants performed materials testing on the precast concrete frame and a foundation condition assessment of the Show Dome at the Mitchell Park Horticultural Conservatory. The assessment work was performed May 16 to June 3 of 2019. The assessment of other domes is not part of the scope of this report.

MITCHELL PARK HORTICULTURAL CONSERVATORY MILWAKEE, WISCONSIN PRECAST CONCRETE FRAME TESTING

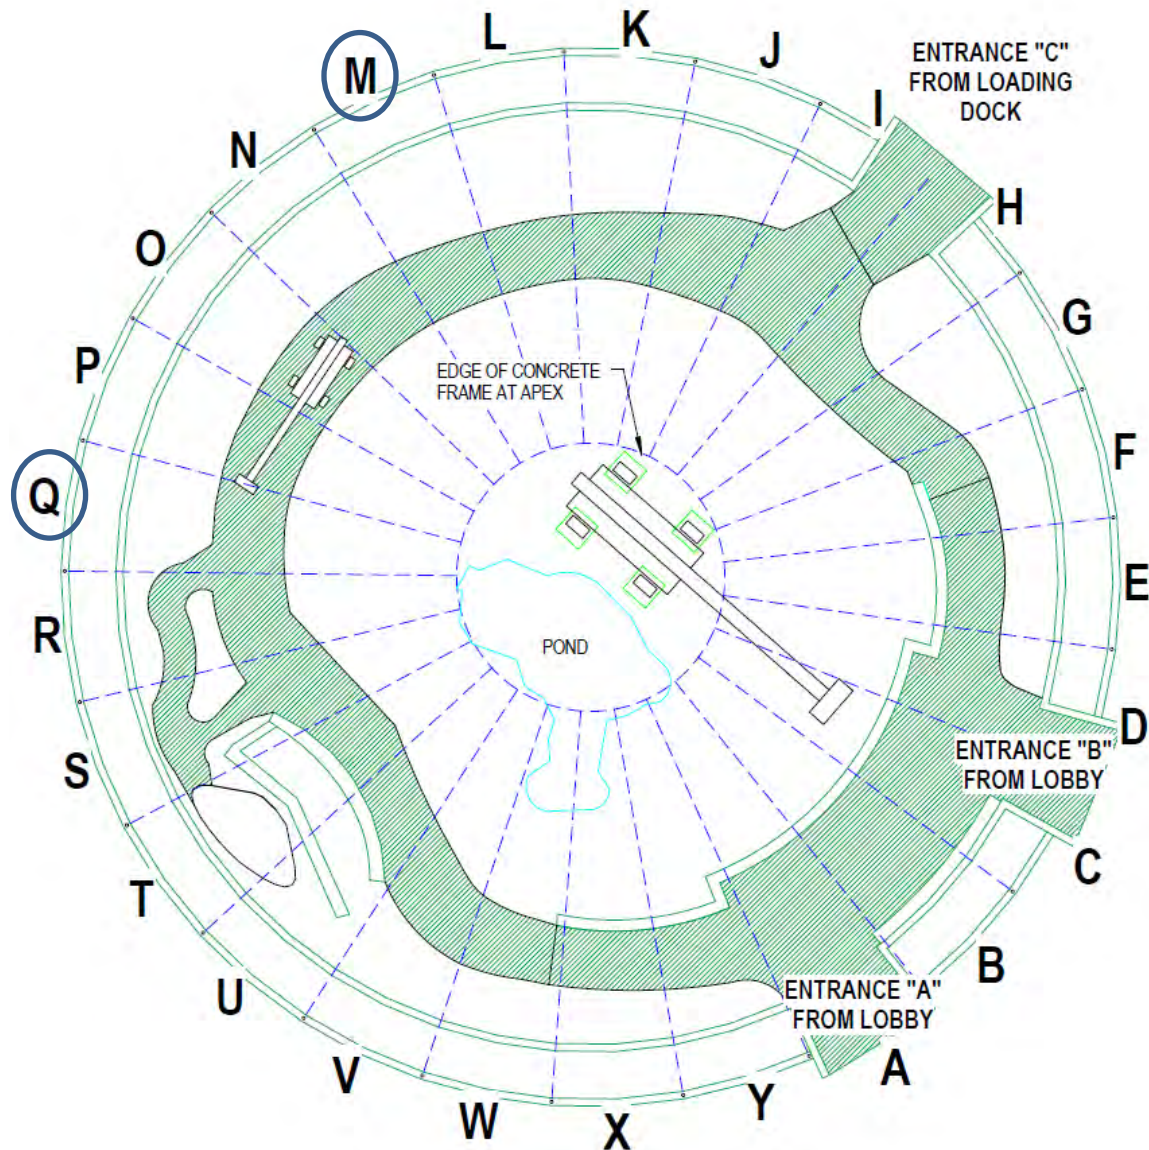
Figure 1: Sector Layout

Two representative areas of the Show Dome were evaluated – they were located at the base of Sectors M and Q. The locations of sectors were identified in the 2015 report by GR̄AEF. The typical sector shapes and connection details were identified in the original structural drawings on Sheet S-11.

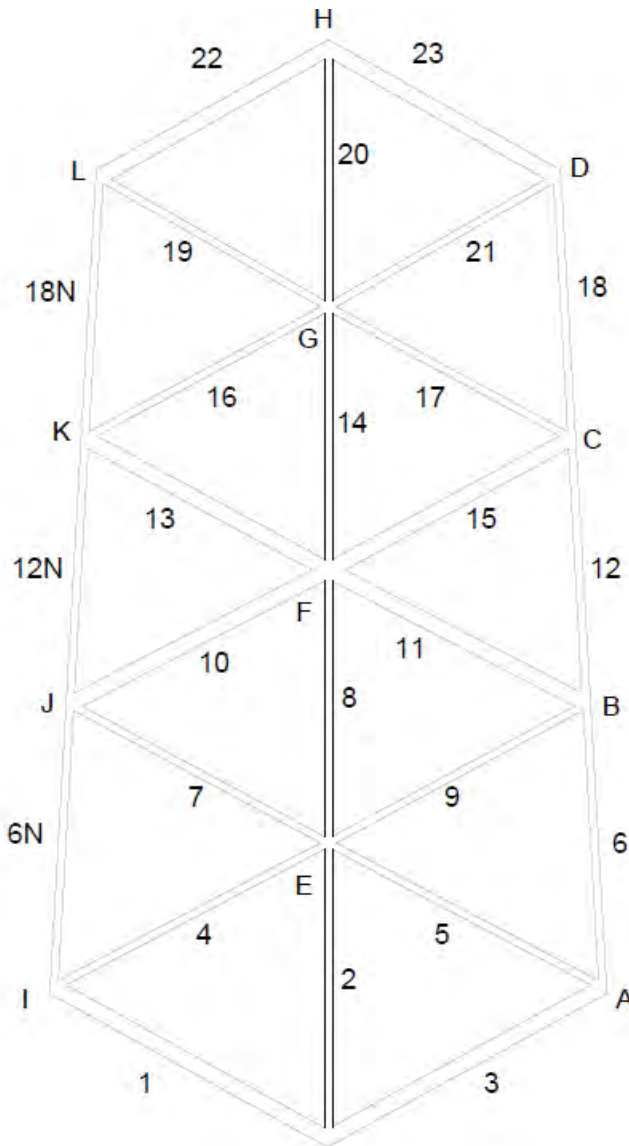
Figure 2: Test Location Key for Area M, (Area Q is similar) Show Dome

The naming convention used within the representative test areas is presented in Figure 2. A letter designation was used to identify the 12 weld plate joints, while a number designation was used for the 23 structural units evaluated in each representative test area.

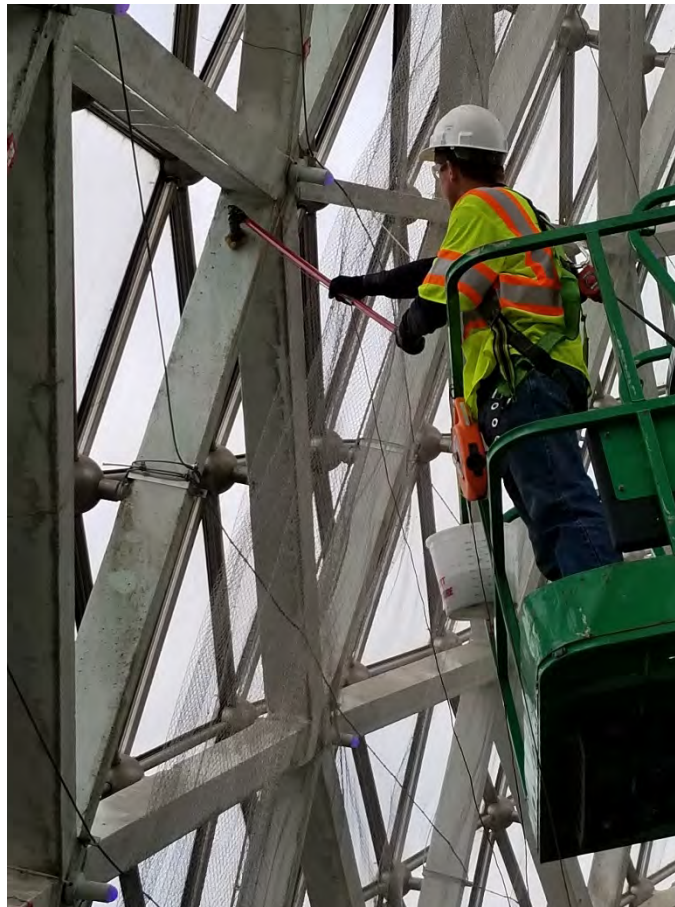
Figure 3: Corrosion Potential Testing

Corrosion potential measurement were collected on the structural units within M and Q at four locations designated A-D and the measured values are presented in Table 2 and Table 3, respectively. All the measurements were above -350 mV, which indicates a low probability of active corrosion. However, another effective method of interpreting corrosion potential data is to look at the relative change in potential between two adjacent measurements. Significant potential difference (delta or gradient analysis) between two locations indicates a high probability of active corrosion. The delta values were calculated for all the measurements to better assess the probability of corrosion and are included in Table 2 and Table 3. A delta value of 100 mV in 2 ft was used to indicate probable active corrosion. Delta values of 100 mV or higher are highlighted in red in Table 2 and Table 3.

It is clear from the delta analysis that despite low corrosion potential values recorded for all the structural units, there are still some areas with a reasonable probability for active corrosion. These areas of active corrosion were located predominantly at the weld plates where cracking or poorly consolidated grout was observed. The location and direction of the voltage gradients indicates the probability of corrosion as illustrated in Figure 4 and Figure 5.

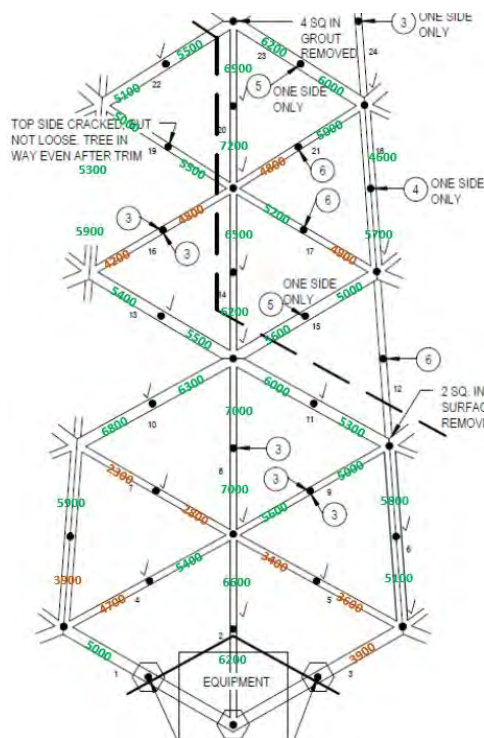
Figure 7: Sonic/Ultrasonic Compressive Strengths Measured in Element M

Sonic/ultrasonic surface measurements were conducted at the quarter point (two locations per member) of each of the structural members 1 through 23 for Element M and Q. Compressive strengths calculated using the stress wave velocity relationship for the structural units tested in elements M and Q are presented in Figure 7 and Figure 8. Locations where the average strength is less than 5,000 psi correspond to lower than average compressional and shear wave velocities and are indicative of increased cracking and deterioration. These locations have been highlighted in orange. Statistical summary of this data is presented in Table 4.

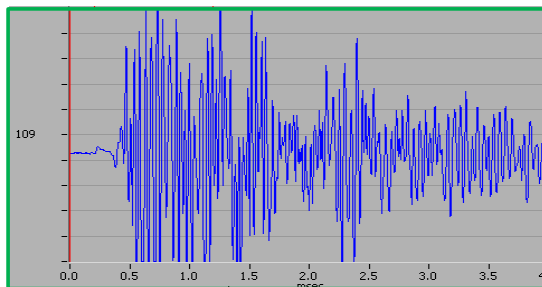
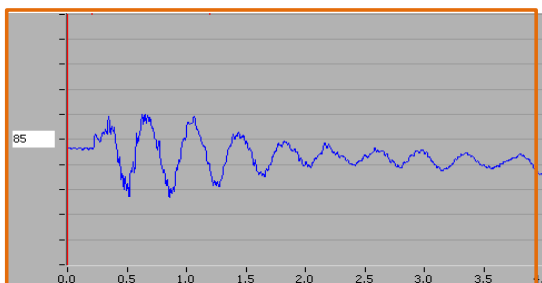
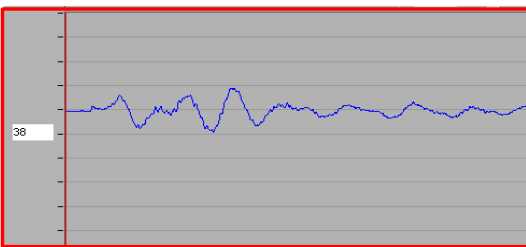
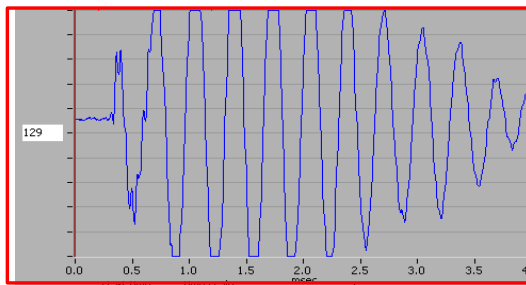
Figure 9: Typical Waveforms and Their Interpretation

Delaminations or “voiding” may also be detected by the presence of a “drum-head” frequency. The low rolling “drum-head” frequency is caused by the flexing of a “relatively” thin layer of concrete overlaying a void/delamination. The waveforms shown in Figure 9 (data collected on this project) are indicative of these conditions.

Well-Bonded - Good signal quality
Strong signal amplitude
Good signal attenuation
High frequencies un-filtered

Partial Bonding (cracking/poor grout) - Fair signal quality
Diminished signal amplitude
Moderate signal attenuation
High frequencies partially filtered

Poor/no Bonding (cracking/poor grout) - Poor signal quality
Low signal amplitude
Poor signal attenuation
High frequencies filtered

Poor/no Bonding (cracking/poor grout high potential for delamination/voiding)
 Poor signal quality
 Signal dominated by Low frequency "Drum-head"
 Poor signal attenuation
 High frequencies filtered

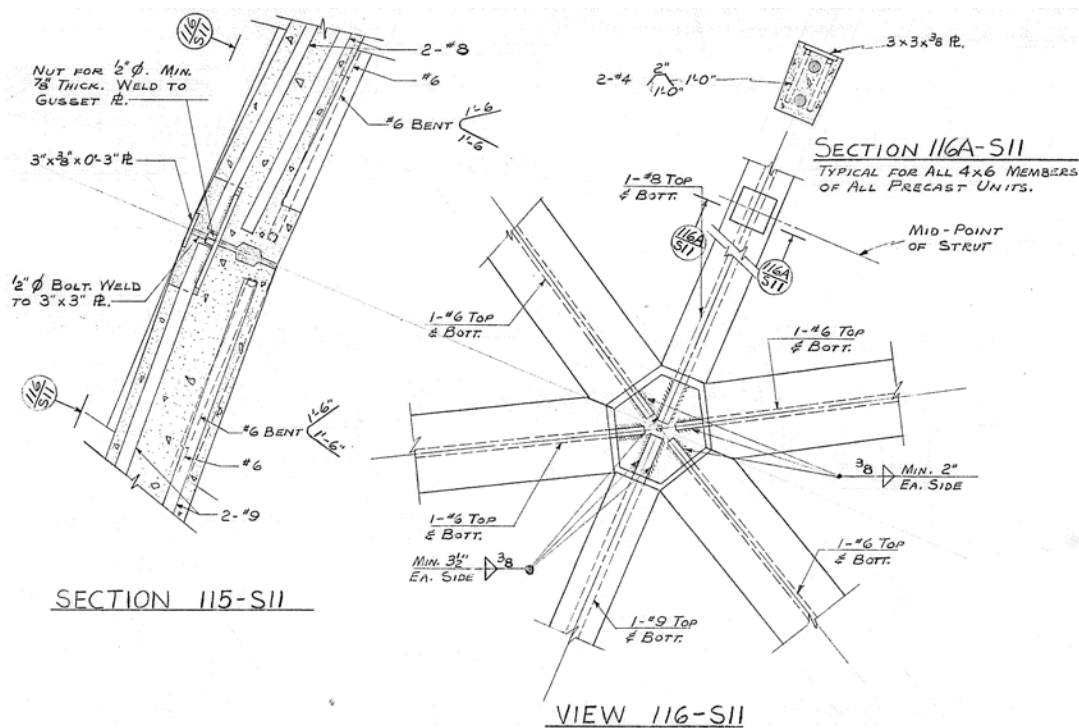
Figure 10: Original Detail at Grouted Weld Plates

Two openings were made to expose the weld plates at Joint F in both test areas. This joint is a “hub” location where several beam elements combine at one hexagonal weld plate, as shown in Figure 10. These weld plates are located on the glass-side of the concrete frame, with a hemi-spherically shaped glazing frame connection hub welded to it. The distance between the glass and the concrete frame is less than eight inches. Concrete removal in both locations was limited to the top half of the weld plate to expose the exterior reinforcing of vertical member No. 14 that is welded to the plate.

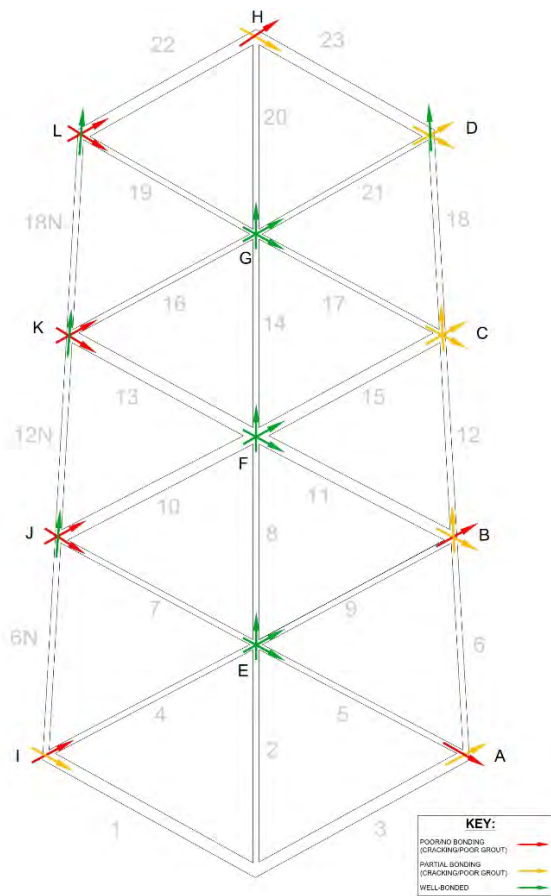
Figure 12: Shear Key Testing of Element M

Surface PV was used to directly measure the compressional wave velocity values through the concrete/grout joint at each of the member intersections (shear keys) A – L to assess the quality of the bond between the concrete and the grout. Three measurements were conducted at each member intersection with the array centered across the grout joint. The configuration for the impact source and sensor location used for the shear key assessment is shown in Figure 11. The test results for all the shear keys in Area M and Q are presented in Figure 12 and Figure 13, respectively. The poor bonding is indicated by the red arrows, partial bonding is indicated by the yellow arrows, and green arrows indicate good bonding.

6. Wave analysis of the weld plate tests indicates roughly 1/3 are fully bonded, 1/3 are partially bonded, and 1/3 are poorly bonded or voided. Figure 13 and Figure 14 illustrate that 1 out of 23 weld plates was fully bonded at all sides, 2 out of 23 were entirely poor and that 20 of the 23 the weld plates were a mixed bag with combinations of good, partial, and poor signal transmission though the weld plates

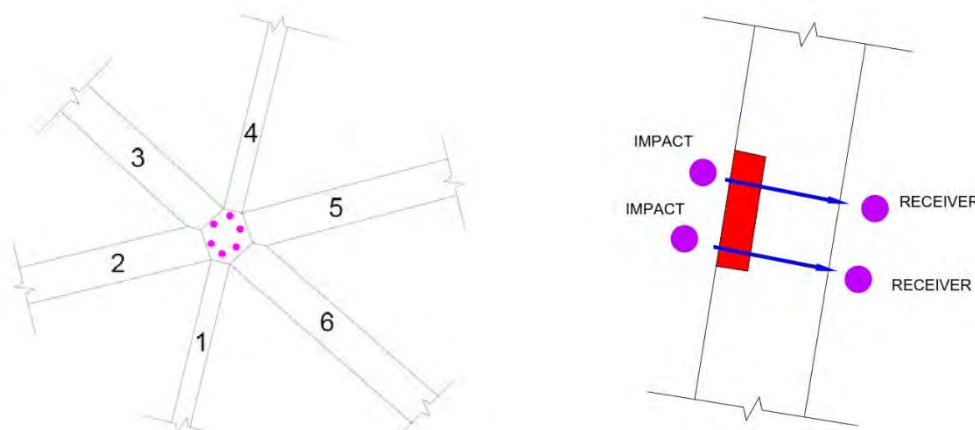
Figure 14: Weld Plate Testing Configuration

Sonic/ultrasonic measurements of the weld plates were conducted through the member with the high frequency energy source located on one face of the element and the sensor at the same location on the opposing face of the element approximately 1-2 inch from the glazing frame connection as shown in Figure 14. These measurements are intended to provide a general assessment of the internal condition of the grout around and behind the weld plates. Confirmation openings were created at joint F for both Areas M and Q.

- a. Verify soundness of grout behind weld plates using sonic through-member testing identified in Figure 14 through Figure 16.
 - b. Conduct a corrosion potential survey to locate joints with corrosion activity.

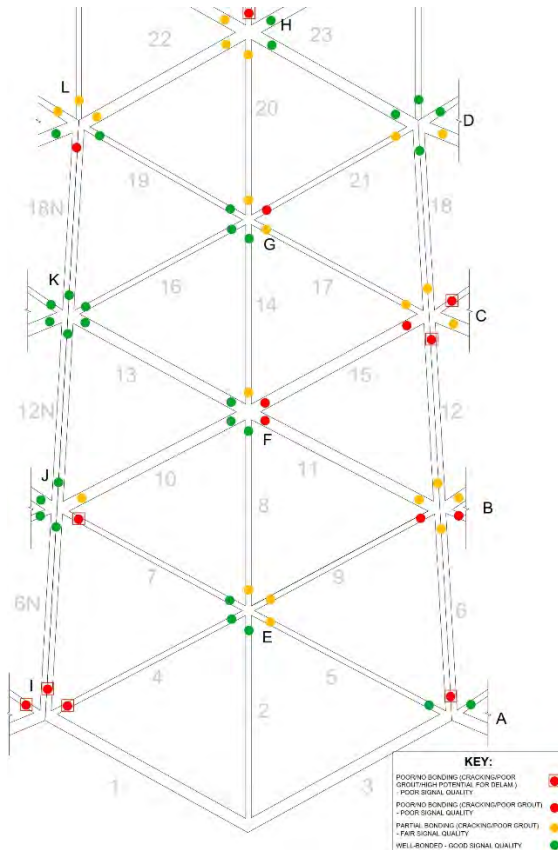
Figure 15: Weld Plate Testing of Element M

1. Well-Bonded – good signal quality indicated by the green circles in Figure 15 and Figure 16
2. Partial Bonding – (cracking/poor grout) – fair signal quality indicated by orange circles
3. Poor/No Bonding – (cracking/poor grout) – poor signal quality indicated by red circles
4. Poor/No Bonding – (cracking/poor grout high potential for delamination/ voiding) – poor signal quality indicated by red circles with squares

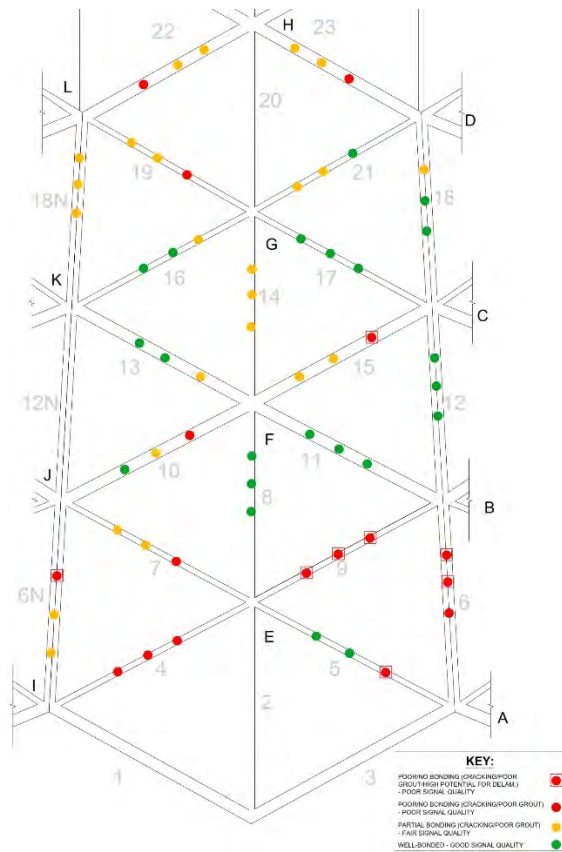
Figure 18: Element Plate Testing of Element M

The data was classified based in signal quality using the same four categories as used for the connection weld plates. The results are presented in Figure 18 and Figure 19.

Table 8 indicates similar quantities as Table 7 for the quality of contact between the weld plates and the concrete. However, the “poor bond” finding is more likely the result of a small air gap between the weld plate and the concrete than any other phenomenon. These weld plates were cast into the concrete, so it is plausible that the process of welding and thermal movements of the glazing may have influenced or loosened the plates slightly. Visual observations indicate the weld plates are intact and in good shape. If a small air gap was present when it was originally cast, the air gap would register as a potential void in this test arrangement.

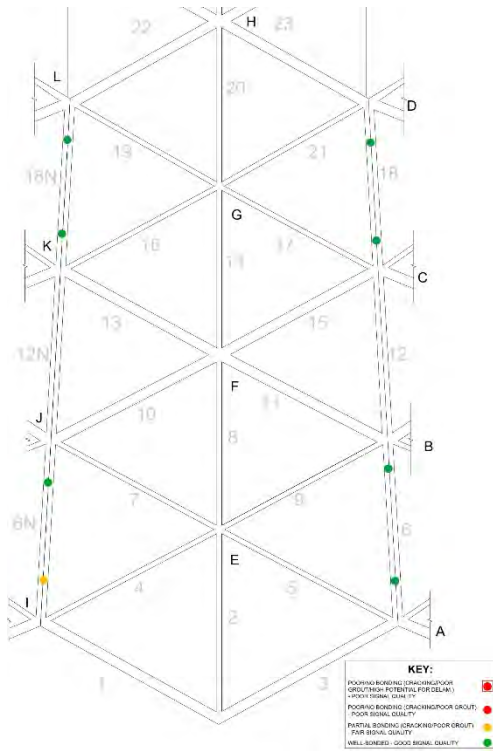
Figure 21: Vertical Grout Pockets Testing of Element M

Measurements were performed at eight locations in each Area M and Q, with a total of 16 tested locations. The same four categories as described previously were used to categorize the measurements based on signal quality. It was determined that 11 measurements (69%) in both elements indicated that the grout pockets were well-bonded and 5 measurements (31%) indicated partial bonding of the grout pockets. These results are illustrated in Figure 21 and Figure 22. It is important to note that no vertical grout joints were categorized as voided.

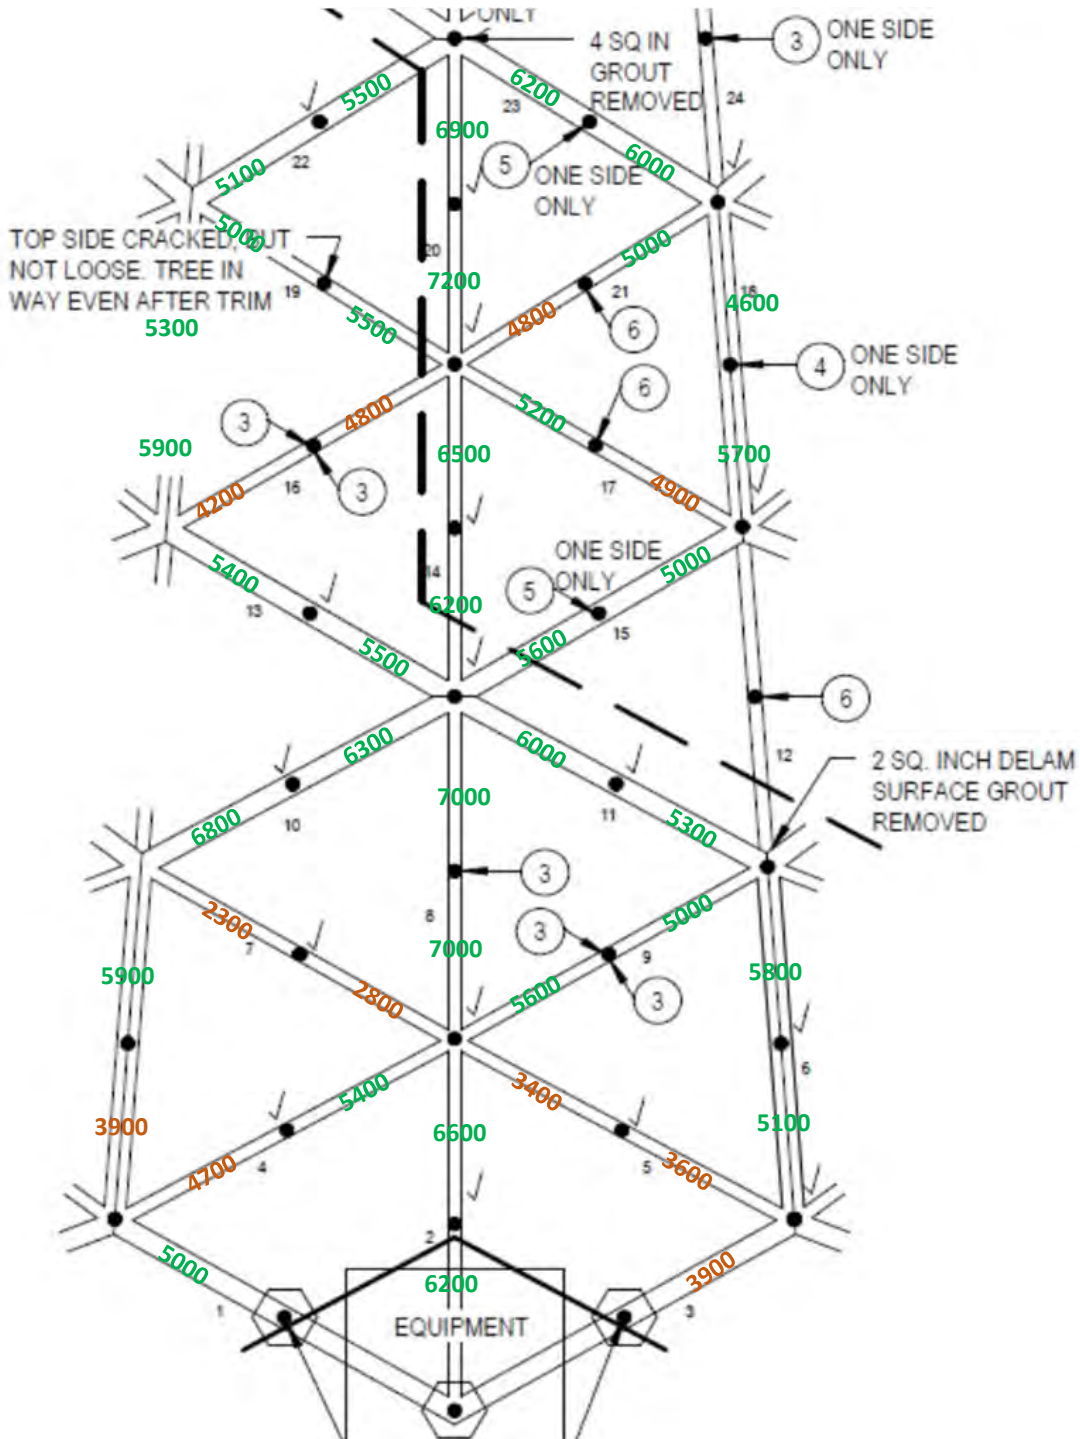
Sonic/ultrasonic velocity and strength results
Element M - Show Dome
Surface Measurements on Structural Units

Compressional and Shear Wave values are directly measured and used to calculate an Average Calculated In-Situ Strength

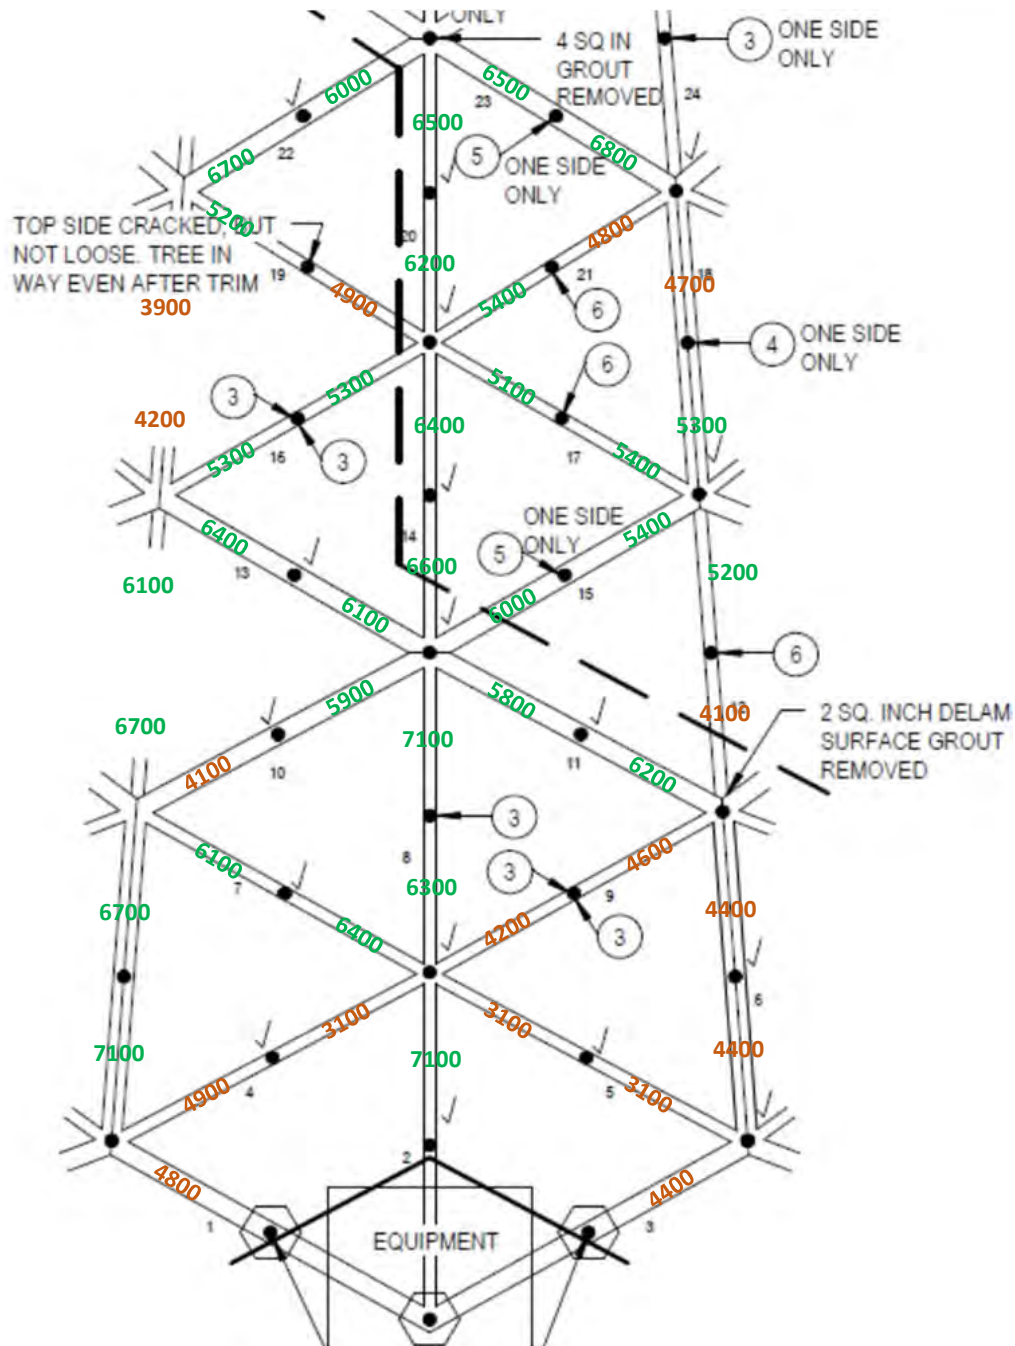
Sonic/ultrasonic velocity and strength results
Element Q - Show Dome
Surface Measurements on Structural Units

Compressional and Shear Wave values are directly measured and used to calculate an Average Calculated In-Situ Strength
