# **Graef Report**

**PROJECT NAME:** O'DONNELL PARK PAVILION WATERPROOFING

**DATE:** 8/18/2011

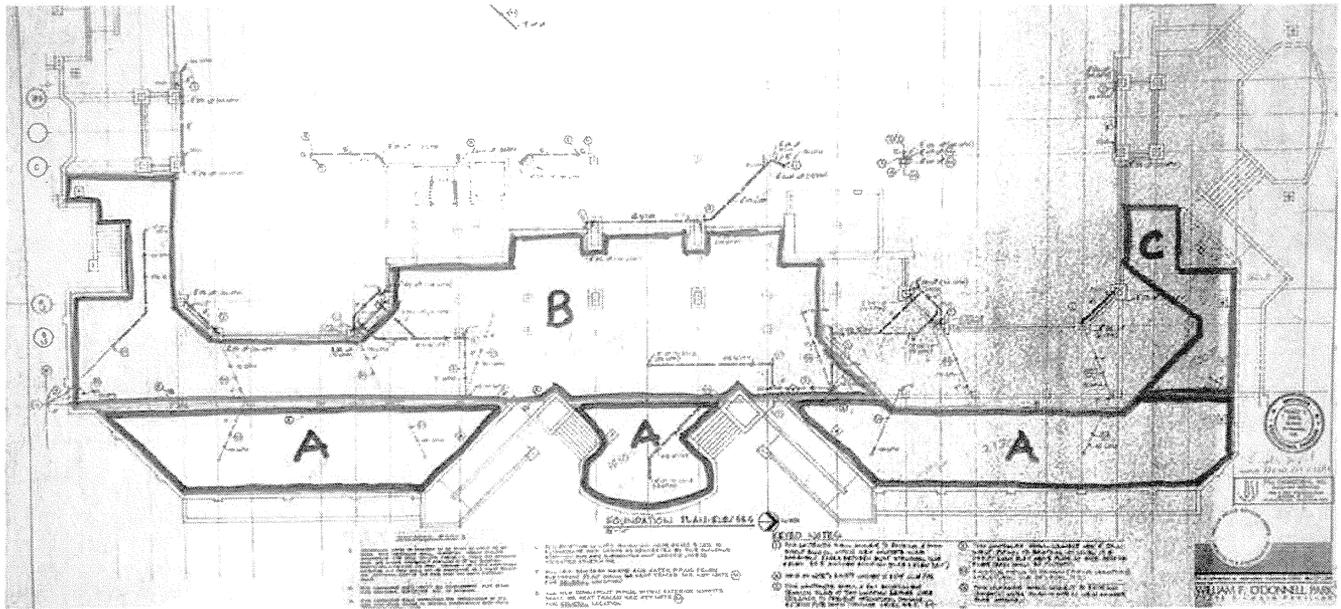
## ZONE A (MOAT)

LEFT  
1800 SF  
225 LF PERIMETER

MIDDLE  
1030 SF  
142 LF PER.

RIGHT  
2170 SF  
254 LF PER.

## ZONE B

6920 SF  
620 LF PERIMETER

## ZONE C

230 SF  
160 LF PERIMETER
