Estabrook Dam Environmental Assessment Public Scoping Meeting

Hydraulic Analyses of Alternatives

June 5, 2014

Michael G. Hahn, P.E., P.H.
SEWRPC Chief Environmental Engineer

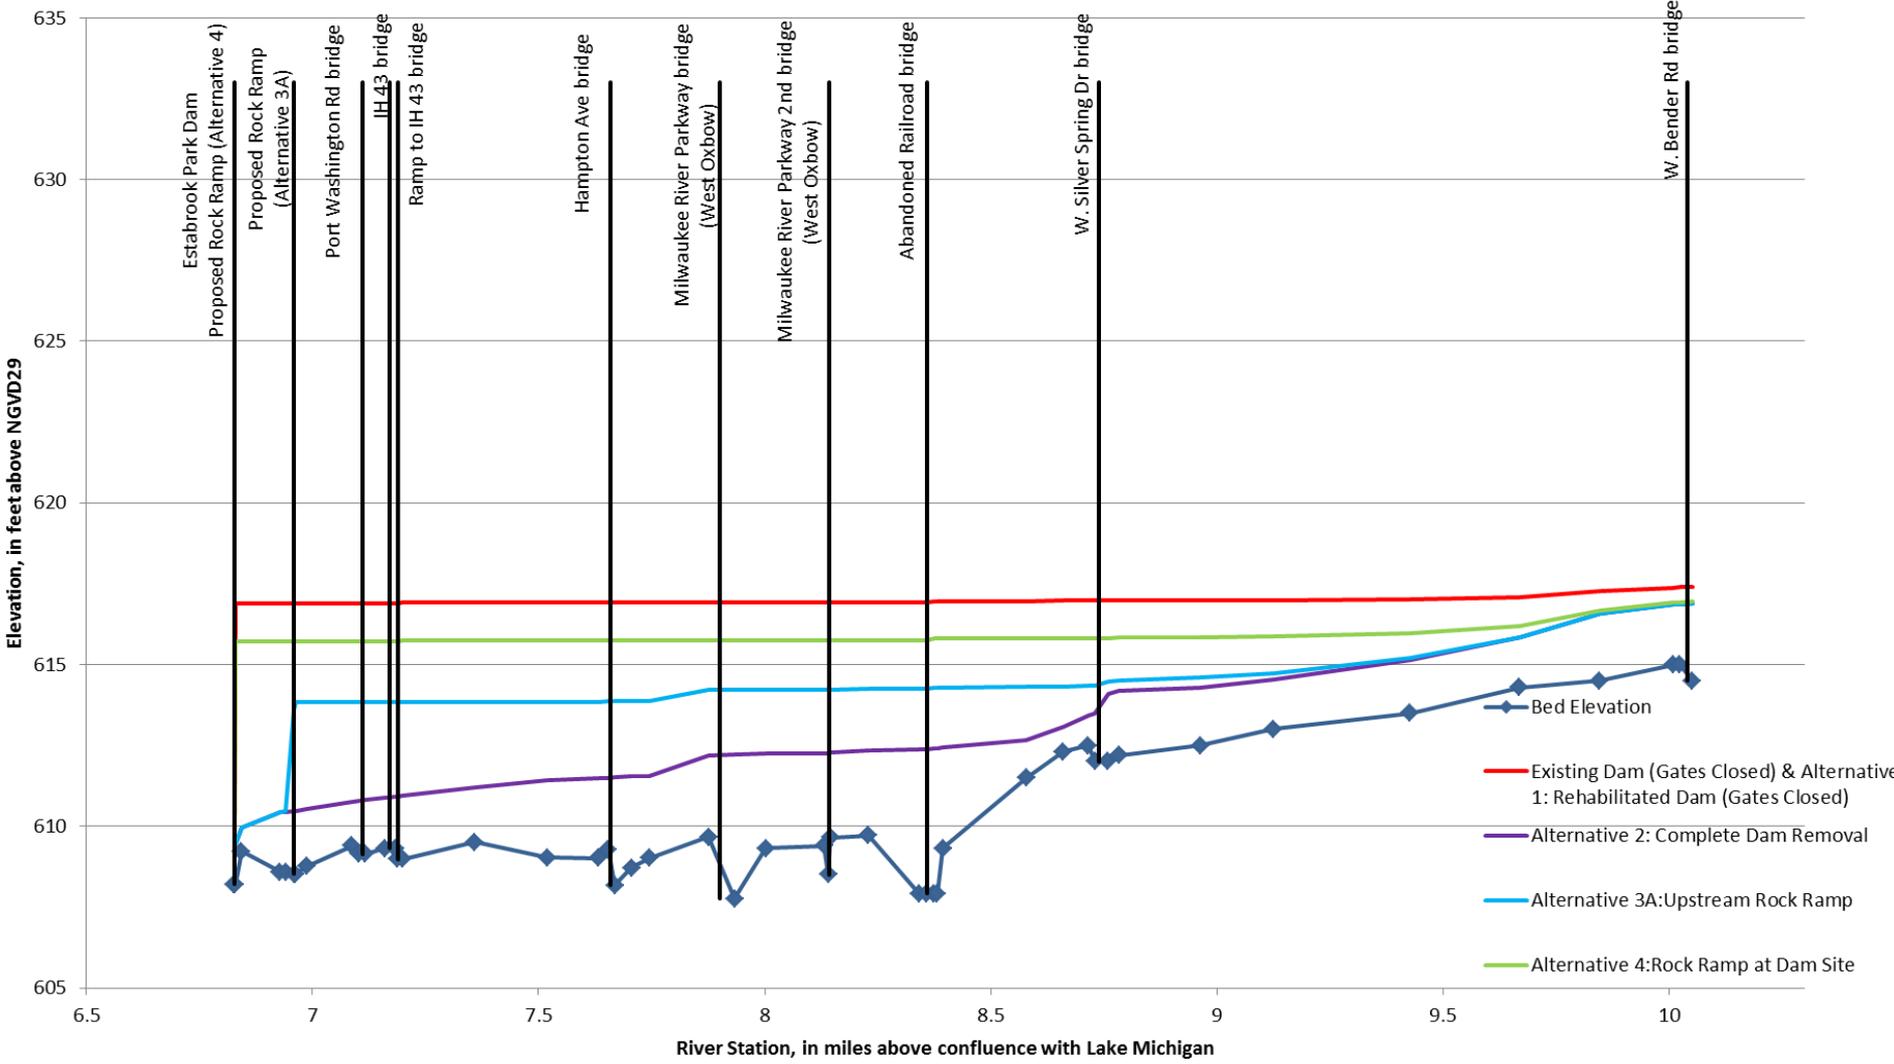
Estabrook Dam Environmental Assessment Alternatives, Milwaukee River Water Surface Profiles for Normal (Median) Flow

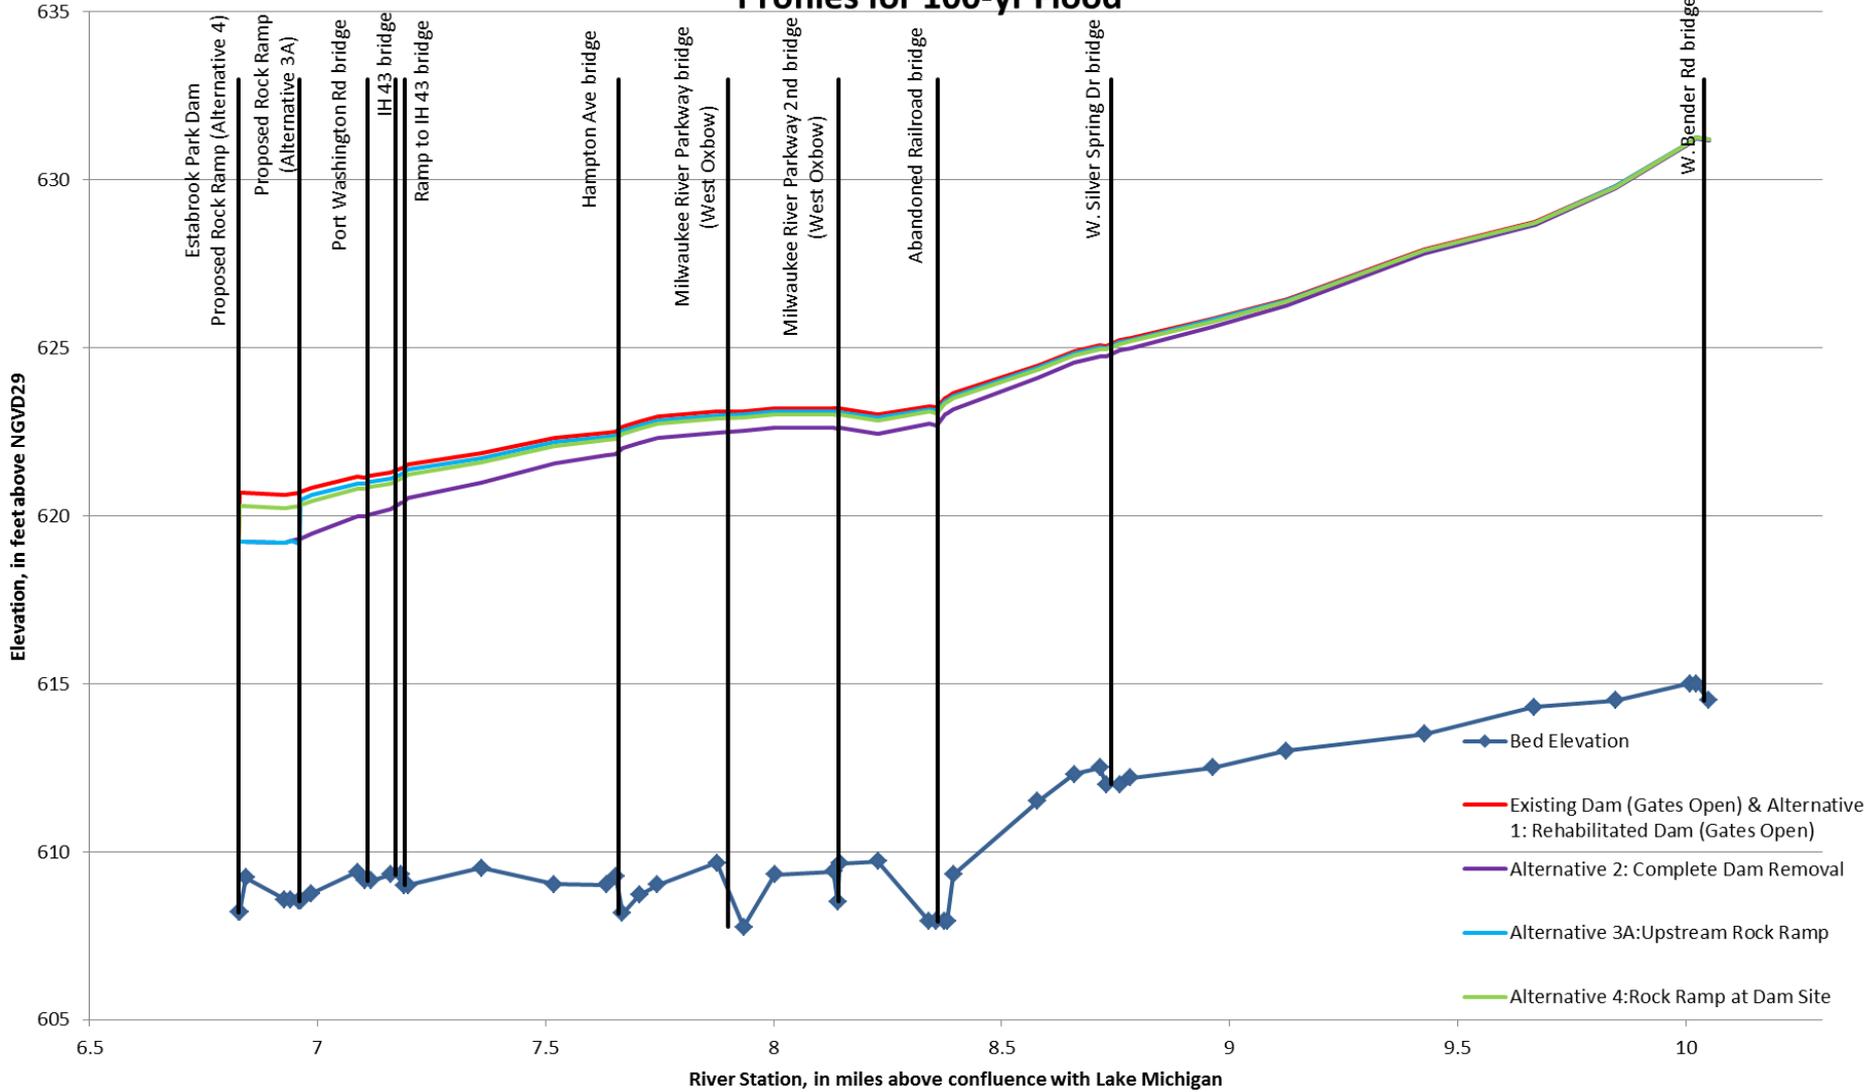
Estabrook Dam Environmental Assessment Alternatives, Milwaukee River Water Surface Profiles for 100-yr Flood

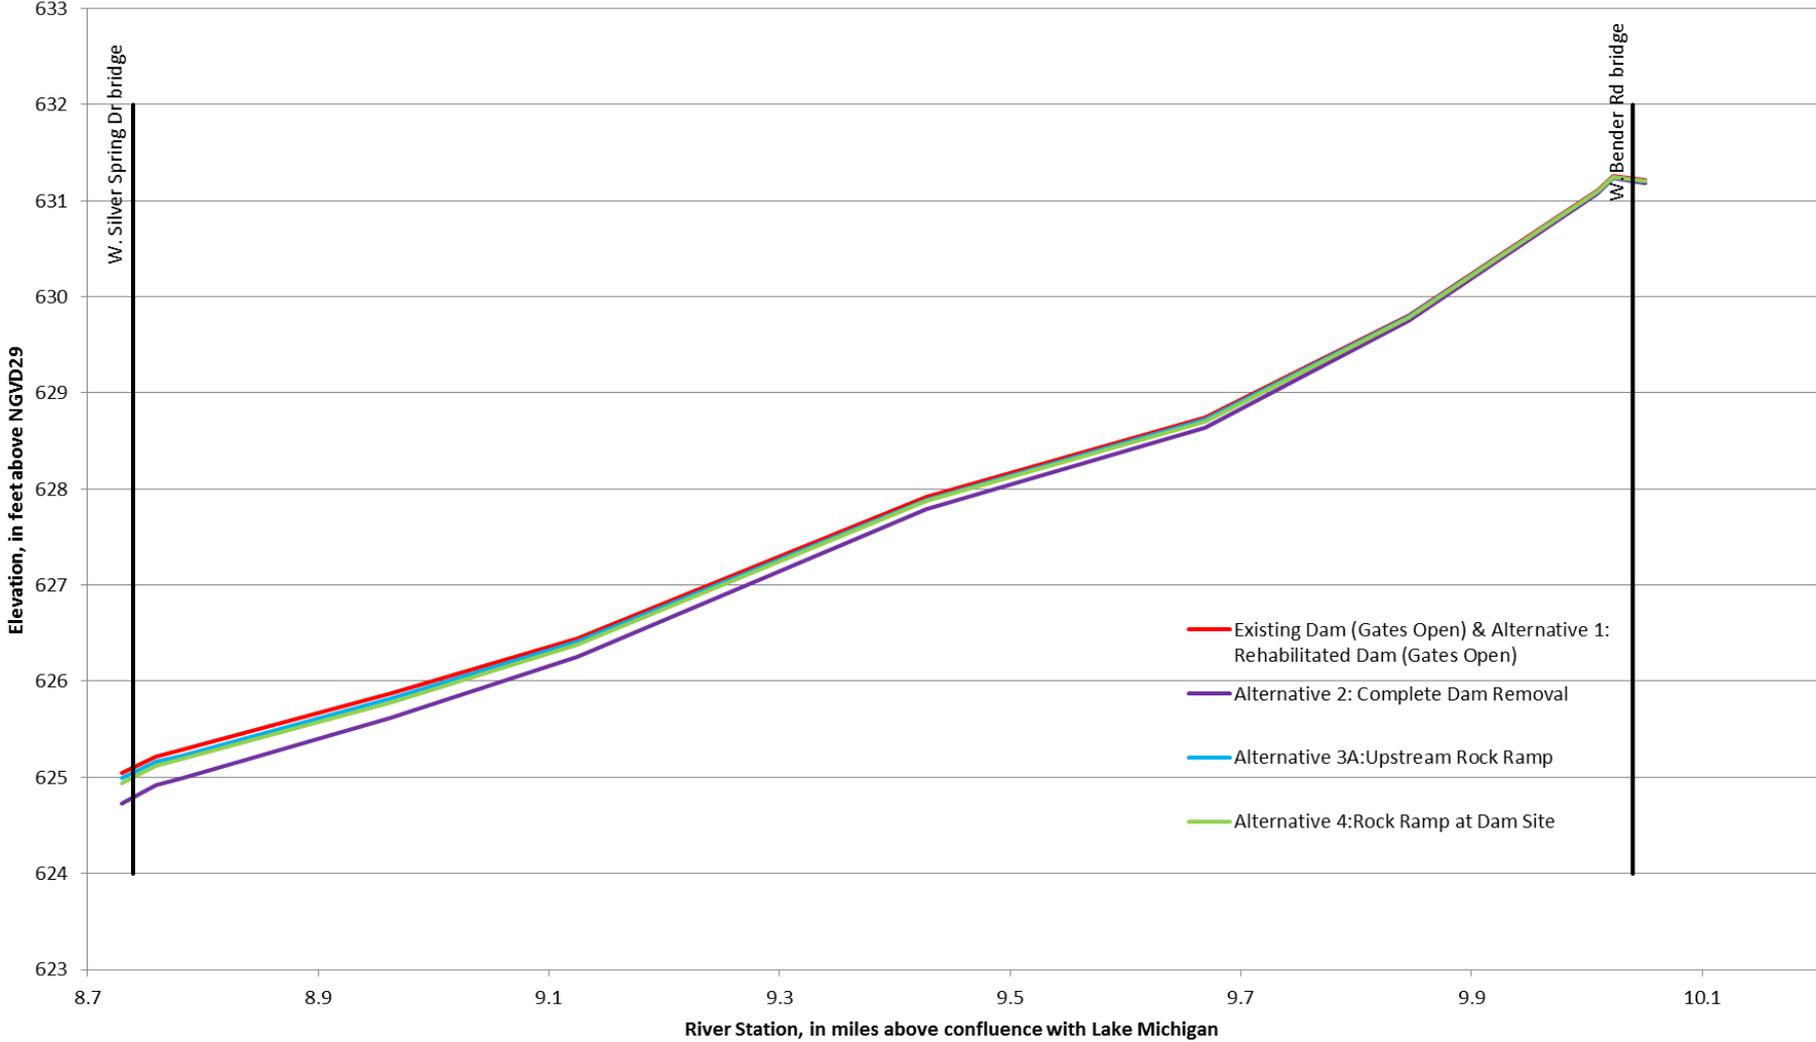
W. Silver Spring Drive to W. Bender Road, Milwaukee River Water Surface Profiles for 100-yr Flood
